Sentry Pest Management

Standard Timber Pest Inspection Report

Report Date	21 Apr 2026
Structure At	54 Norman St, Deagon QLD 4017, Australia
Appointment Date	Tue 21 Apr 2026 10:00AM - 11:30AM
Document Prepared By	Shayne Mullervy
Licence Number	PMT-0-13334 Pest control activity including Timber Pest

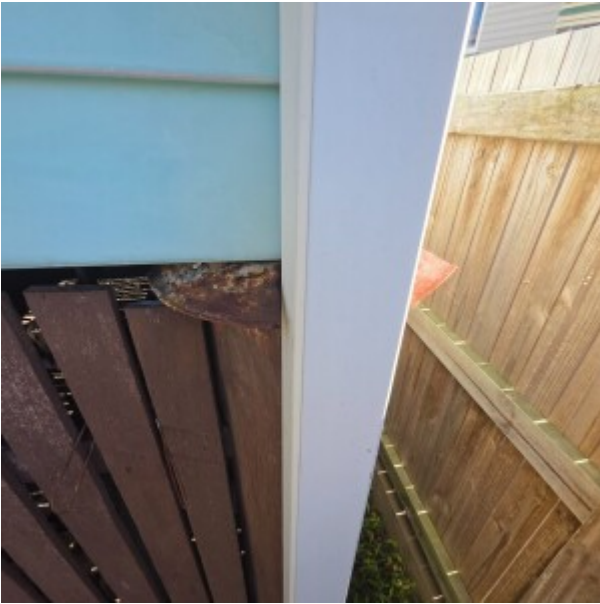
The house is raised off the ground on timber piers with termite shield fitted, however many shields are rusted and or damaged. This can prove termites with concealed entry into the house.

Timber piers cut for downpipe

It is considered essential that the external perimeter of the house is treated to prevent termite infestations.

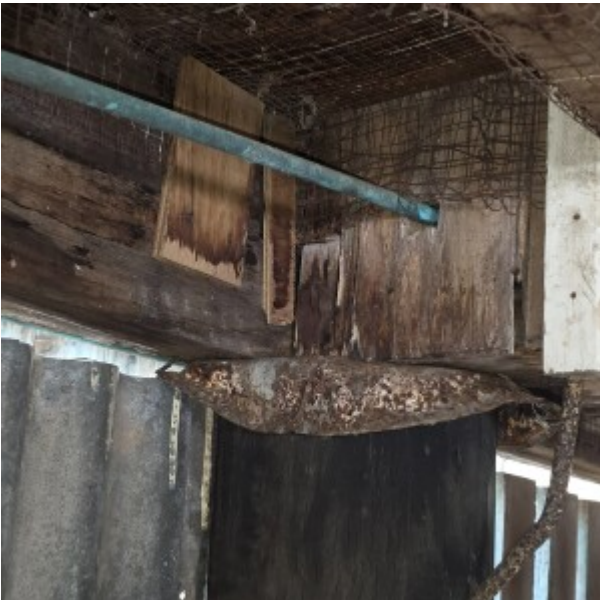
Rusted termite shield

Termite shields have been cut and modify, some are rusted others are damaged.

This Can provide termites with concealed entry into the house.

Replace termite shields and install a termite baiting system around the external perimeter of the house to reduce your risk.

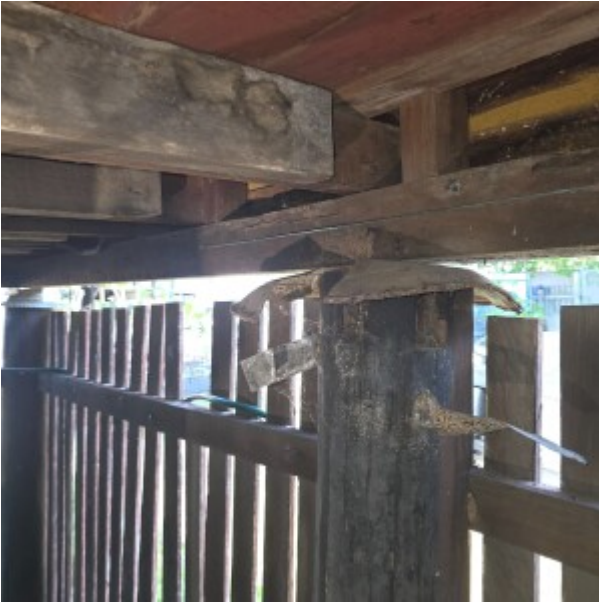
**Damaged termite shields**

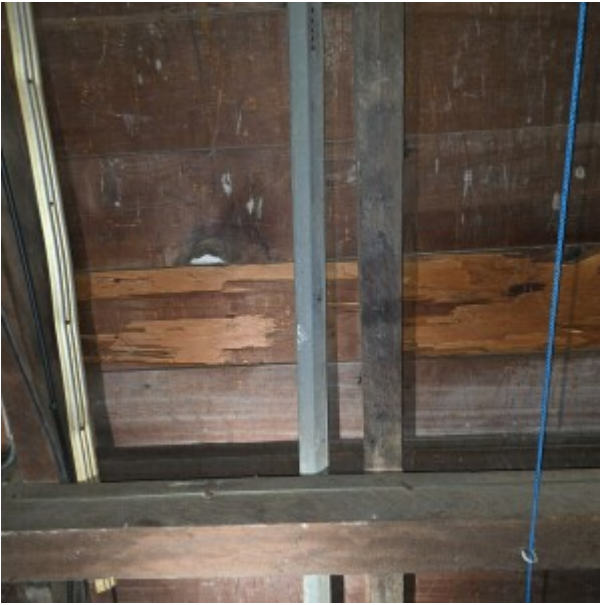
Historical borer damage in some floor boards and possibly historical drywood termite damage, much of the damage has been dug out making clear identify difficult.

Damage in flooring

Consult with a building professional for advice on structural integrity and repair options regarding damaged flooring.

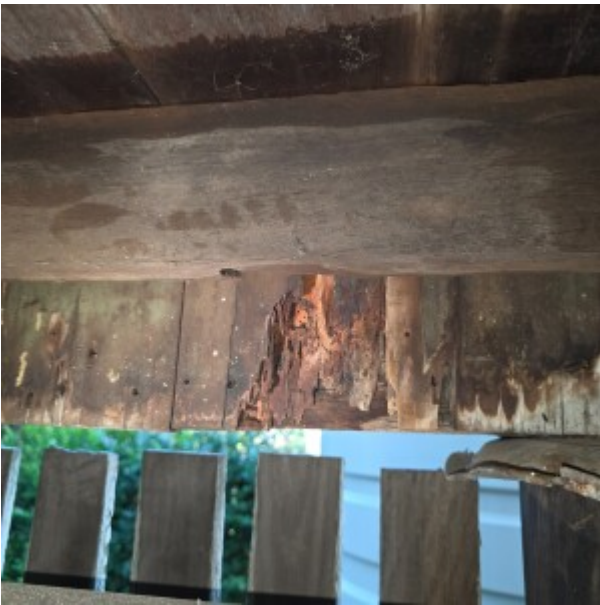
Damage in wall boards

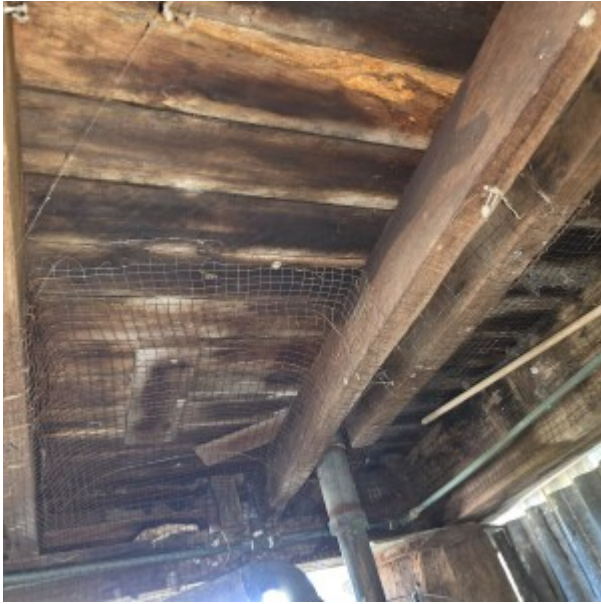
Damage in flooring

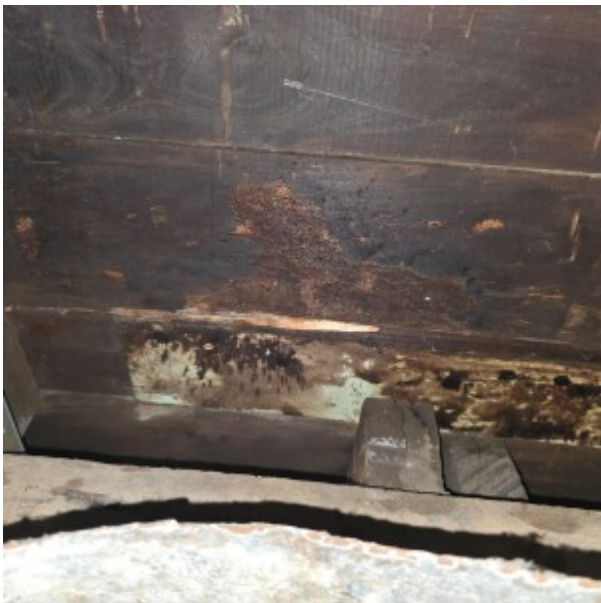
Damage in flooring
