PRE-SALE STANDARD BUILDING REPORT

Report number: 2026024

Inspection date: 02 Feb 2026

Property address: 63 Ronald Court
Caboolture South

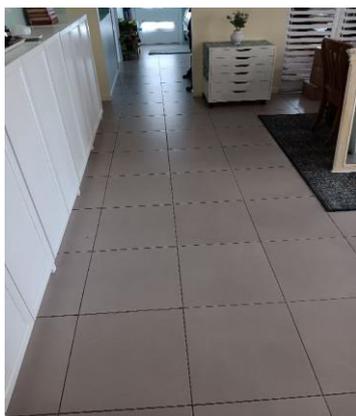
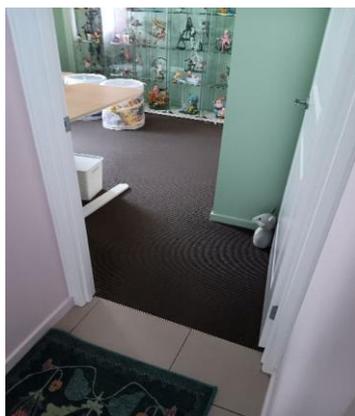
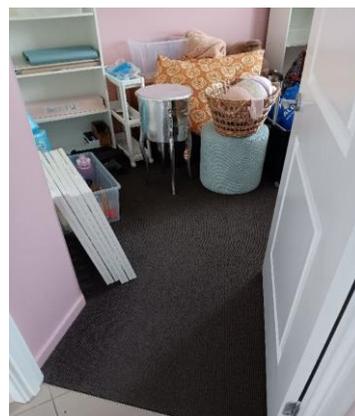
Floor Coverings.
General wear to the floor coverings throughout the house.

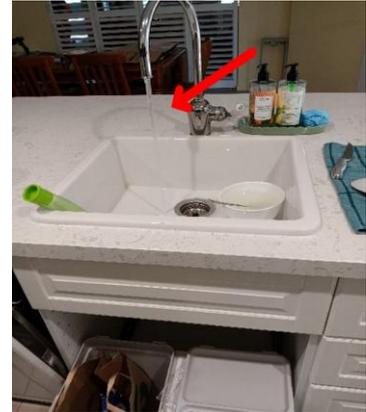
Kitchen.

No water leaks were found under the kitchen sink on the day of inspection.
Red arrow shows the water running for water leak inspection.
Minor water stains and minimal moisture damage to the cabinets. Please note that this was dry on the day of inspection.
Please note the obstructions under the kitchen sink are preventing a full inspection of this area.

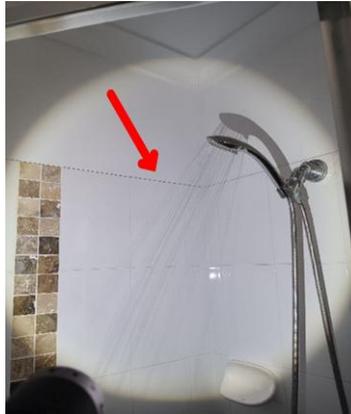
Ensuite.

Shower Testing.

The red arrow shows the shower running. We are checking for water leaks / moisture readings inside the wall cavity and around the shower recess. Please note shower leaks can appear at any time. Owners should always monitor this.

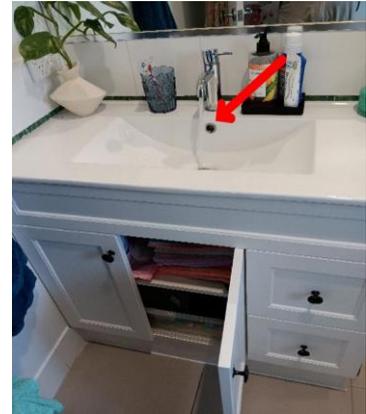
Ensuite Bathroom Vanity.

No water leaks were found inside the cabinet on the day of inspection.

Please note, the red arrow shows the water running for water leak inspection.

Minor stains & minimal moisture damage to the cabinet. (This was dry on the day of inspection.)

Please note the obstructions under the vanity basin are preventing a full inspection of this area.

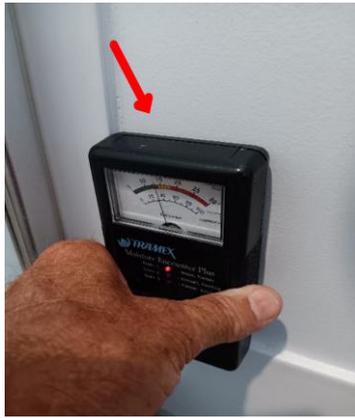
Ensuite.

Moisture Reading Test.
(Internal wall reading)

No major moisture readings or water leaks were found around the wet areas or behind the shower recess on the day of inspection.

Please note, water leaks can occur at any time. Recommend the owner to visually inspect all wet areas.

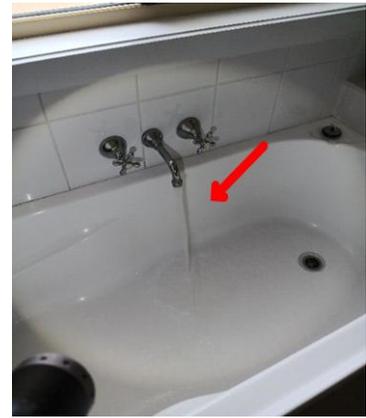
Bath- water Testing.

Please note that the water is running, to check the bath for leaks. No visual leaks were found on the day of inspection.

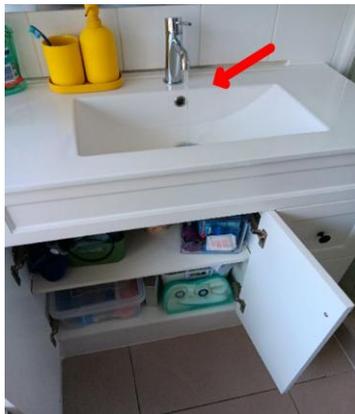
Main Bathroom Vanity.

No water leaks were found inside the cabinet on the day of inspection.

Please note, the red arrow shows the water running for water leak inspection.

Minor stains & minimal moisture damage to the cabinet. (This was dry on the day of inspection.)

Please note the obstructions under the vanity basin are preventing a full inspection of this area.

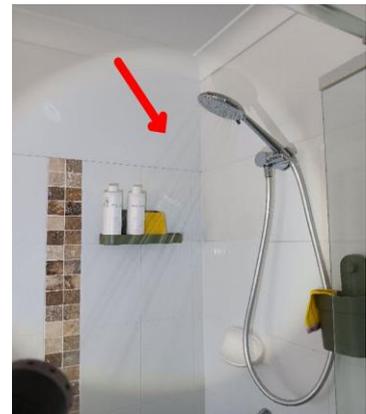
Main Bathroom.

Shower Testing.

The red arrow shows the shower running. We are checking for water leaks / moisture readings inside the wall cavity and around the shower recess. Please note shower leaks can appear at any time. Owners should always monitor this.

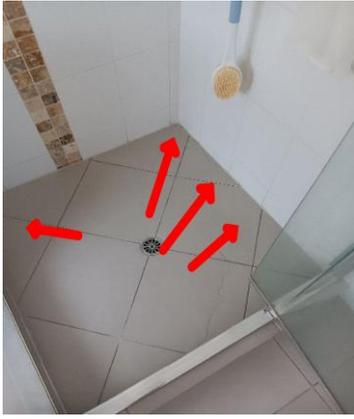
Minor tile fractures to the main bathroom shower recess.

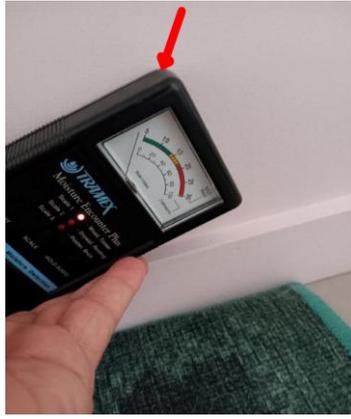
Main Bathroom.
Moisture Reading Test.
(Internal wall reading)
No major moisture readings or water leaks were found around the wet areas or behind the shower recess on the day of inspection.
Please note, water leaks can occur at any time. Recommend the owner to visually inspect all wet areas.

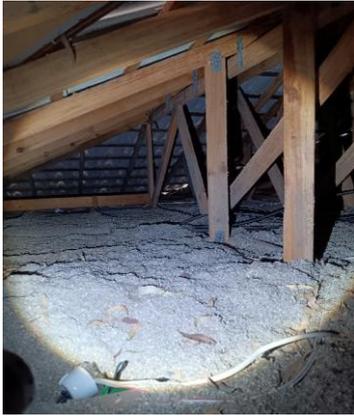
Roof Cavity Insulation.
There is roof cavity insulation installed. Please note the insulation is an obstruction, preventing us from visually inspecting all areas of the roof cavity, bottom of the trusses & the rear of the ceiling sheets.

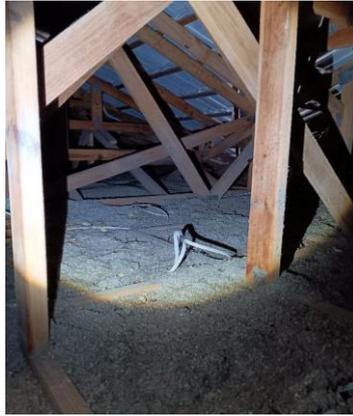
Restricted visibility to the soffits / eaves, subject to these being below the ceiling height and are in a concealed area. This prevents us from visually inspecting any structural beams / framing, garage beams, window lintels and the external wall framing.

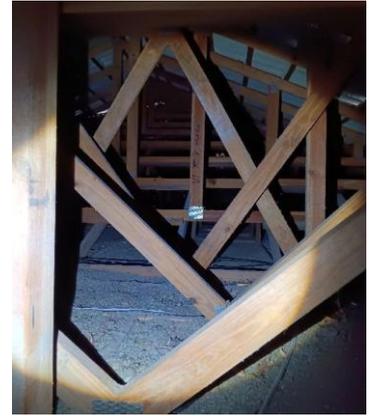
Some areas obstructed.

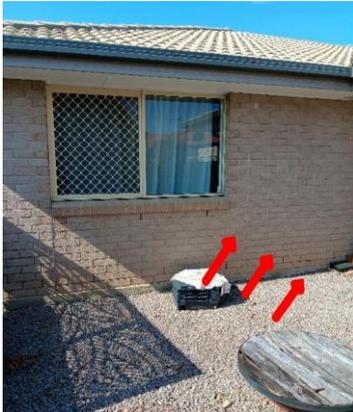
Minor movement fracture to the northern wall. Recommend the buyer to monitor this for future repairs.

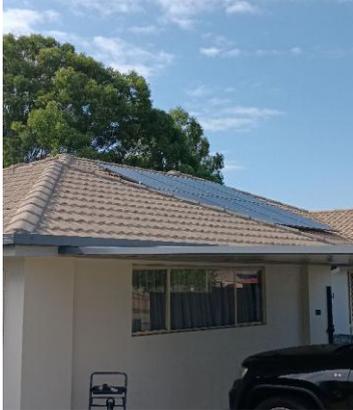
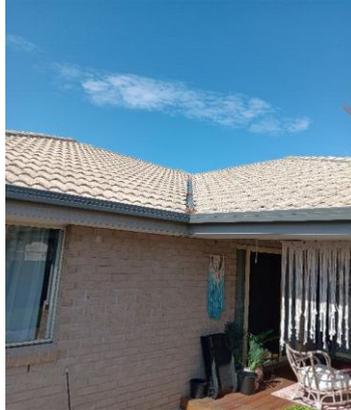
Roof Exterior.

Minor movement fracturing to the roof hip tiles.

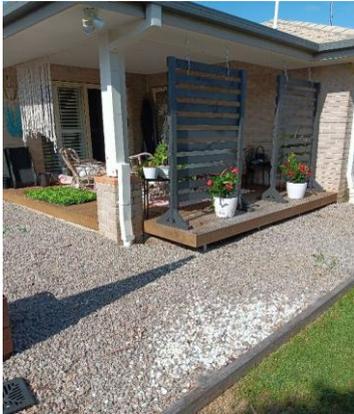
Low Decking.

Subject to the decking being close to the ground, we could not visually inspect the condition of the structure under this decking.

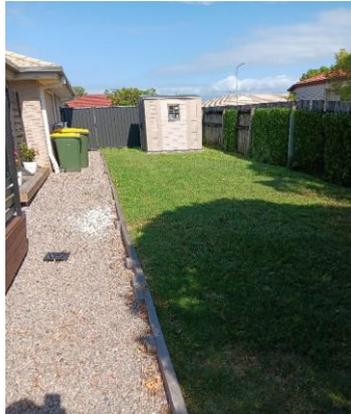
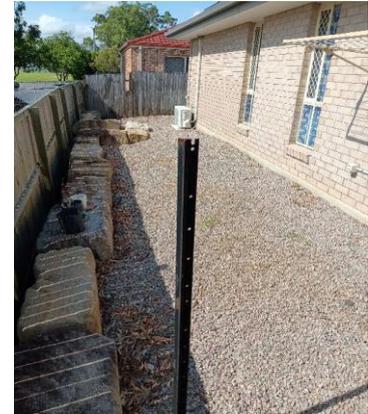
Major visual subsidence to the eastern rear yard. This is causing the rear retaining wall to lean. Buyer to monitor this for future repairs by a builder.

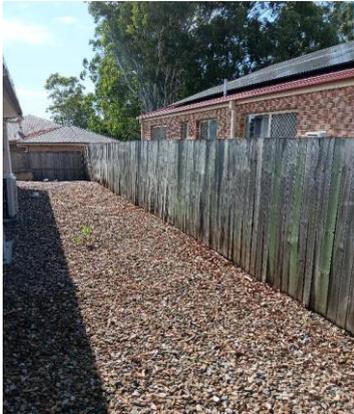
Fences.

General maintenance will be required in the future to maintain all the timber fences around the property. Signs of wood decay and weathering to the timber fences.

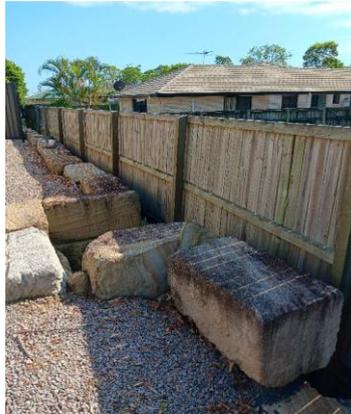
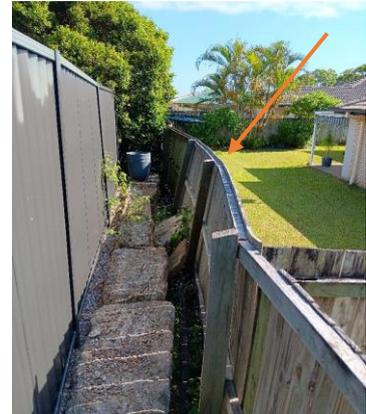
Major.

The rear eastern fence is collapsing. Recommend a carpenter to fix this.

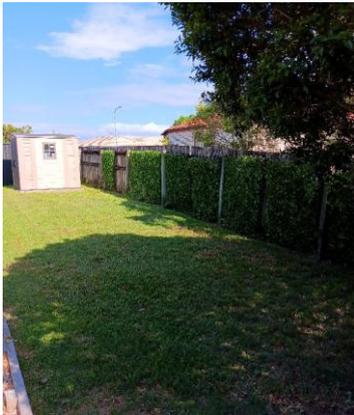
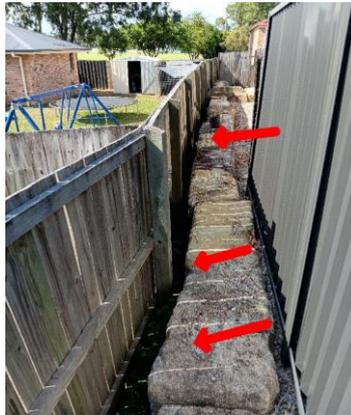
Major.

The eastern retaining wall is leaning. Recommend the buyer to monitor this for future repairs by a builder.

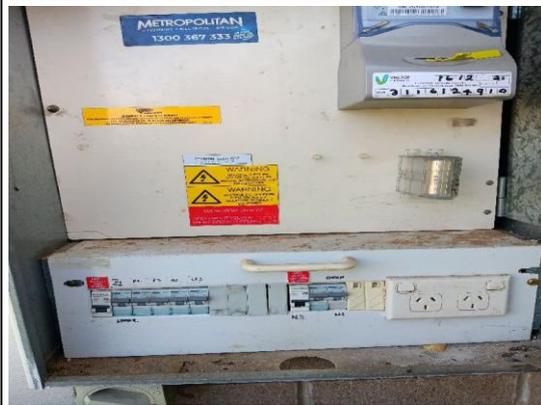
Switch Board.

Observation Only. (Not listed as a Defect.)

If the buyer is concerned, we recommend an electrician to check that all required safety switches have been installed.
