Sentry Pest Management

Standard Timber Pest Inspection Report

Report Date	02 Feb 2026
Structure At	63 Ronald Ct, Caboolture South QLD 4510, Australia
Appointment Date	Mon 02 Feb 2026 8:30AM - 10:00AM
Document Prepared By	Shayne Mullervy
Licence Number	PMT-0-13334 Pest control activity including Timber Pest

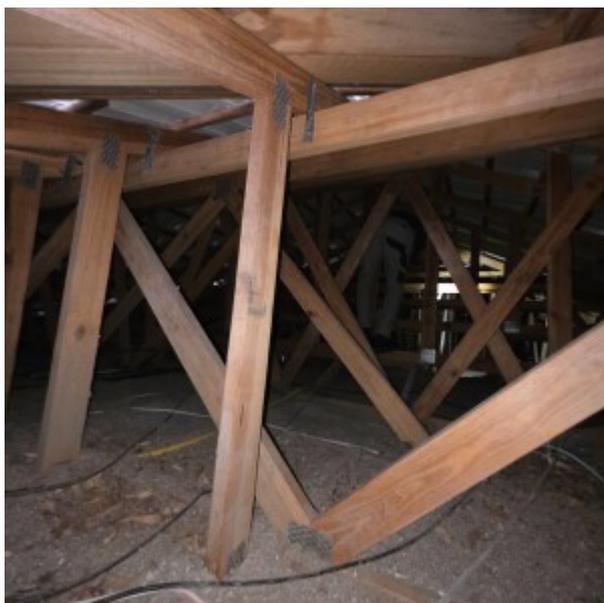
Roof space

Roof space: Thermal insulation can conceal termite activity. We do not move thermal insulation.

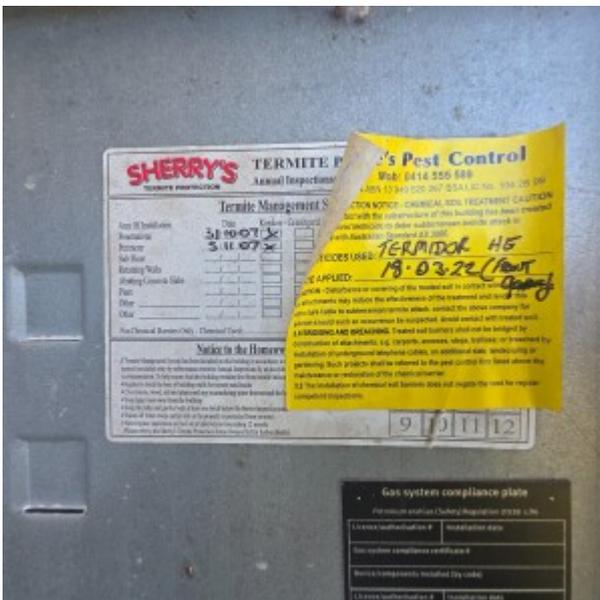
Treatment stickers in the meter box indicates kordon is installed in the brickwork of the house and service penetrations of the house slab.

Treatment sticker in the meter box indicates a chemically treated zone is installed along the front of the house.

Treatment stickers

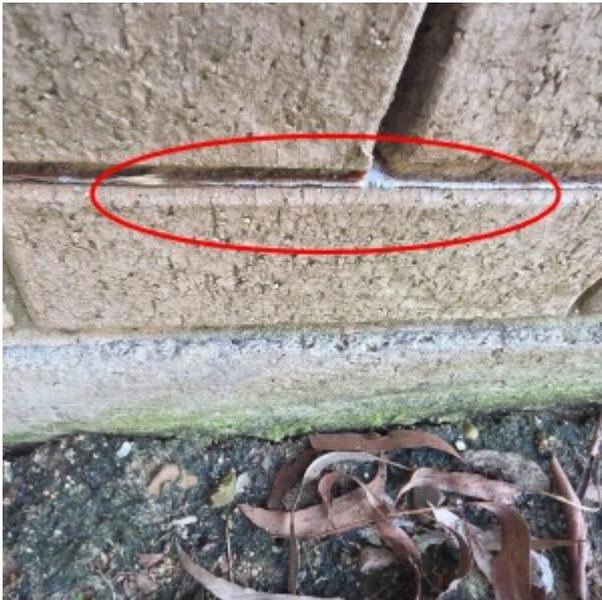
Termite management system

Kordon installed in the brickwork

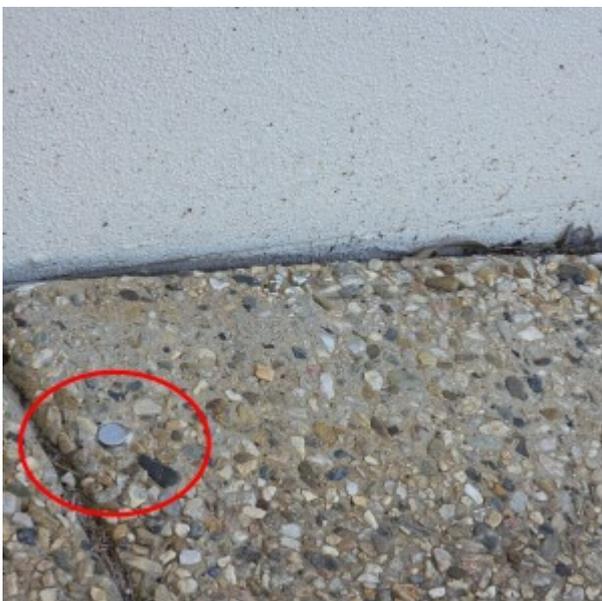
Termite management system

Drill holes in the concrete slab indicates a chemical treated zone is installed.

Chemically treated zone. Drill holes in concrete

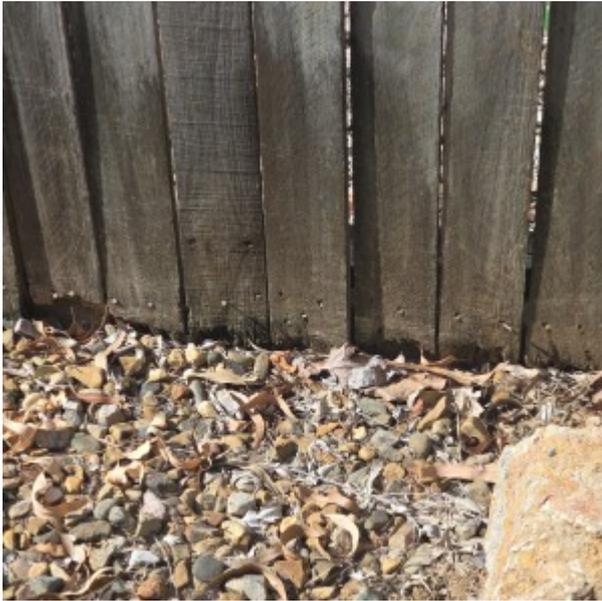
Fences

Decay in fences

Decay in pailings

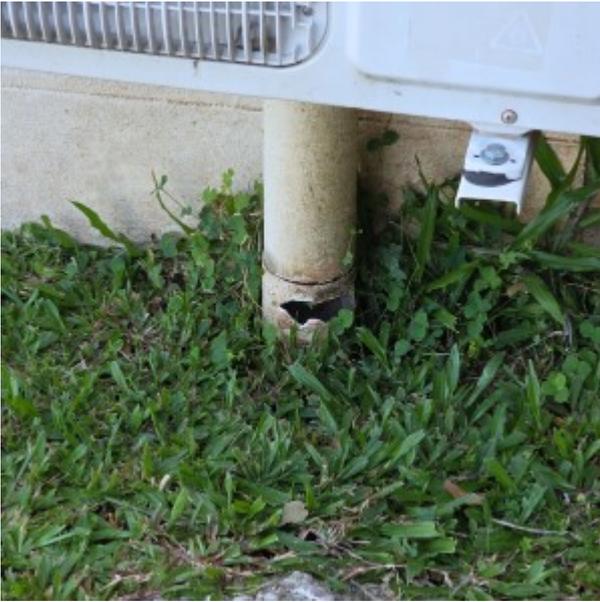
Broken down pipes can discharge water close to the house. Repair pipes to reduce your risk of termite infestation.

Damaged downpipe

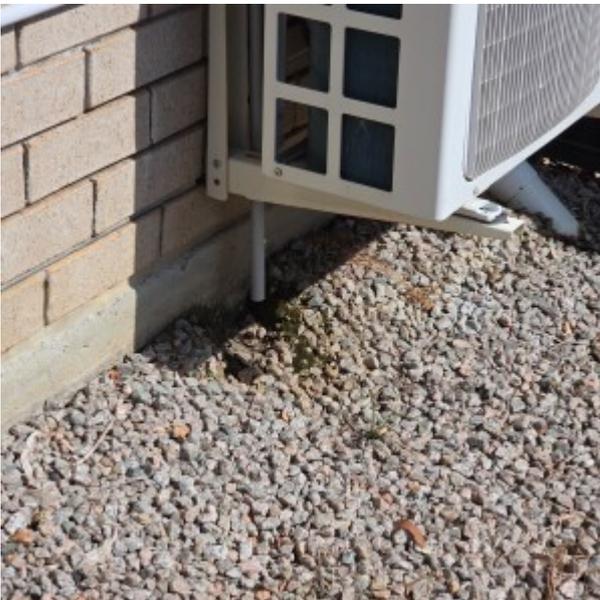
Air-conditioning discharge pipe discharges close to the house abs water pools. Connect Air-conditioning discharge pipe to a nearby drain or drain further out from the house to reduce your risk.

Air-conditioning discharge pipe

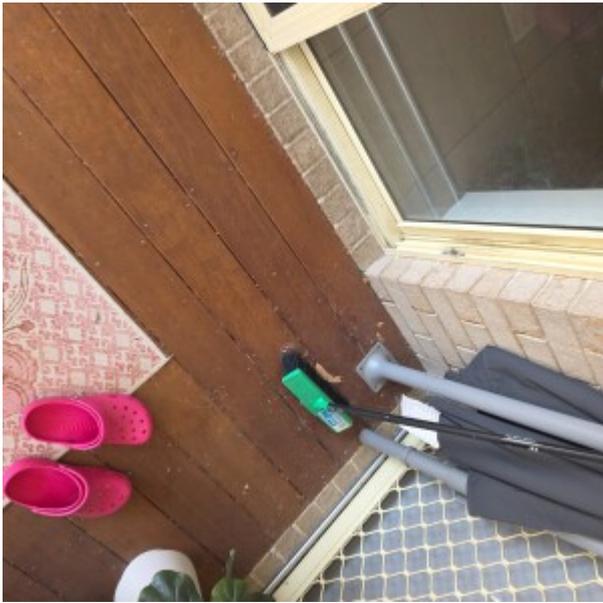
The rear deck abuts the external wall of the house above the termite management system this can provide termites with concealed entry into the house. Decks should have a minimum 30mm clearance from the wall to provide clear line of sight and help prevent termite infestations.

Rear deck
