# VISUAL TIMBER PEST INSPECTION & REPORT

Complies with Australian Standard AS 4349.3-2010

80 Commodore Crescent  
Port Macquarie, NSW  
2444, Australia

Inspection Date: 18 Jun 2026  
T: 0423 559 129

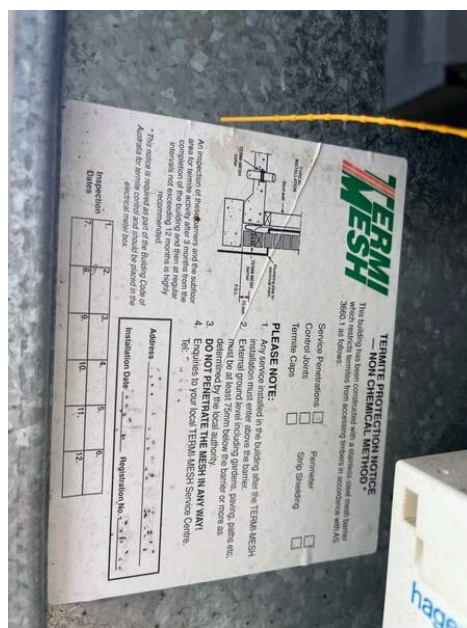
Type of notice: preconstruction physical termite barrier  
Condition of notice: Poor

Photo Ref #2: The durable notice appears to refer to a Termimesh

perimeter and pipe penetration termite barrier

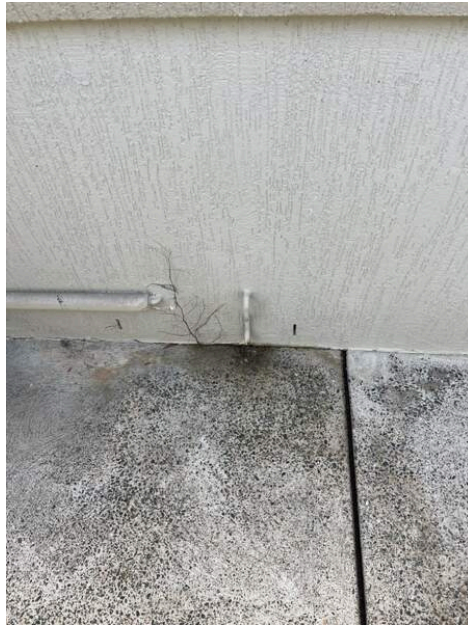
✗ Yes, HWS overflow pipe. The hot water system overflow pipe may discharge moisture adjacent to the structure. We recommend the overflow be directed into a drain. This should be rectified as moist soil conditions are highly conducive to timber pest attack and can also break down termite barriers quicker than their expected life span.

Comments : Overflow pipe for HWS is up against the western side of the home

Photo Ref #3: The hot water system pressure relief valve should be redirected into a downpipe or away from the house as high moisture levels are conducive to timber pest activity.

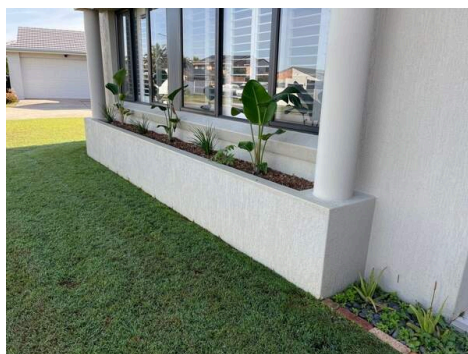
Comments : The garden bed at the front entry is breaching the weep holes  
Front entry tiles are at the base / breaching the weep holes

Photo Ref #4: The front garden beds abutting the external walls breach the termite barrier. Due to this a chemical

barrier and/or bait stations should be installed to this region to prevent possible concealed termite entry.

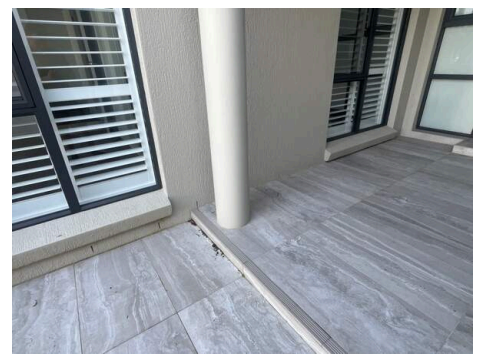
Photo Ref #5: The front entrance tiles breach the weep holes and the termite barrier. Due to this a chemical drill and

inject barrier should be installed to this region to prevent possible concealed termite entry.

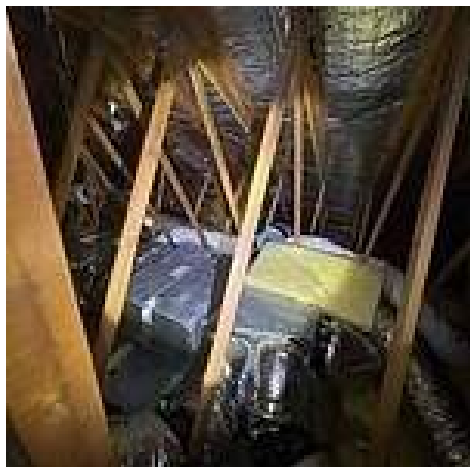
✗ Roof void due to sarking, insulation material & AC ducting.

Photo Ref #7: A complete visual inspection of all timber framing members to the roof void was restricted by insulation and air conditioning units.
