# Property and Timber Pest Report

Inspection Date: 22 Jun 2026

Property Address: 25 Astronomers Terrace Port Macquarie 2444

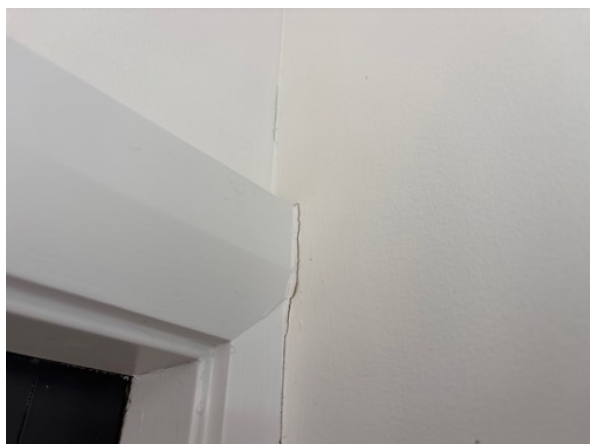
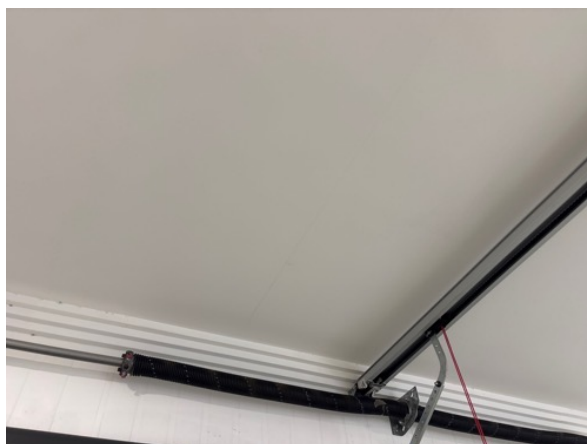
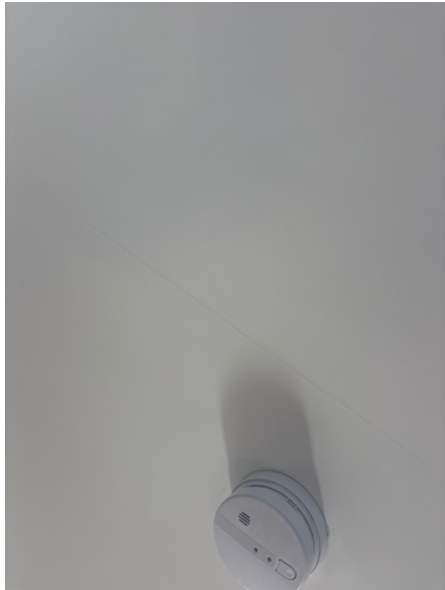
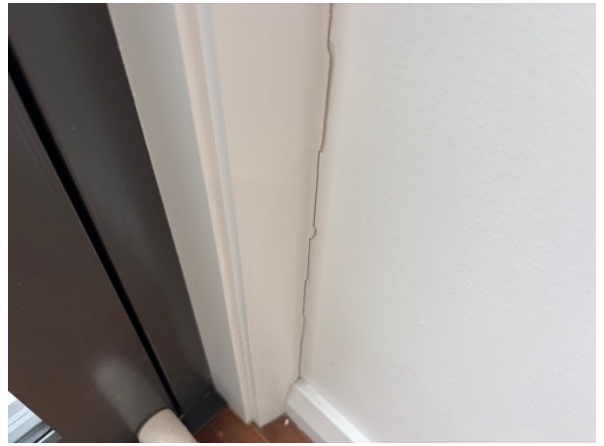
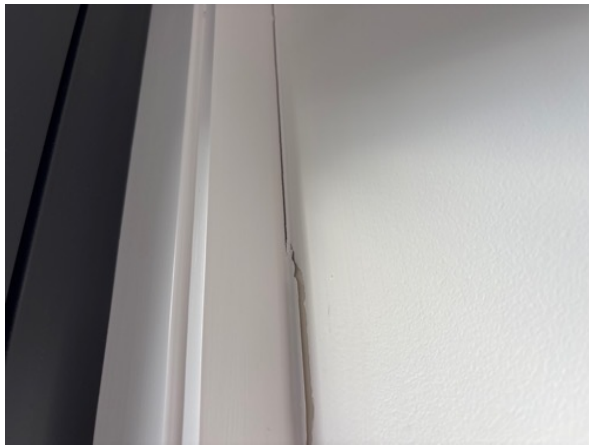
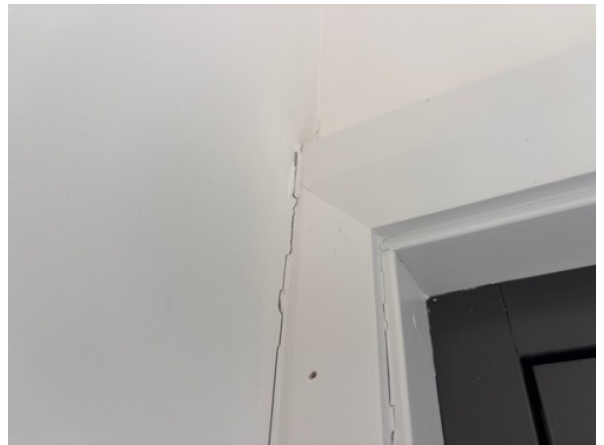
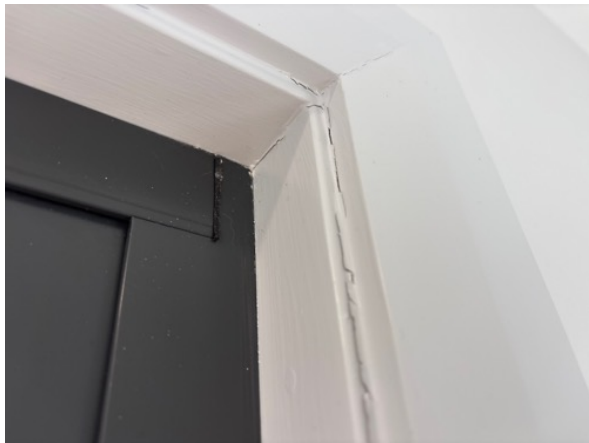
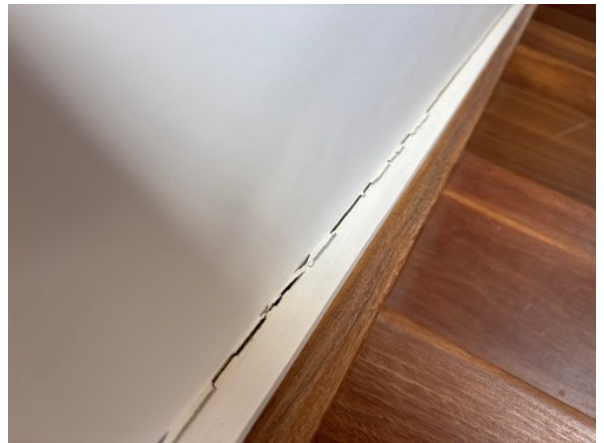
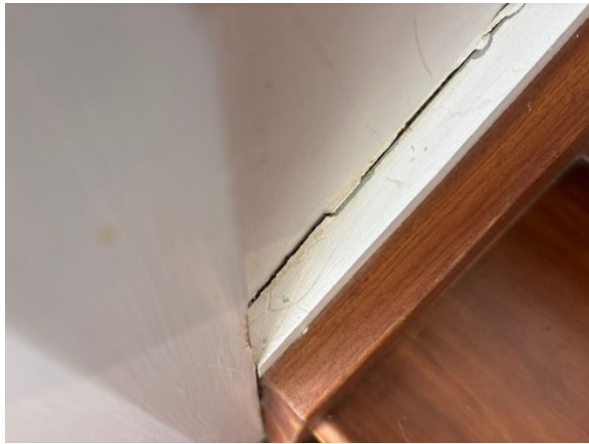
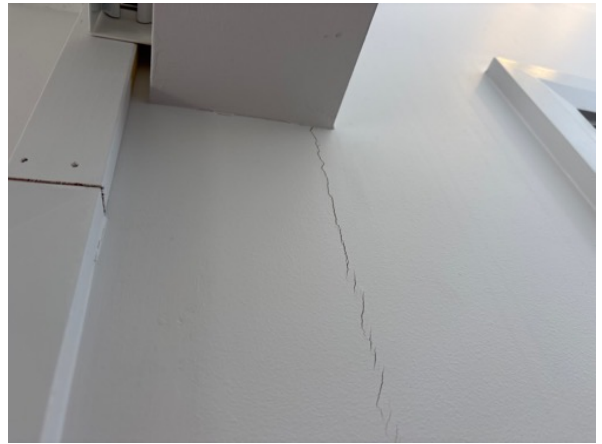
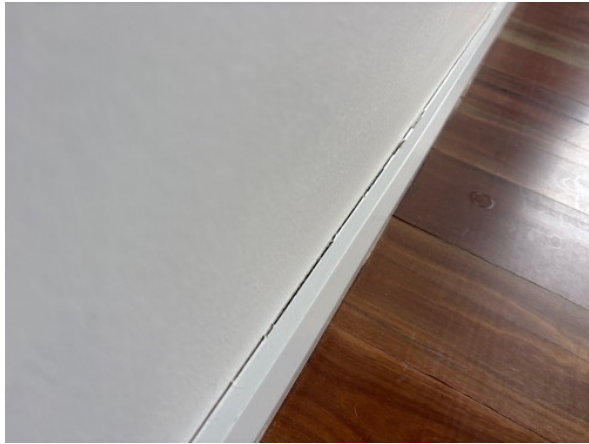
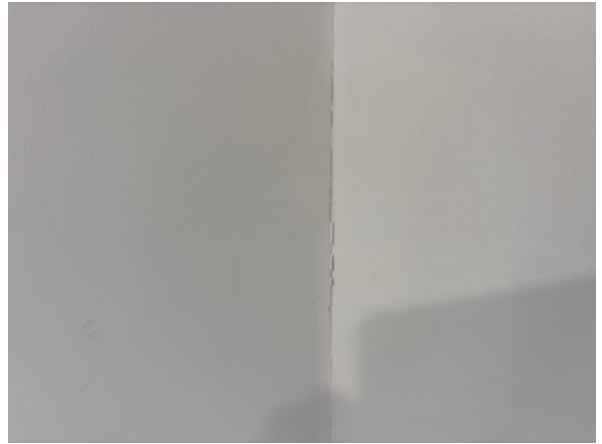
**Finding:** Small cracks in plasterboard and timber finishings

A small number of minor cracks were observed in the plasterboard and timber elements. These fine cracks are generally cosmetic in nature and are classified as appearance defects. While they may be noticeable, such cracking is common and does not indicate structural failure. Fine cracking typically results from normal movement and minor separation between building materials and finishes. Repairs are generally minor and can be addressed by filling, sanding, and repainting as required.

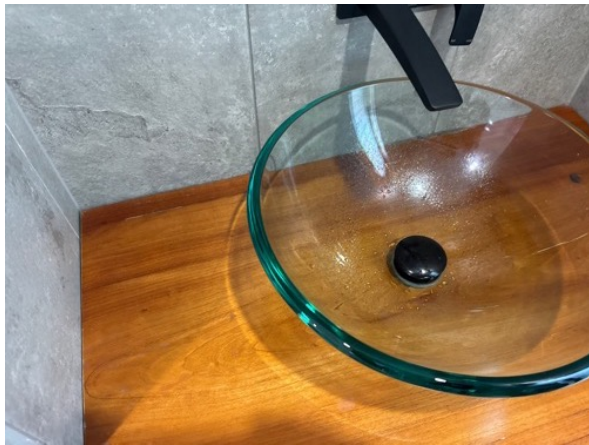
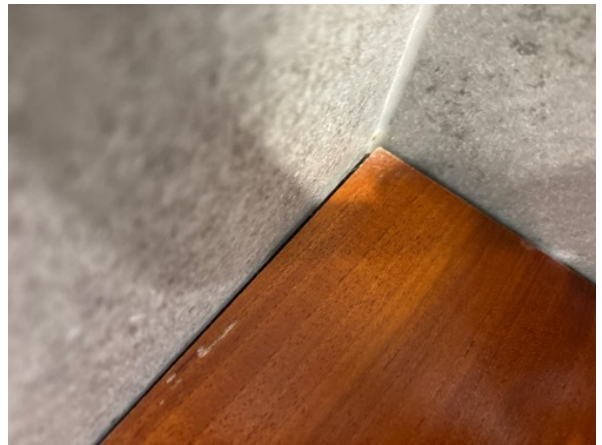
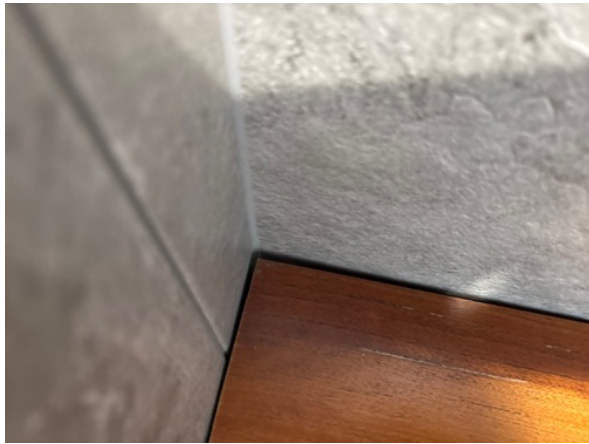
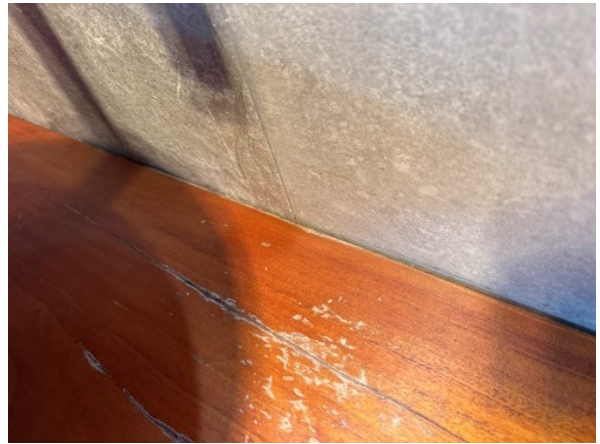
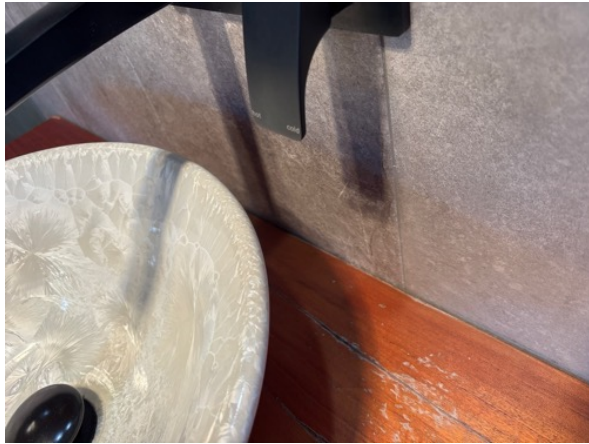
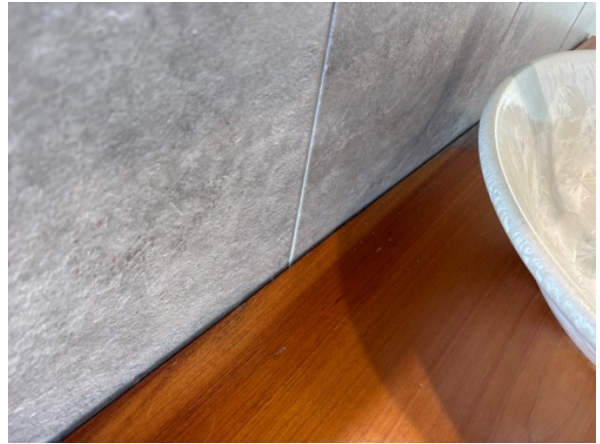
**Location:** Bathrooms And En Suite

**Finding:** Vanity units – silicone required

A silicone seal is missing at the junction between the vanity bench tops and the wall tiles. This will allow moisture ingress behind the cabinetry, causing long-term damage. I recommend contacting a handyman to install a silicone seal in these areas.

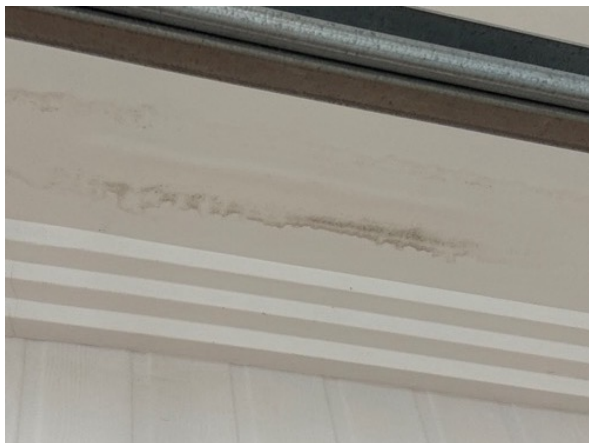
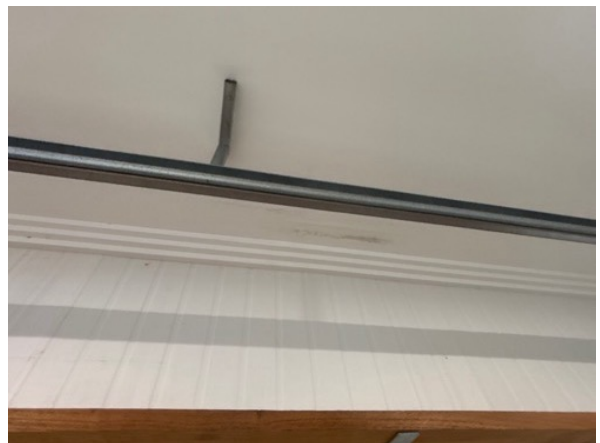
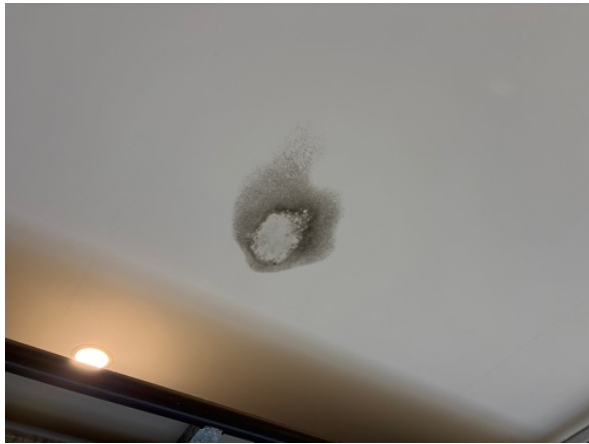
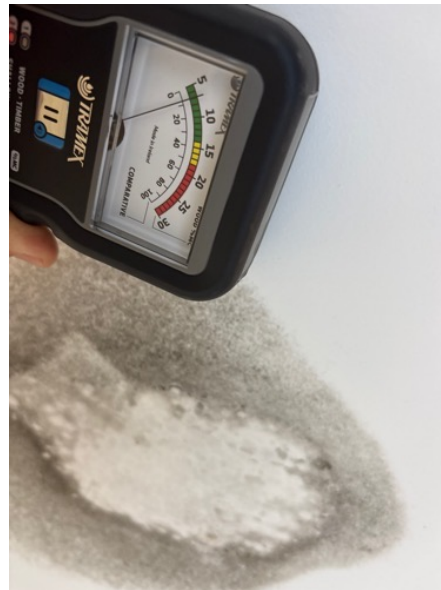
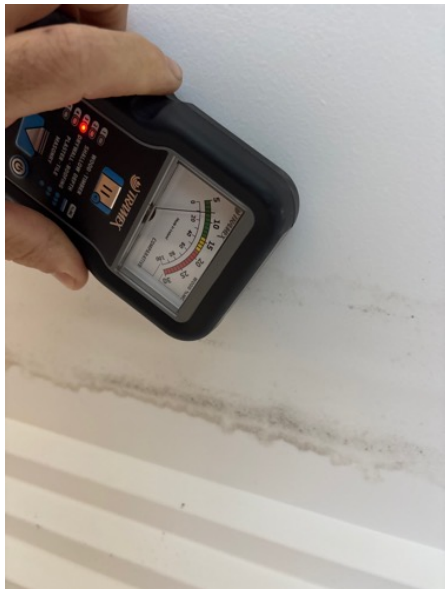
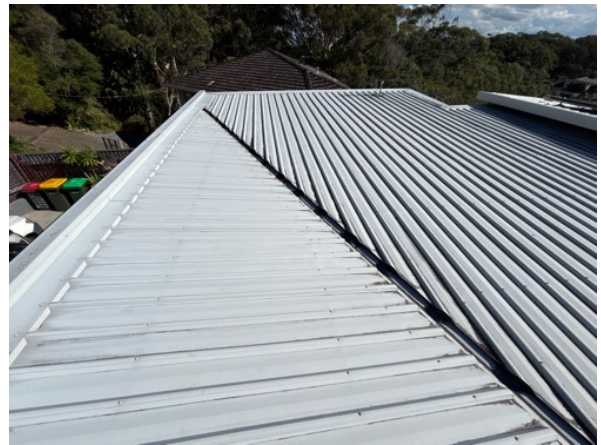
**Location:** Garage

**Finding:** Moisture stains identified

Moisture staining and mould growth were observed in two small areas on the plasterboard ceiling within the garage. Moisture meter readings taken to the affected area were within normal limits at the time of the inspection, indicating no elevated moisture was detected during testing. Such staining may result from a range of causes, including previous water ingress associated with blocked or overflowing gutters, roof valleys, or other roof drainage defects. Inspection of the metal roof above the affected area identified a low pitched roof with a valley gutter directly over the staining; however, no visible signs of damage, deterioration, or blockage were evident at the time of inspection. It is recommended that a licensed roofing contractor be engaged to further investigate the source of the moisture ingress, and carry out any necessary repairs.

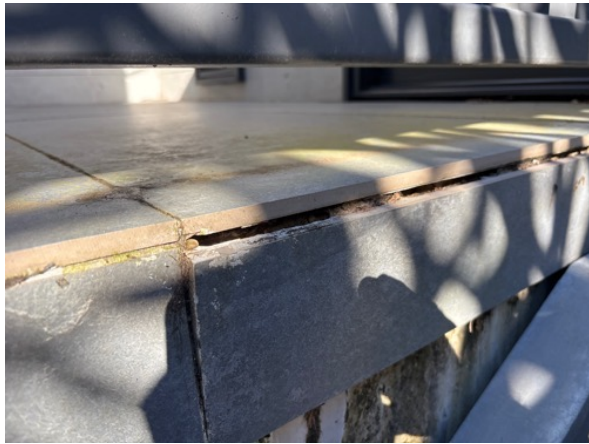
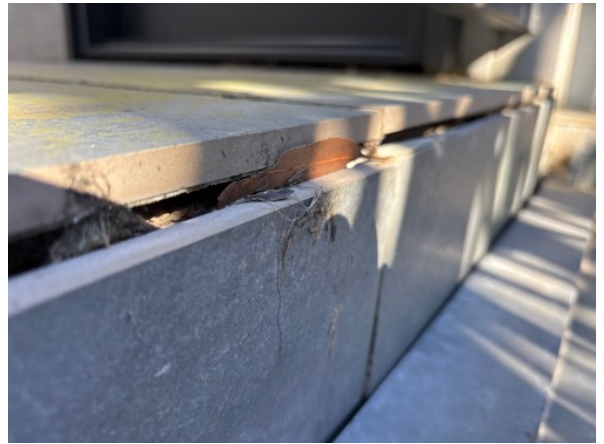
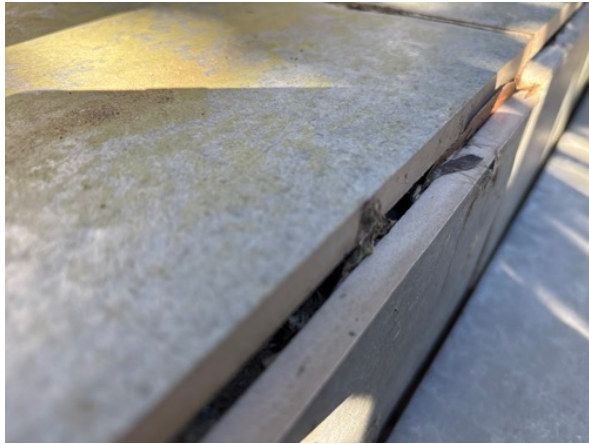
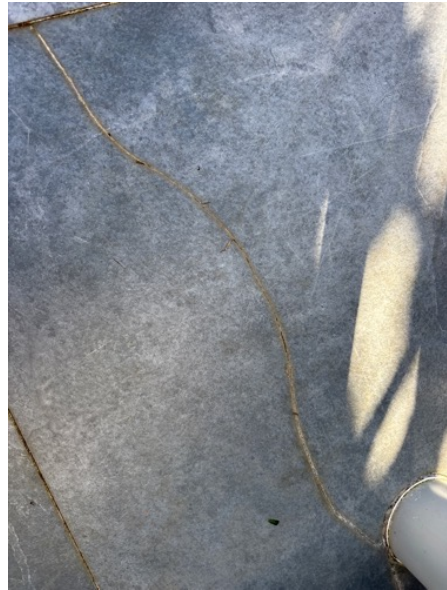
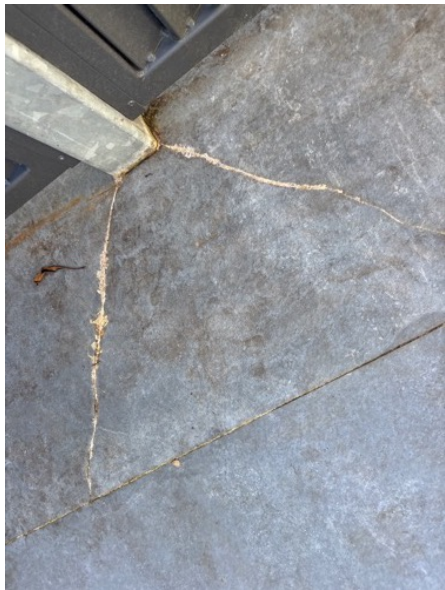
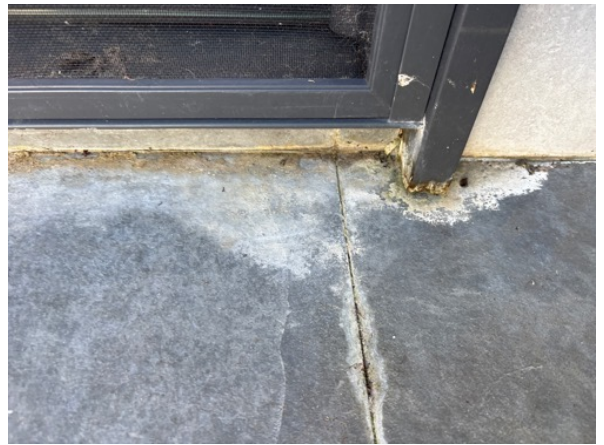
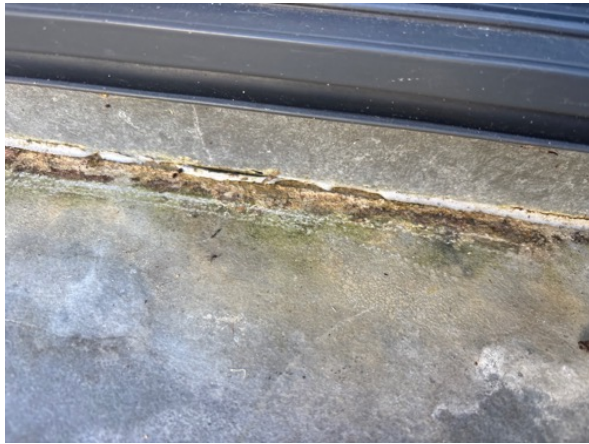
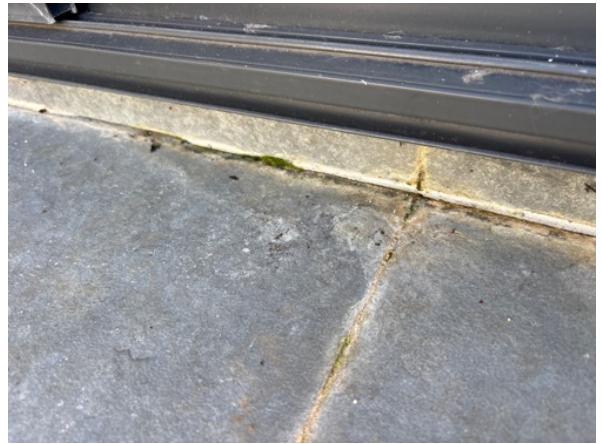
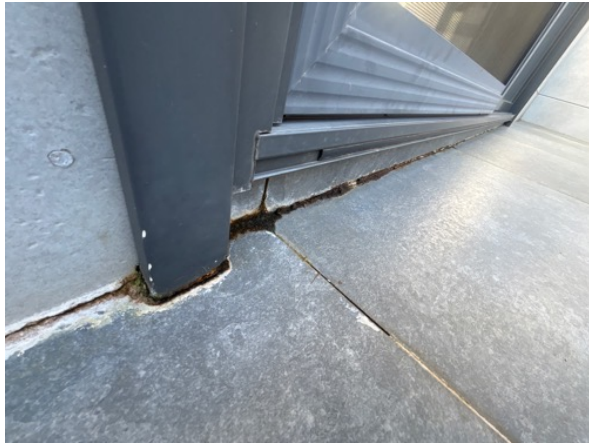
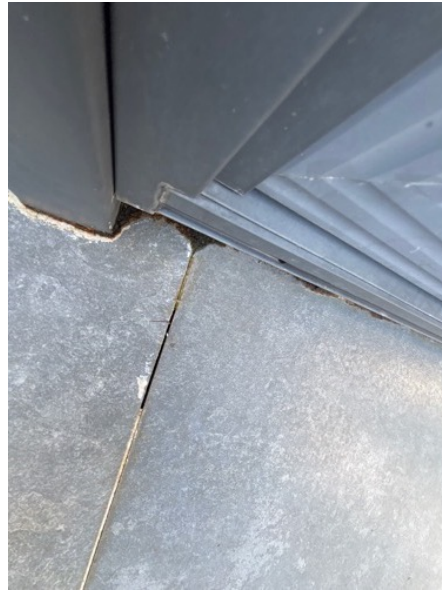
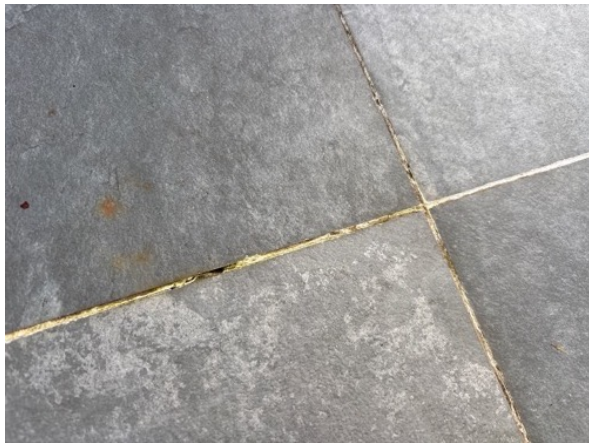
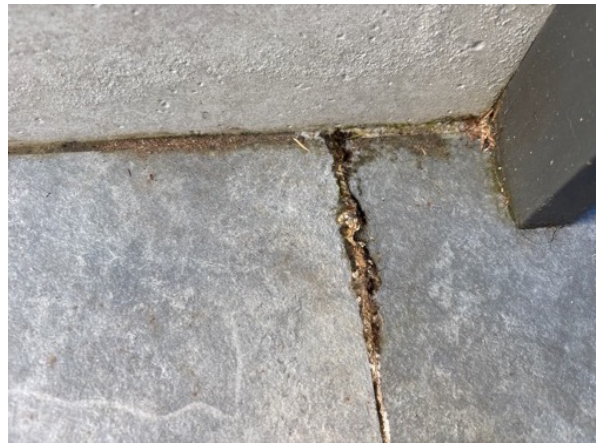
**Location:** Tiled Deck Areas

**Finding:** Floor tiles – minor deterioration

The tiled deck areas on the eastern side of the first floor exhibited minor deterioration in several locations. Some edge tiles were noted to be partially detached from the substrate, creating gaps behind the tiles and resulting in missing sections of grout. Minor cracking was also observed to some floor tiles. Deterioration of the silicone sealant was identified in areas where the floor tiles abut the external cladding, and minor mineral deposit buildup was noted in some locations. It is recommended that a licensed tiling contractor be engaged to resecure and regROUT the affected edge tiles, replace any cracked tiles, renew deteriorated silicone sealant, remove mineral deposits as required, and undertake any associated remedial works to prevent further deterioration.

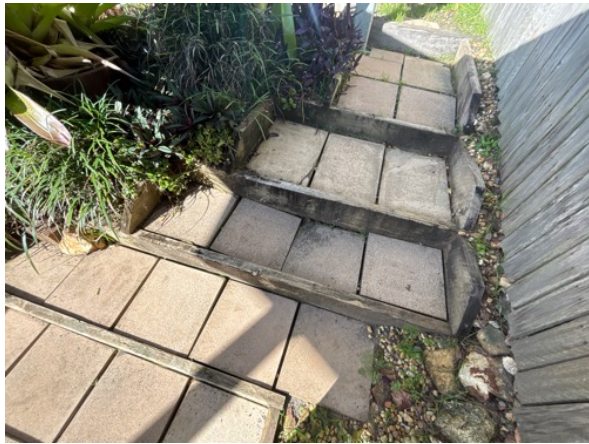
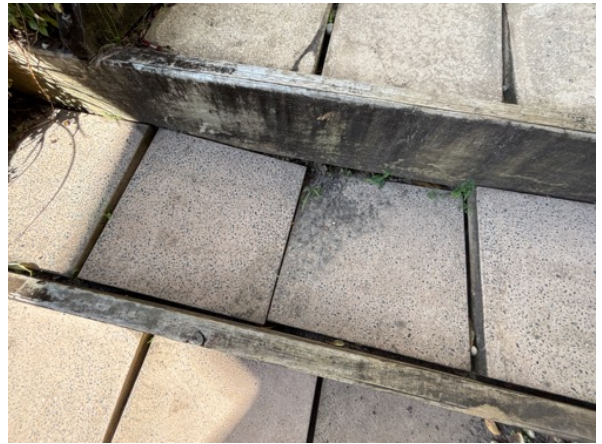
**Location:** All External Areas

**Finding:** Paved steps – subsidence identified

The paved steps located at the north-western corner of the property appear to have experienced minor subsidence. Several pavers have settled unevenly in sections of the stairs, resulting in uneven surfaces and a potential trip hazard. We recommend engaging a licensed landscaping contractor to rectify the affected areas and reinstate a safe and level surface.

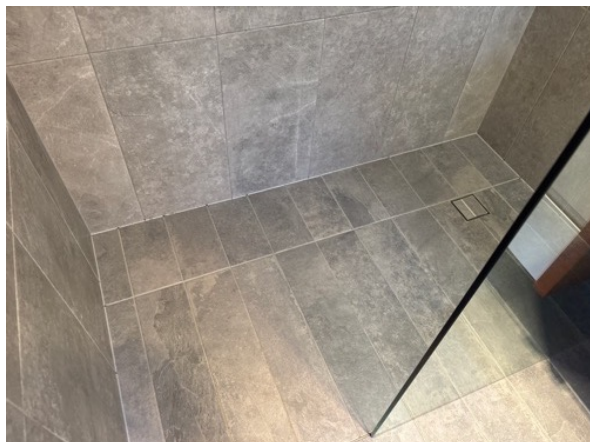
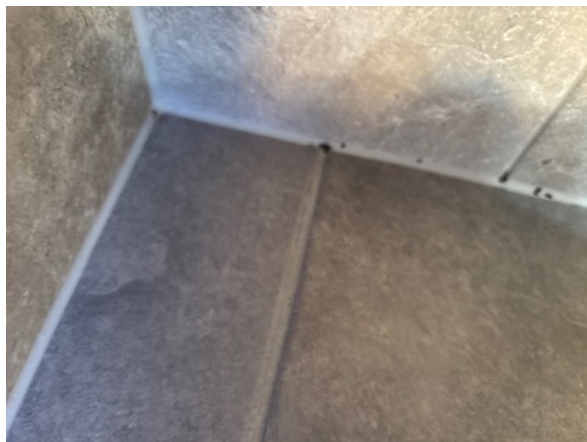
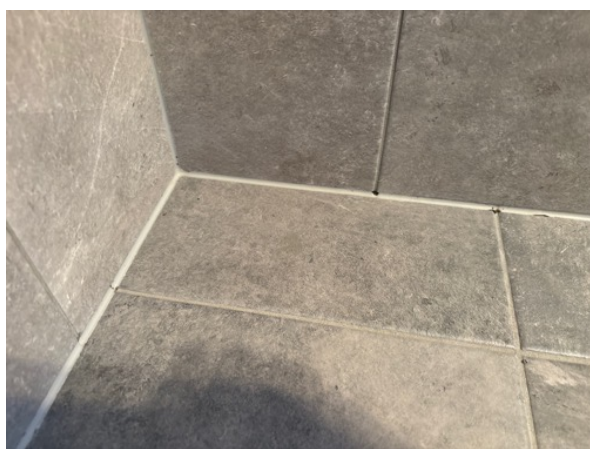
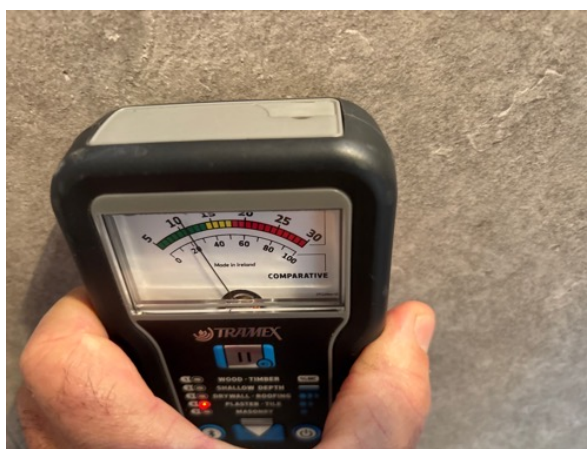
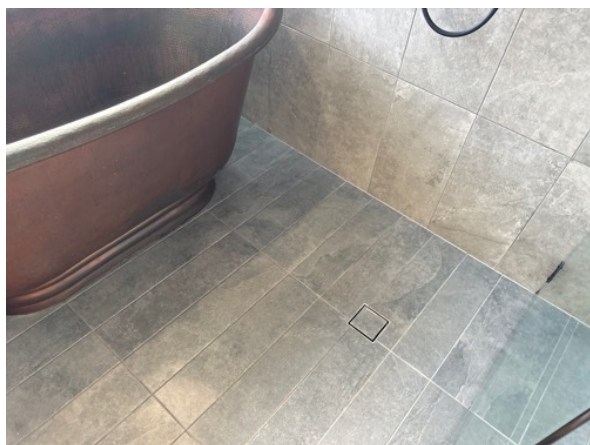
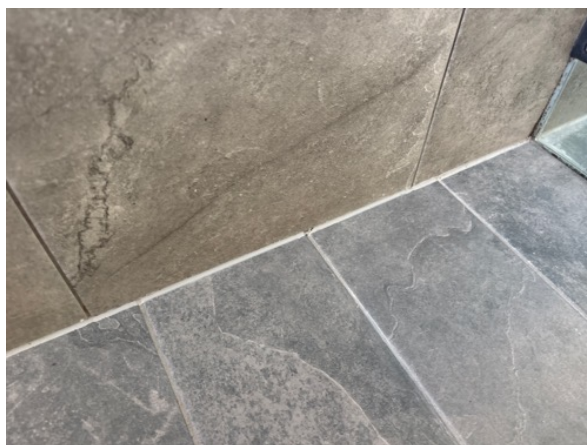
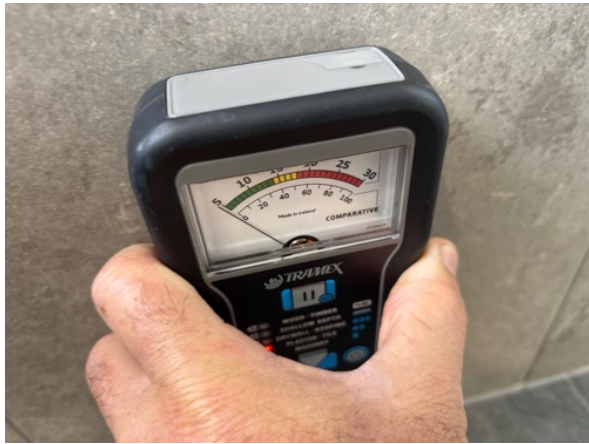
**Finding:** Showers

No evidence of leaks observed at the time of the inspection. Moisture meter readings taken were within normal limits. The shower enclosures were found to be in generally good condition at the time of inspection.

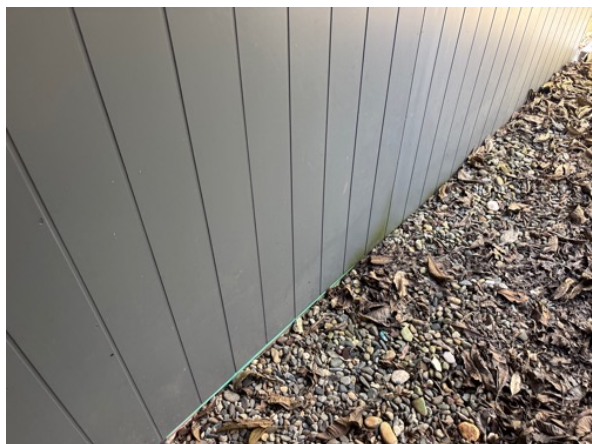
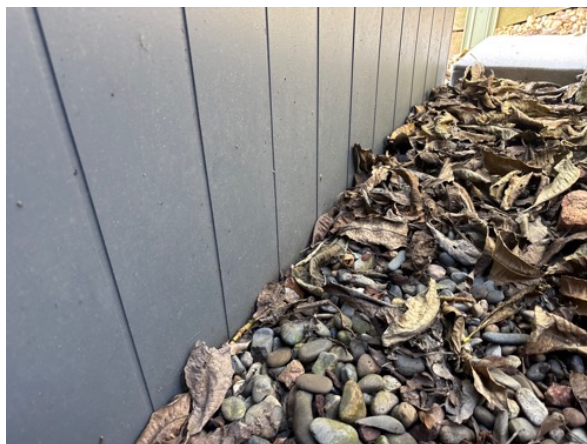
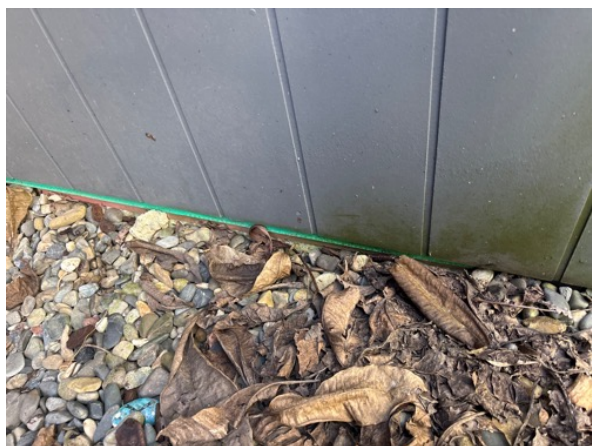
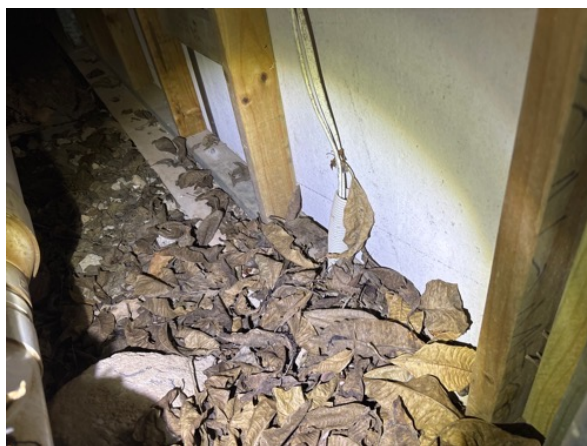
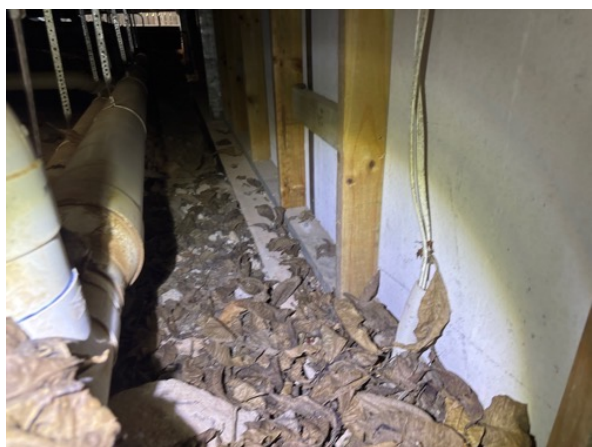
The external cladding to one of the timber-framed walls is in direct contact with the soil in one area. In addition, leaf debris have accumulated at the base of another timber-framed wall. These conditions are considered conducive to termite activity, as they may provide concealed access points and impede effective visual inspection of the structure.

It is recommended that a licensed pest control contractor be engaged to remove the soil and debris from around the affected walls and maintain an unobstructed visual inspection zone. Regular termite inspections should also be undertaken as part of an ongoing pest management program.

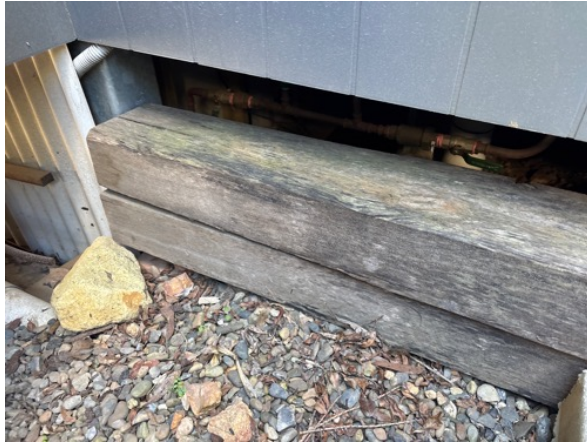
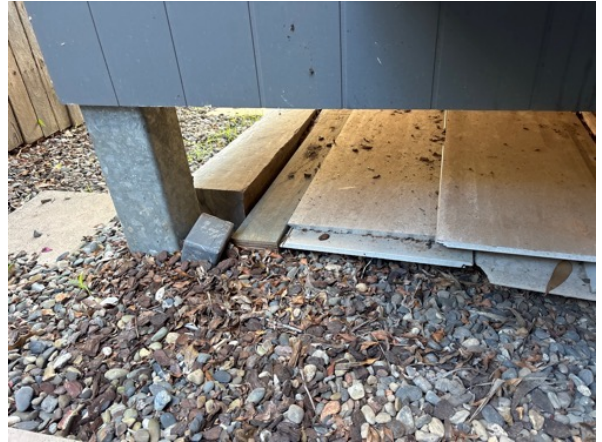
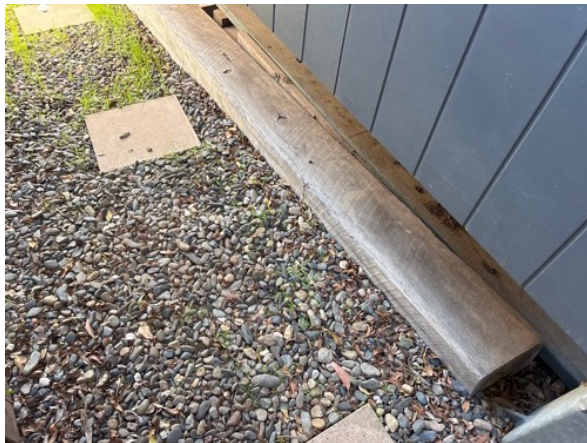
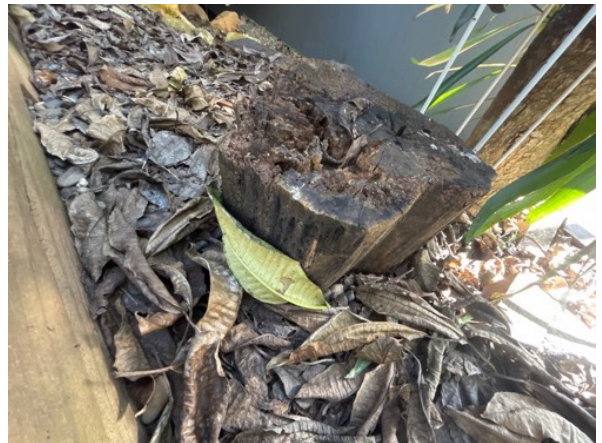
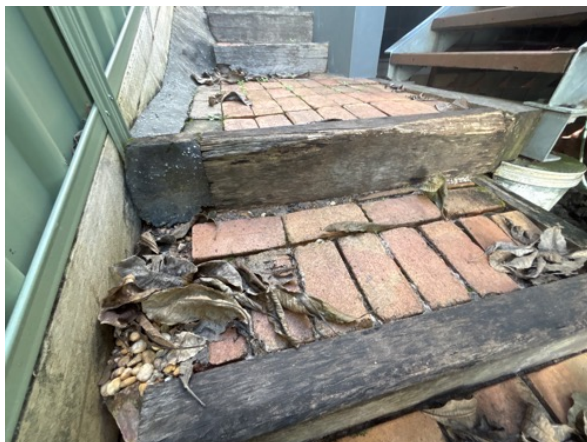
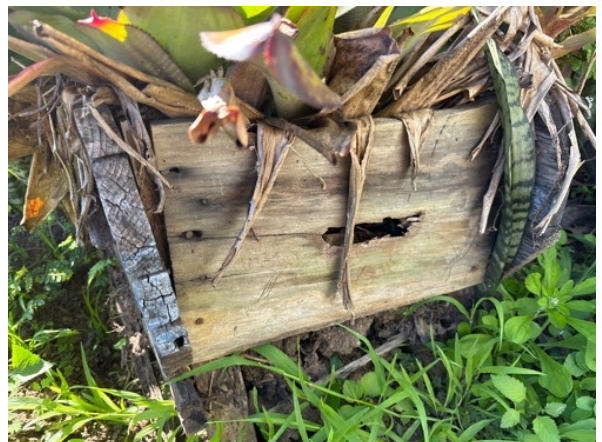
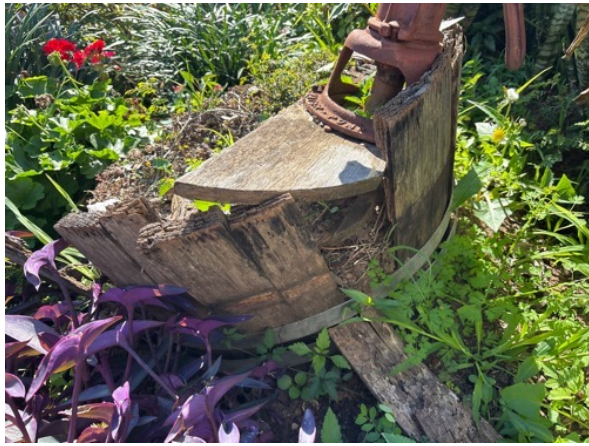
**Finding:** Timber to ground contact

Timber to ground contact was identified in some areas of the property. Timber which is in contact with the ground is conducive to termite attack. I recommend removing any timber off the ground where possible and engage a pest control contractor to schedule future termite inspections of the property
