Property and Timber Pest Report

Inspection Date: 4 May 2026

Property Address: 14 Rosehill Avenue Port Macquarie 2444

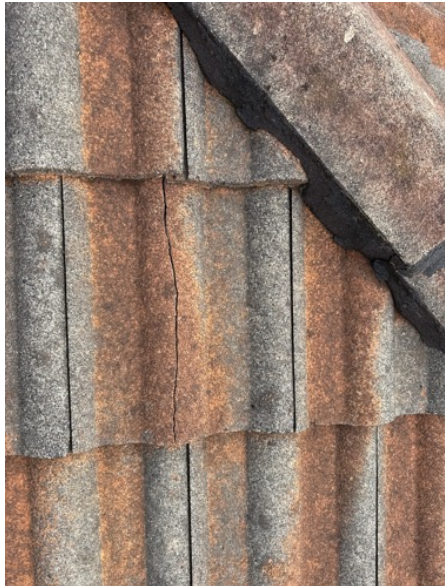
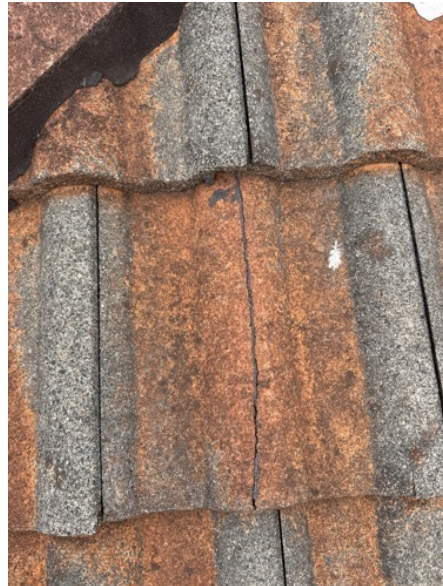
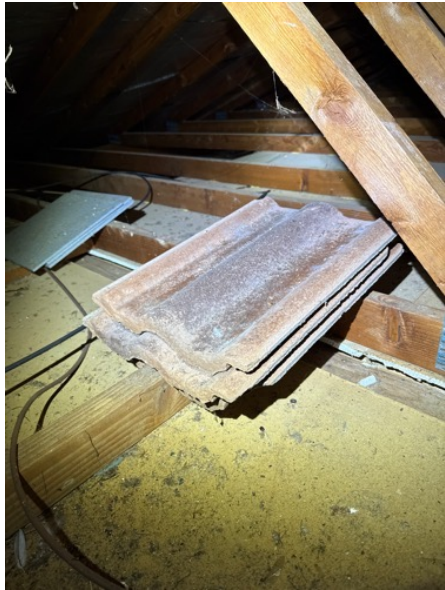
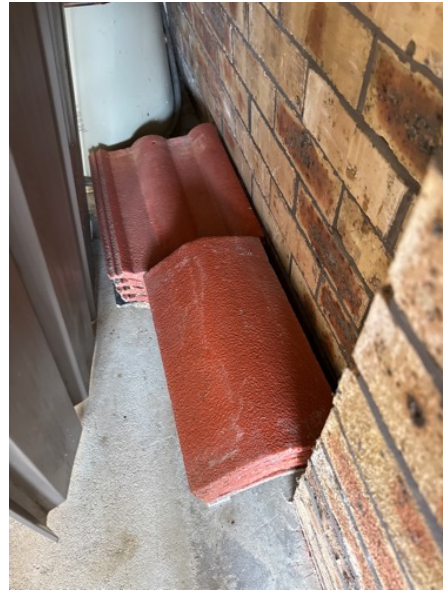
Minor Defect 1.01

Finding: Damage

2 roof tiles on the north-eastern corner of the roof were found to be cracked, which may allow water ingress into the roof space if left unaddressed. 3 spare roof tiles were noted in the roof space and some in the garage. Recommend contacting a roof tiling specialist to replace the damaged tiles.

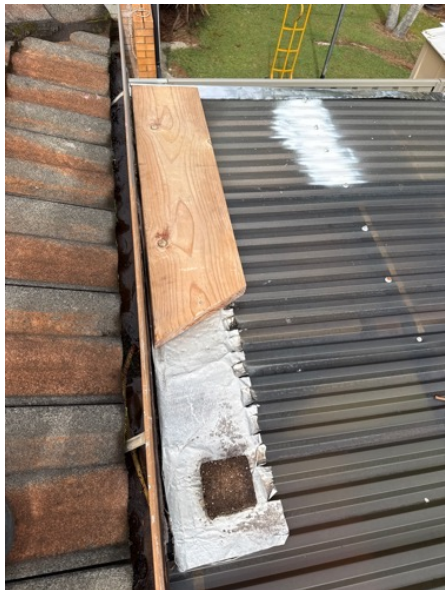
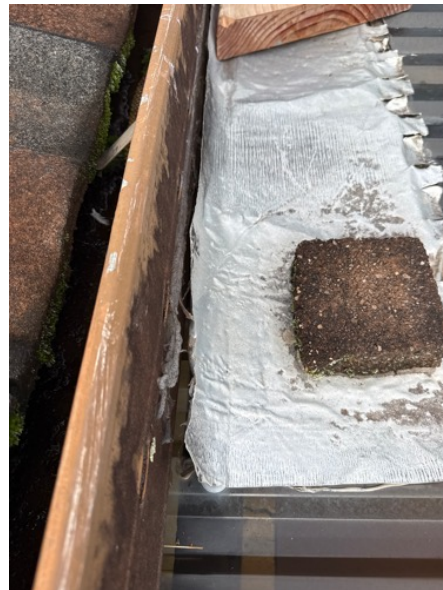
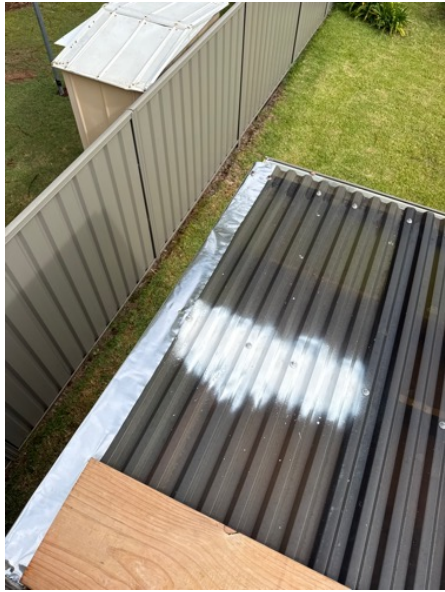
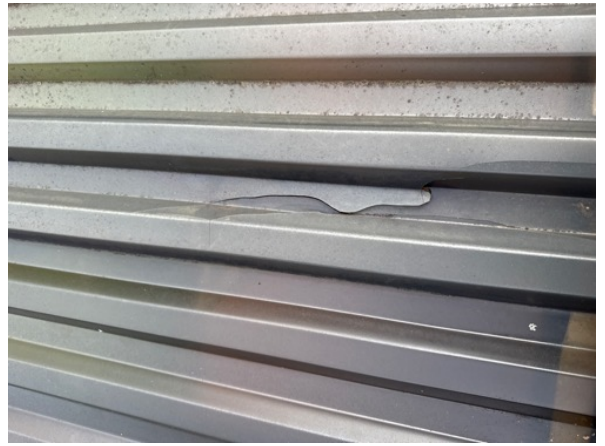
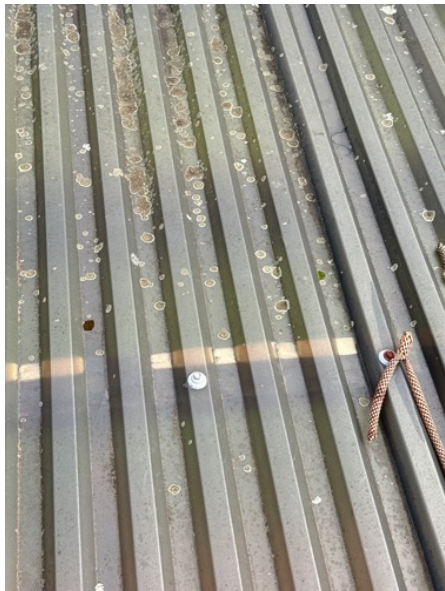
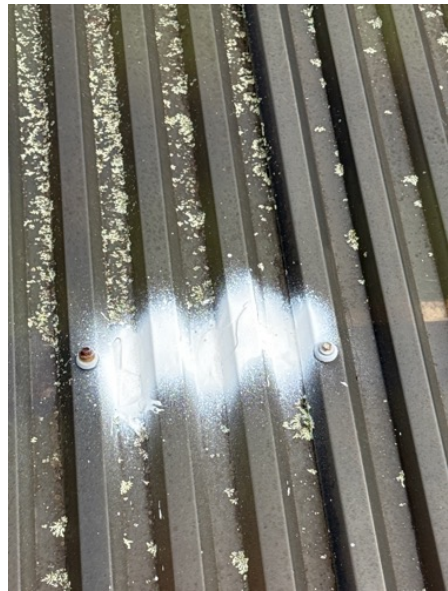
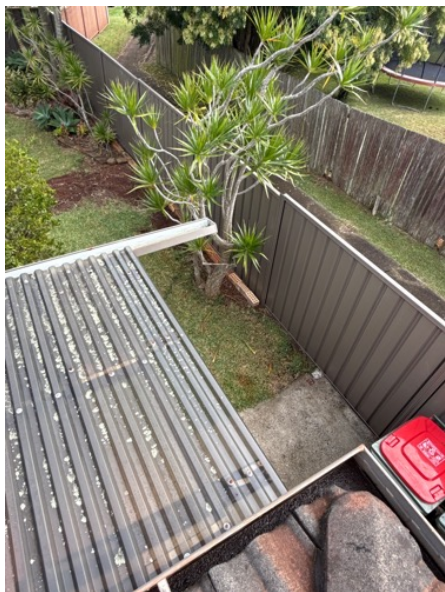
Minor Defect 1.02

Location: Roof exterior

Finding: Material deterioration / installation

The polycarbonate roof sheeting to the rear attached pergola has been installed with a makeshift flashing to the southern end and was found to have several sections that are damaged and brittle, while the northern end has not been properly finished, which may lead to water ingress and ongoing deterioration. Recommend contacting a licensed roofing specialist to further investigate and carry out repairs as required.

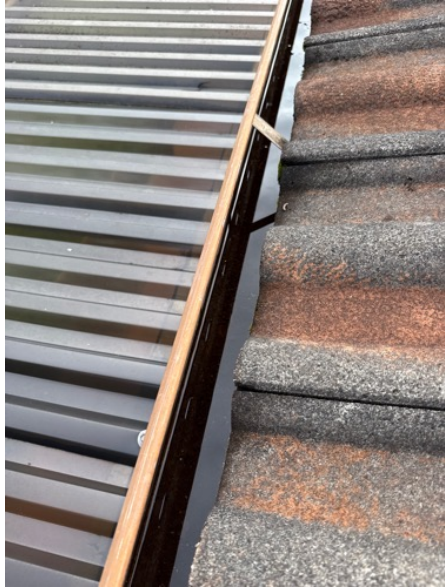
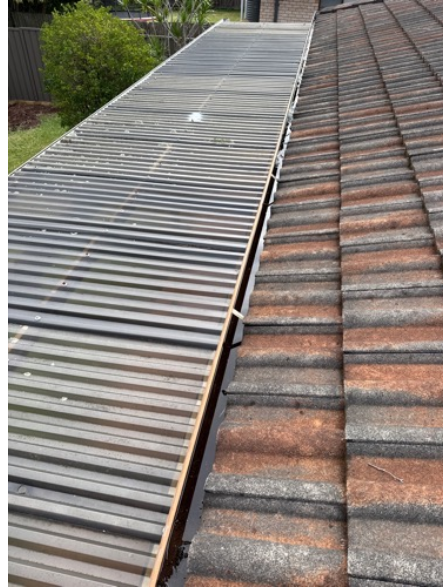
Minor Defect 1.03

Location: Roof exterior

Finding: Gutters

The gutters were observed to be holding water in sections, which indicates inadequate fall and may lead to premature rusting and deterioration if not corrected. Recommend contacting a licensed plumber to realign the gutters to ensure they drain correctly.

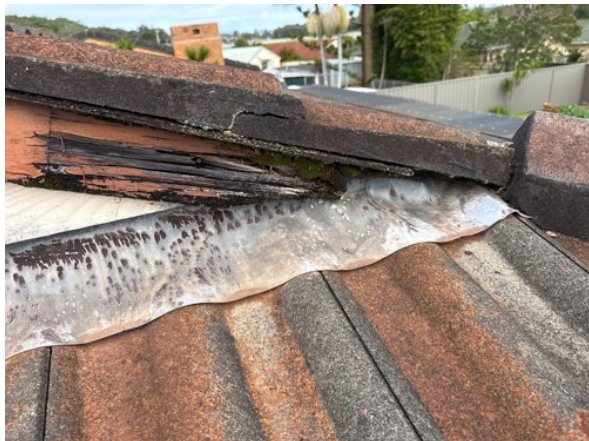
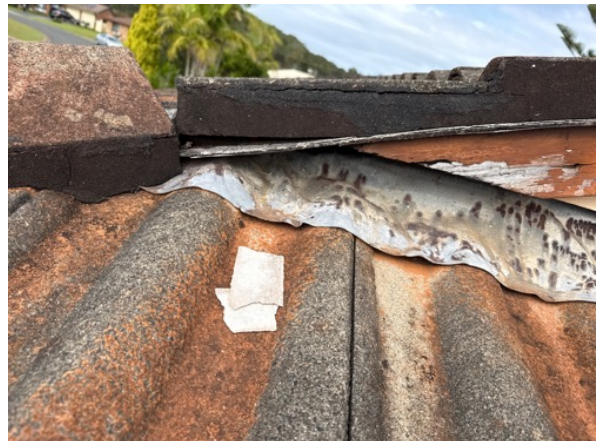
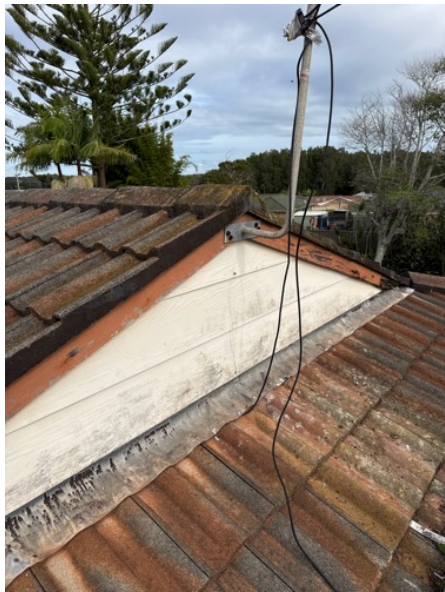
Minor Defect 1.04

Location: Roof exterior

Finding: Material deterioration

The barge boards to the Dutch gable on the northern side of the roof were found to be significantly decayed and deteriorated, with sections of timber breakdown evident, which may allow water ingress and further structural deterioration if left unaddressed. Recommend contacting a carpenter or building specialist to further investigate and carry out repairs as required.

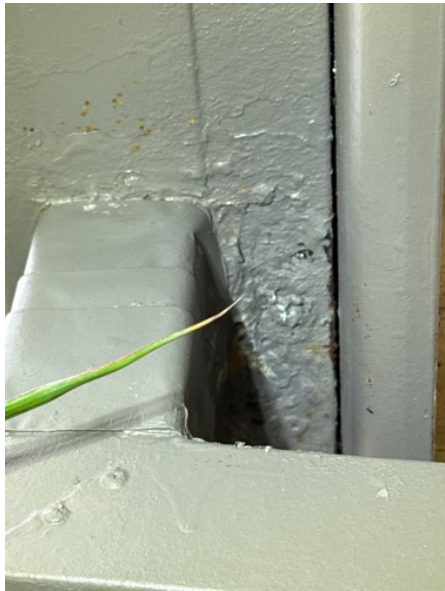
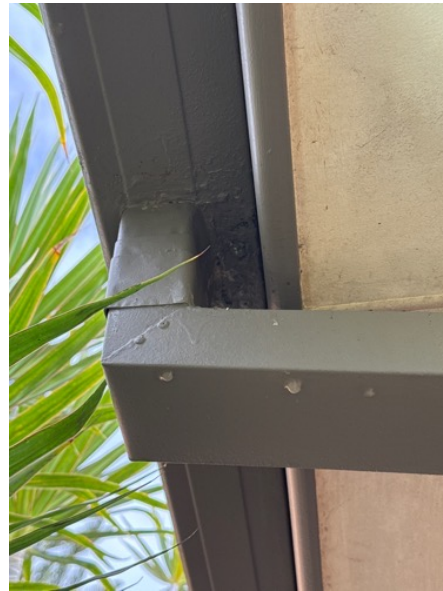
Minor Defect 1.05

Location: Roof exterior

Finding: Material deterioration

The gutter to the south-eastern corner behind the downpipe connection was found to be rusted, which may lead to leaks and further deterioration if left unaddressed. Recommend contacting a licensed plumber to repair or replace the affected section.

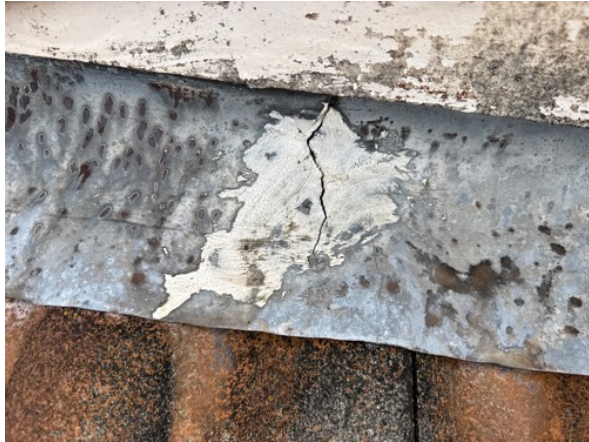
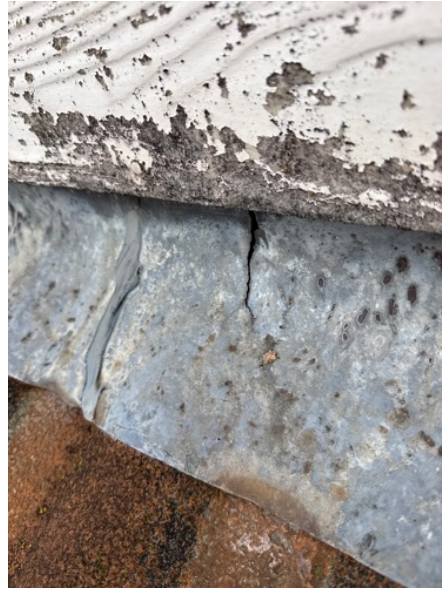
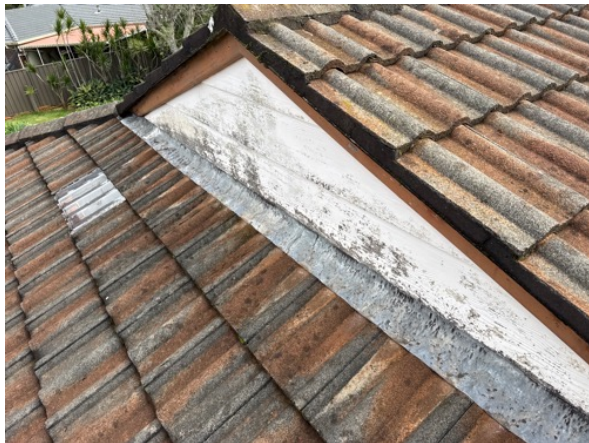
Minor Defect 1.06

Location: Roof exterior

Finding: Material deterioration

The lead flashing to the Dutch gable on the southern end of the roof has cracked, which may allow water ingress into the roof space if left unaddressed. Recommend contacting a licensed roof plumber to further investigate and carry out repairs.

The cladding and barge boards to the Dutch gable on the southern end of the roof show signs of weathering and paint deterioration, which may lead to ongoing deterioration if not

of weathering and paint deterioration, which may lead to ongoing deterioration if not maintained. Recommend contacting a painting professional to prepare and repaint the affected areas.

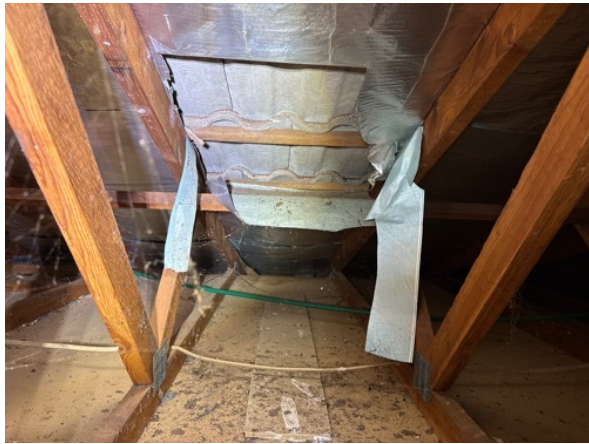
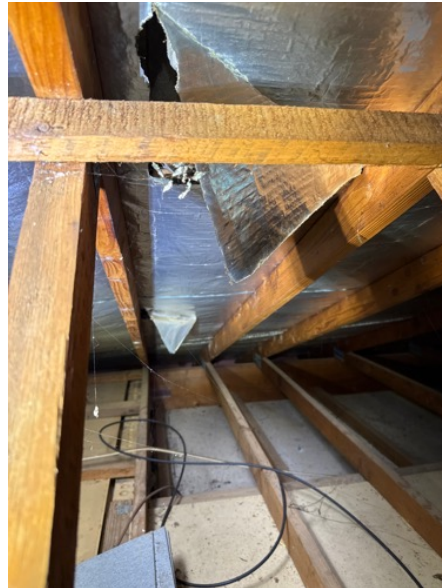
Minor Defect 1.07

Location: Roofspace

Finding: Sarking - Damaged

The sarking has been damaged in some areas, holes and tears reduce the effectiveness of the sarking as a moisture and insulation barrier. Where possible, the sarking should be repaired using a bitumen tape.

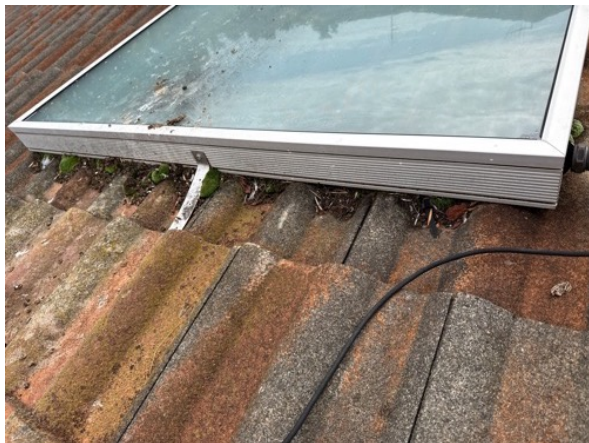
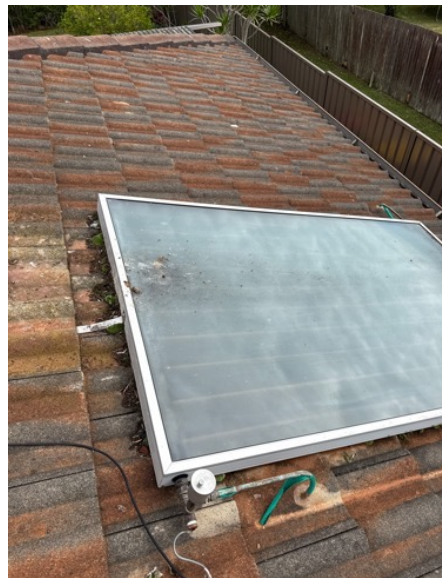
Finding: Maintenance

Leaf litter and debris have accumulated to the upper side of the solar hot water panel on the roof, blocking the natural water flow channels, which may lead to ponding of water and increase the risk of moisture ingress or premature deterioration of surrounding materials. Recommend contacting a roofing specialist to clear the debris and ensure adequate drainage is maintained.

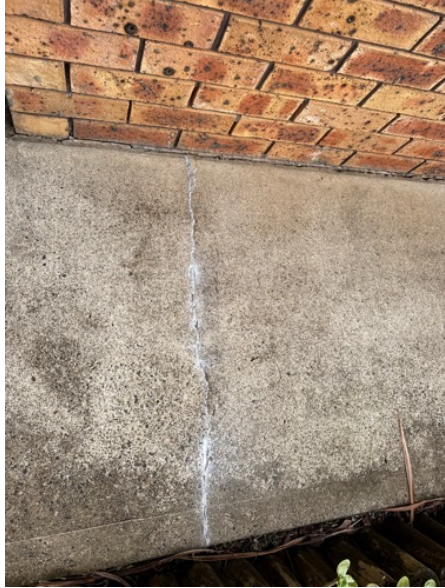
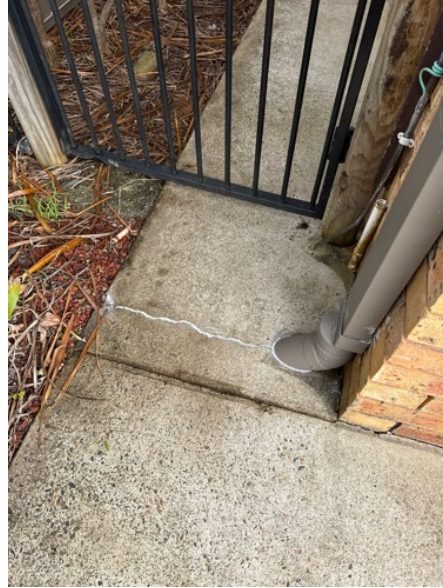
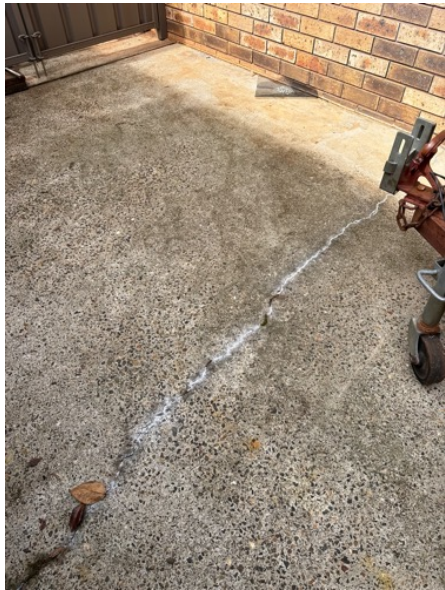
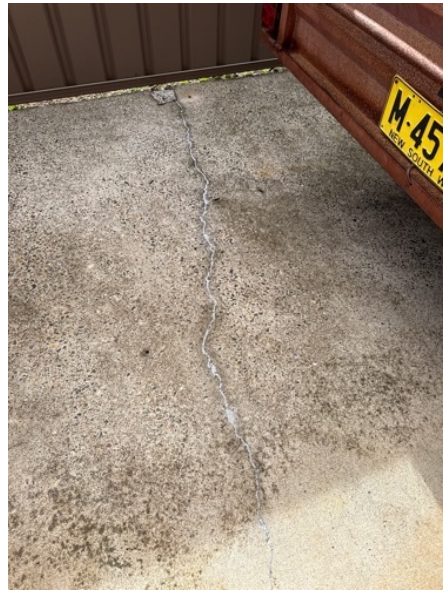
For your information 2.02

Location: The site

Finding: Cracking

Some minor cracking noted to the concrete pathways in areas. This is not considered to be structurally concerning and the pathways were considered to be serviceable.

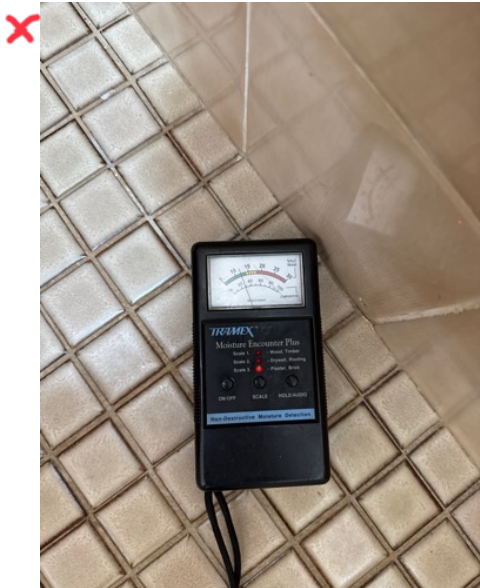
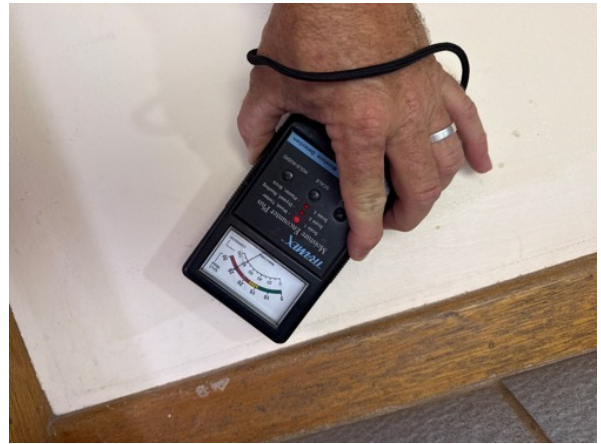
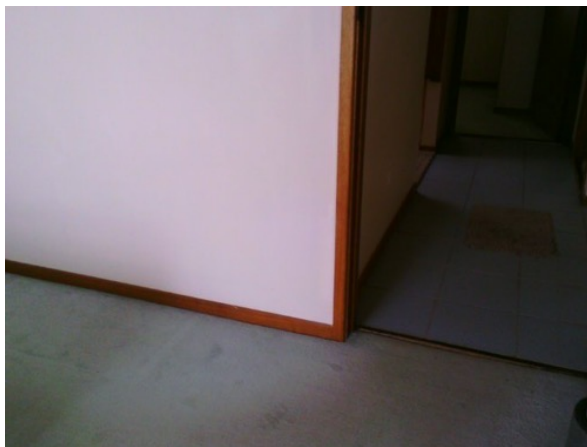
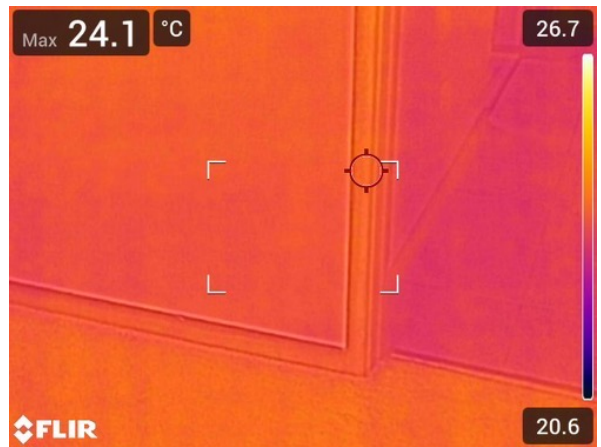
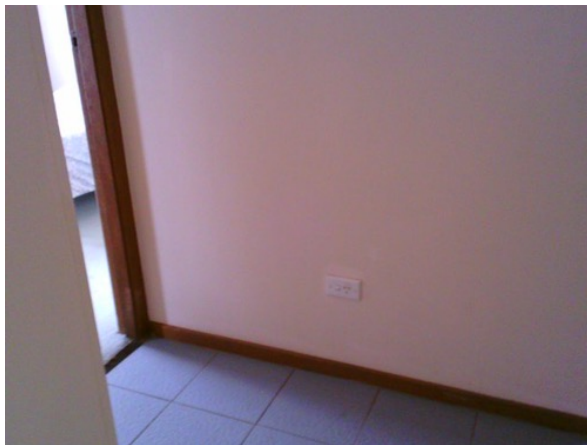
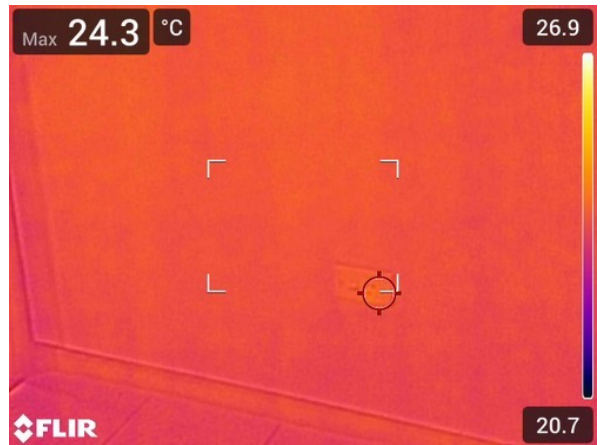
For your information 2.03

Location: Bathroom

Elevated moisture meter readings were recorded to the lower section of the internal wall backing onto the shower recess, however thermal imaging did not identify any obvious temperature anomalies at the time of inspection. Moisture meter readings can be influenced by a range of factors and are not conclusive evidence of the presence of moisture within the wall. Recommend that further invasive investigation should be a consideration to determine whether any moisture ingress is present and to identify the source if confirmed.

***Occupant had shower 10mins prior to inspection**
