# Visual Timber Pest Inspection and Report in Accordance with AS 4349.3-2010

42 Hassall Street

Type of inspection: Pre-Purchase Timber Pest Inspection AS  
4349.3-2010

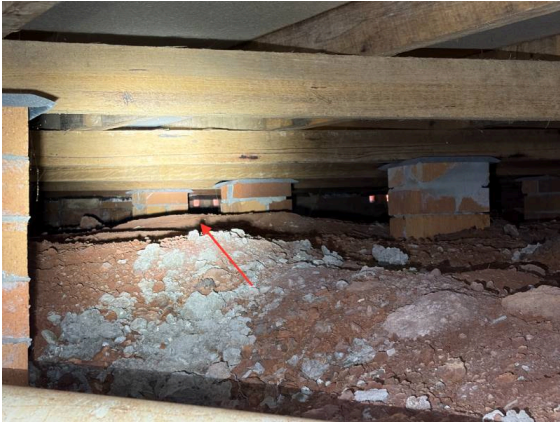
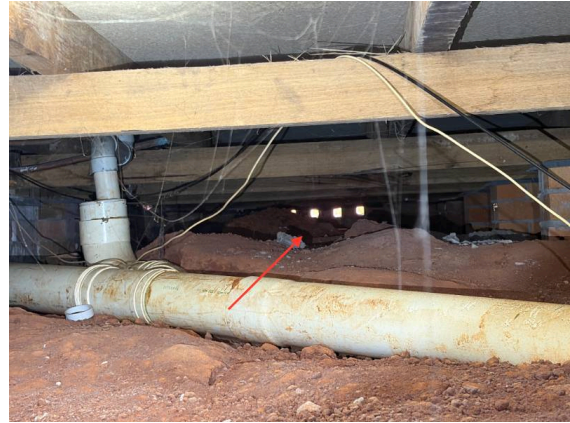
ACCESS ISSUE - Subfloor

Height

Due to limited crawl space under the western side of the house access was restricted.

Further Inspections are strongly recommended to areas where Reasonable Access is Unavailable, Obstructed or Restricted or a High Risk of possible Timber Pests and /or Damage exists.

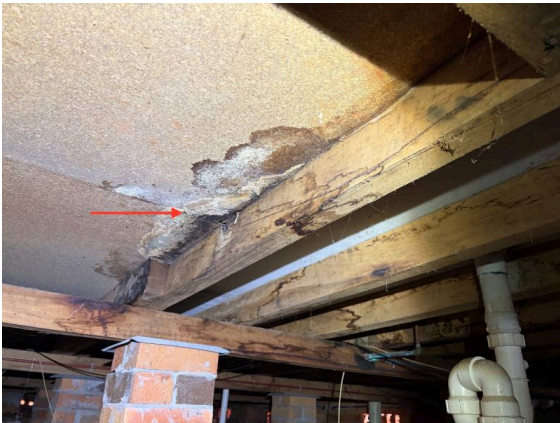
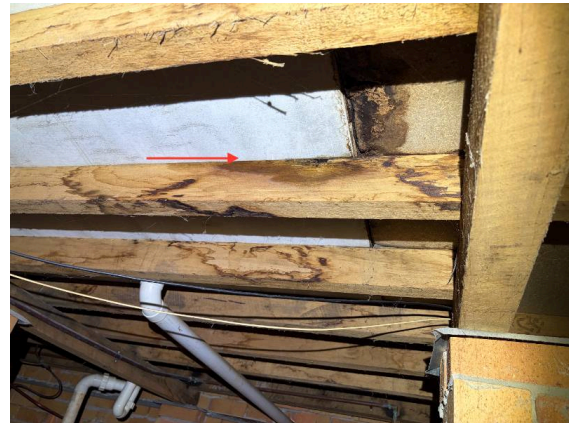
As seen from under the house there is water ingress and stains to the flooring below the main shower. Constant moisture is conducive for timber pests. I recommend to minimise termite attacks a qualified builder is engaged to determine the cause and rectification required.

As seen from under the house water leaking from the shower flooring.

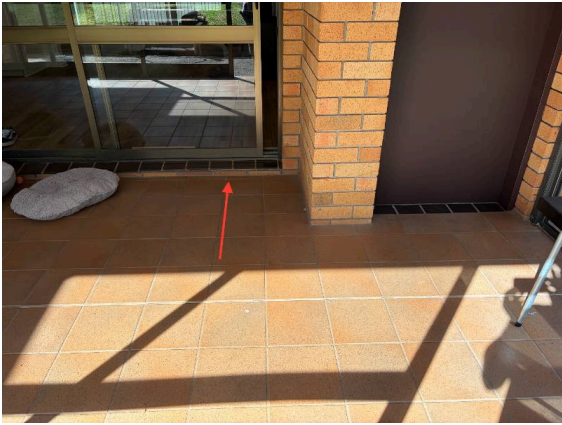
Concrete patio in the back yard is built above the termite shield inspection zone and is obstructing the inspection zone. This can give termites hidden access. I recommend a termite management system is implemented by a qualified timber pest controller.

Concrete porch obstructing the termite shield inspection zone.

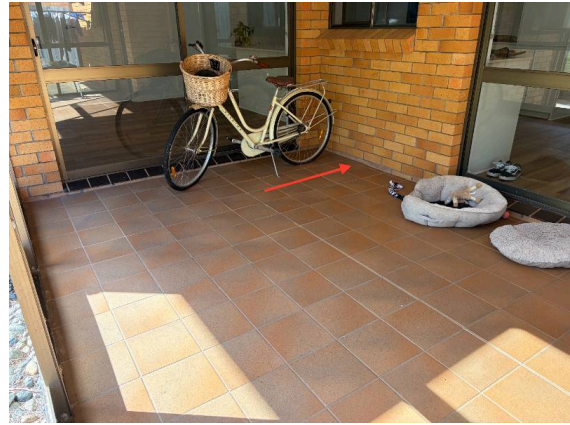
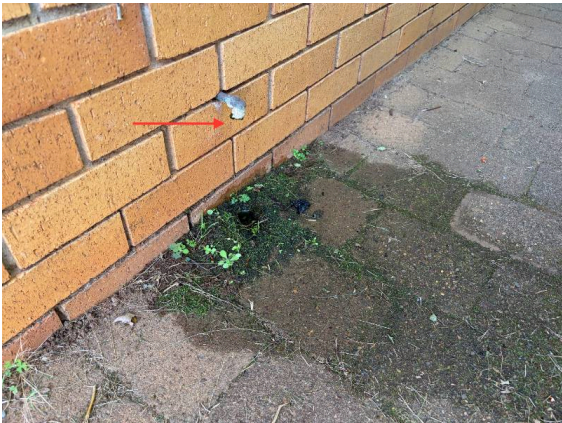
Hotwater system overflow falls next to the house. Constant moisture is conducive for timber pest attacks. I recommend to minimise timber pest attacks the overflow is either diverted away from the house or into a storm water.

Hotwater system overflow falling next to the house in the southern side.
