# PEST AND BUILDING PRE-PURCHASE REPORTS

## Standard Visual Timber Pest Detection Report In Accord With AS4349.3-2010

<b>Date of Inspection:</b>	Thursday 23 April 2026
<b>Address of Property Inspected:</b>	885 Dulguigan Road North Tumbulgam NSW 2490
<b>Name of Client:</b>	[REDACTED]
<b>Client Email Address:</b>	[REDACTED]
<b>Contact Phone:</b>	[REDACTED]
<b>Time of Inspection:</b>	10.00 AM

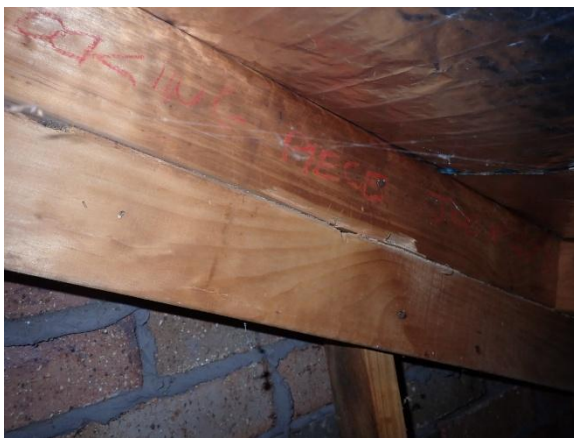
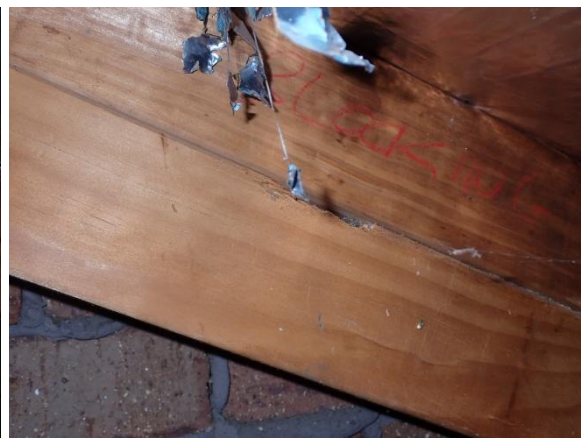
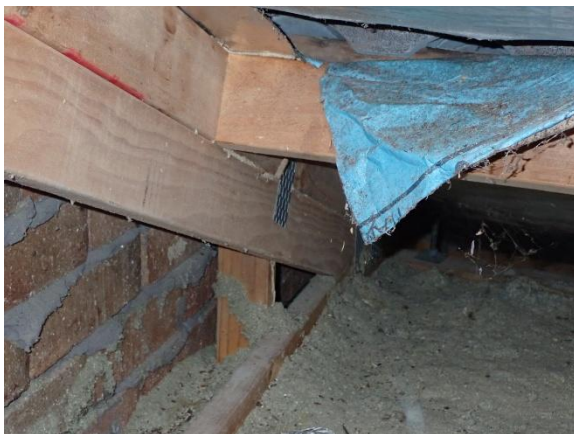
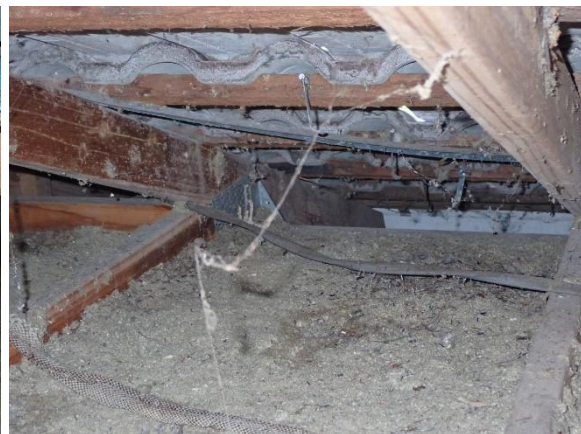
Slight to moderate termite damage to timber wall studs and timber roof trusses around master bedroom and ensuite and bedroom 3 area (timbers seen from roof space above this area).

While we are not builders, the termite damage appears to be: S-M

**\*Possible and likely damage in wall voids. We recommend a builder ascertains a more intrusive inspection to determine the full extent of termite damage.**

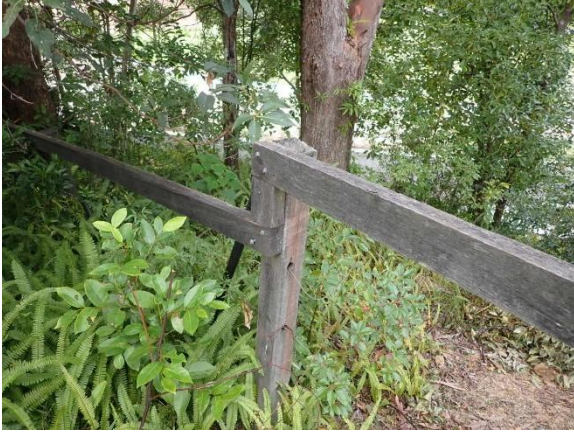
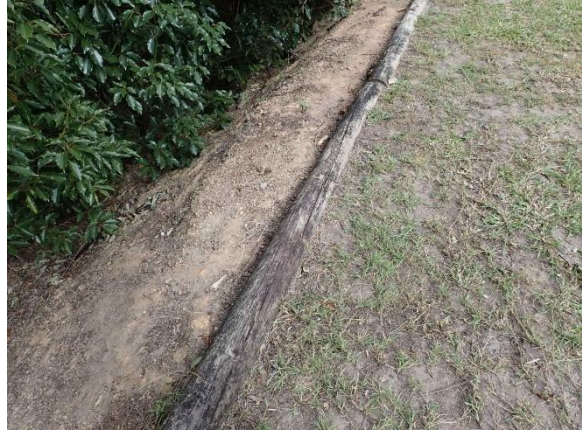
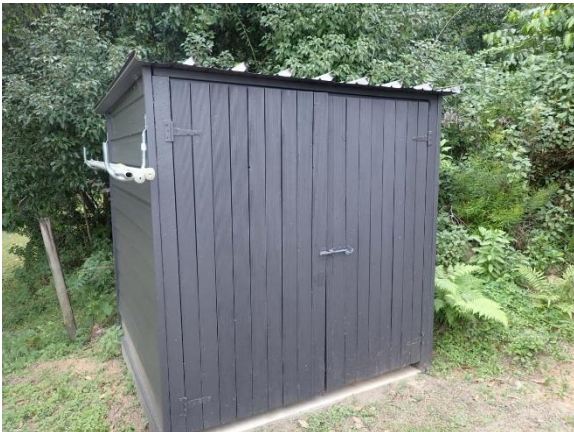
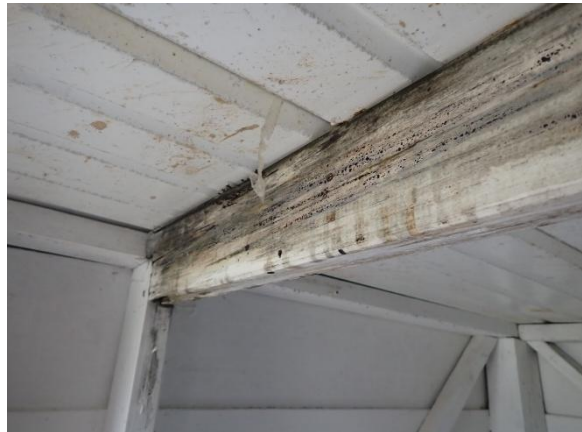
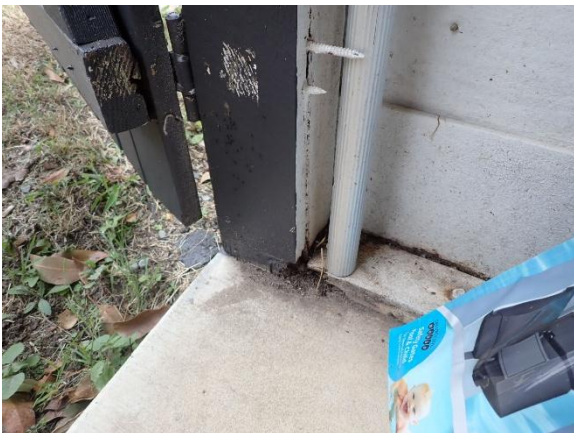
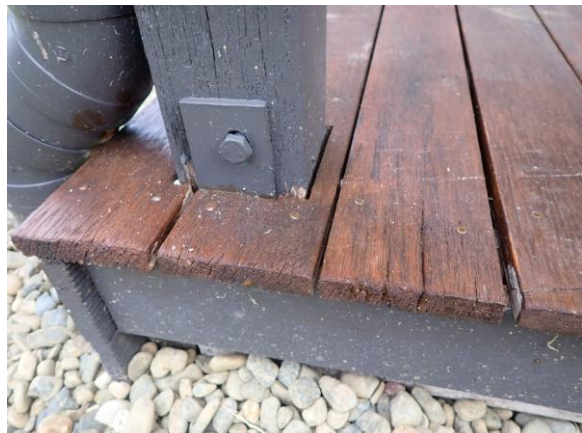
Visible evidence of fungal wood decay was located to:

(Normal for the age of the structure). It is recommended that these timbers be replaced to prevent further damage to adjoining timbers. Fungal decay may be present in concealed areas behind wet areas that can only be located by the removal of wall linings.

While we are not builders the fungal decay damage appears to be: S-M

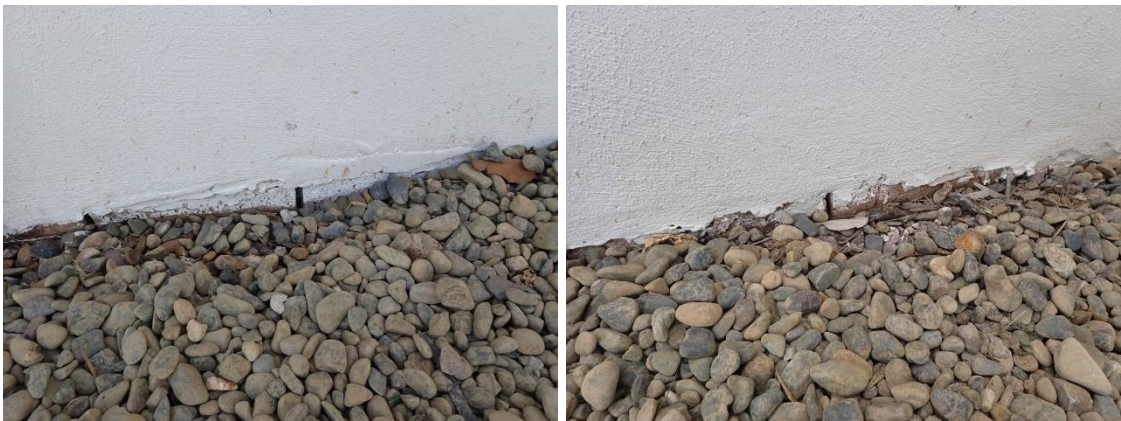
4. External weep holes are very close to the ground level in some areas. This can allow concealed termite entry. It is recommended all weep holes be exposed and a minimum of 75mm is kept clear of soil, foliage, debris, stored items or any other obstructions. Furthermore, these areas should be regularly inspected and if this is not achieved then a suitable chemical or physical barrier should be installed to the perimeter (with regular inspections).

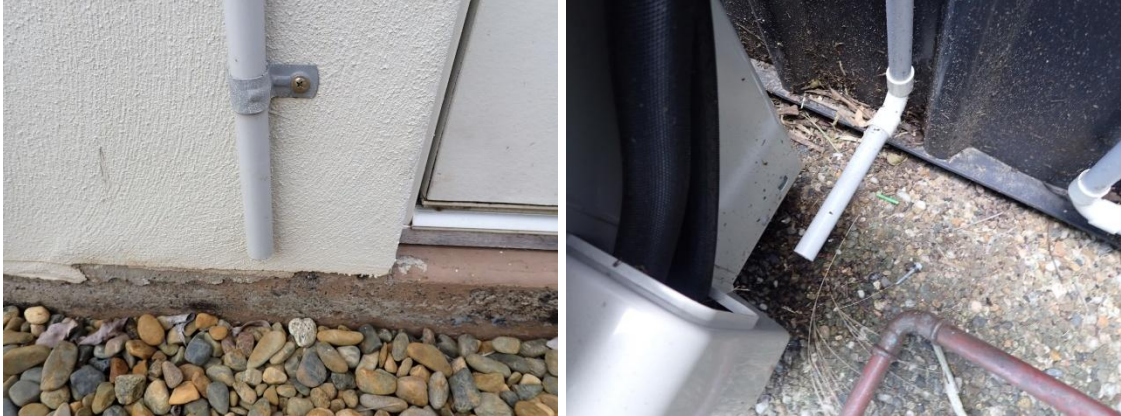
6. Main structure and free-standing shed air conditioner overflow should be connected to catchment points immediately as it provides an ideal environment for termite activity and ingress.

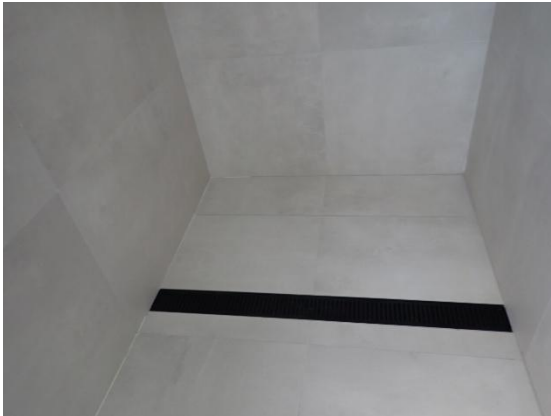
6. Reseal free-standing studio shower tap flanges and shower recess wall and floor junctions immediately as it provides an ideal environment for termite activity.

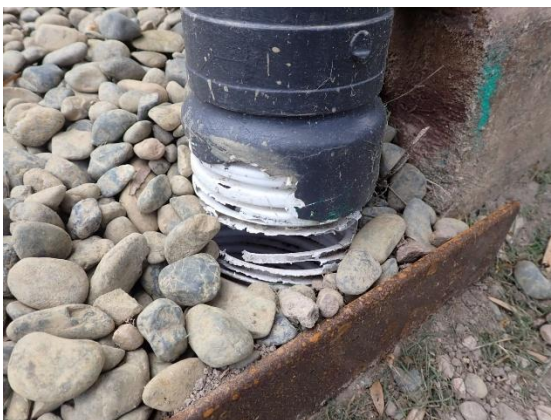
6. Faulty main structure storm water downpipes should be repaired and sealed immediately, as it appears rainwater is leaking directly adjacent to the foundations of the structure. Water alongside or near to building walls is highly conducive to termites. These should be repaired by suitably qualified person.

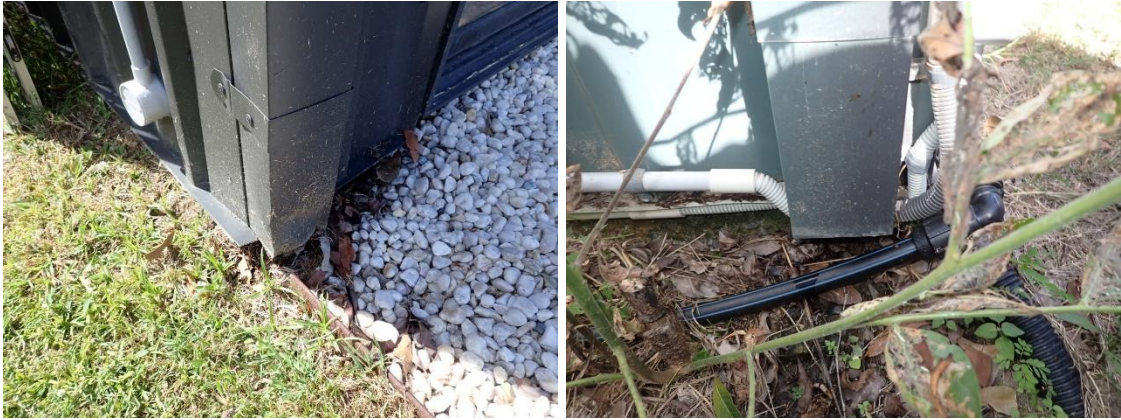
- Faulty free-standing shed storm water downpipes should be connected to the storm water drain immediately, as it appears rainwater is leaking directly adjacent to the foundations of the structure. Water alongside or near to building walls is highly conducive to termites. These should be repaired by suitably qualified person.

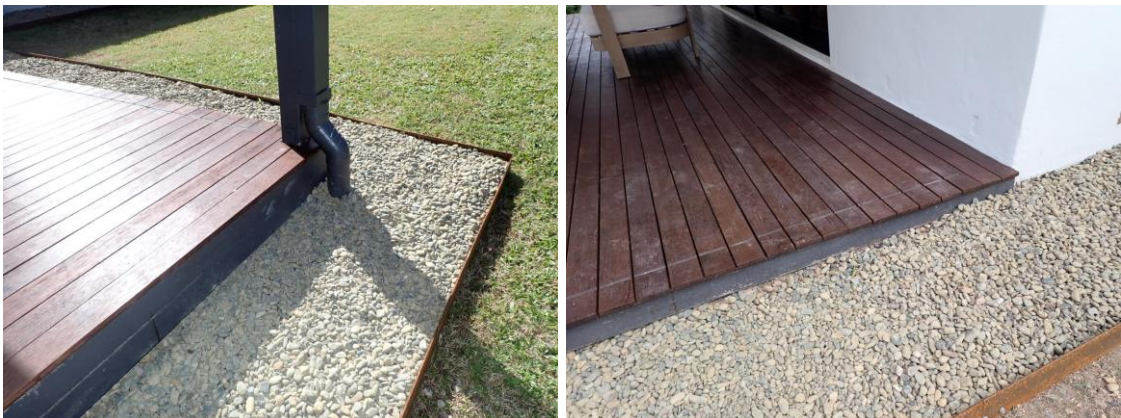
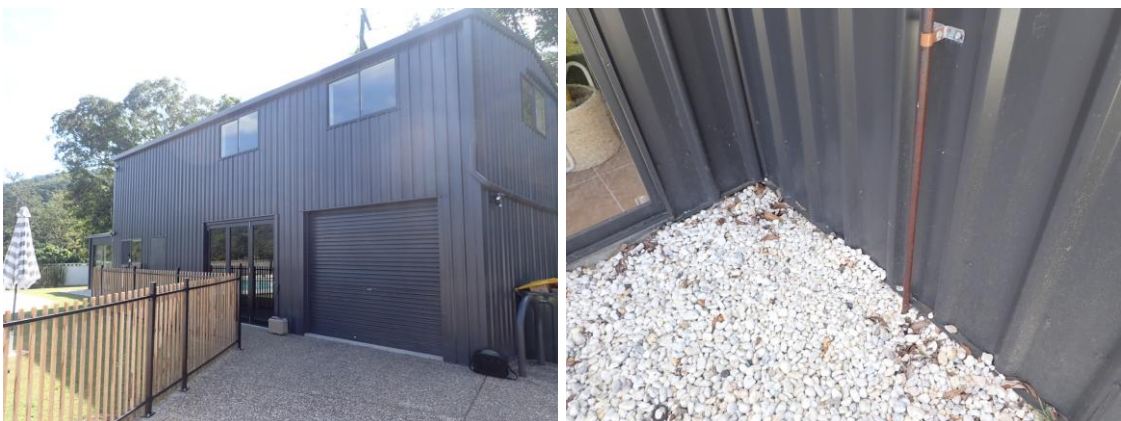
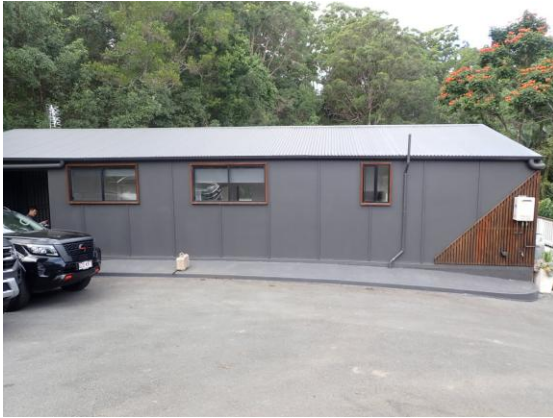
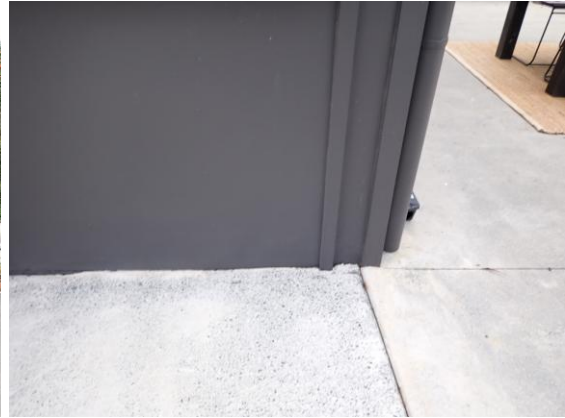
- Ground level deck timber members and main structure and free-standing shed and studio external wall sheeting are not the minimum 75mm from ground level. The Australian Standards recommend that the timber members and external wall sheeting need to be a minimum 75mm from ground level. This will avoid timber rot and unseen termite entry from occurring. Repairs are required to maintain the 75mm clearance.

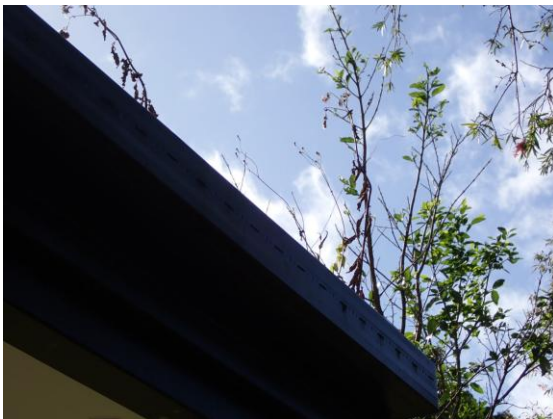
10. Vegetation growing in roof guttering should be removed.

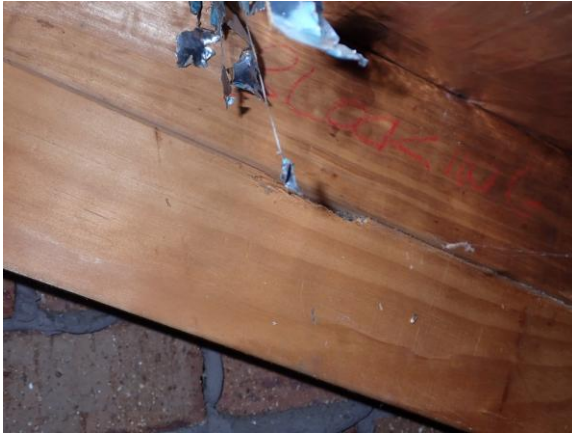
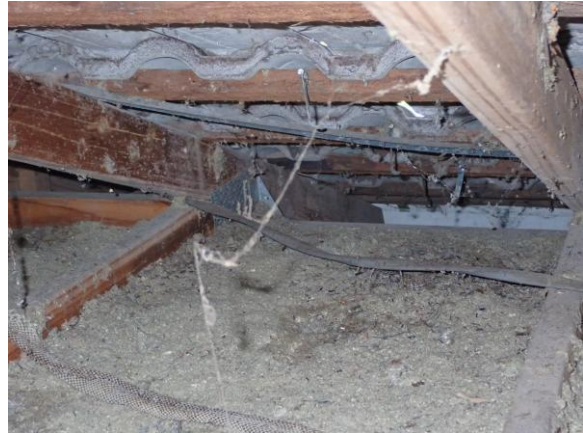
- A destructive investigation to the area listed in **section A.3** should be conducted as soon as possible to determine the full extent of damage to wall and roof framing members. No termite activity at the time of inspection, however activity may be concealed or occur at a later time.

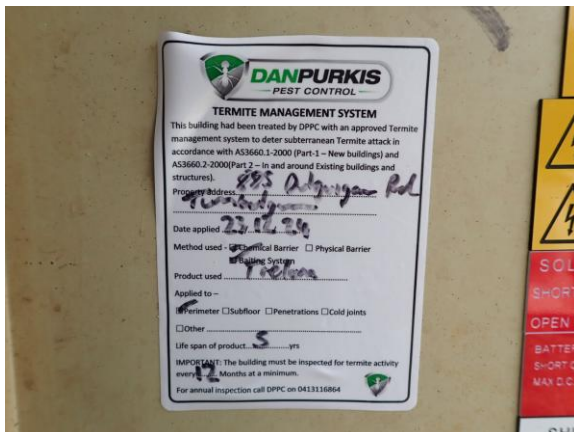
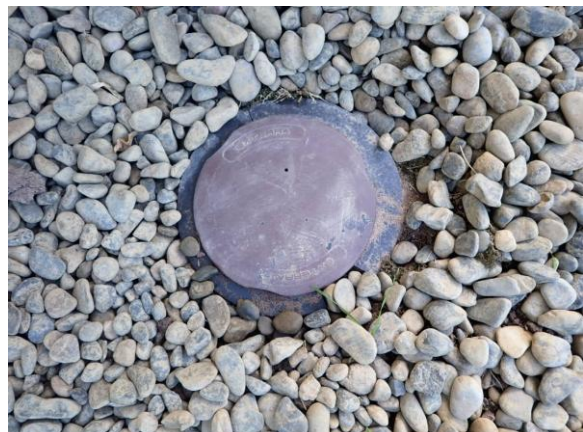
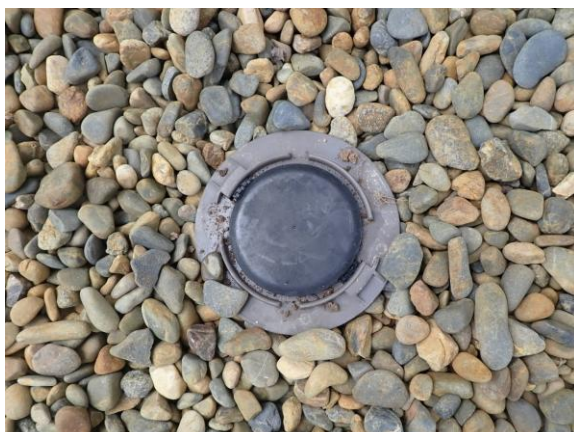
- An exterra and trelona advance termite baiting system was installed to the perimeter of the structure. Recommend obtaining all the appropriate installation and warranty documents regarding this treatment from the vendor, as this will determine what areas are protected under this system, where the infestation was within the structure and how extensive and to what areas and if there are any warranties available to the new owner. If no documents can be obtained, then it must be assumed that this system is no longer effective at protecting the structure against subterranean termite attack and that there is a high possibility that termite workings and damage exist within concealed areas of the structure.

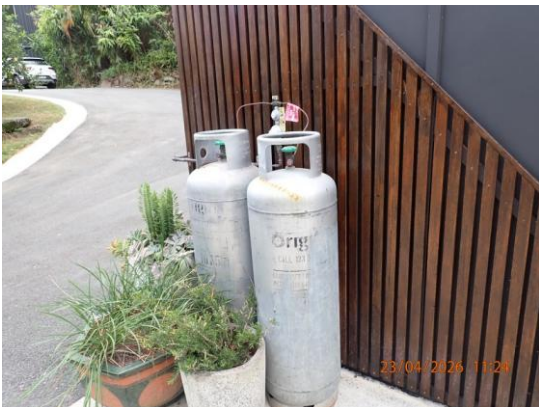
The gas bottles require securing in position for safety reasons (see photo below).

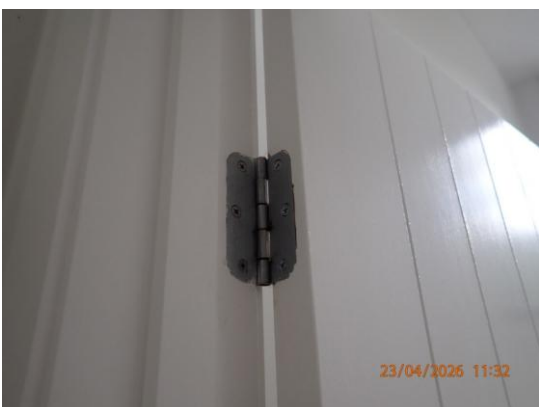
It is recommended that Lift Off Hinges be provided to the Studio toilet door for safety reasons (see photo below).

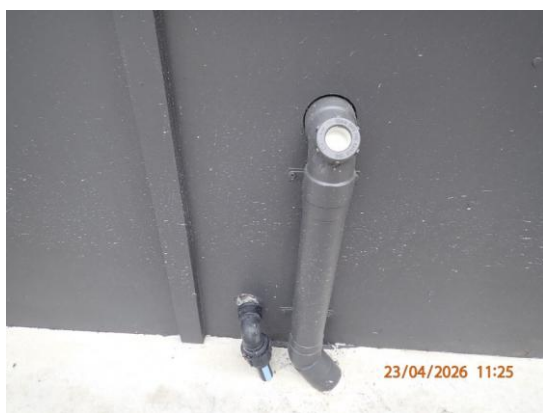
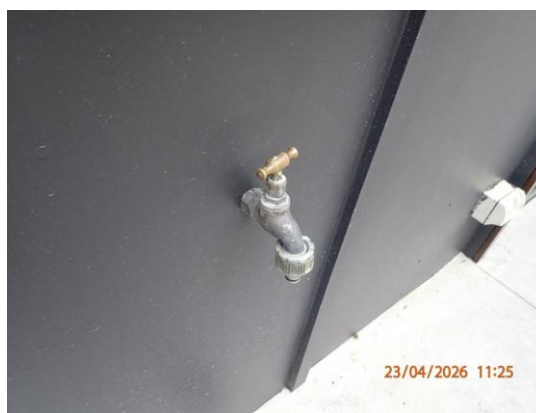
- The pipework penetrations to the Studio require sealing for weather and vermin proofing purposes (see photos below).

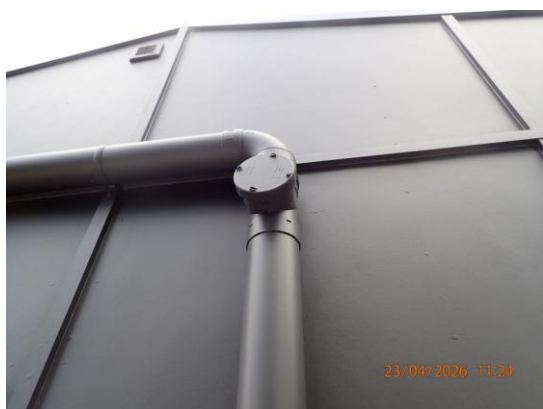
- There are leaks to the joints of the guttering and downpipes of the Studio in areas, which require sealing with a flexible sealant (see photo below).

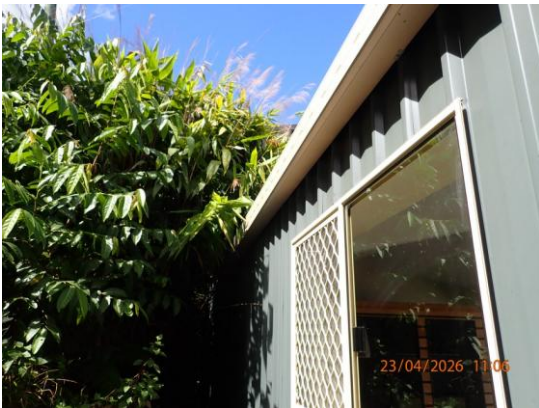
- The vegetation should be cleared away from the Shed/Studio to prevent undetected access for termites into the Shed/Studio as well as premature deterioration of some building elements (see photos below).

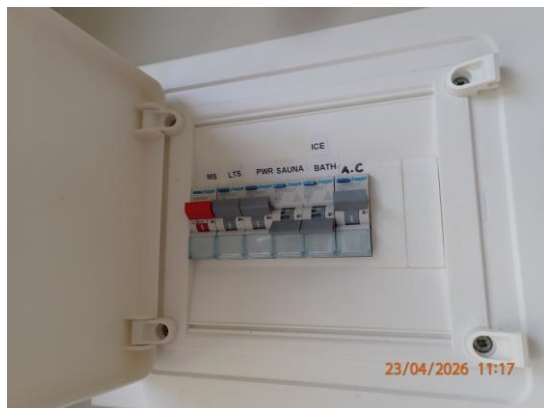
A safety switch has been provided to the sub board of the shed (see photo below). It is recommended that a Licenced Electrician be engaged to inspect and check the operation of safety switches and electrical circuits.

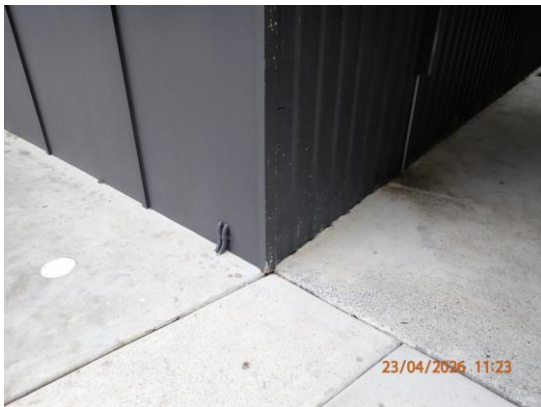
The cladding to the Studio (see photos 1 & 2) and Shed/Studio (see photos 3 & 4) were in contact with the ground and there should be a minimum clearance of 75 millimetres between the base of the cladding and the ground level to prevent undetected access for termites into the structure as well as premature deterioration of the building elements.

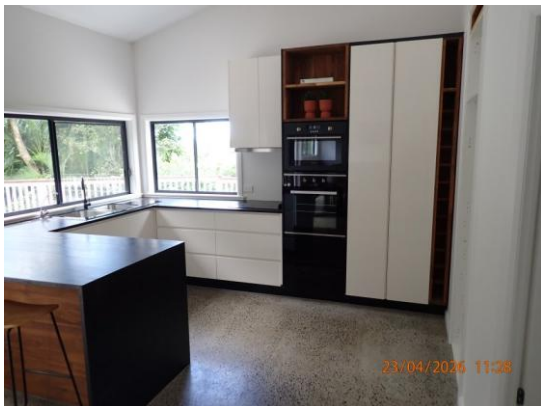
The Studio kitchen and bathroom/laundry have been renovated at some stage and it is recommended that the relevant documentation be obtained in regard to the renovations (Water Proofing Certificate) see photos below.

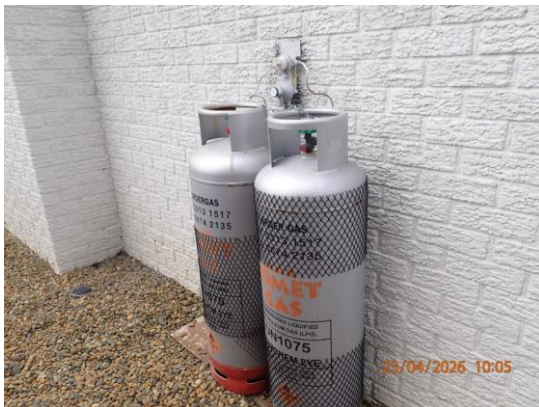
The gas bottles require securing in position for safety reasons (see photo below).

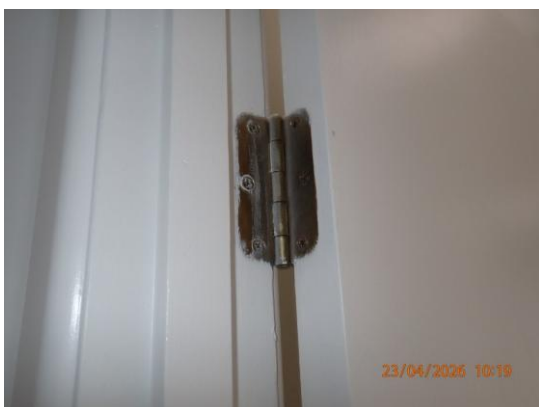
It is recommended that Lift Off Hinges be provided to the toilet door and ensuite toilet door for safety reasons (see photos below).

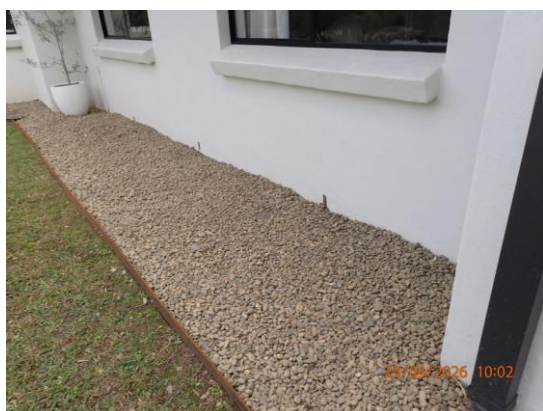
- The ground/garden level around the dwelling should be lowered to 75 millimetres below the weepholes to prevent undetected access for termites into the dwelling (see photo below).

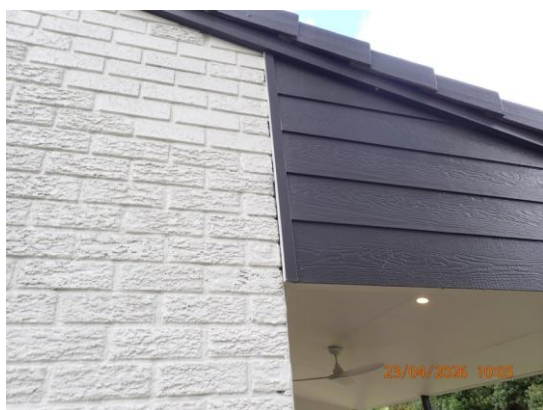
- The weatherboard/brick junctions require sealing with a flexible sealant for weather proofing purposes (see photo below).

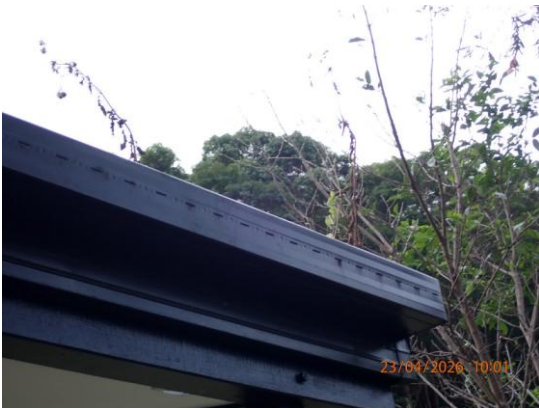
- All debris should be removed from the guttering to allow water flow during times of rain and to prevent premature deterioration of the guttering (see photo below).

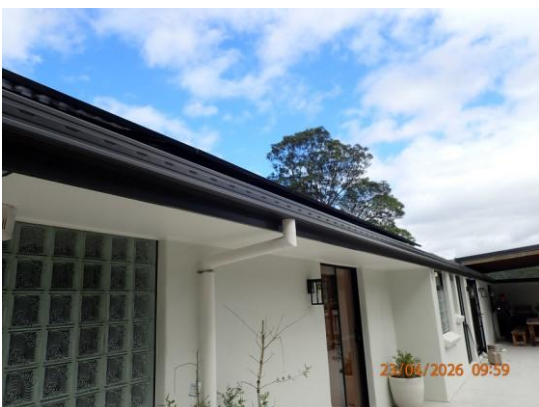
- There appears to be an insufficient number of downpipes to the length/run of guttering, and it is recommended that additional downpipes be provided to assist with the flow of stormwater in times of rain. The downpipe should be connected to the stormwater system to ensure stormwater is directed clear of the building (see photo below).

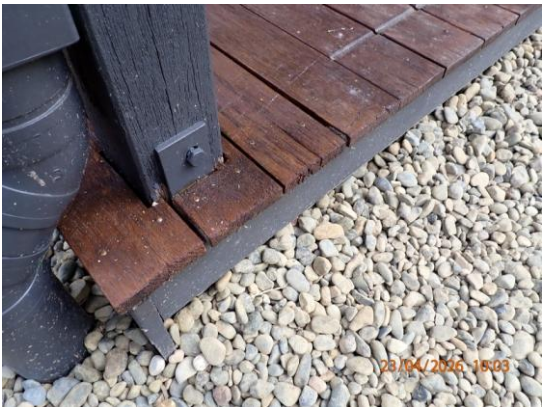
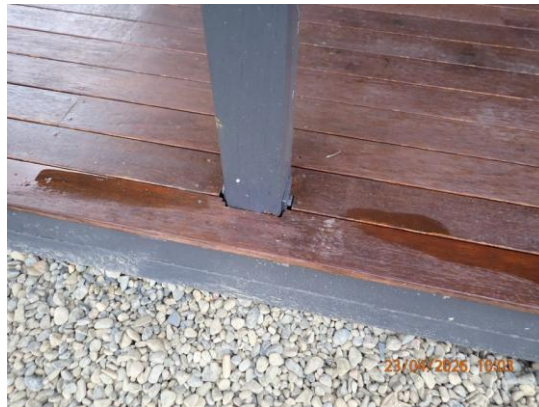
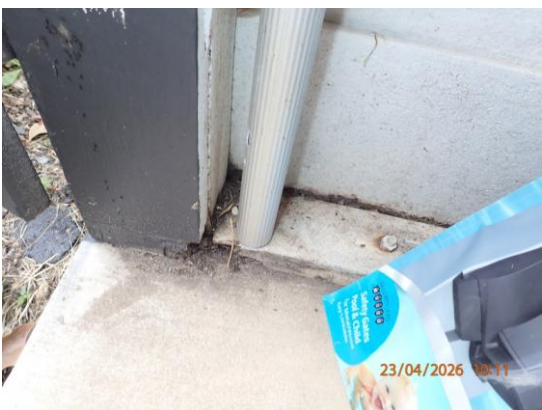
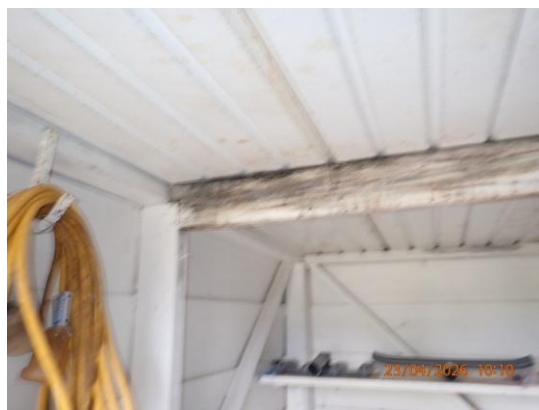
- There is decay to the timber members of the patio/deck (see photos 1 & 2) and decay to the pool pump house (see photos 3 & 4) which require repair, maintenance and/or treatment to prevent deterioration.

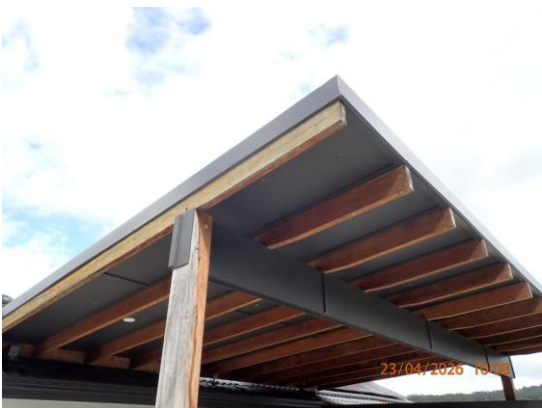
- There is evidence of weathering to the timber members of the pergola which require maintenance and treatment to prevent deterioration (see photo below).

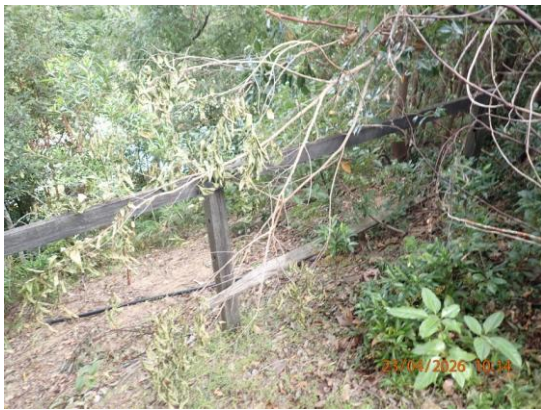
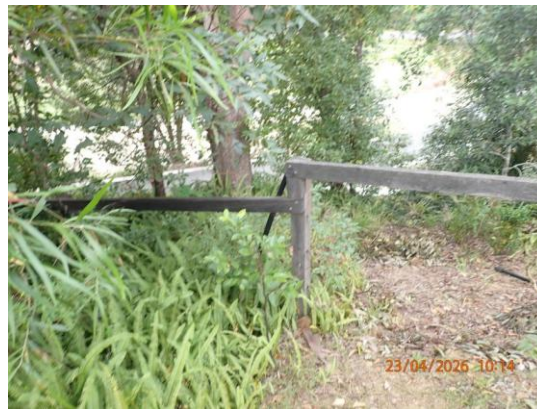
- There is decay to the timber members of the fencing which require repair, maintenance and/or treatment to prevent further deterioration (see photos below).

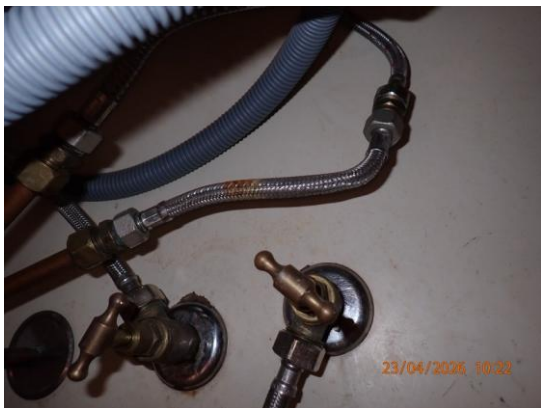
- The lock/handles are missing from windows of bedroom 2 and toilet and require replacement for practical purposes.
- The ceiling lining to bedroom 2 has a wavy appearance in places due to minor sagging of the lining between fixing points.
- There is rusting to the flexible water hose to the laundry tub which requires attention to prevent further deterioration (see photo below).

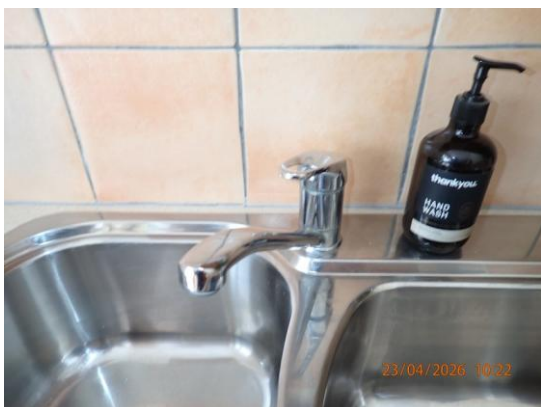
- The junction between the splashback and tub requires sealing with a flexible sealant to prevent water build up behind the tiles or in the cavity (see photo below).

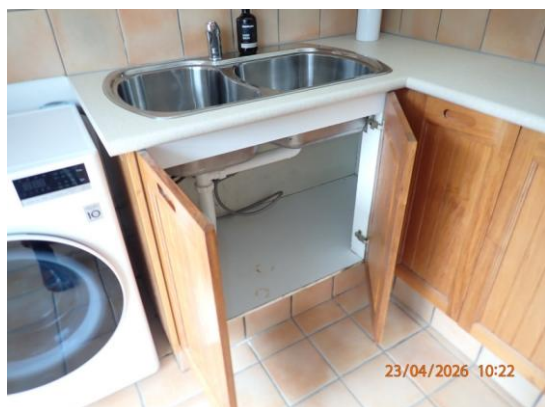
- There is deterioration to the laundry tub cabinet due to moisture damage (see photos below). There was no evidence of recent leaking at the time of the inspection. It is recommended that the affected area be monitored to be sure there are no further leaks and if so the leaks need to be located and repairs made to prevent premature deterioration of the building elements.

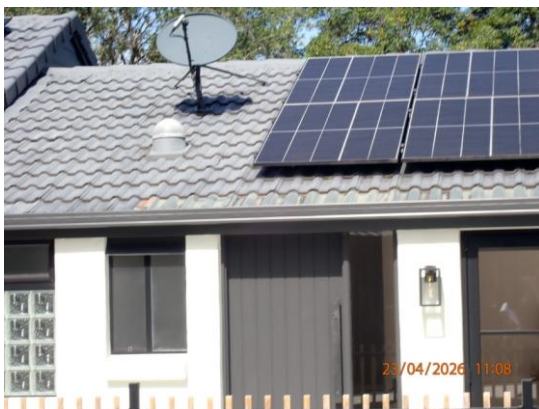
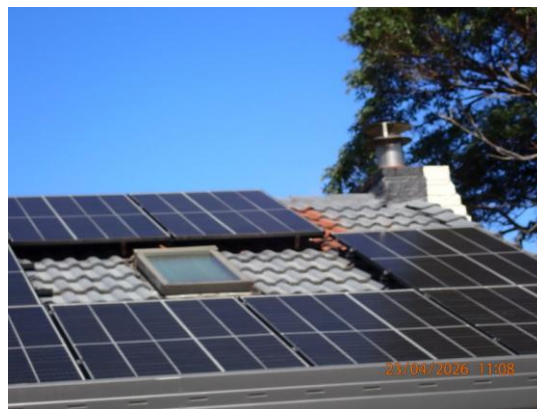
There is evidence of repairs to the roof covering with different tiles in areas (see photos below).

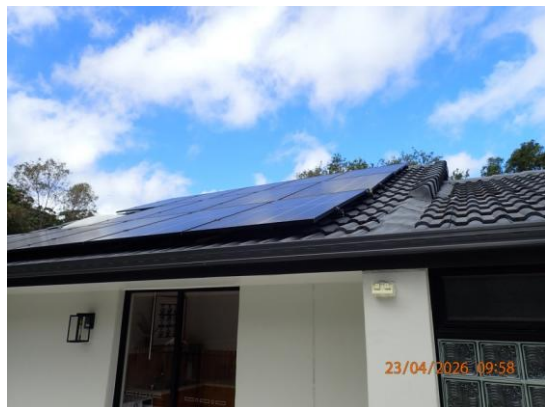
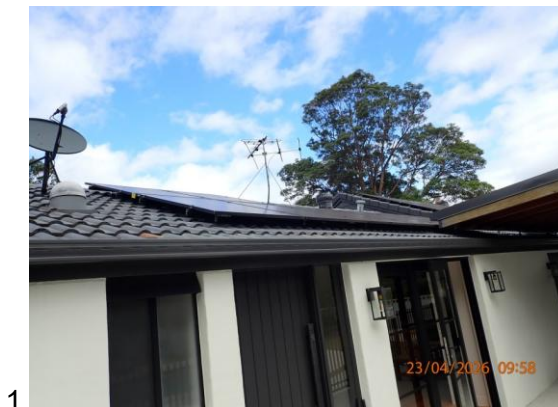
The solar panels obscured the inspection of the roof covering in areas (see photos below).

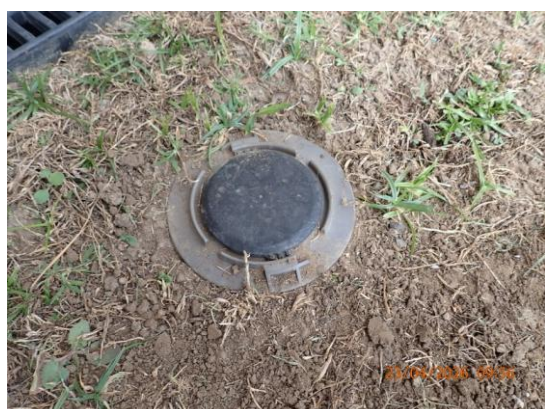
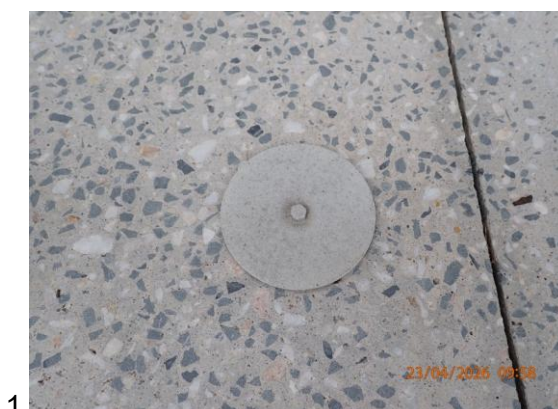
There is evidence of a termite baiting system to the perimeter of the building, and it is recommended that the relevant documentation be obtained regarding its installation (see photos below).

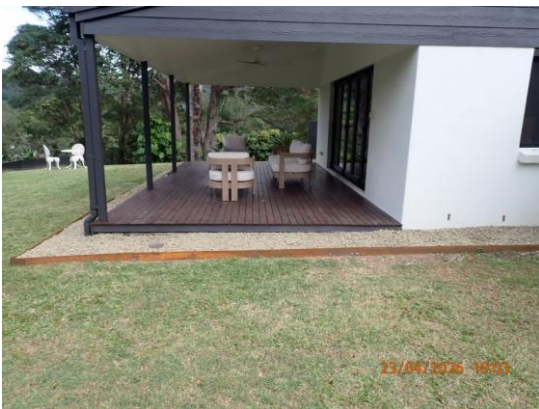
There was no access below the patio/deck for inspection (see photo below).

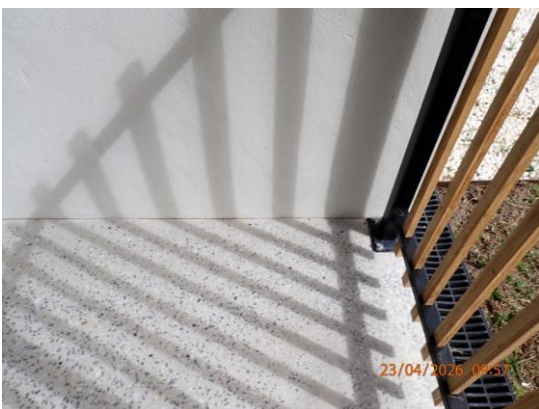
The cladding is in contact with the ground and there should be a minimum clearance of 75 millimetres between the base of the cladding and the ground level to prevent undetected access for termites into the structure as well as premature deterioration of the building elements (see photo below).

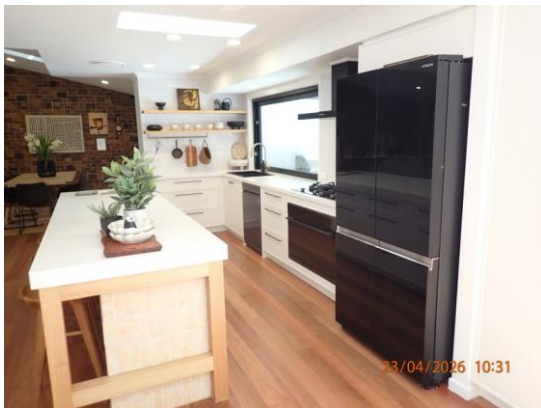
The kitchen, bathroom and toilet have been renovated at some stage and it is recommended that the relevant documentation be obtained in regard to the renovations (Water Proofing Certificate) see photos below.

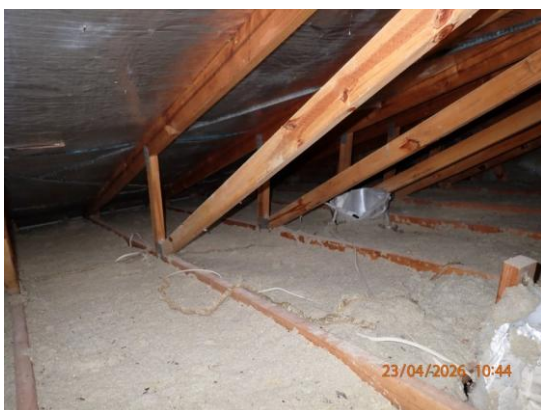
The inspection of the roof void was limited due to the truss configuration, low crawl space, insulation, air conditioning duct work and sarking (see photos below). There was no access to the skillion roof areas for inspection.

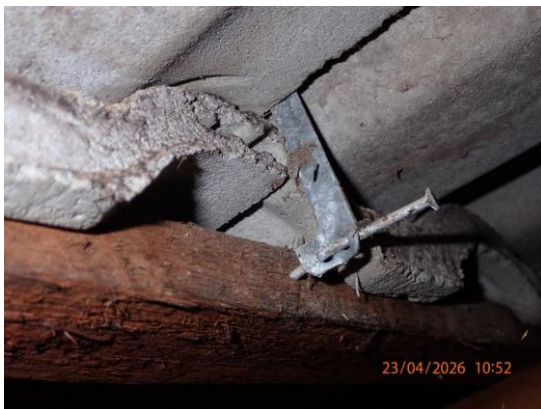
The tile clips used to hold the roof tiles in place are well known for causing water leaks (see photo below). There was no evidence of recent leaking at the time of the inspection, it is recommended that the area be monitored to be sure there are no leaks and if so the leaks need to be located and repairs made to prevent premature deterioration of the building elements.
