**PRE SALE  
STANDARD PROPERTY REPORT**

Report number: PPI2025442

Inspection date: Monday 25<sup>th</sup> August 2025

Property address: 15 and 15a Peppermint Place Banora Point NSW

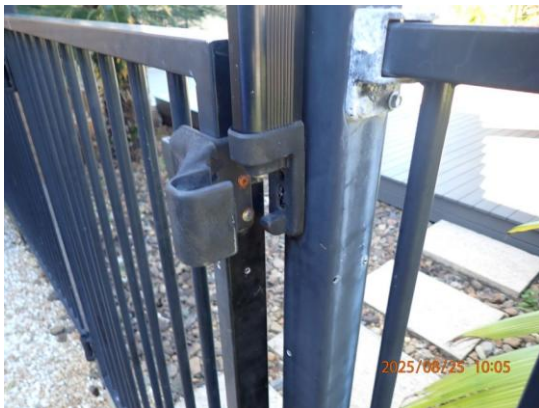
The pool gate requires adjustment to ensure that it is self-closing and locking (see photo below). It is recommended that a Swimming Pool Compliance Certificate be obtained in regard to pool fencing.

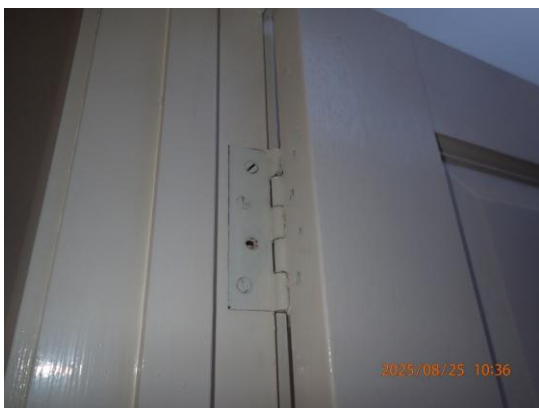
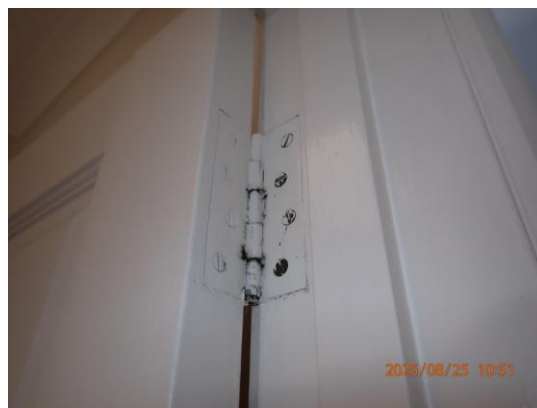
It is recommended that Lift Off Hinges be provided to the toilet doors for safety reasons (see photos below).

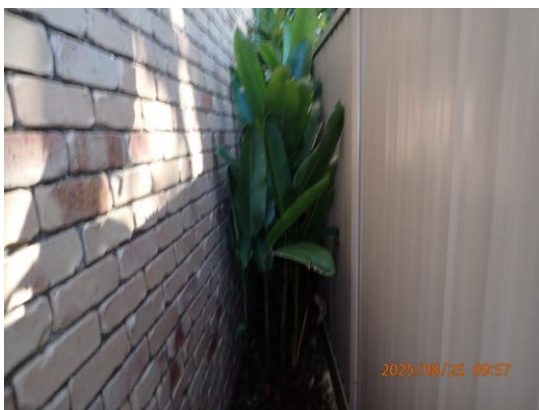
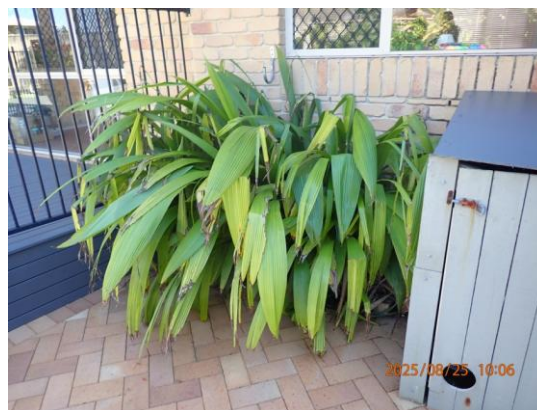
- The vegetation should be cleared away from the main dwelling to prevent undetected access for termites into the dwelling as well as premature deterioration of some building elements (see photos below).

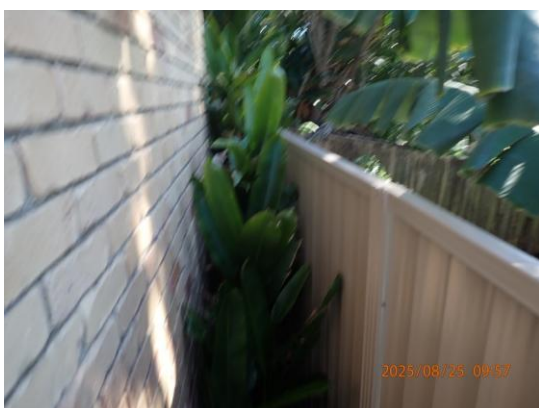
- The inspection to the complete exterior of the main dwelling was limited due to vegetation growing close to the dwelling (see photo below).

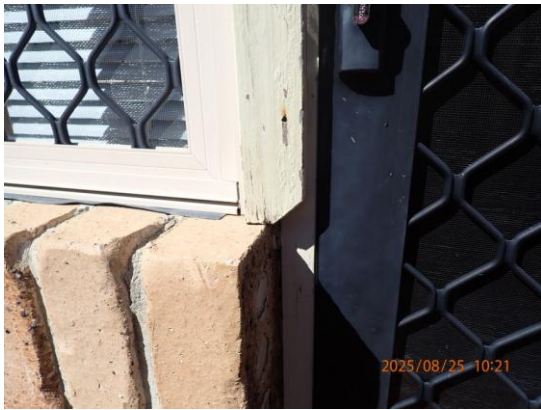
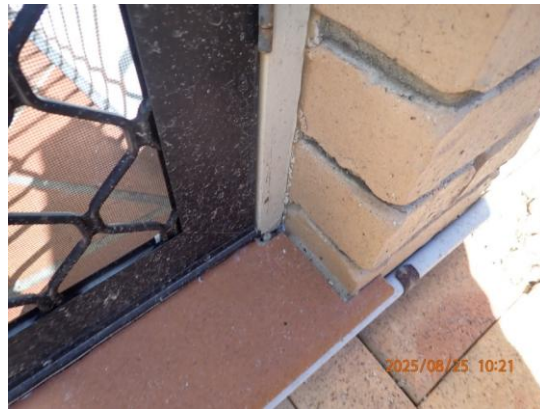
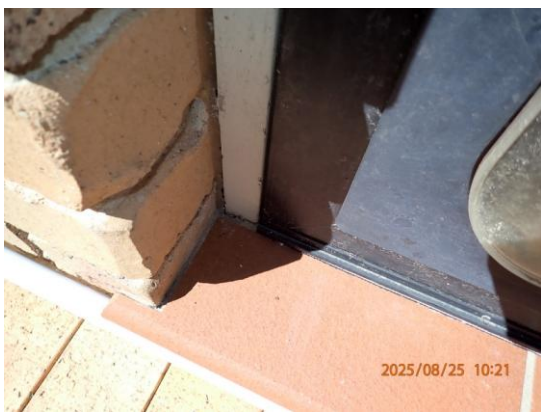
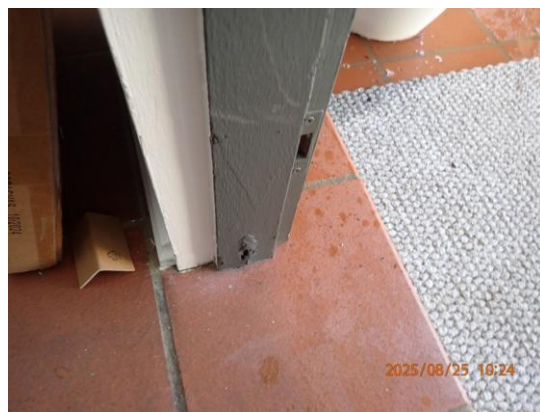
- There is weathering and decay to the external door jambs and mouldings of the main dwelling which require repair, maintenance and/or treatment to prevent deterioration (see photos below).

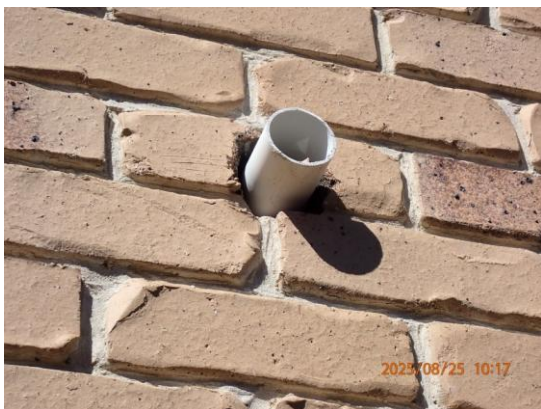
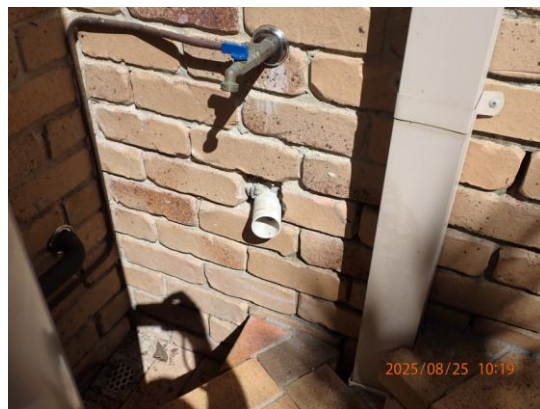
- The pipework penetrations to the main dwelling require sealing for weather and vermin proofing purposes (see photos below).

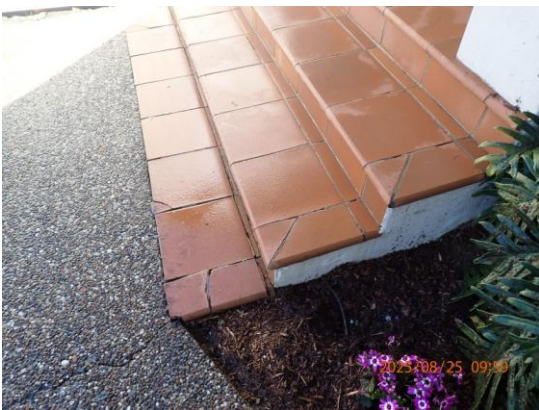
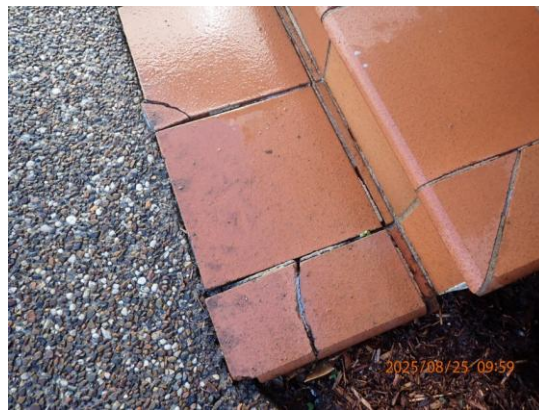
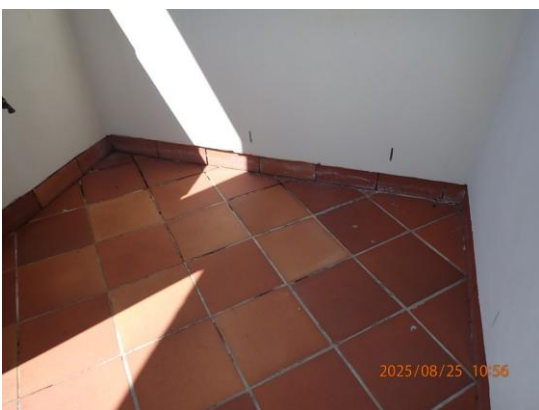
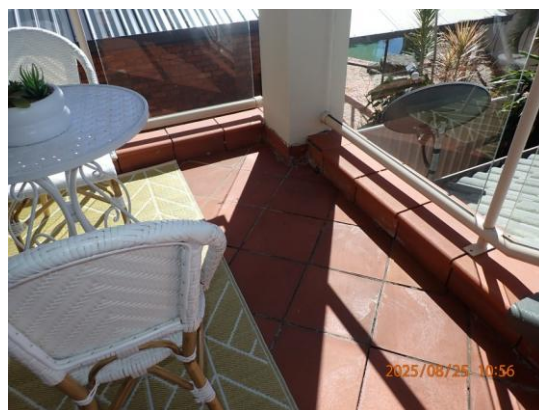
- There are dummy, broken and cracked floor tiles to the main dwelling entry stairs and landing (see photos 1 & 2) and drummy floor tiles to the main dwelling main bedroom balcony (see photos 3 & 4) which require refixing and/or replacement where necessary.

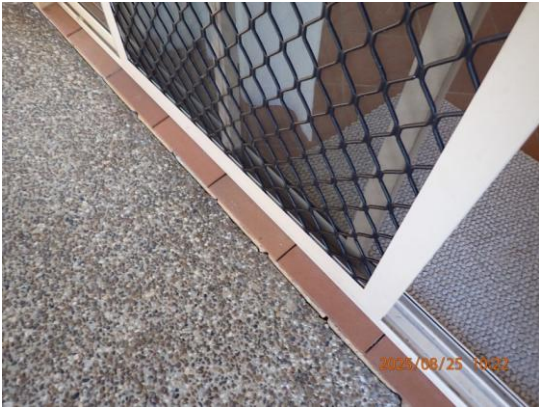
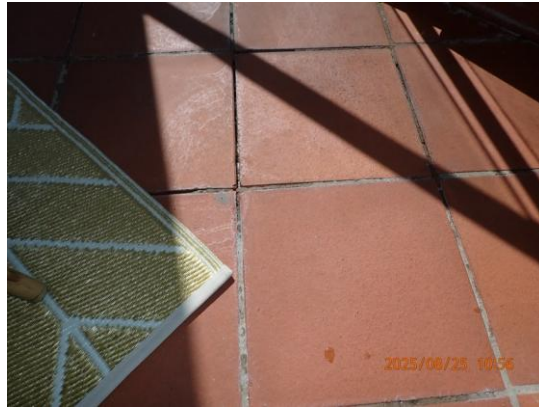
- The grout to the sill tiles of the main dwelling and grout to the floor tiles of the main bedroom balcony has eroded and come away and requires regrouting where necessary (see photos below). Please engage a Licenced Wall and Floor Tiler to inspect and carry out repairs.

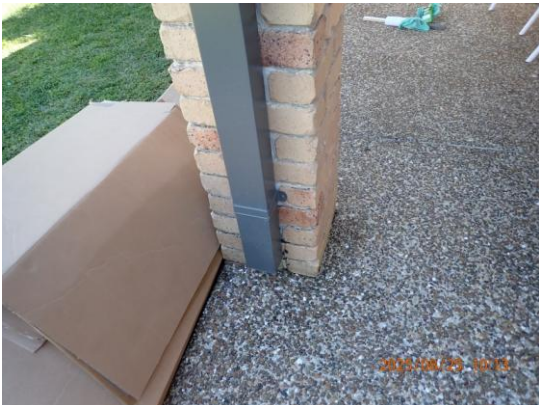
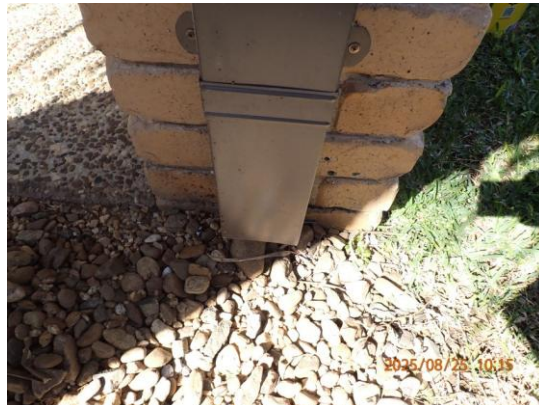
- The downpipes to the main dwelling pergola are directed onto the ground and should be connected to a stormwater system discharging to the street or away from the building (see photos below).

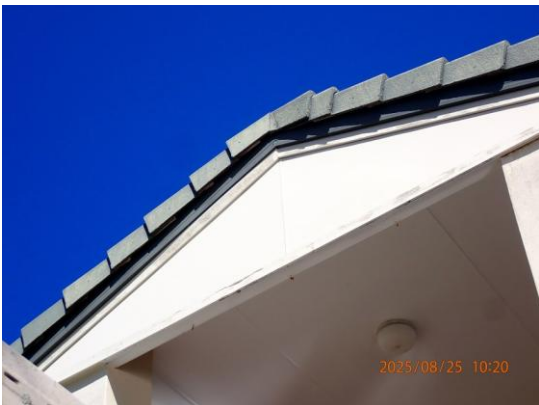
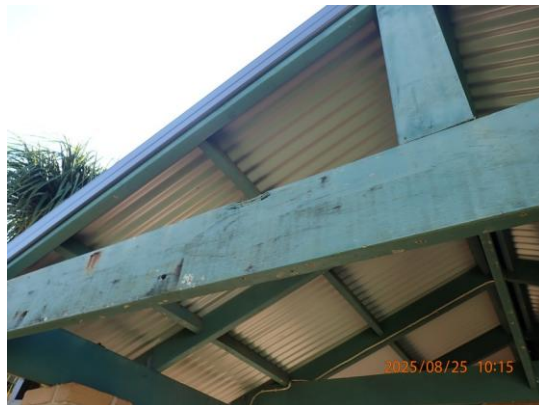
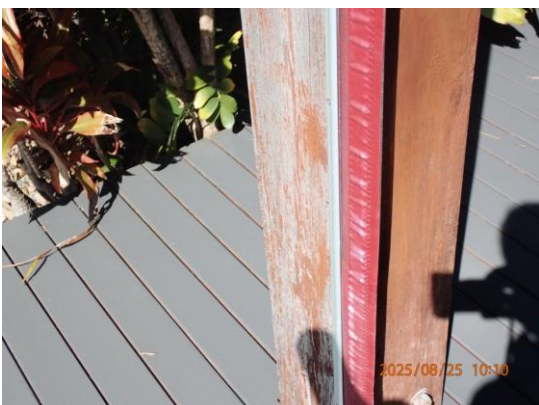
- There is decay to the timber mouldings of the gable end (see photo 1), timber members of the pergola (see photo 2) and weathering to the finish of the pool pergola (see photo 3) of the main dwelling which requires repair, maintenance and/or treatment to prevent deterioration.

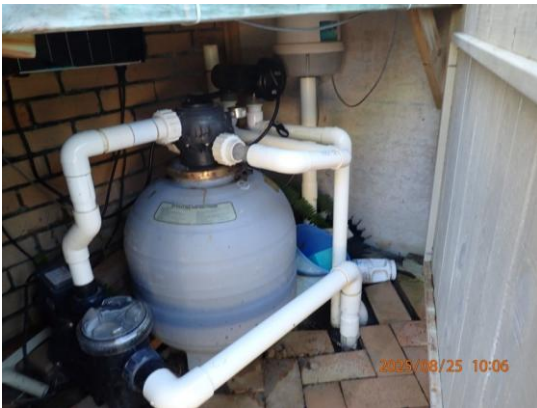
- There is deterioration to the pool pump enclosure which requires which requires repair (see photo below).

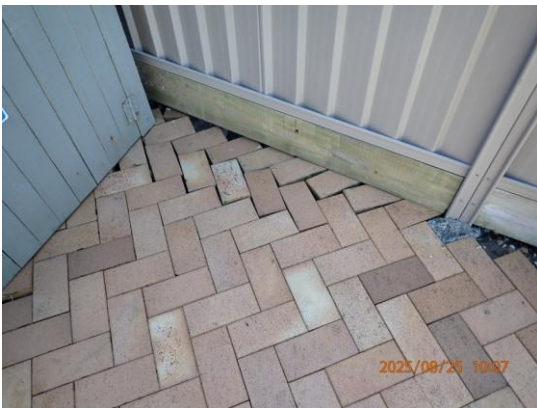
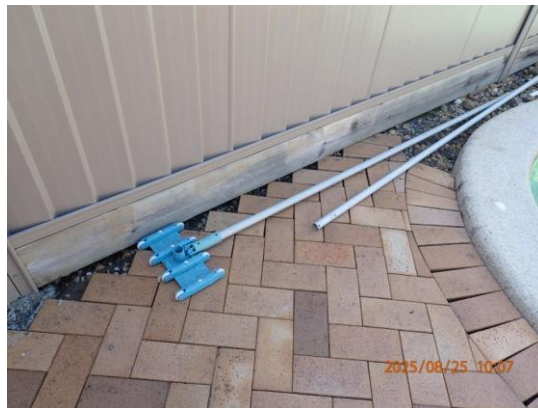
- There is settlement and loose pavers to the surround of the pool and settlement to the path pavers which has caused the surface to become uneven and rectification works should be carried out on these areas (see photos below).

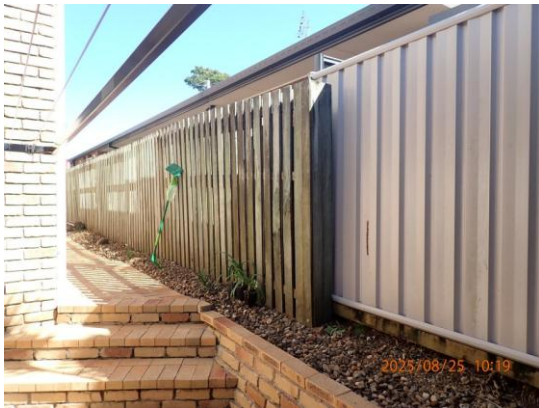
- There is weathering and decay to the timber members of the main dwelling fencing which require repair, maintenance and treatment to prevent further deterioration (see photo below).

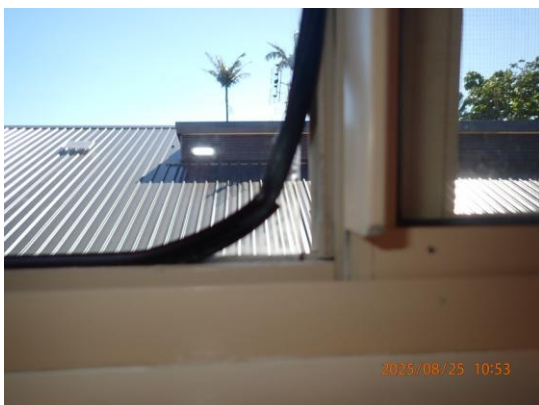
- The rubber glazing beads to the main dwelling ensuite window is coming away/damaged in areas and where necessary require reinstating and/or replacement for weather proofing purposes (see photo below).

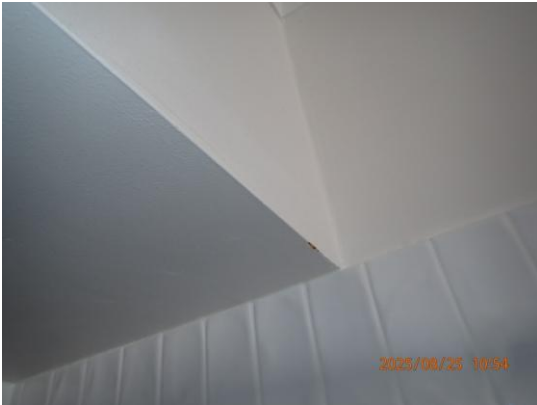
- There is rusting to the corner angles of the main dwelling ensuite wall lining at the bulkhead of the shower (see photo below). The corner angle requires repair, maintenance and/or treatment with a rust inhibiting paint to prevent further deterioration.

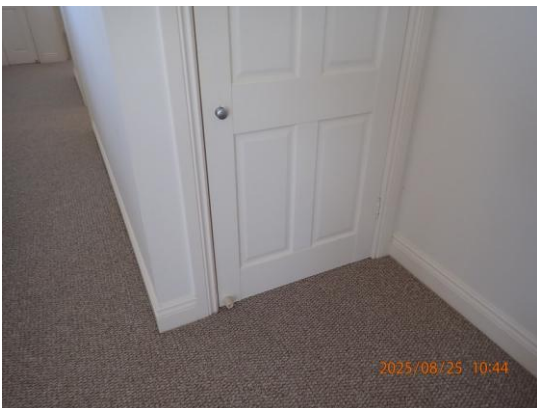
- There is damage to the hallway window lock handles of the main dwelling which require repair for practical purposes.
- The hallway linen cupboard door to the main dwelling is binding on the floor and requires adjustment for ease of use (see photo below).

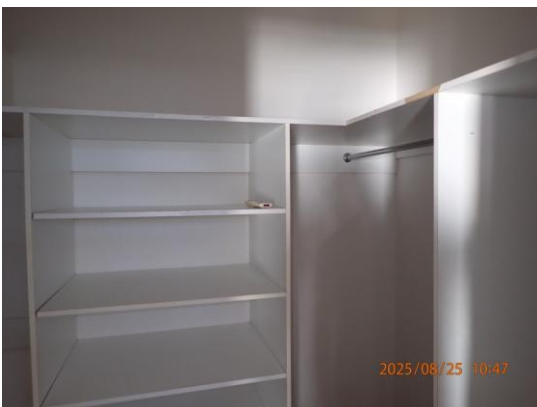
- There is deterioration to the shelving of the main bedroom robe which requires attention (see photo below).

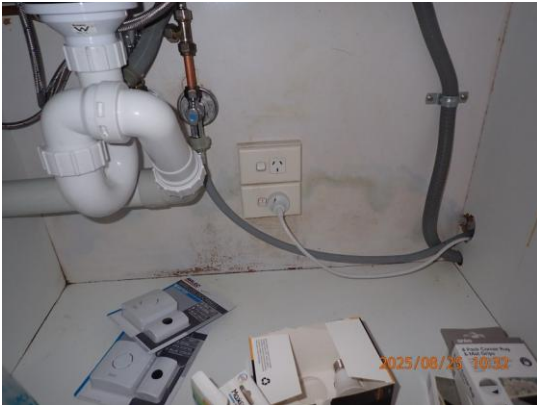
- There is evidence of a previous water leak below the main dwelling kitchen sink with swelling and stains to the cabinet (see photo below). There was no evidence of recent leaks at the time of the inspection. It is recommended that the affected areas be monitored to ensure there are no further leaks and if moisture becomes obvious, the leaks need to be located and repairs made.

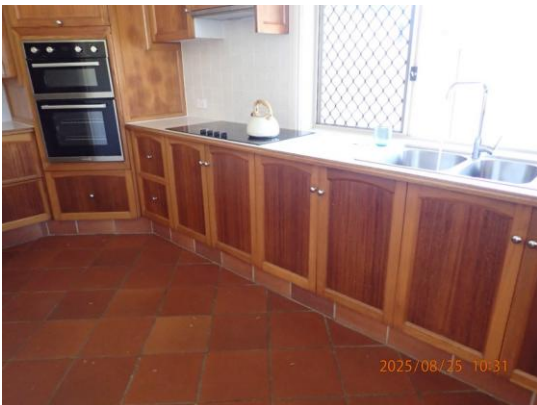
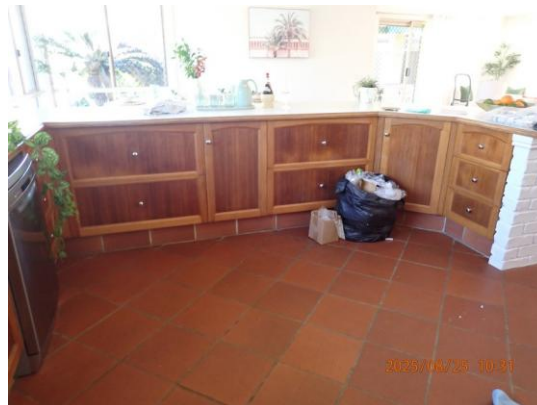
- There is deterioration to the kitchen cabinets of the main dwelling due to their age and general wear and tear (see photos below).

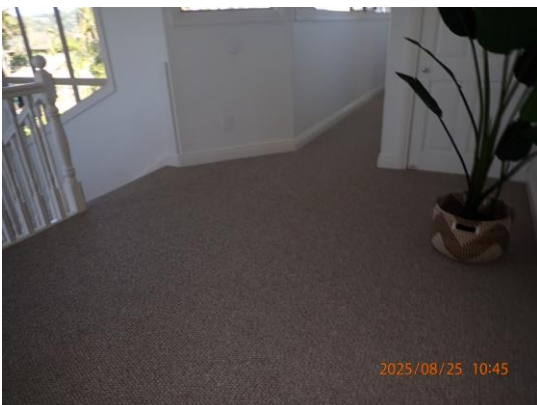
- The upper level timber floor to the main dwelling appears to be out of level and uneven in some areas, which may be caused by shrinkage of unseasoned floor timbers used at the time of construction and the age of the building (see photo below).

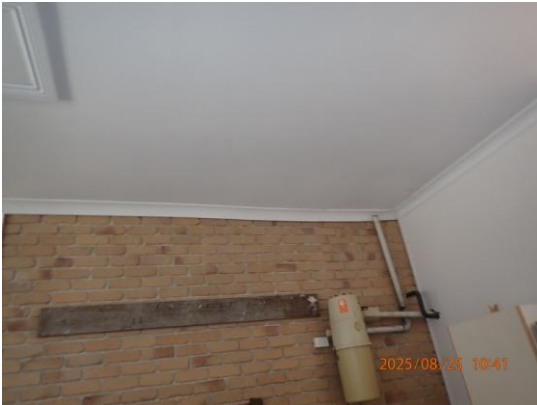
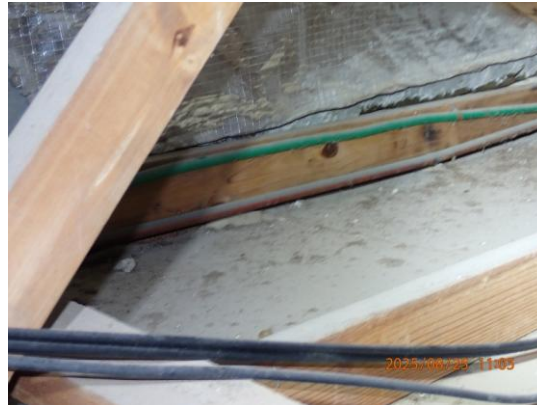
- The ceiling lining and cornice to the garage is coming away and requires refixing where necessary (see photos below). Please engage a Licenced Plasterer/Gyprocker to inspect and carry out repairs.

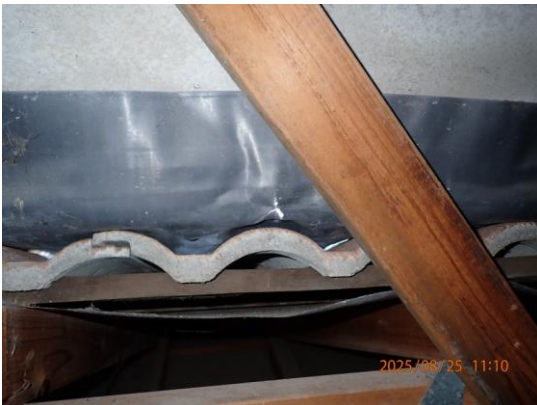
1

- There is cracking to the lead flashing of the gable ends which requires repair for weather proofing purposes (see photos below). Please engage a Licenced Plumber/Roofer to inspect and carry out repairs.

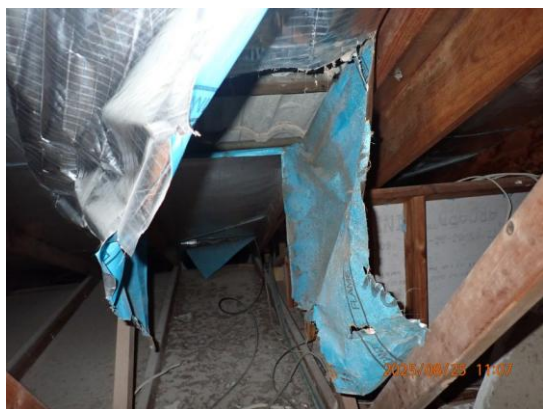
- The sarking to the main dwelling is coming away and should be retaped to gain maximum benefit from its installation (see photos below).

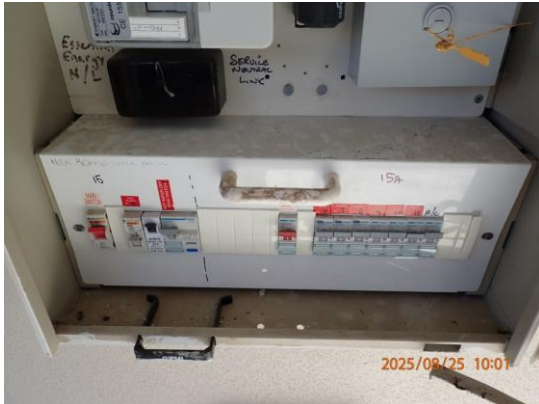
1

Safety switches have been provided to the meter box and sub board below the stairs (see photos below). It is recommended that a Licenced Electrician be engaged to inspect and check the operation of safety switches and electrical circuits.

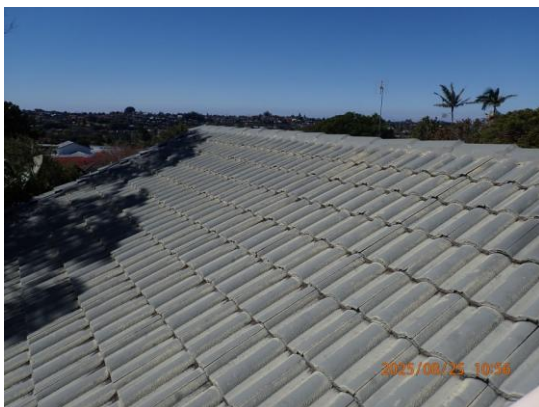
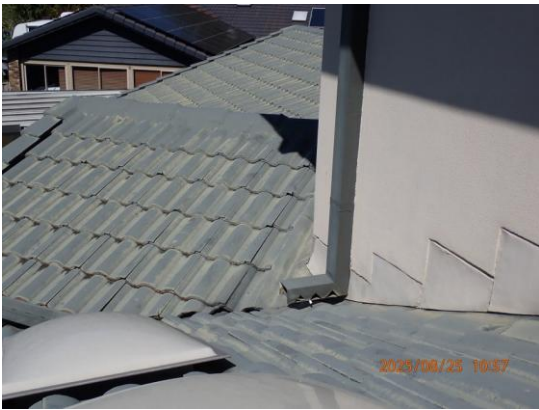
There is evidence of weathering to the finish of the roof tiles to the main dwelling due to age and wear and tear (see photo below).

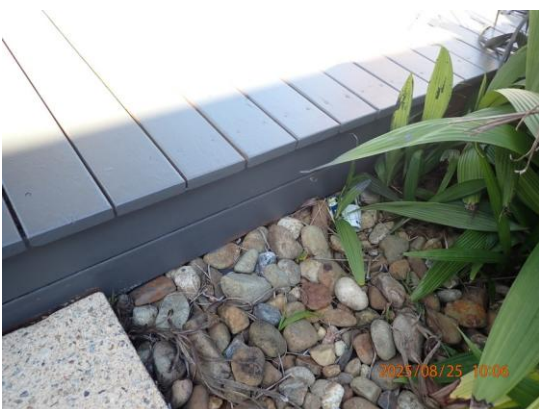
The timber members of the pool deck are in contact with the ground and there should be a minimum clearance of 75 millimetres between the base of the members and ground level to prevent undetected access for termites into the structure as well as premature deterioration of the building elements (see photos below).

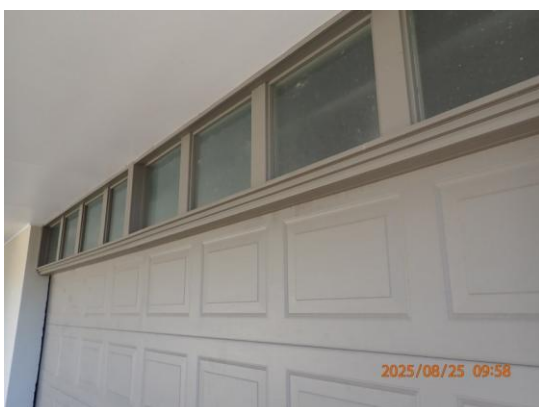
There is evidence of deflection to the head above the garage door which could be due to the excessive span of the framing members above this area (see photo below).

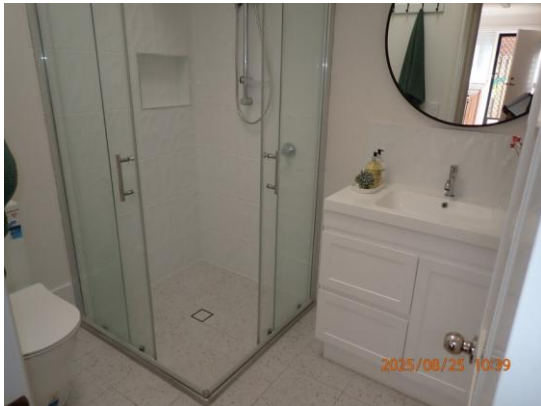
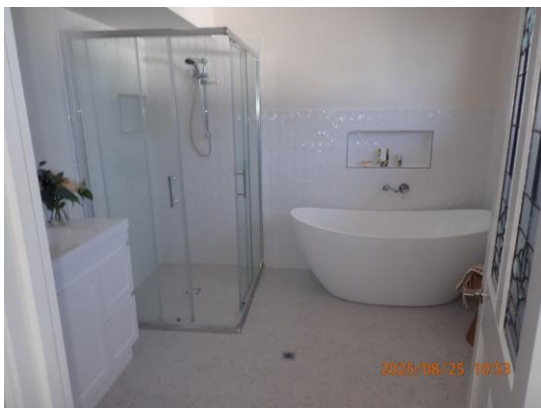
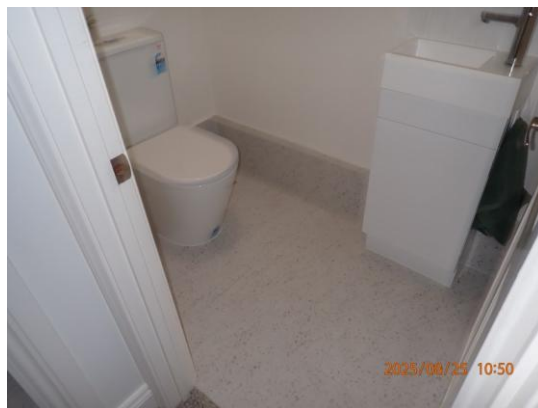
The bathrooms, ensuite and upper level toilet to the main dwelling have been renovated at some stage and it is recommended that the relevant documentation be obtained in regard to the renovations (Water Proofing Certificate) see photos below.

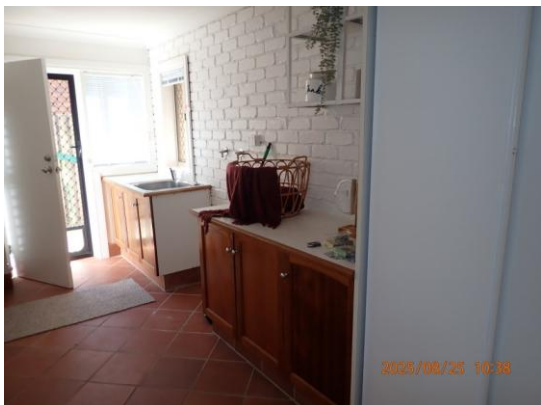
There is evidence of general wear and tear to the main dwelling laundry cabinets due to age (see photo below).
