**PRE SALE
STANDARD PROPERTY REPORT**

Report number: PPI202687

Inspection date: Monday 9th March 2026

Property address: 34 Laura Street Banora Point NSW

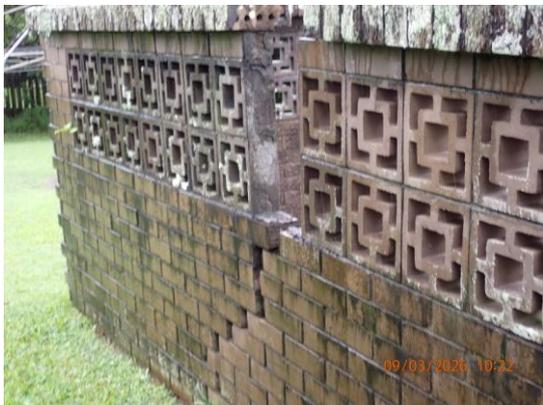
1

There is cracking and movement to the brick fencing (see photos below). The fencing is leaning over and requires repair and/or replacement for safety reasons.

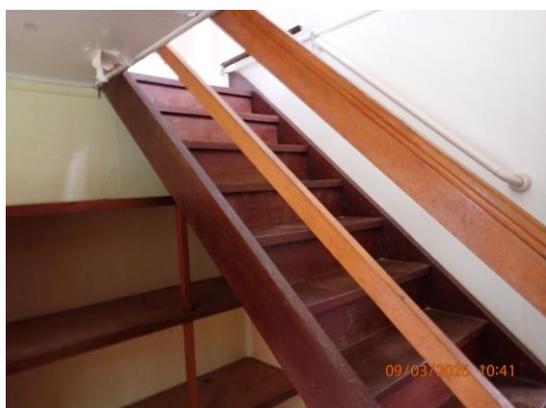
The handrail to the internal stairs requires upgrading for safety reasons (see photo below). For advice and recommendations on handrails please contact Tweed Shire Council.

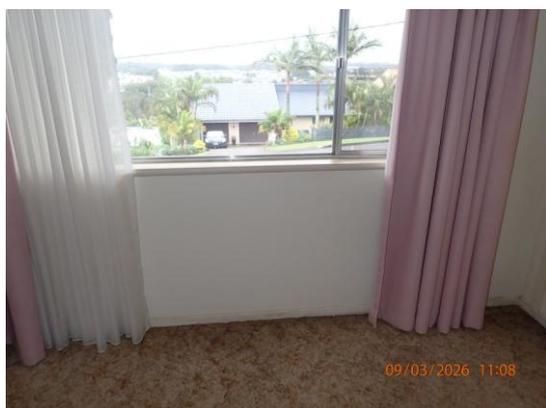
The window should be limited when opened and/or a security screen provided for safety reasons (see photo below). It should be noted that windows to the Second (2nd) Story and/or High Set Dwelling/Building which are less than a One (1) Metre from the floor level to the rail should be limited to 125mm when opened and/or a security screen provided to the opening side of the window for safety reasons.

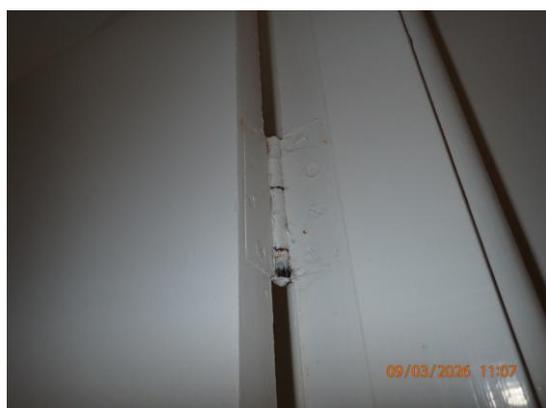
It is recommended that Lift Off Hinges be provided to the toilet door for safety reasons (see photo below).

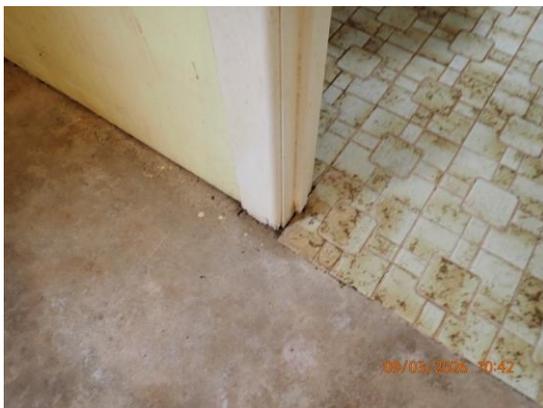
1

The wall framing to the laundry/bathroom and the wall framing backing onto the garage are loose and require securing in position (see photos below). Please engage a Licenced Builder to inspect, give advice and carry out repairs where necessary.

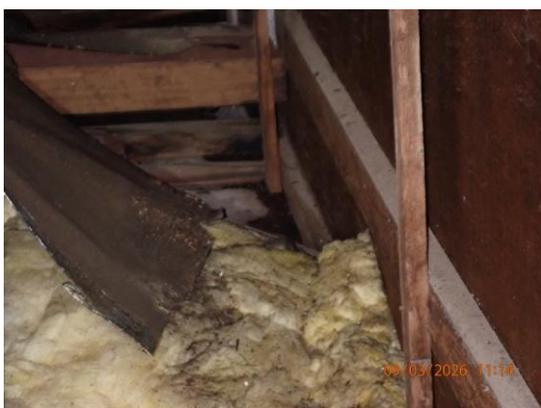
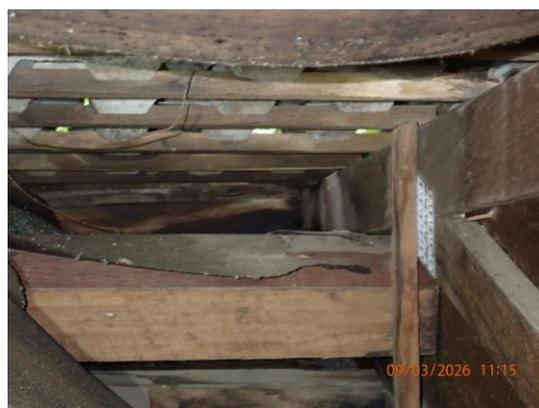
The roof tile is broken/missing above the eave at the south west corner which requires replacement for weather proofing purposes (see photo below).

There are stains and decay to the eave and roof framing below the broken/missing tile (see photos below).

Please engage a Licenced Roof Tiler to inspect, give advice and carry out rectification work where necessary.

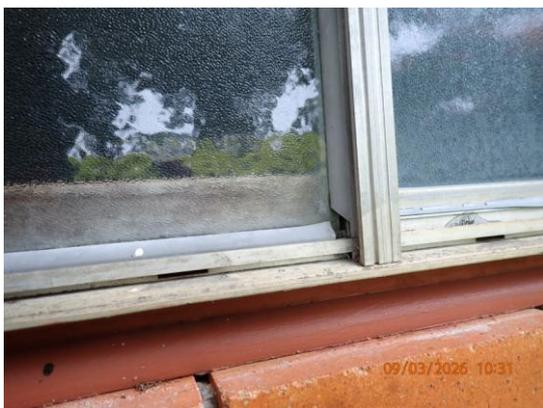
1

The rubber glazing beads to the windows and doors are coming away and damaged in areas and where necessary require reinstating and/or replacement for weather proofing purposes (see photos below).

Please Note: Due to the age and condition of the windows and doors they will require repair and/or replacement in the foreseeable future.

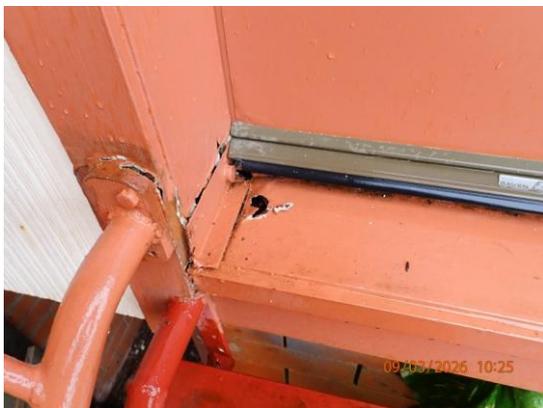
There is decay to the door jamb and sill (see photos 1 & 2) and decay to the timber mouldings and framing at the handrail fixing (see photo 3) of the enclosed rear entry balcony. The affected areas require repair and/or replacement. Due to the limits of the visual inspection it is hard to determine if there is damage to the framing members covered by wall linings and cladding. It is recommended that a more invasive inspection be undertaken. If damage is found the affected timber members should be repaired and/or replaced.

Please engage a Licenced Builder to inspect, give advice and carry out repairs where necessary.

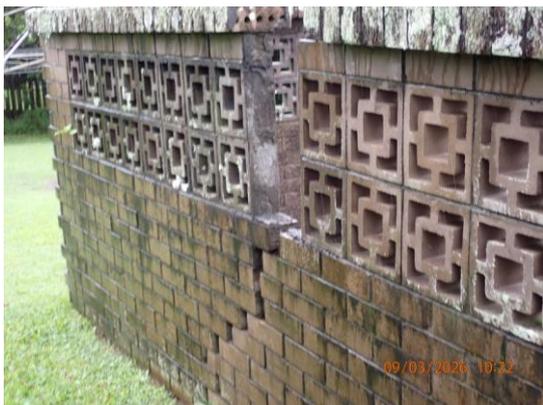
1

There is cracking and movement to the brick fencing and retaining walls (see photos below). The fencing and retaining walls require repair and/or replacement. Please engage a Licenced Bricklayer to inspect, give advice and carry out repairs where necessary.

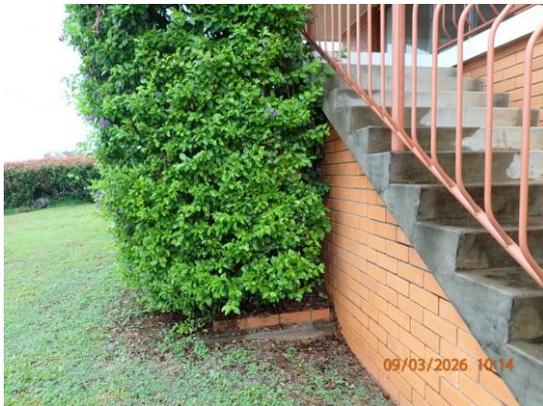
1

- The vegetation should be cleared away from the dwelling to prevent undetected access for termites into the dwelling as well as premature deterioration of some building elements (see photos below).

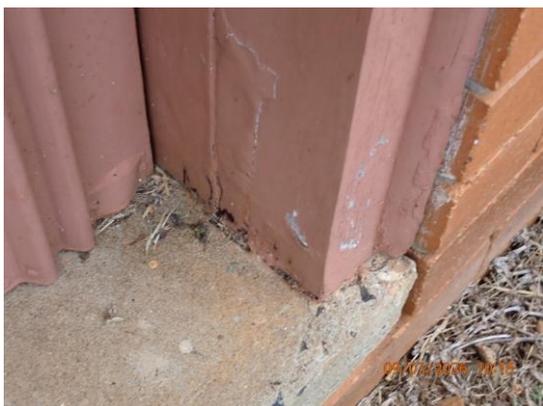
1

- There is decay to the garage door jambs which require repair, maintenance and/or treatment to prevent deterioration (see photos below).

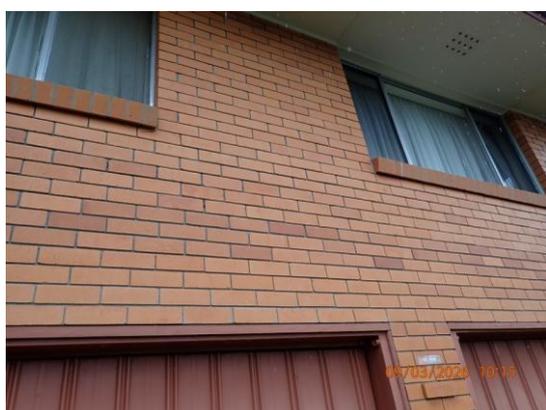
1

- There is evidence of erosion to the mortar joints of the brickwork in areas which could be repointed to prevent further deterioration (see photos below).

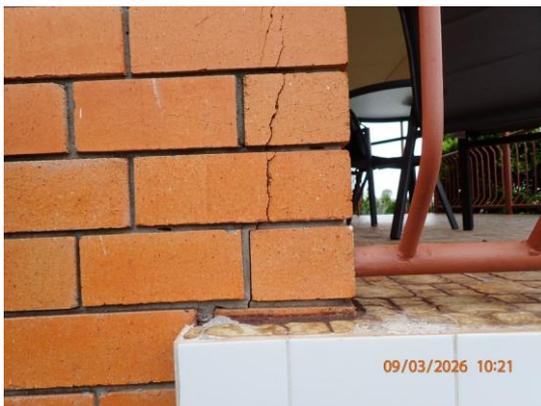
- There is cracking to the brickwork at the balcony handrail junction (see photo 1) and below the balcony (see photos 2 & 3). The cracks appear to have been there for some time and show no signs of recent movement. It is recommended that the affected areas be monitored to ensure there is no further movement, and if so the services of a Practising Structural Engineer be sought to assess the adequacy of the building, determine the risk of further settlement, recommend measures to counter any such movement, and if required, provide a specification for rectification works.

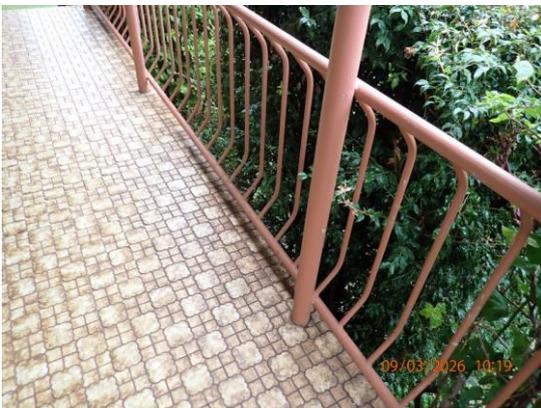
3

- There is rusting to the metal support posts and handrails of the balcony which require repair, maintenance and/or treatment with a rust inhibiting paint to prevent further deterioration (see photos below).

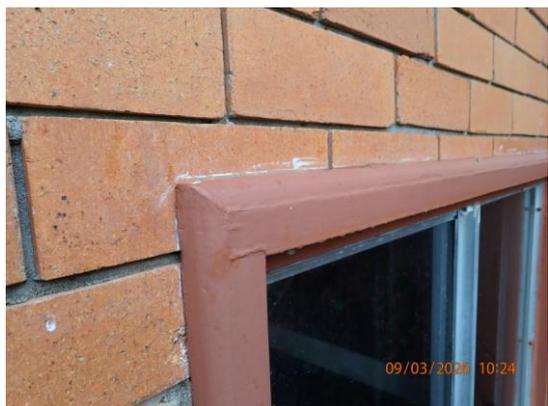
5

- There is decay to the timber mouldings of the sheeting and windows which requires repair, maintenance and/or treatment to prevent deterioration (see photos below).

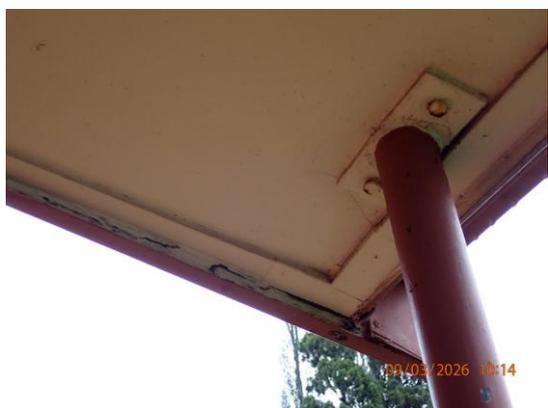
1

- There is decay to the timber fascia barge which require repair, maintenance and/or treatment to prevent deterioration (see photos below).

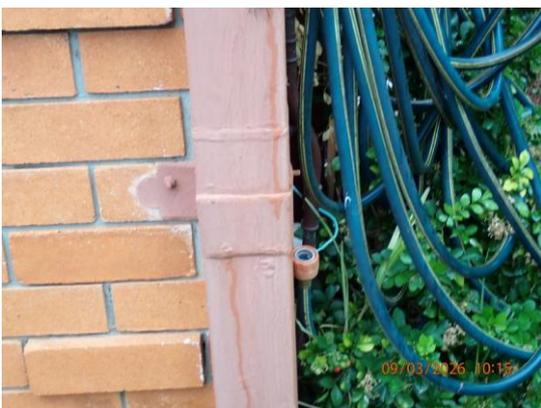
1

- There are leaks to the joins of the guttering and downpipes in areas, which require sealing with a flexible sealant.
- There is rusting to the gutters and downpipes, which requires repair, maintenance and/or treatment with rust inhibiting paint to prevent further deterioration (see photos below).

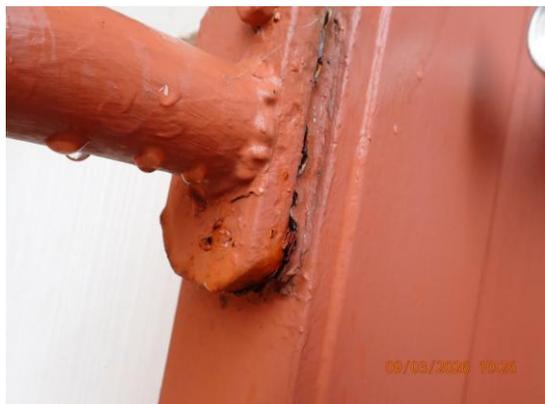
- There is rusting to the metal handrail of the enclosed rear entry balcony which requires repair, maintenance and/or treatment with a rust inhibiting paint to prevent further deterioration (see photo below).

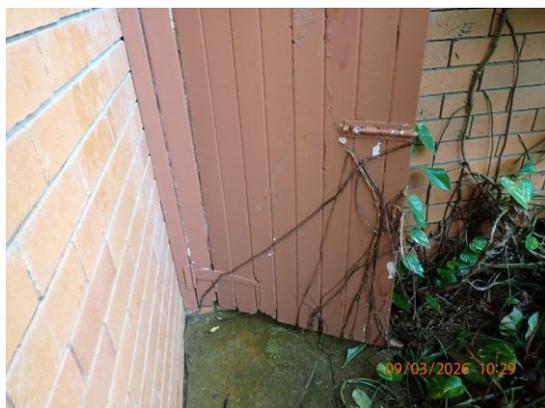
- There is damage to the storage room door of the enclosed rear entry balcony which requires repair and/or replacement (see photo below).

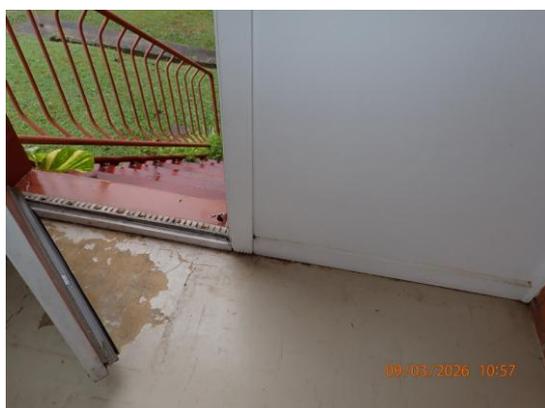
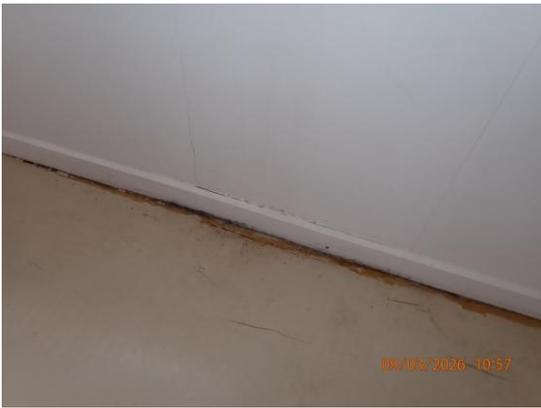
- There is decay to the timber mouldings and skirting of the enclosed rear entry balcony which requires repair, maintenance and/or treatment to prevent deterioration (see photo below). The decay is due to moisture. There was no evidence of recent leaking. It is recommended that the affected areas be monitored to ensure there are no further leaks and if moisture becomes obvious. The leaks need to be located and repairs made. Due to the limits of the visual inspection it is hard to determine if there is damage to the framing members covered by wall linings and cladding. It is recommended that a more invasive inspection be undertaken. If damage is found the affected timber members should be repaired and/or replaced.

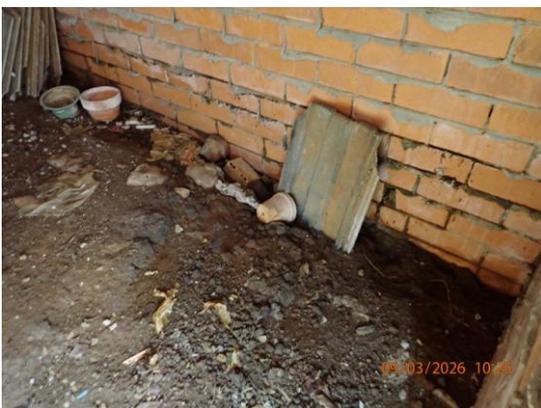
- The soil below the enclosed rear entry balcony was damp due to the outside ground being higher than the inside floor level.

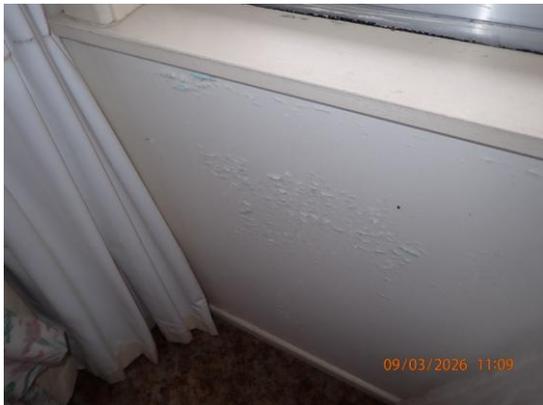
- The timber floor appears to be out of level and uneven in some areas, which may be caused by shrinkage of unseasoned floor timbers used at the time of construction and the age of the building.
- The paint finish below bedroom 3 window is blistering and coming away and requires patching and repainting (see photos below).

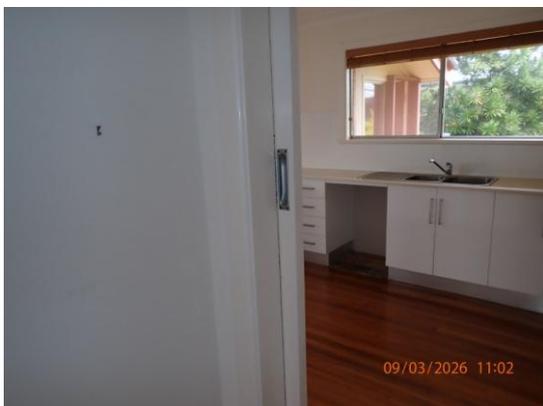
- Some of the kitchen cabinet doors/drawers require adjustment to allow for ease of operation.
- The cavity sliding door to the kitchen is binding/stuck and was not operational at the time of the inspection (see photo below). The door requires repair and/or maintenance to allow ease of operation.

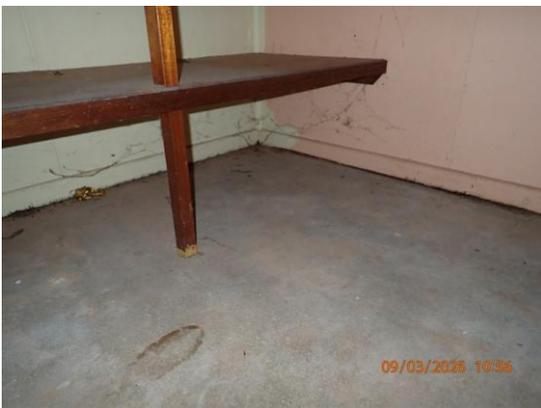
5

- There is decay to the external door and jambs (see photo 1), wall framing and door jambs (see photo 2) and decay to the skirting below the stairs (see photos 3 to 5) of the laundry/bathroom which requires repair, maintenance and/or treatment to prevent deterioration.

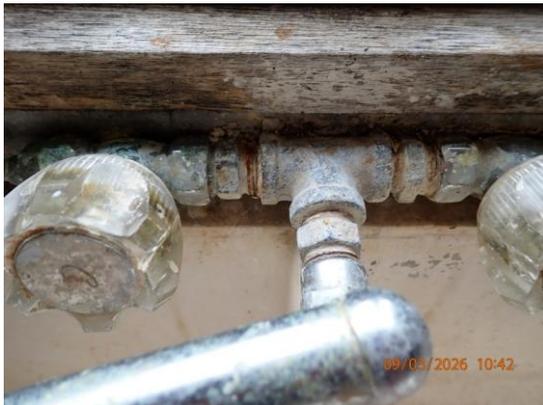
- There is rusting to the pipework of the laundry/bathroom which requires repair, maintenance and/or treatment with a rust inhibiting paint to prevent further deterioration (see photo below).

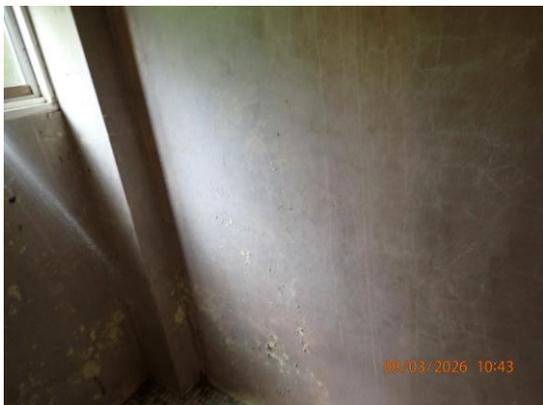
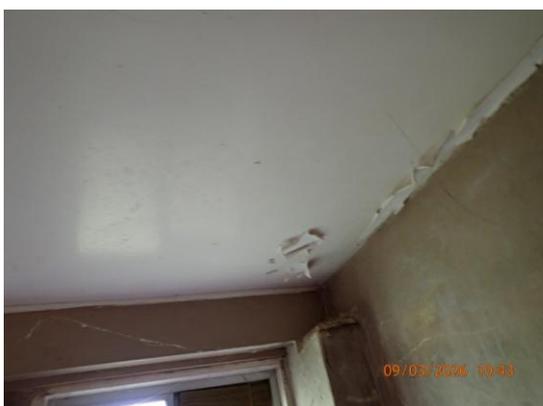
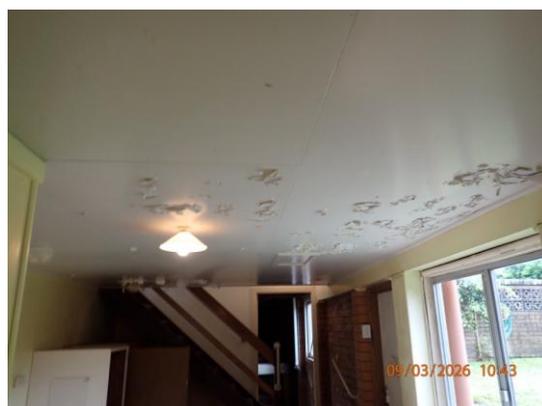
- The paint finish to the laundry/bathroom is blistering and coming away which could be due to poor paint preparation prior to painting and the type of paint used (see photos below). Please engage a Licenced Painter to inspect, give advice and carry out repairs and rectification works.

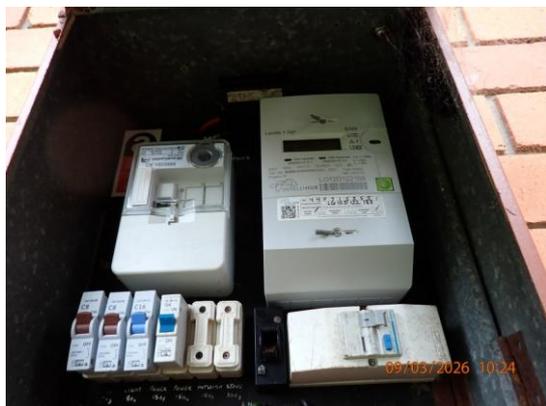
A safety switch has been provided to the meter box (see photo below). It is recommended that a Licenced Electrician be engaged to inspect and check the operation of safety switches and electrical circuits.

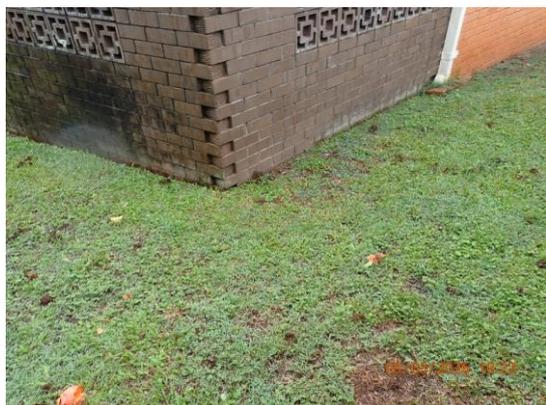
The soil was damp at the time of the inspection due to the recent rain (see photo below). **Please Note:** Due to the soil being a clay base soil it takes a long time for the soil to dry out as it holds moisture for a long period of time. It is recommended that the area be monitored to ensure damp condition do not continue. The affected areas could have the ground levels altered and the hollows filled to prevent water ponding and additional surface drains installed to assist with water runoff.

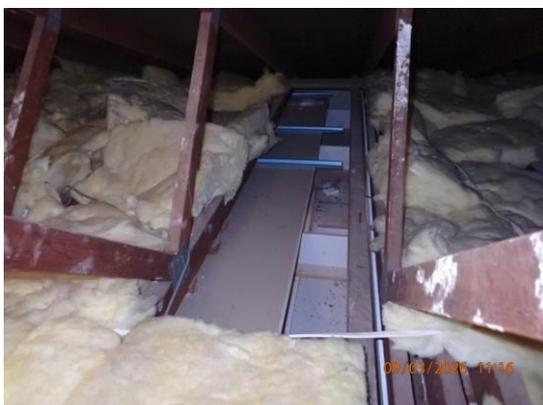
The ceiling above the kitchen has been replaced at some stage (see photo below).

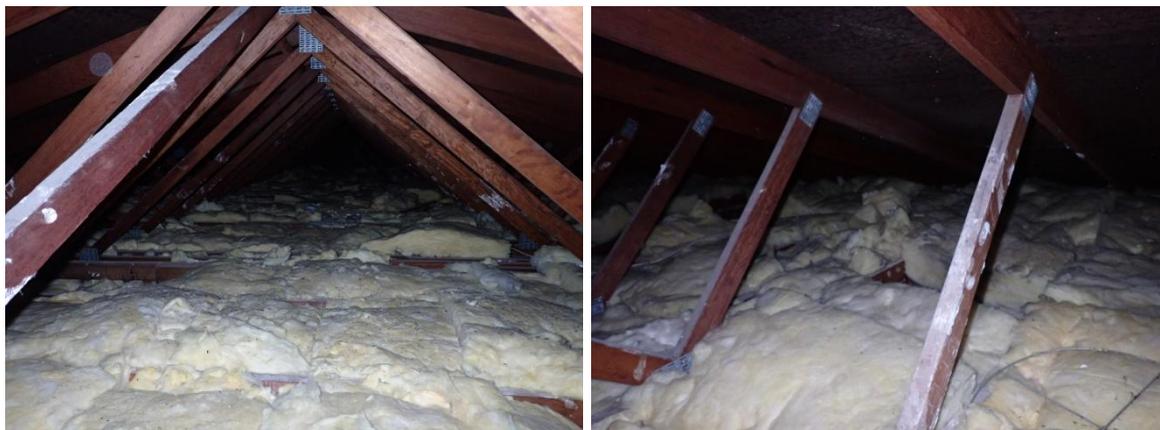
- Thermal insulation in the roof space obscured top plates of the wall frames and the bottom cords of the trusses for inspection. This may conceal evidence of termite infestation and/or damage. Removal of the insulation is not within the scope of this report.

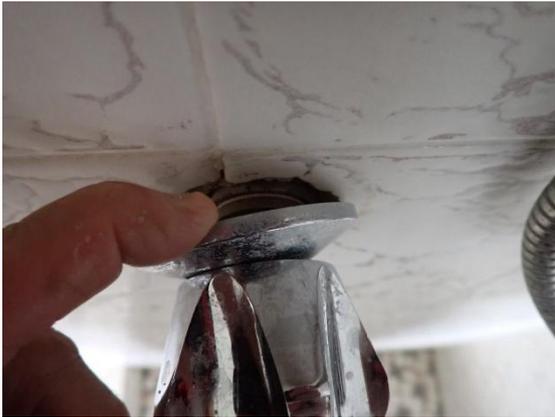
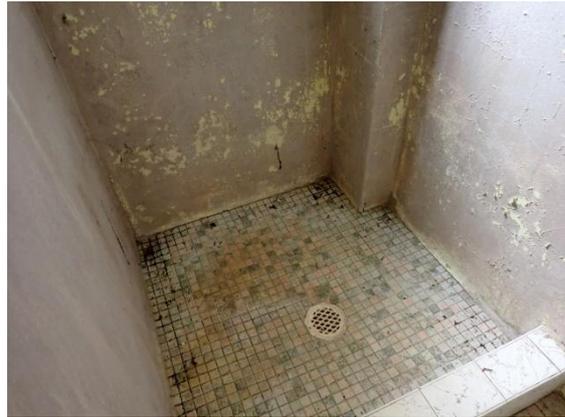
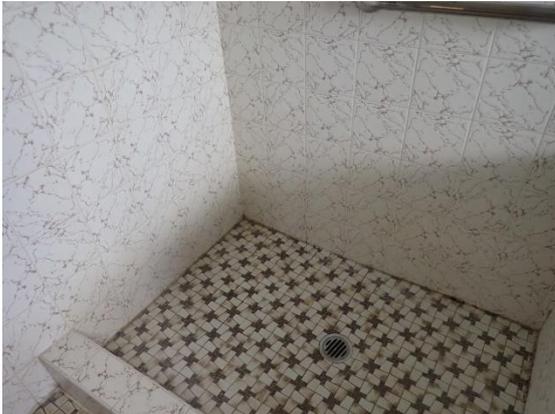
6. Reseal shower tap flanges and shower recess wall and floor junctions immediately as it provides an ideal environment for termite activity.

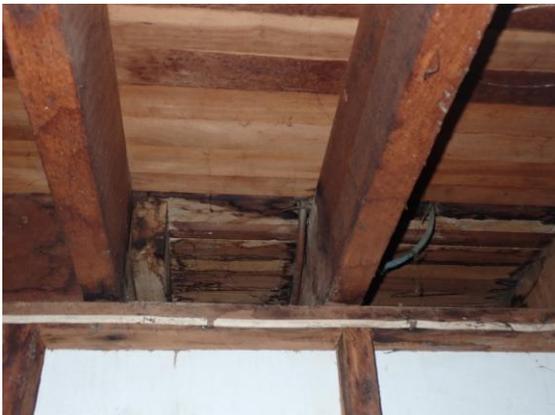
6. Moisture stains on timber flooring below wet area. Further invasive inspection is required to ascertain the moisture source. **Appears to be dry at the time of inspection.**

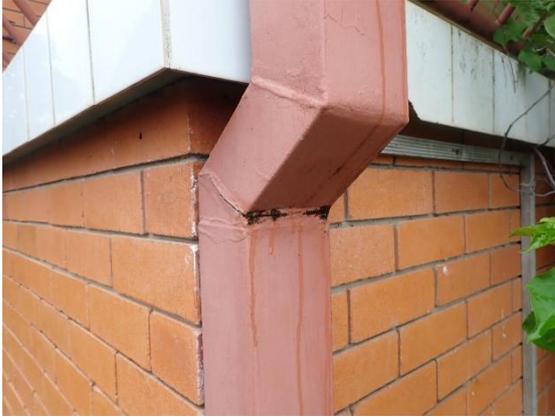
- Faulty storm water downpipes and gutters should be repaired and sealed immediately, as it appears rainwater is leaking directly adjacent to the foundations of the structure. Water alongside or near to building walls is highly conducive to termites. These should be repaired by suitably qualified person.
