# PEST AND BUILDING PRE-PURCHASE REPORTS

# STANDARD PROPERTY & TIMBER PEST REPORT

Report number: **1781038478656**  
Inspection date: **10-06-2026**  
Client:  
Property address: **6 Clancy Pl, Terranora NSW 2486, Australia**

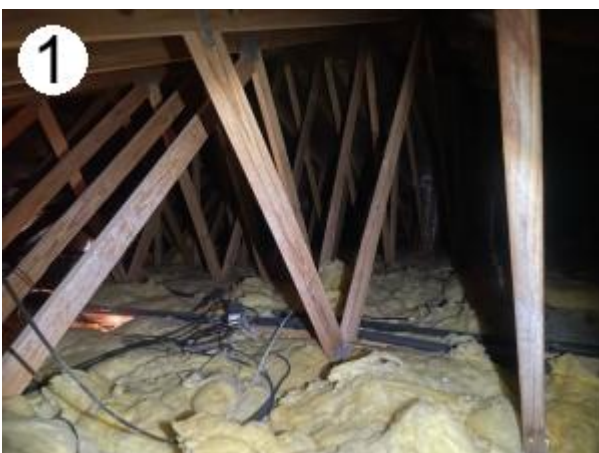
#1

**Excessive insulation to roof void, defects, active termites and or termite damage may exist were insulation is covering roof timbers, removal of insulation is not part of the inspection process**

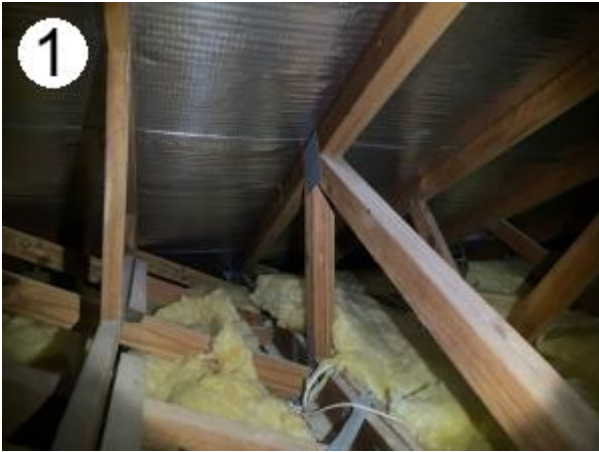
#1

**In inspecting the roof space, there was no inspection of the roof interior in the vicinity of**

**the eaves where the area of accessibility was less than 600 mm high x 600 mm wide**

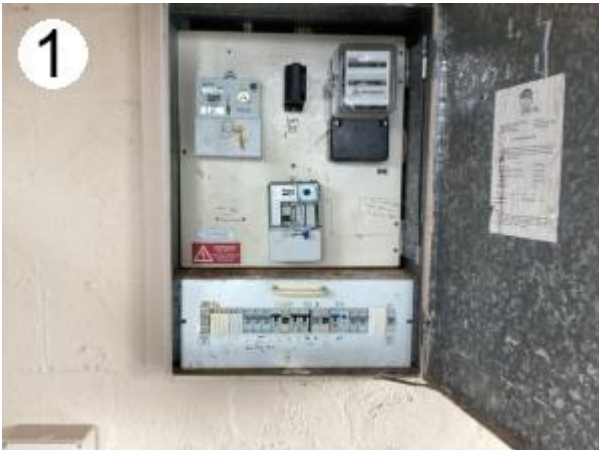
#1. A safety switch has been installed.

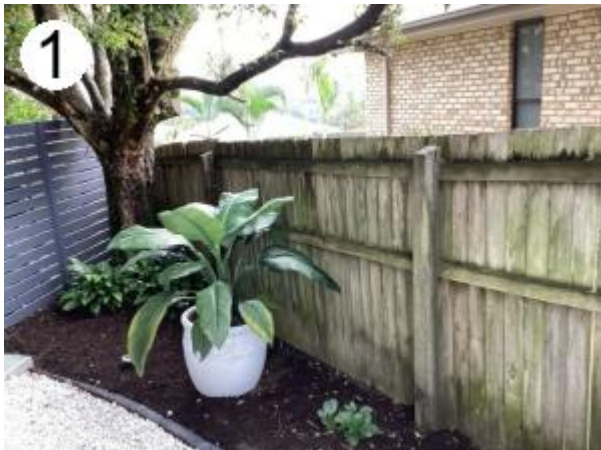
#1. Various wood decay and deterioration / movement has occurred to the timber fencing around the perimeter of the property. A further detailed investigation by a competent person, e.g. a licensed building / fencing contractor is recommended to determine the cause, method and extent of any remedial work required, and associated costs. The above recommendation should be implemented as soon as possible.

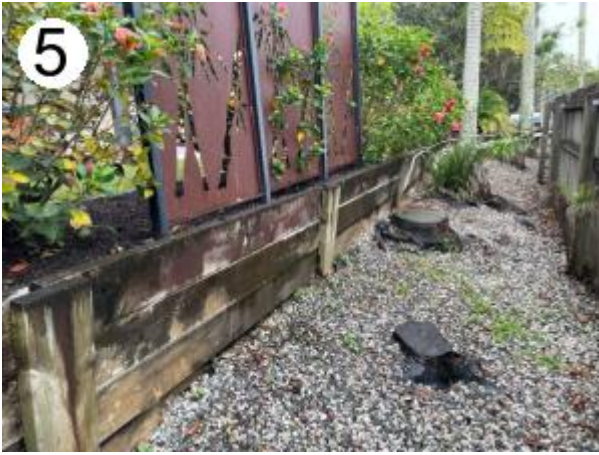
#5. Various wood decay and deterioration / movement has occurred to retaining wall timbers. A further detailed investigation by a competent person, e.g. a licensed building contractor / retaining wall specialist is recommended to determine the cause, method and extent of any remedial work required, and associated costs. The above recommendation should be implemented as soon as possible.

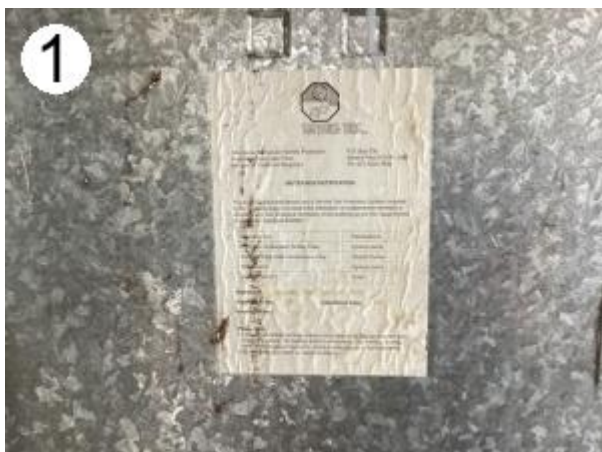
Evidence of a possible previous termite management program **WAS FOUND - SEE ITEM E4.**

#1. A notice was affixed to the inside of the electrical meter box indicating that a physical management system ( termite tite) had been installed during construction. Importantly, where evidence of a possible termite management program was noted, the Client should obtain all information on the termite barrier system type and installation, and keep on file all relevant documents pertaining to the extent of the program, and any service warranties and advice in regard to the building owner's obligation to maintain the management program.

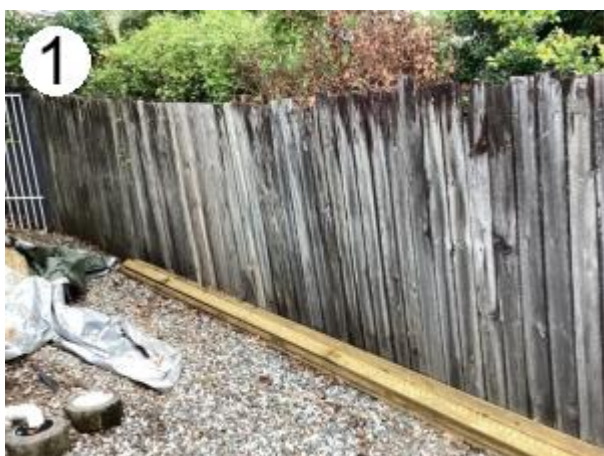
Evidence of fungal decay activity and/or damage **WAS FOUND - SEE ITEM E7.**

#1. Various wood decay and deterioration / movement has occurred to the timber fencing and timber retaining walls around the perimeter of the property. A further detailed investigation by a competent person, e.g. a licensed building / fencing contractor is recommended to determine the cause, method and extent of any remedial work required, and associated costs. The above recommendation should be implemented as soon as possible.
