# STANDARD VISUAL TIMBER PEST DETECTION REPORT

IN ACCORD WITH AS4349.3-2010

**Date of Inspection:** 25 February 2025

**Address of Property Inspected:** 100 Winders Place Banora Point NSW 2486

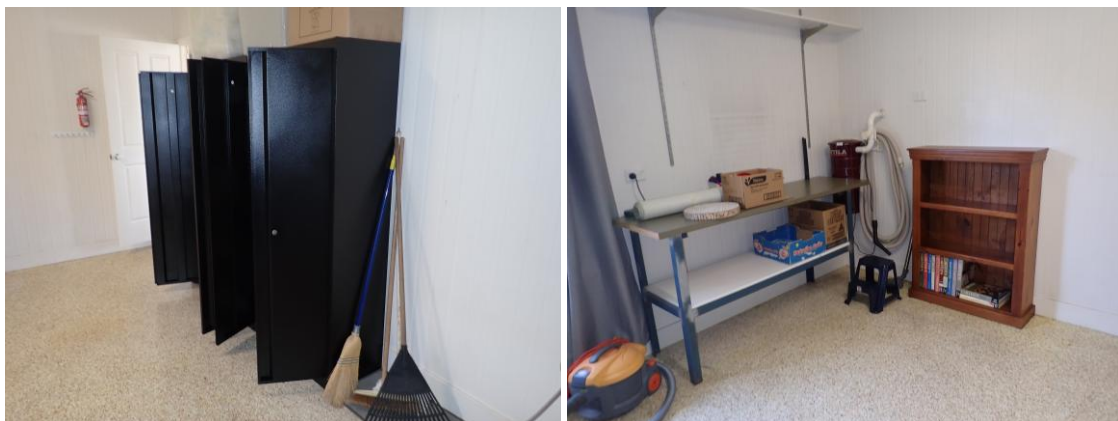
- No access to wall cavities due to fixed wall coverings.
- Floor coverings.
- No access to areas under kitchen cupboards, vanities and any fixed cupboards or bathtub.
- No physical access to roof space eaves due to design.
- General furnishings, stored and personal items against internal walls present and restrict inspection within these areas, pest activity and or damage and building defects may be present behind household furnishings.
- Stored items in cupboards and wardrobes.
- Presence of window furnishings restricted access to windows and reveals.
- Visual inspection was obstructed and restricted in the garage due to stored items.

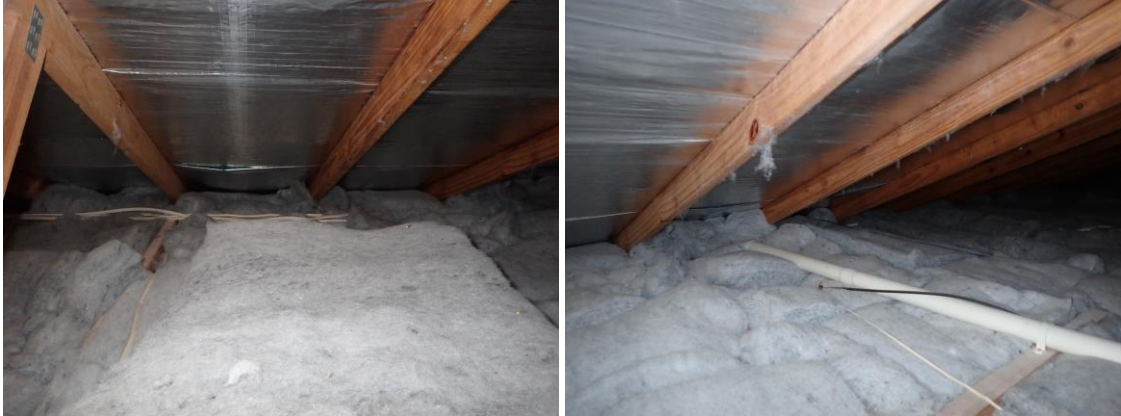
- Thermal insulation in the roof space obscured top plates of the wall frames and the bottom cords of the trusses for inspection. This may conceal evidence of termite infestation and/or damage. Removal of the insulation is not within the scope of this report.

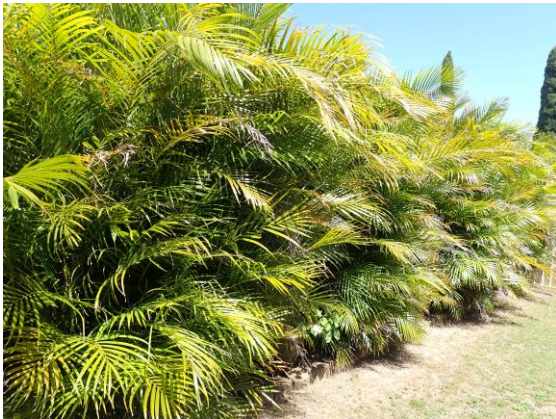
- Sarking blanket obscured timber roof battens for inspection.
- Dense vegetation obscured timber paling fence for inspection in areas.

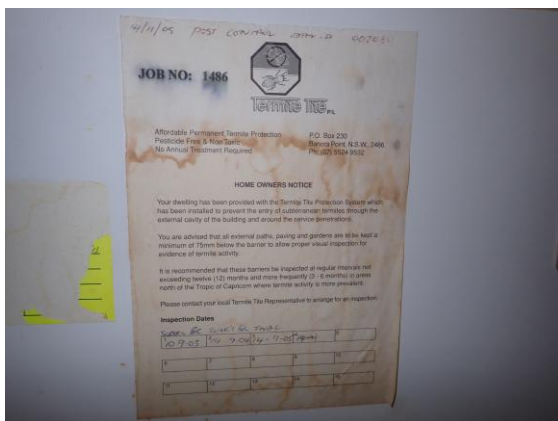
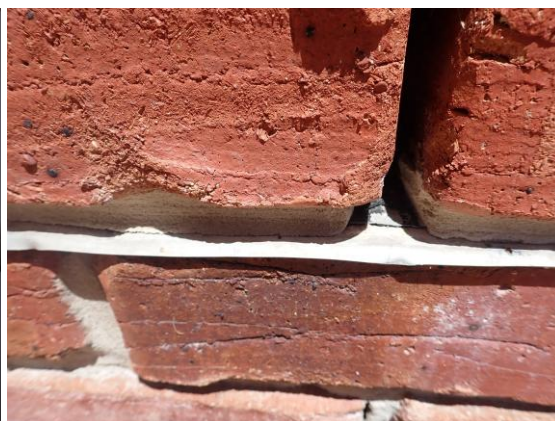
Termite Tite termite protection notice affixed in meter box and kitchen sink cupboard (Service penetrations and external cavity).

**Installation documentation should be requested from vendor and warranty details read carefully and any associated inspection reports should be requested from vendor.**

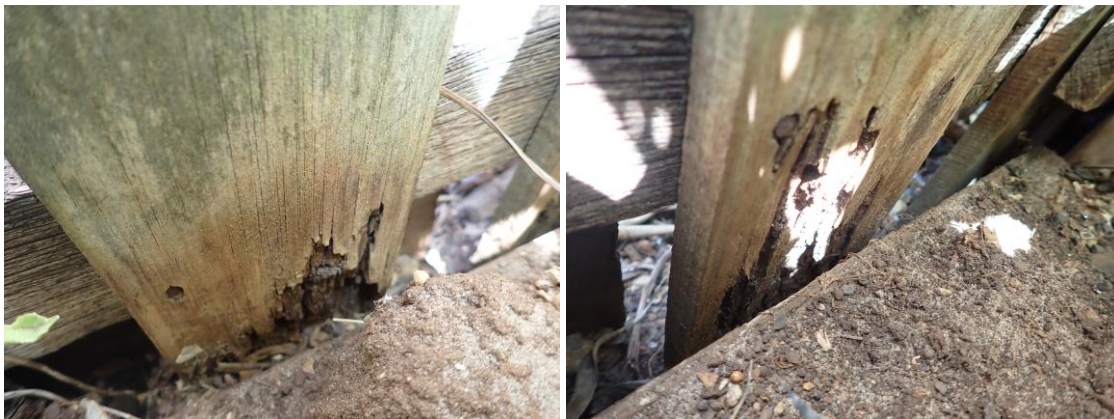
Visible evidence of fungal wood decay was located to:

External timber members including timber paling fence in areas.

While we are not builders the fungal decay damage appears to be: S

(Normal for the age of the structure). It is recommended that these timbers be replaced to prevent further damage to adjoining timbers. Fungal decay may be present in concealed areas behind wet areas that can only be located by the removal of wall linings.

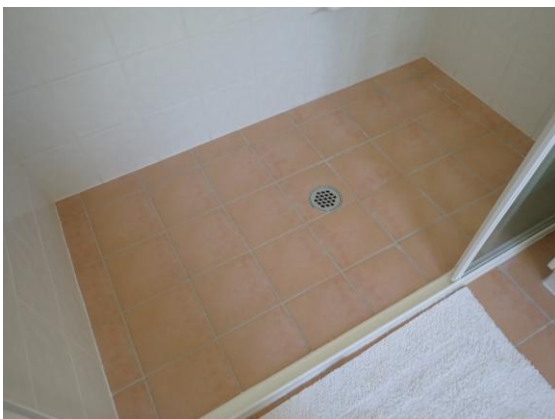
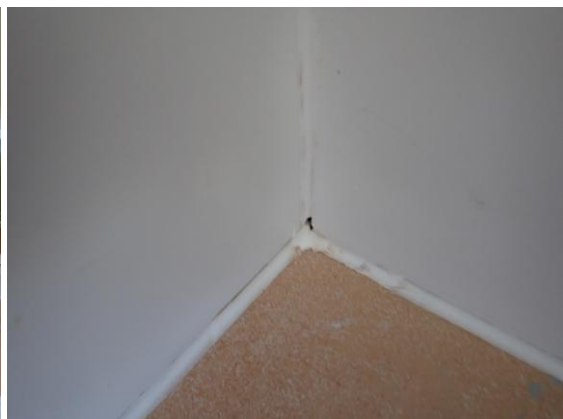
6. Reseal ensuite shower recess wall and floor junctions immediately as it provides an ideal environment for termite activity.

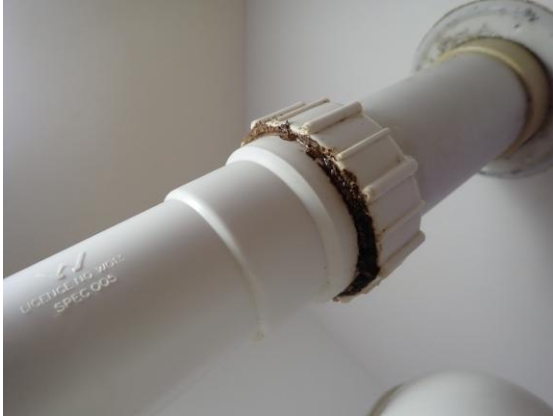
6. Leaking laundry sink plumbing pipe must be repaired and sealed immediately as it provides an ideal environment for termite activity. Contact a licensed plumber immediately.

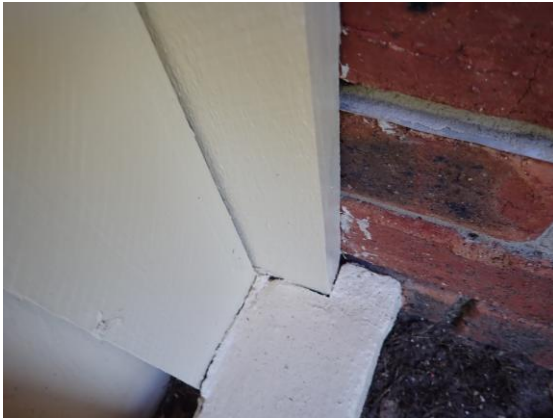
7. Fence or fence posts are in direct contact with the building structure. This situation can allow termites to enter the structure and we recommend that suitable modifications be made so that fencing timbers are not in direct contact with the structure.

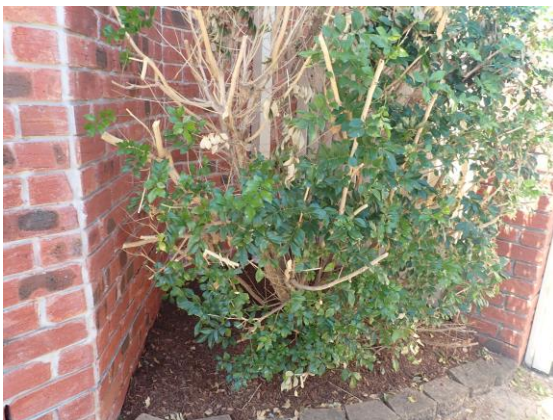
10. Trees, tree roots, vines or shrubs are close to or abutting the external walls of the structure. This can allow concealed termite entry and they should be removed immediately.

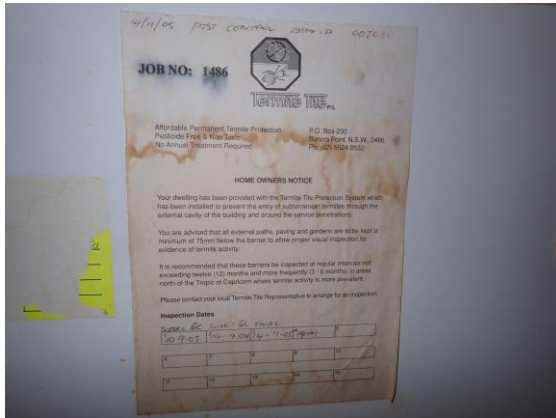
- Termite Tite pre-construction termite protection system was installed to the perimeter and service penetrations of the structure. Recommend obtaining all the appropriate installation and warranty documents regarding this treatment from the vendor, as this will determine what areas are protected under this system and if there are any warranties available to the new owner. If documents cannot be obtained then contact the relevant pest control company that installed the system or builder to obtain the documents.
