# **BUILDING AND TIMBER PEST INSPECTION REPORT**

431 Lawrence Hargrave Drive, Scarborough.

# BUILDING AND TIMBER PEST INSPECTION REPORT TO AS4349.1 2007 & AS4349.3 2010

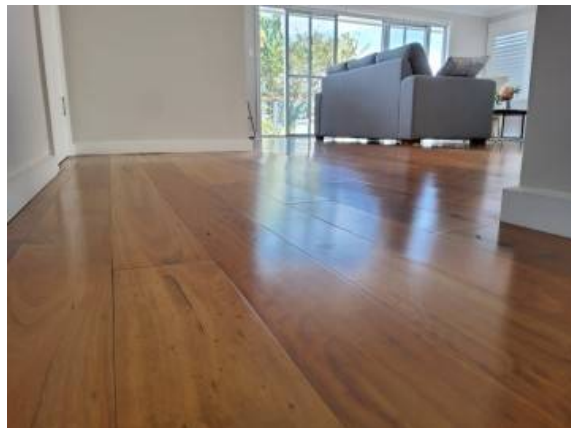
**Out of Level**

Some flooring shows signs of undulations / out of level. This is a visual inspection only, no technical / calibrated instruments have been used. The undulations / out of level areas are consistent with the age and construction type, no visual indicators are present to suggest any structural impairment is present at the time of inspection.

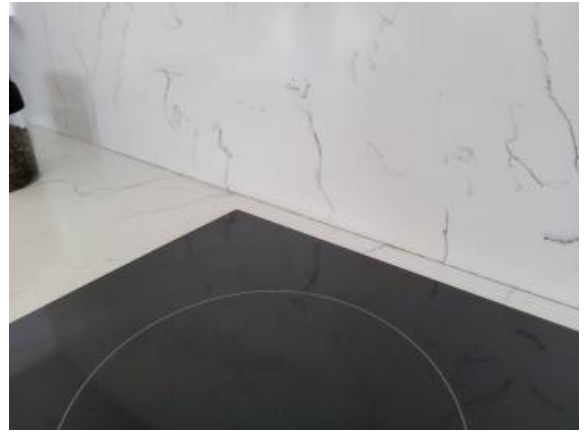
**Other (specify)**

Junctions of bench tops and splashback sheeting require resealing with silicone.

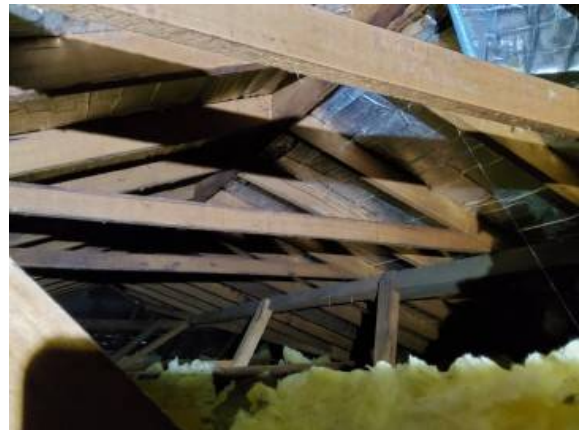
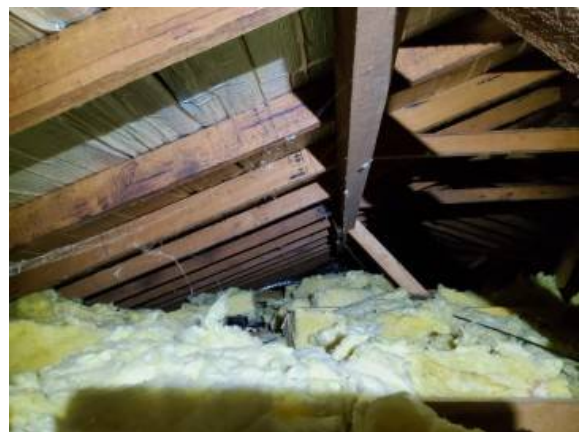
#### Roof Space & Framing - Condition

Older roof frames do not comply with current wind ratings. This roof is in satisfactory / typical condition for the age / construction date. Some sections show of deflection / movement away from their seated position. Some areas may require re-bracing, fitting in the future.

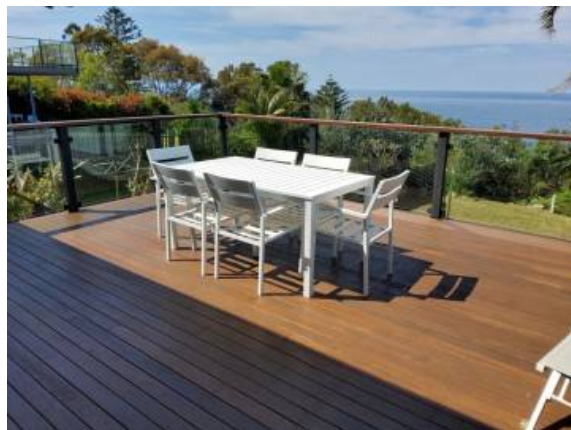
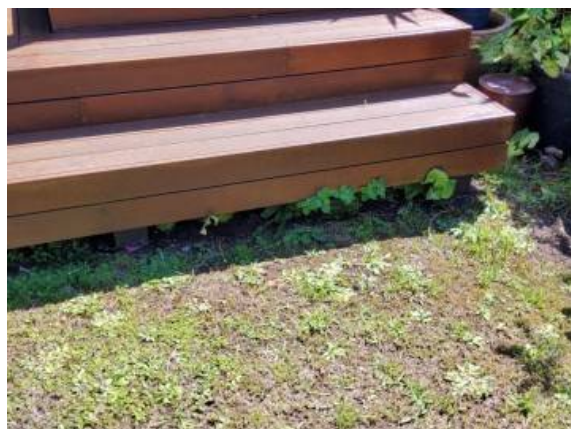
- Timber decks / structures are built for normal domestic use and can fail due to a number of causes (over-loading, deterioration due to weathering).
- Timber decks / structures should be inspected by a competent and licensed person every 12 months to check for signs of deterioration.
- Timber decks / structures must be kept well sealed and ventilated to help prevent deterioration.
- If considering a large gathering on / using the deck / timber structure, you are advised to have a structural engineer inspect and advise of the safe loading capacity of the deck / structure.

Any timbers that are in direct ground contact being in garden areas or the pergola, the awning, the carport or related items should be removed / have stirrups fitted / be treated with termiticide unless evidence is provided that these timbers are of a treated or specific type suitable for its applied application.

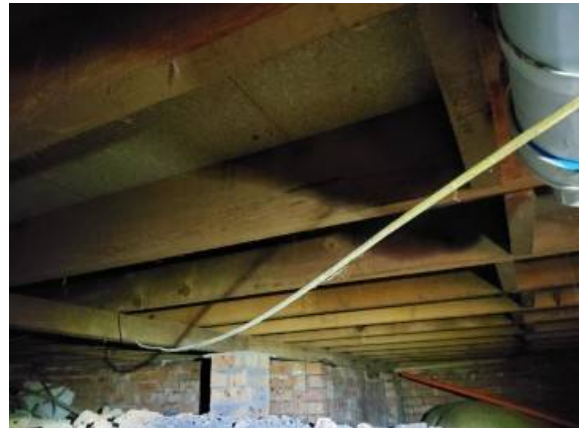
#### Bearers and Joists

Older sub floor frames do not comply with current wind ratings. This framing is in satisfactory / typical condition for the age / construction date. Some sections show of deflection / movement away from their seated position. Some areas may require re-bracing, fitting in the future.

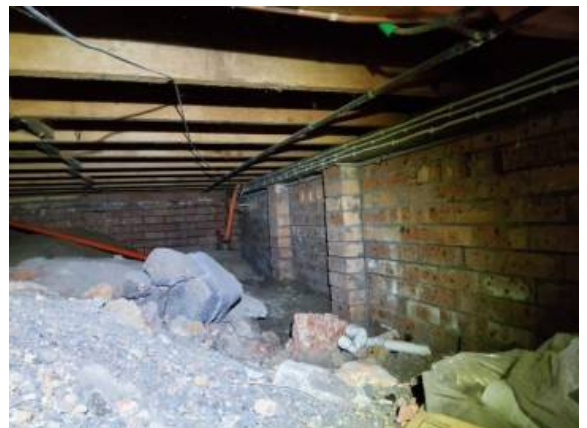
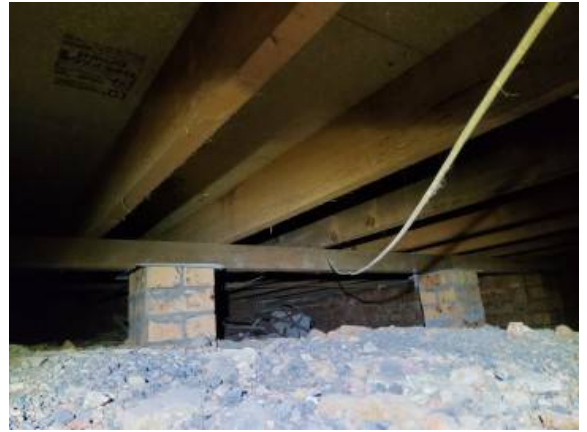
#### Piers / Stumps / Posts - Condition

Some piers show signs of subsidence / movement. The movement is consistent with the age and construction type.

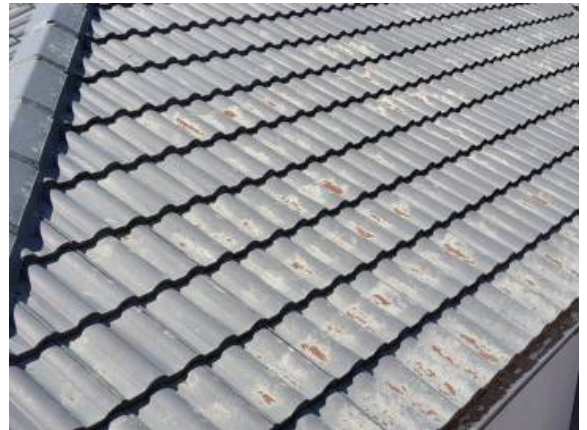
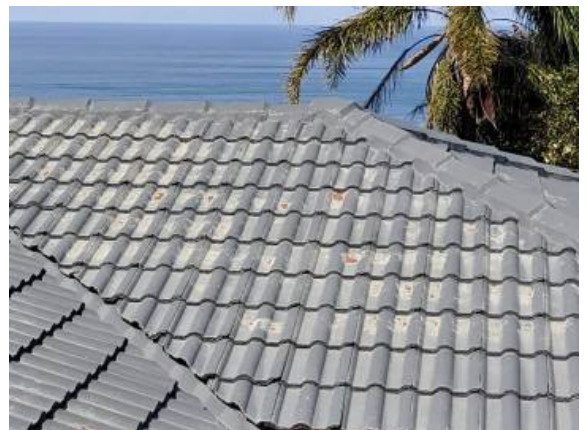
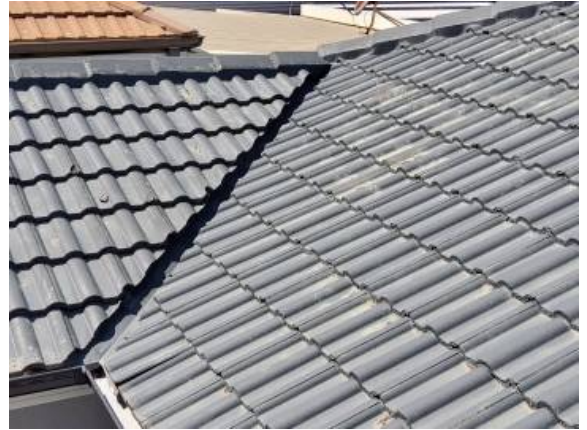
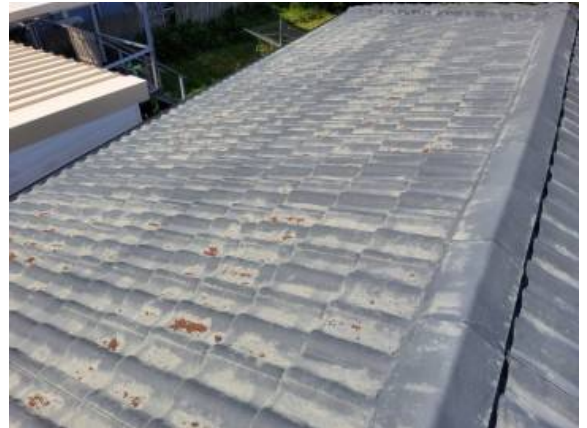
#### ROOF TILES

The tile surface shows of delaminating / loss of surface colour and may require resealing / resurfacing.

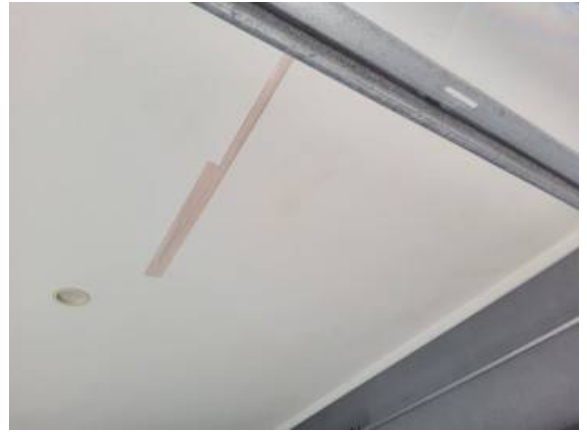
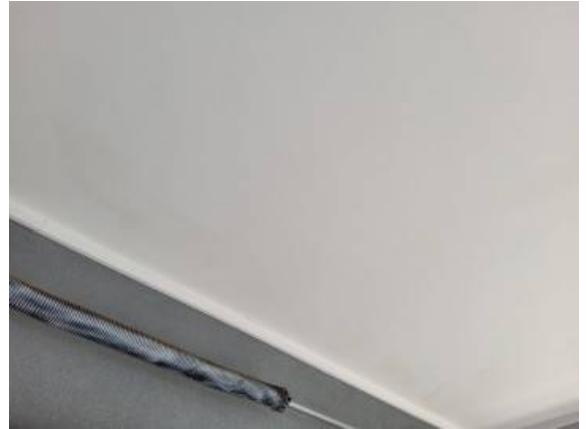
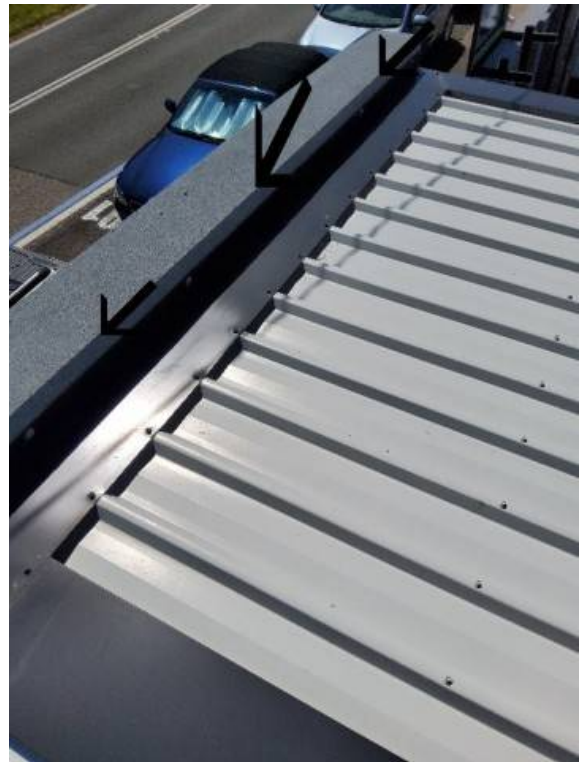
**Condition:**

The garage ceiling shows of water staining / leaking and requires repair / resealing of the roof sheeting / flashings. Have a licenced roofing contractor be engaged to further inspect and provide a scope of works to repair.

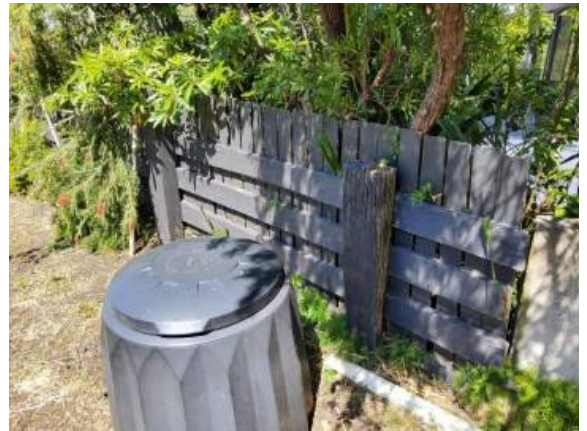
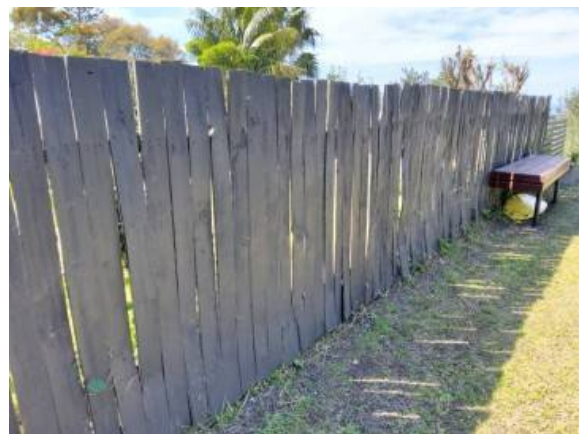
## FENCING

Weather damage to some timber fencing requires repair / replacing. Timber fencing panels require refitting.

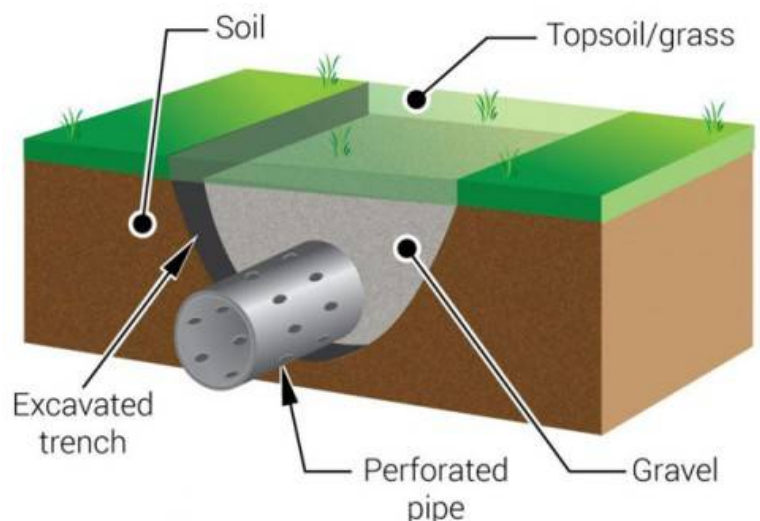
## SURFACE WATER DRAINAGE

There are some low areas that should be monitored during wet weather, and if ponding occurs action should be taken to prevent ponding. This may require top dressing of the turf to eliminate low areas or installation of yard drain/s to this area (connect to existing stormwater) Refer to attached image for standard agg line detail.
