Inspection Report

Dwelling D 13-35 Asquith St, Austinmer, NSW, 2515

Inspection Date: 18 Sep 2024

Pest And Building Inspection

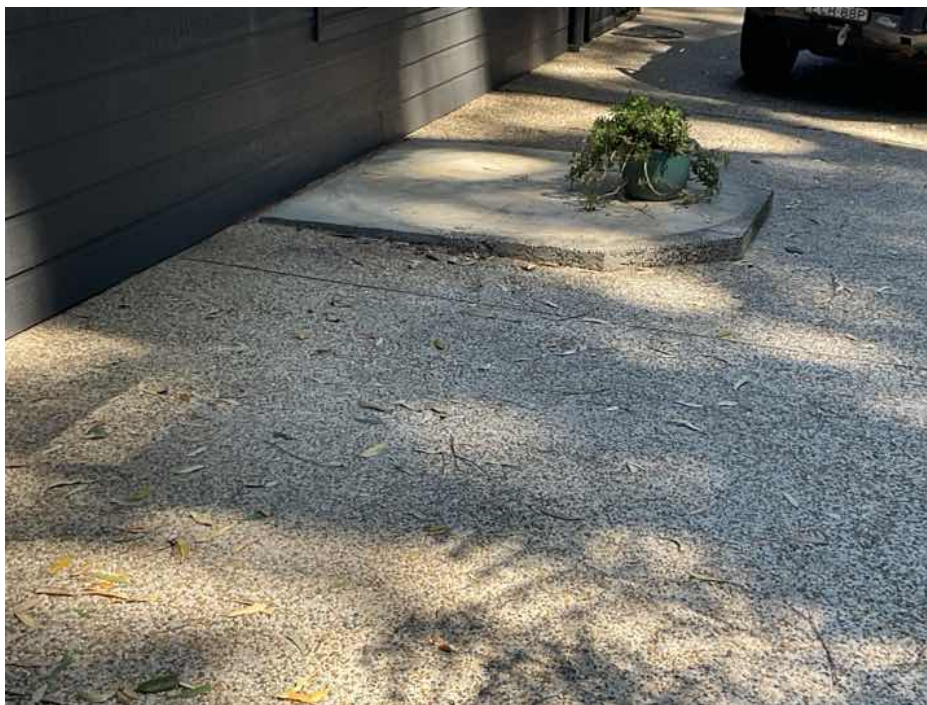
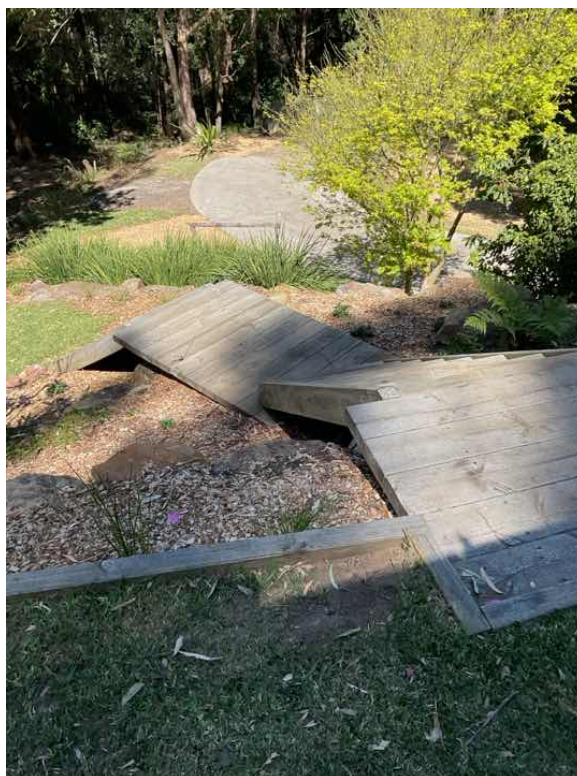
Path has visible tripping hazard due to removal of water storage tank. Remove to avoid potential injury. Considered a safety hazard.

Timber steps appear in a serviceable condition. Do not overload steps. Note: Exposed external timber steps are vulnerable to weathering/deterioration which can occur relatively quickly at times. Monitor condition of steps etc regularly to ensure integrity and safety of same.

We recommend installation of handrail/balustrade to steps/landing >1m drop-off as a safety item.

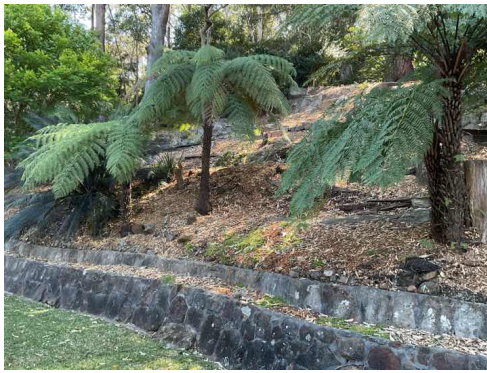
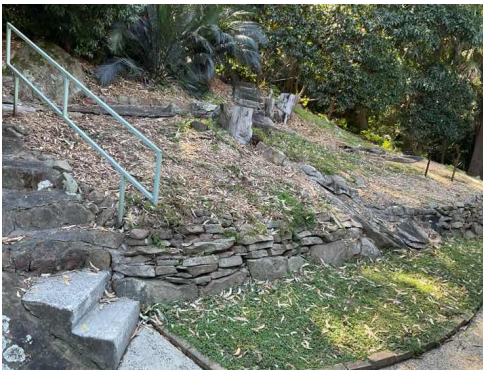
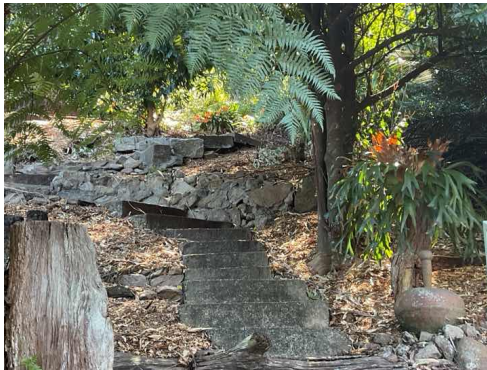
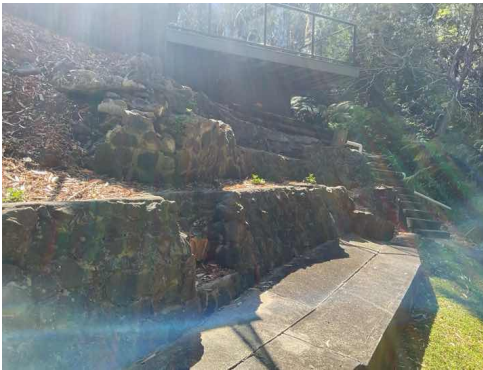
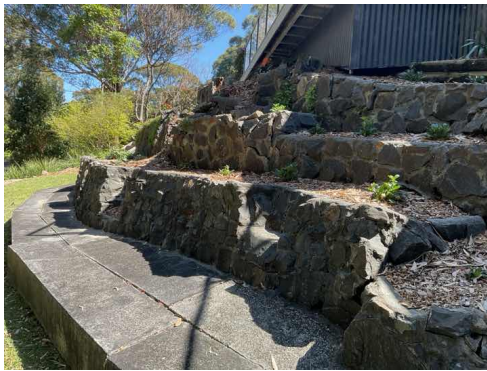
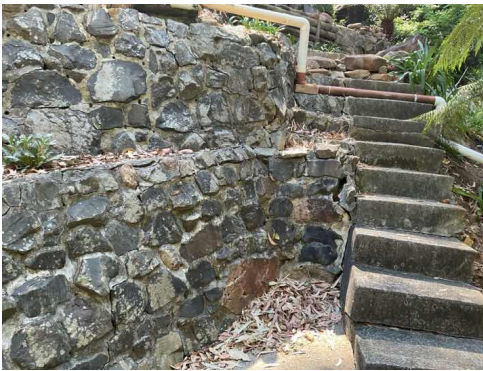
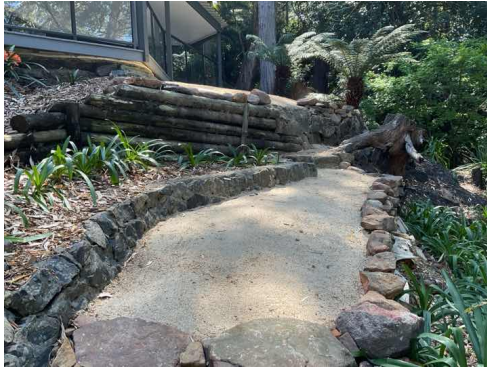
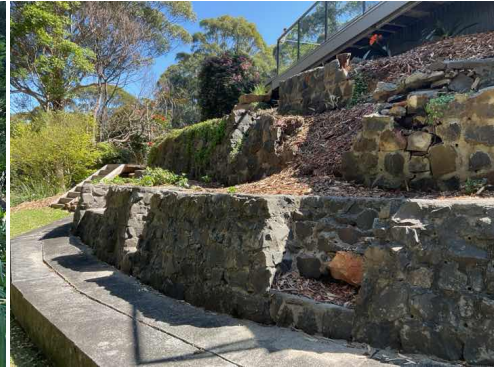
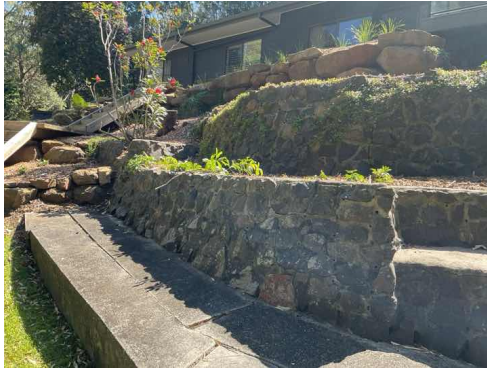
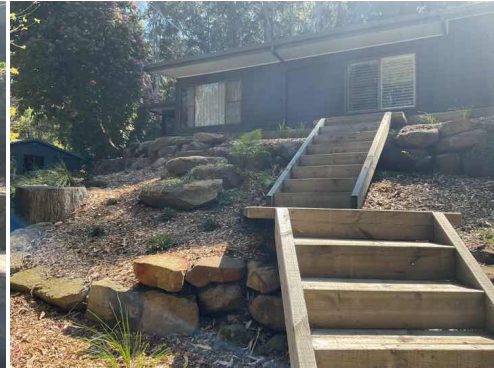
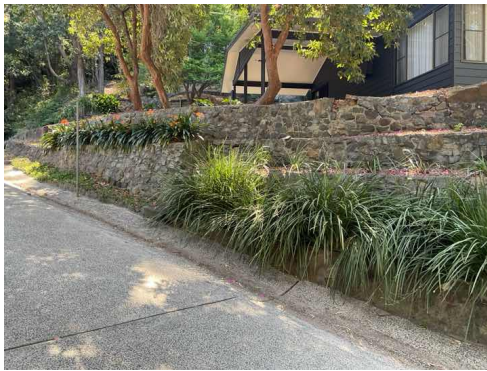
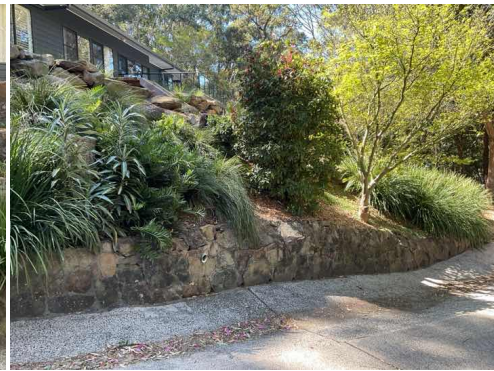
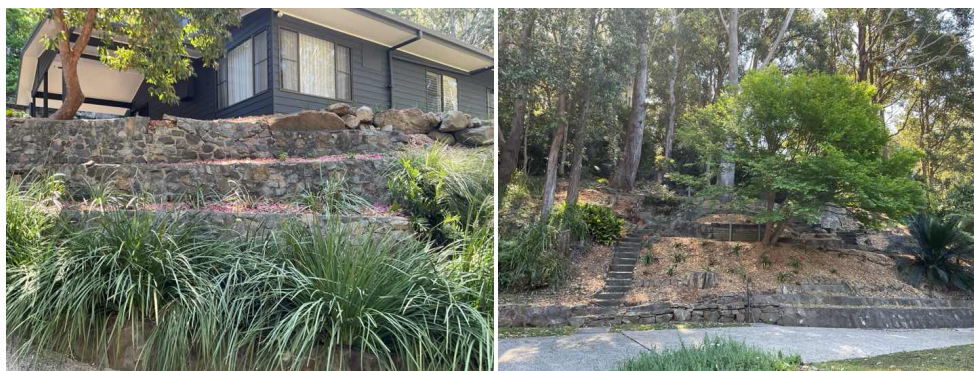
Stone retaining walls to front, southern and external property areas show significant cracking/failure/rotation etc associated with age, site conditions/excessive hydro-static pressure &/or design/footing failure. Replacement/upgrade to include adequate footings/drainage detail in conjunction with an engineer's advice/specification is recommended.

We note there are sections of un-retained site cut to driveway areas. It is recommended to have these areas retained in accordance with an engineers specifications to prevent any potential erosion and shear failure/movement to soil

Retaining walls and retained edges are partially obscured by vegetation. Overgrown vegetation and soil was not moved or disturbed during this inspection. No report is issued for obscured retaining walls. Clear soil/vegetation and reassess condition of same.

Undertake maintenance/improvements/upgrade to all retained garden edges to include suitable support and drainage

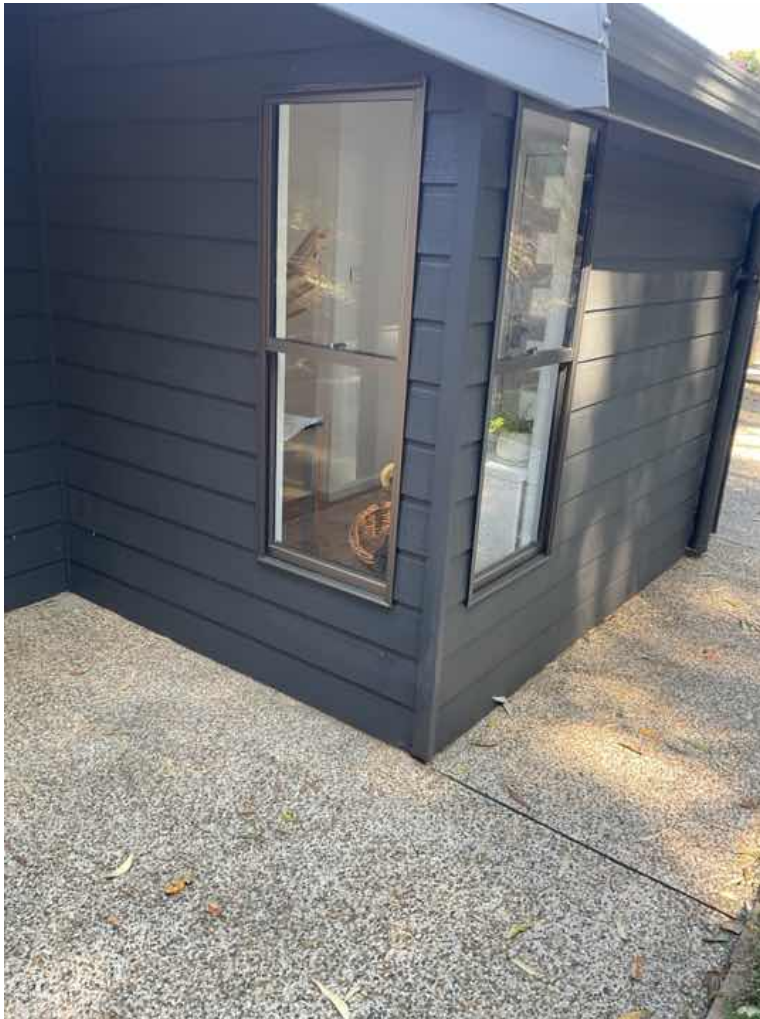
Missing fly screens to individual windows noted. Replace same at your convenience.

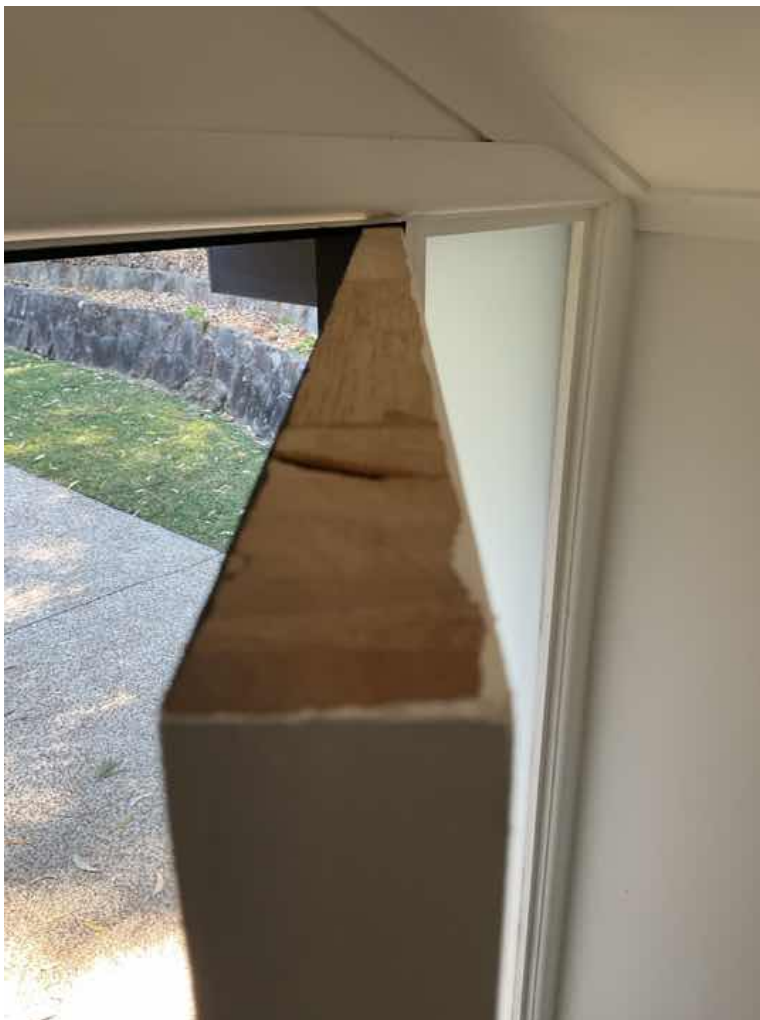
The door is in serviceable condition.

We recommend paint/seal top/bottom edges to entry door to reduce risk of water/weather damage as per building code recommendations.

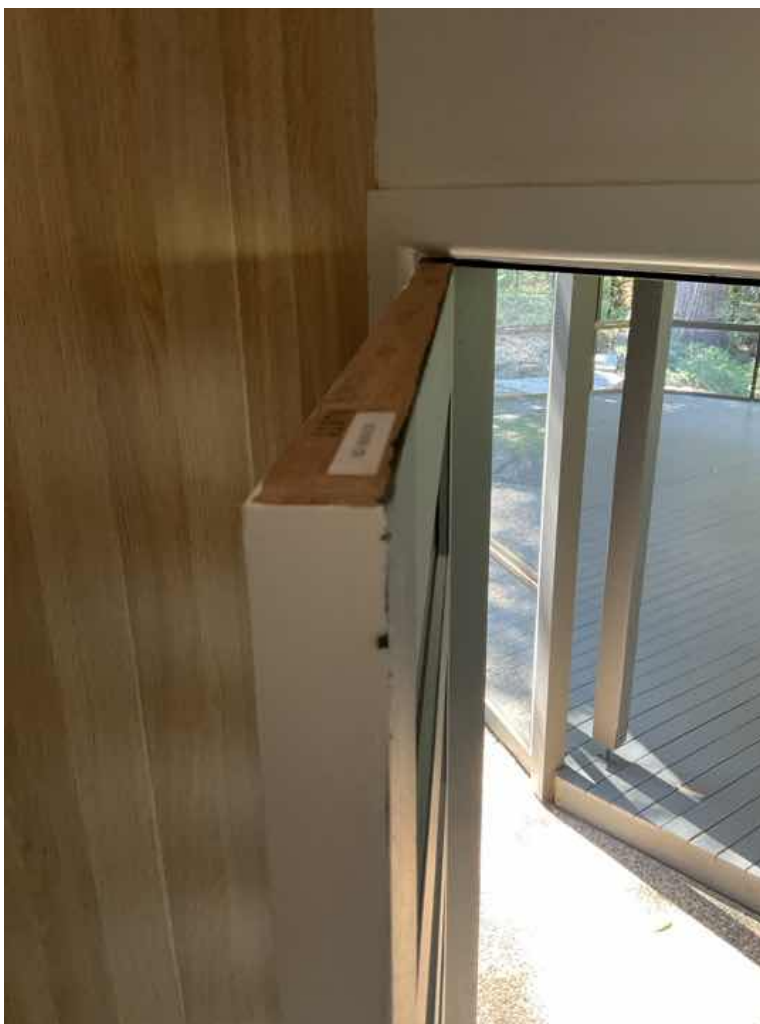
Sliding doors, bifold and laundry side entry door appear in a serviceable condition.

We recommend paint/seal top/bottom edges to rear entry door to reduce risk of water/weather damage as per building code recommendations.

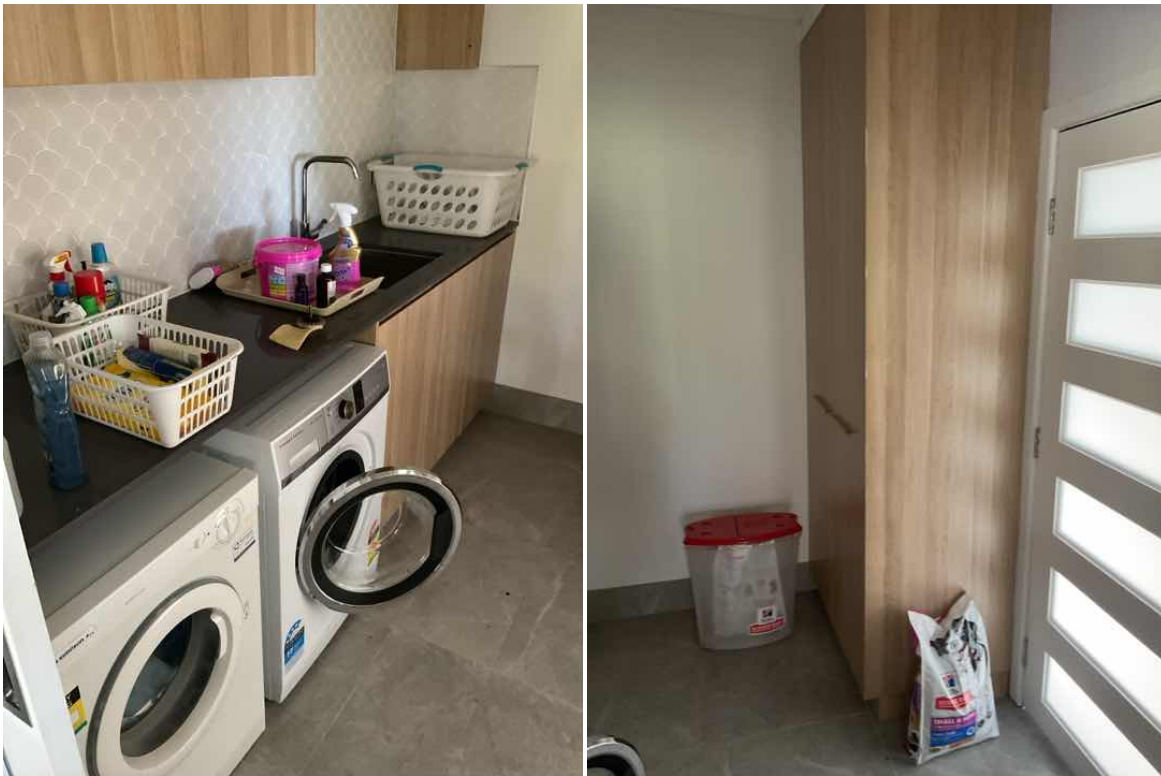
Appliances &/or storage cupboards etc in the laundry restricted full and unobstructed view. Defects may exist behind same.

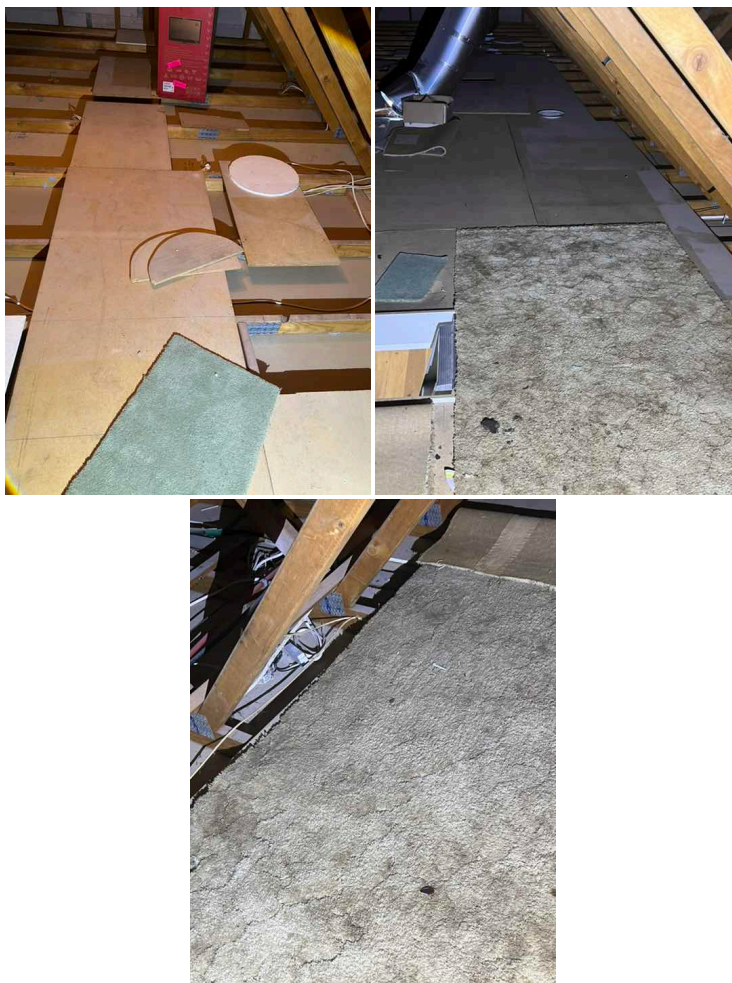
Storage platform in the roof void was not moved or disturbed during this inspection.
