Pre-Purchase Building & Timber Pest Inspection Report

In accordance with Australian Standard AS 4349.1 - 2007 and AS 4349.3-2010

14 Kerenjon Ave Buderim Queensland, 4556

16 Jan 2026

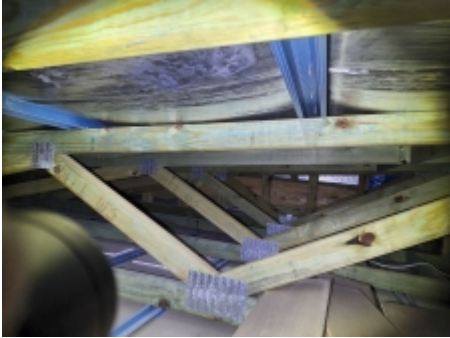
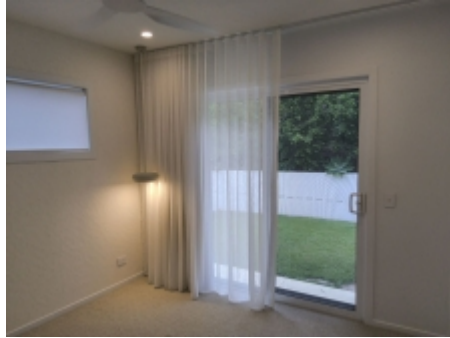
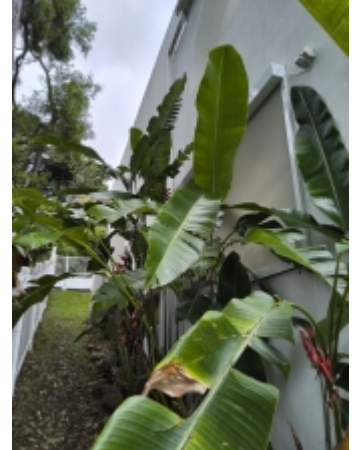
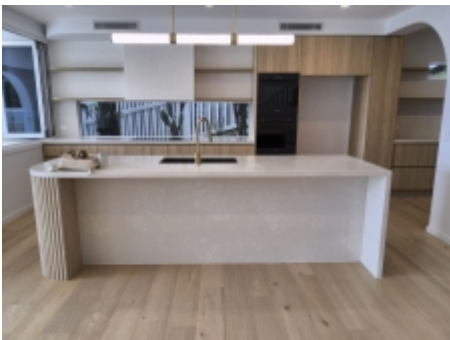
Framing and low clearance in roof space.

It is important to note that as an inspection of the above areas was not possible at the time of the inspection, defects, timber pest activity or damage may therefore exist in these areas.

Reccomendations: Recommend further inspection once obstructions removed.
Recommend further inspection when access gained to all areas.

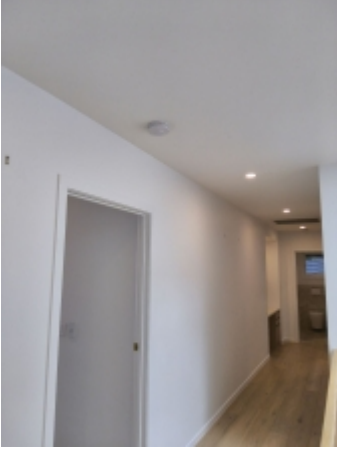
Restricted Area Comments: Upper level roof space not inspected due to no man hole access

It is important to note that as an inspection of the above areas was not possible at the time of the inspection, defects, timber pest activity or damage may therefore exist in these areas.

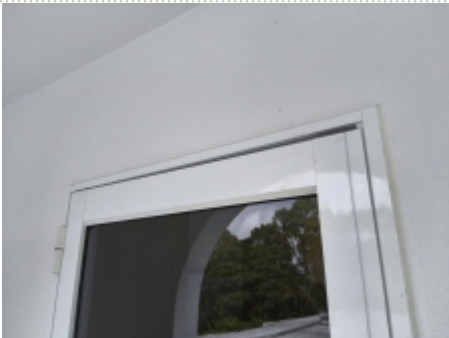
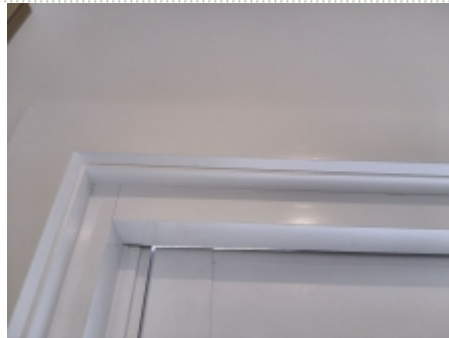
Door is out of line in the frame and has a gap at the top edge, recommend engaging a builder to investigate further and rectify as necessary to make good, secure and weather tight

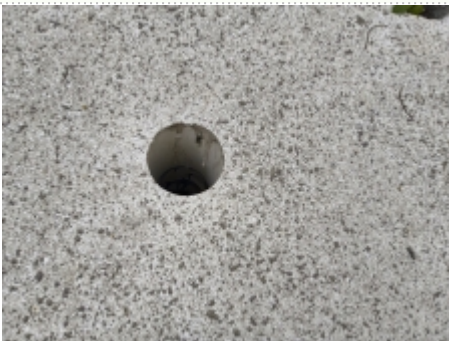
Details and Recommendations: Missing drain grate/covers, recommend engaging a plumber to rectify to prevent items entering the drains.

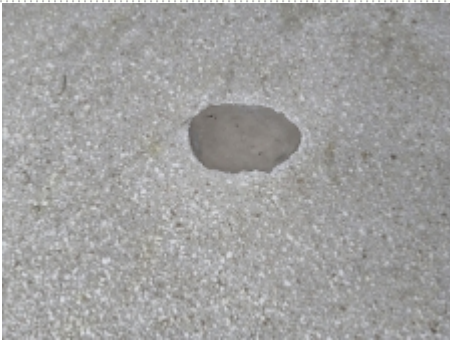
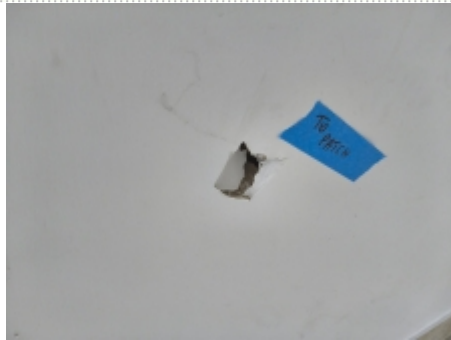
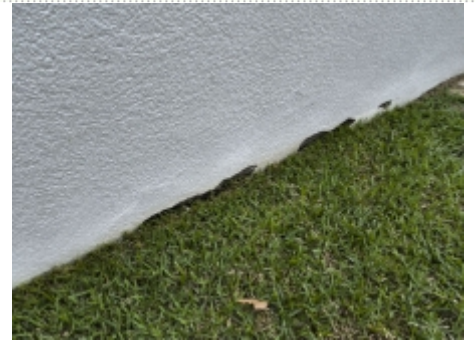
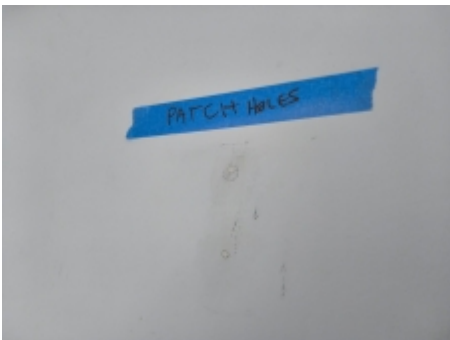
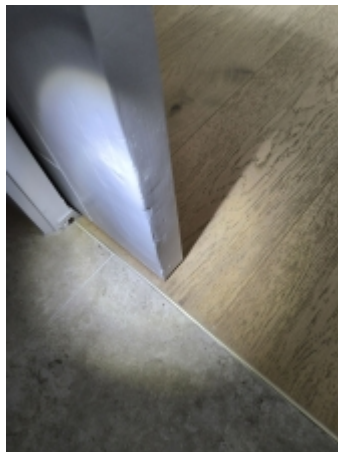
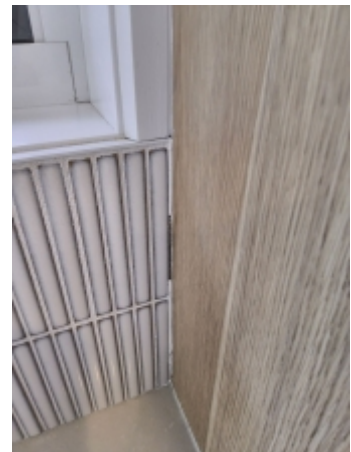
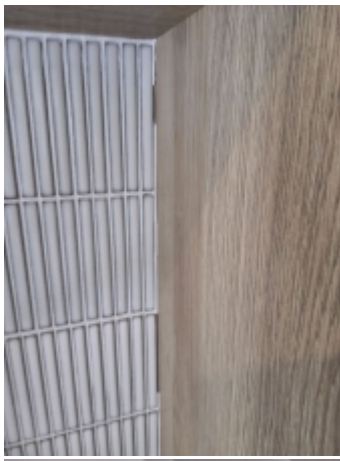
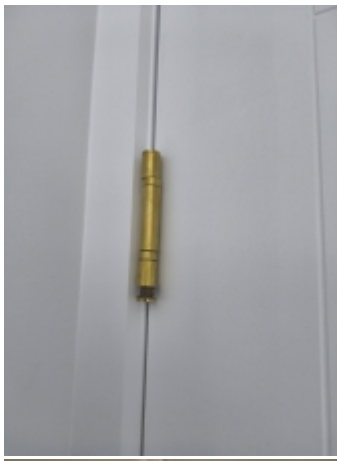
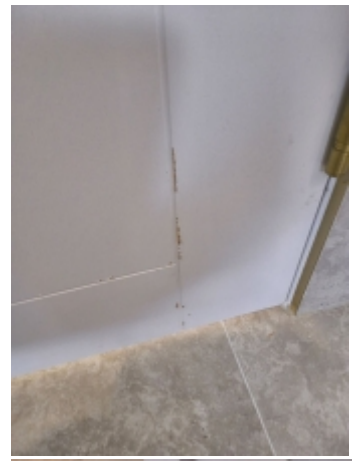
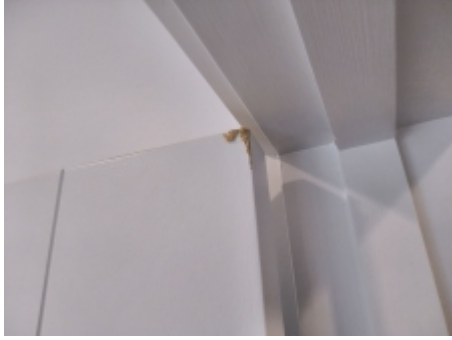
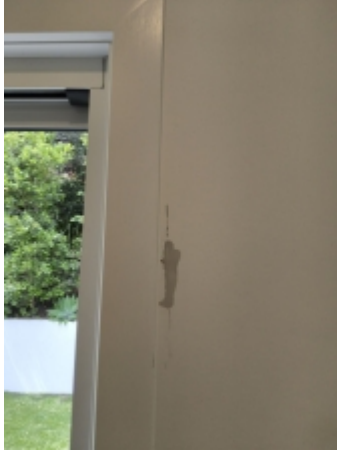
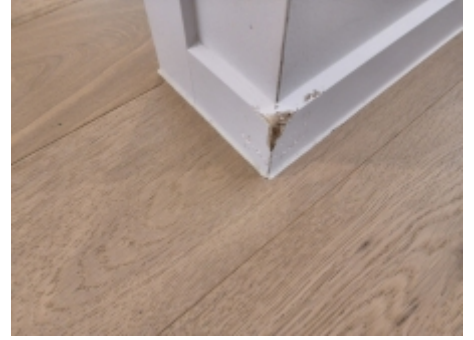
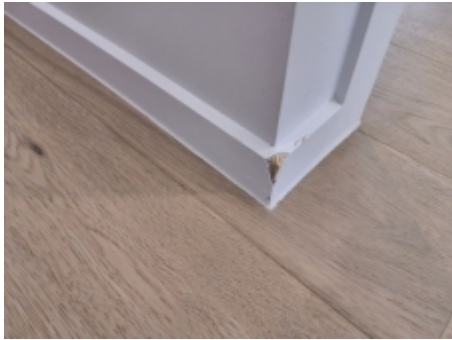
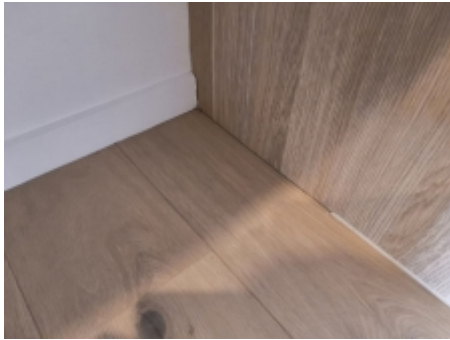
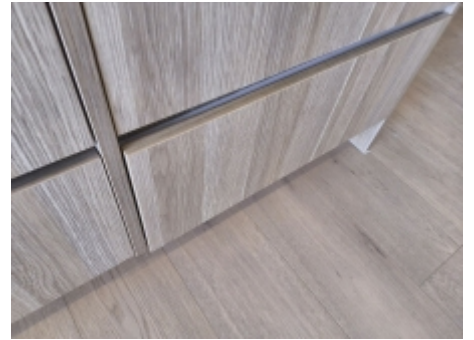
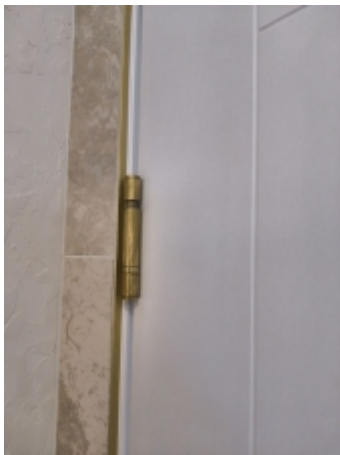
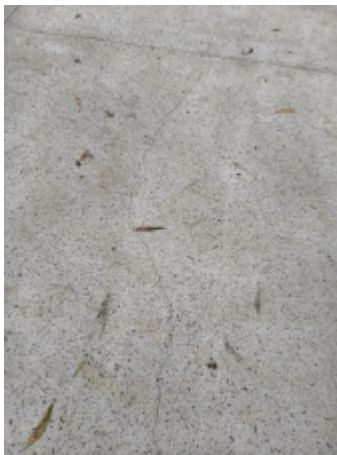
Minor plaster/paint defects

Minor damage to parts

A couple of areas of missing silicon in kitchen and laundry

A couple of loose door hinge pins

Minor cracking to concrete driveway/paths

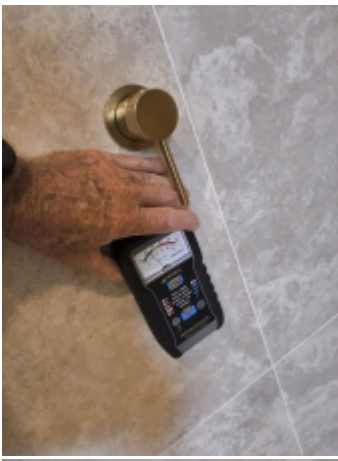
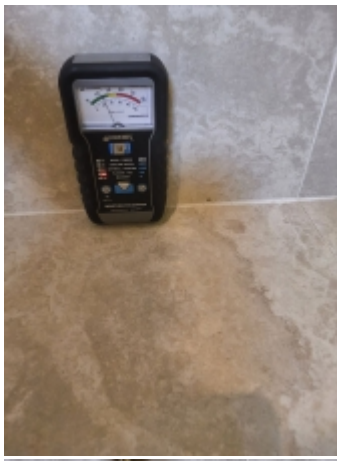
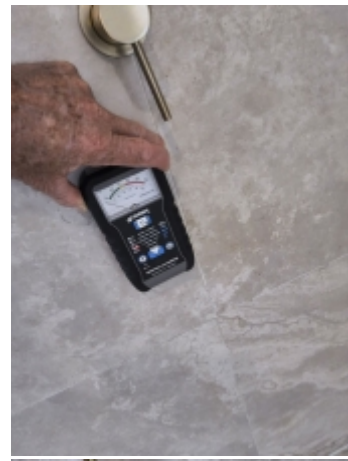
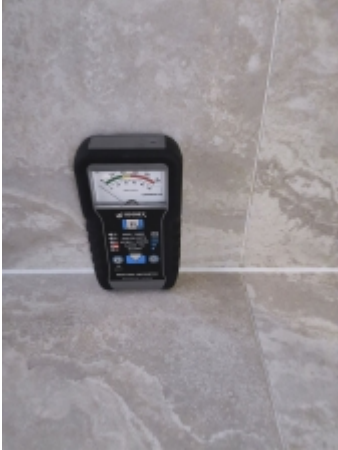
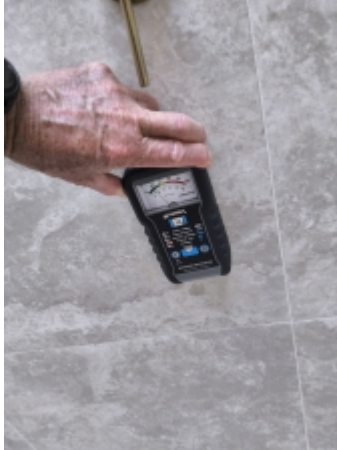
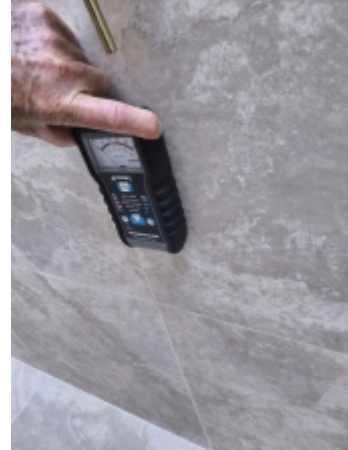
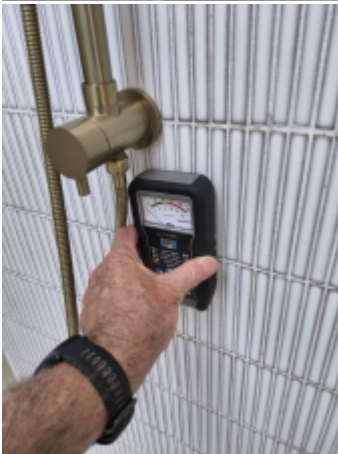
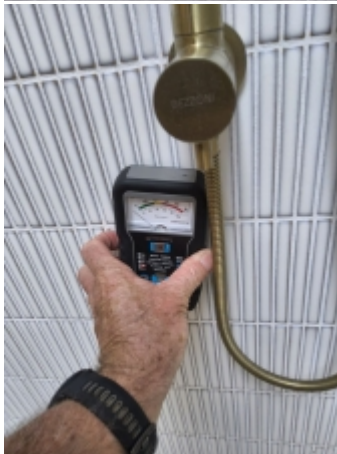
Shown example of moisture readings taken around wet areas that did not indicate elevated moisture.
