SDB Inspecta Homes T/A

Pre Purchase Visual Inspection Report

8 Maitland St Norah Head

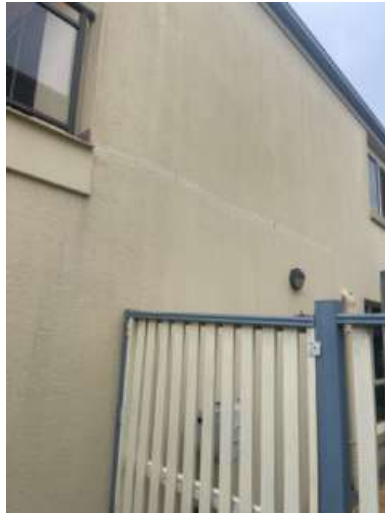
Front elevation.

A damp proof coursing material could not be identified due to applied render coating. Where a damp proof coursing material is not visible or cannot be identified, dampness, rising or otherwise, may become a future problem. Recommend an invasive inspection to determine the status of the dampcourse material.

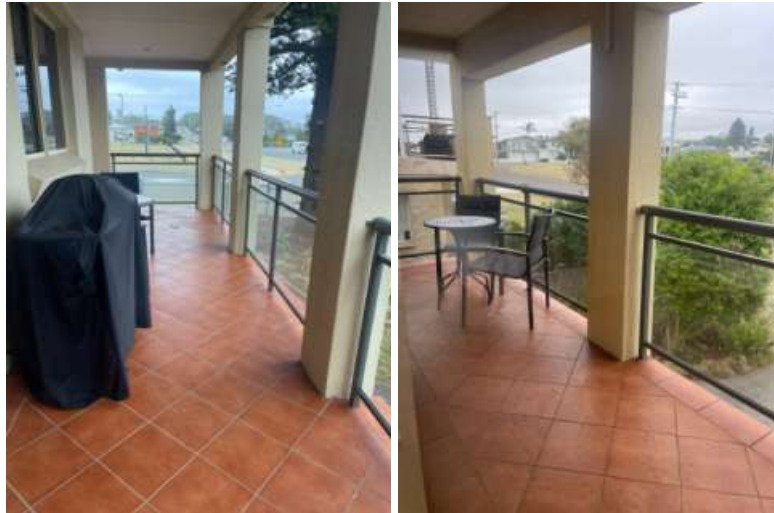
Rear elevation.

Constructed from concrete or masonry. The condition of the structure is generally acceptable.

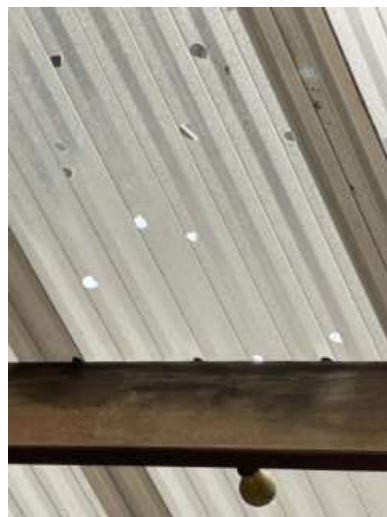
The overall condition of the roof coverings is poor. Roof and/or flashings are allowing water to penetrate the interior of the building. Concealed internal roofing members may be damaged and require repair or replacement. This should be investigated further by a licensed contractor and rectified.

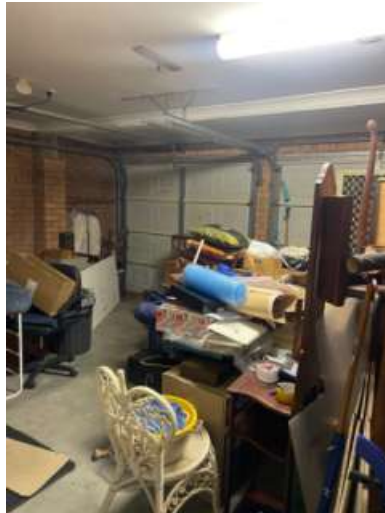
The condition of the ceilings is generally poor. There was evidence of water penetration through the ceiling and this area will require repair.
