Inspection Report

Coastal Building Inspections

12 Kitty Pl , Watanobbi, NSW, 2259

Pest And Building Inspection

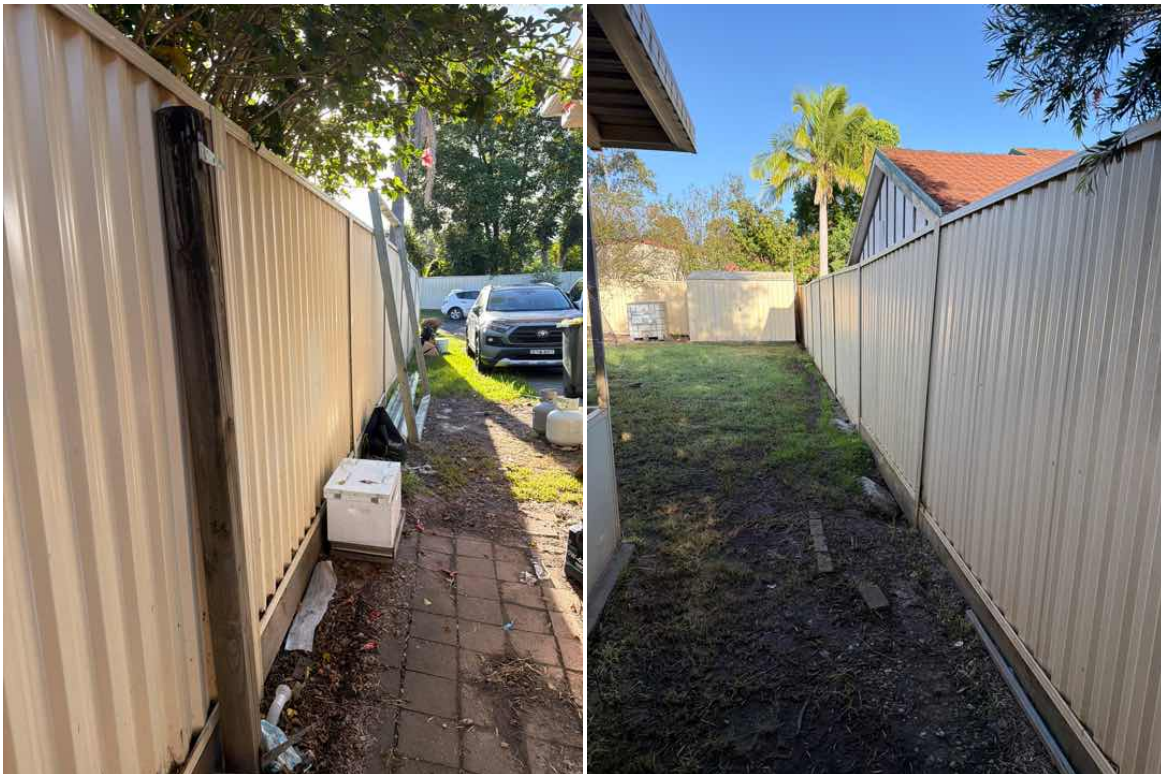
#1. Fence leaning- Recommendations: Repairs are required by fencing contractor to avoid unsafe conditions.

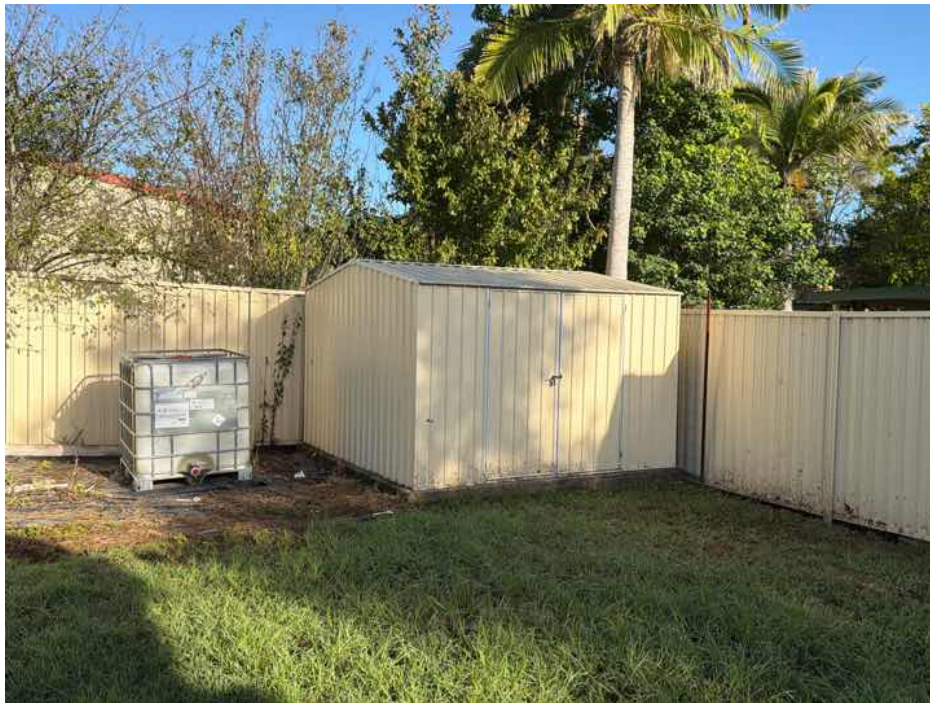
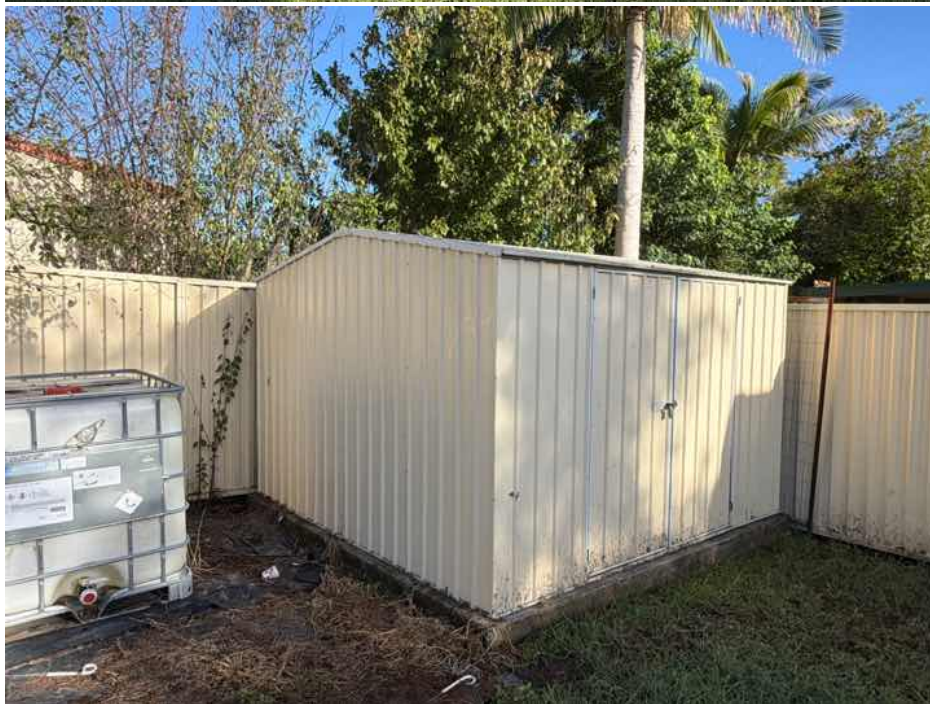
The shed is in fair usable condition.

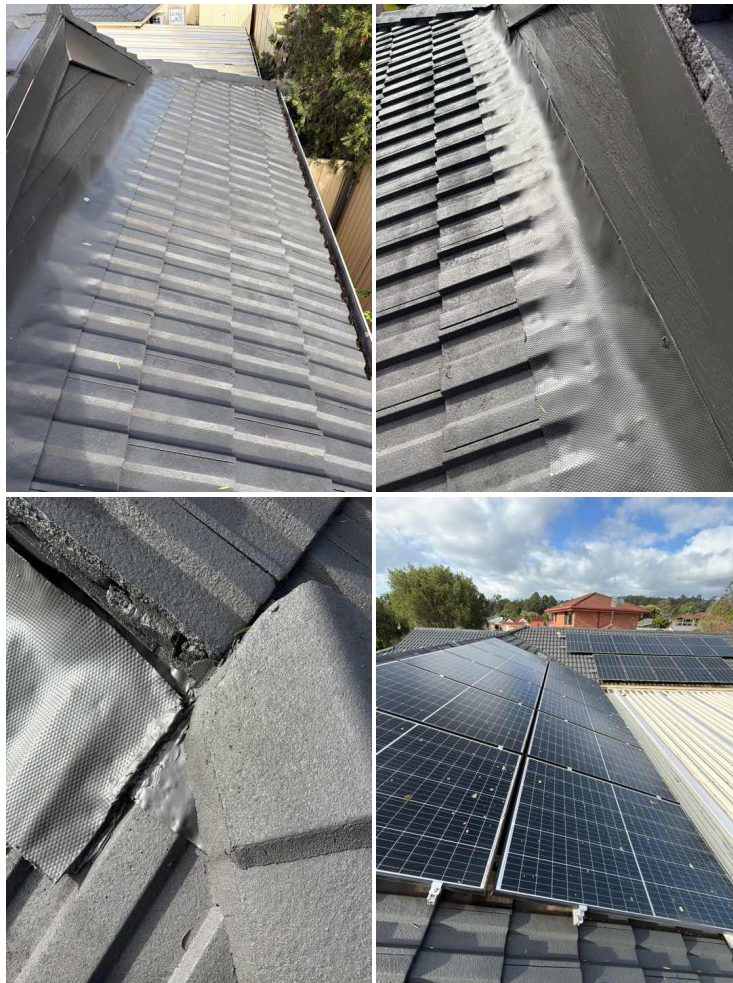
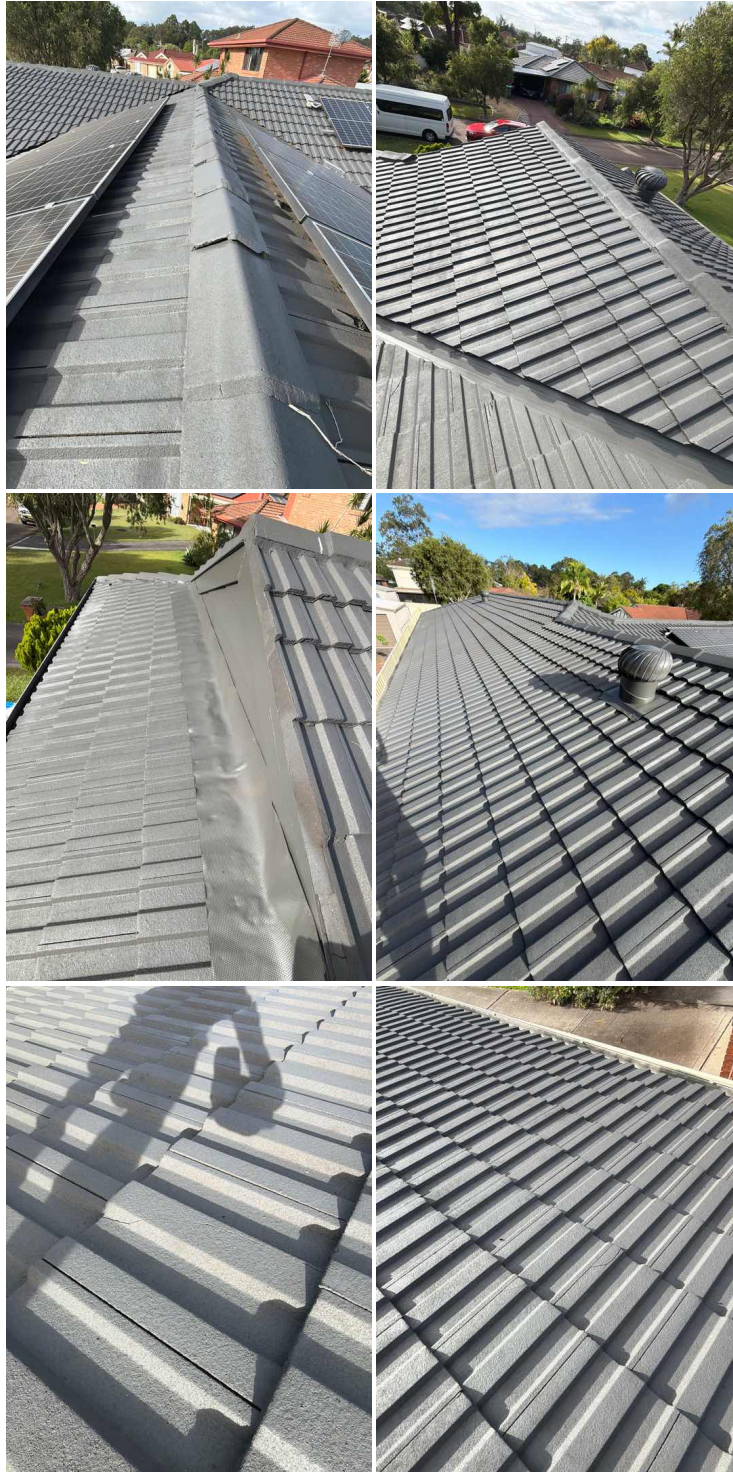
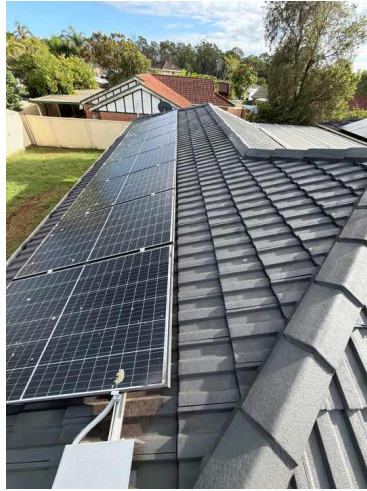
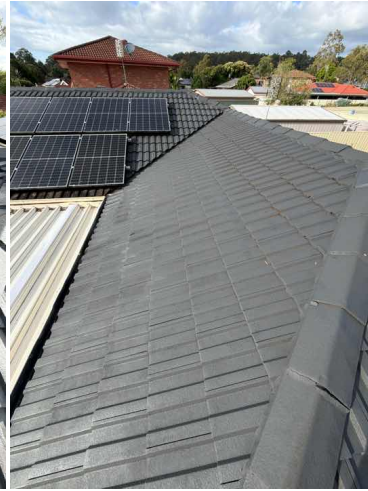
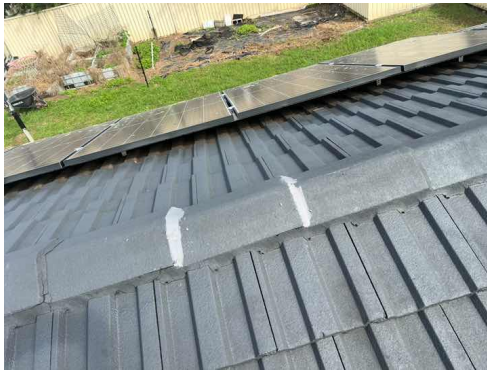
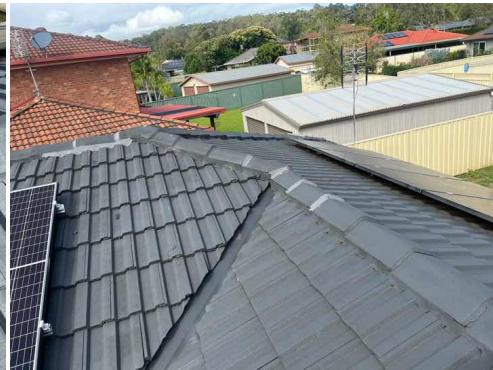
Surface rust to the valleys sheeting.

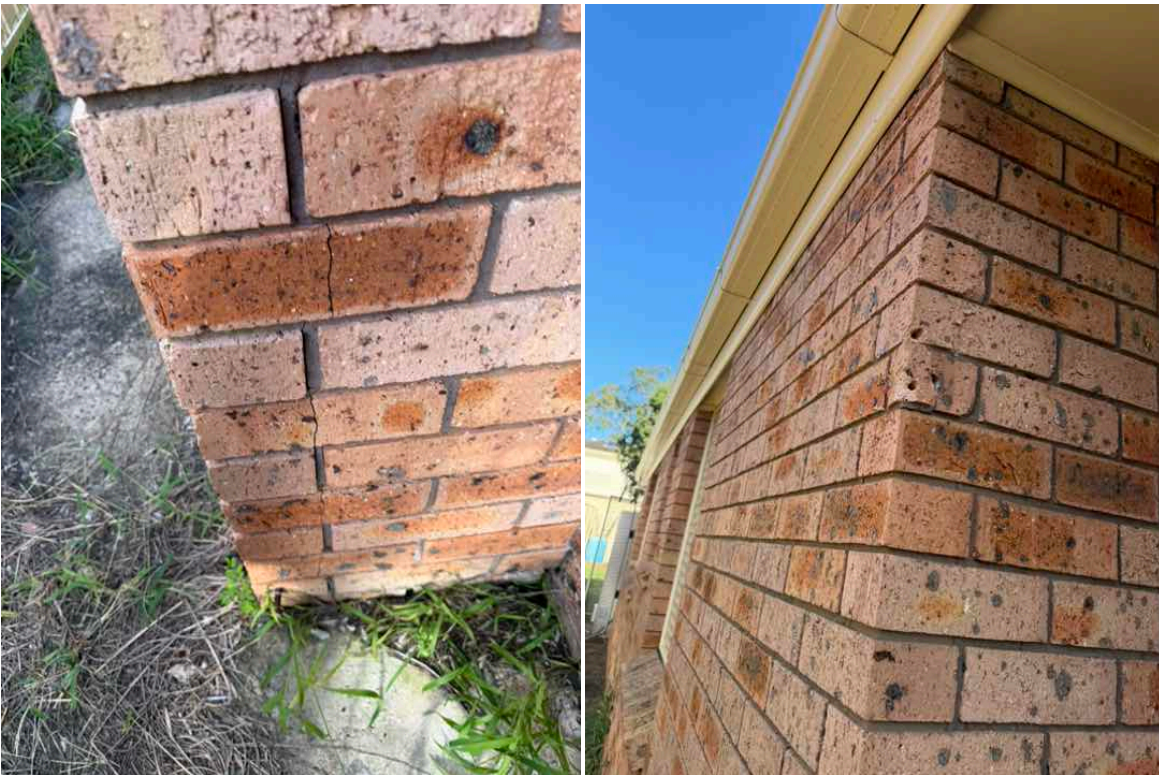
#2. Minor brick damage observed to the brickwork. Have repaired by a licensed brick layer.

#3. some minor settlement in the building which has caused some cracking to the walls. Considered minor

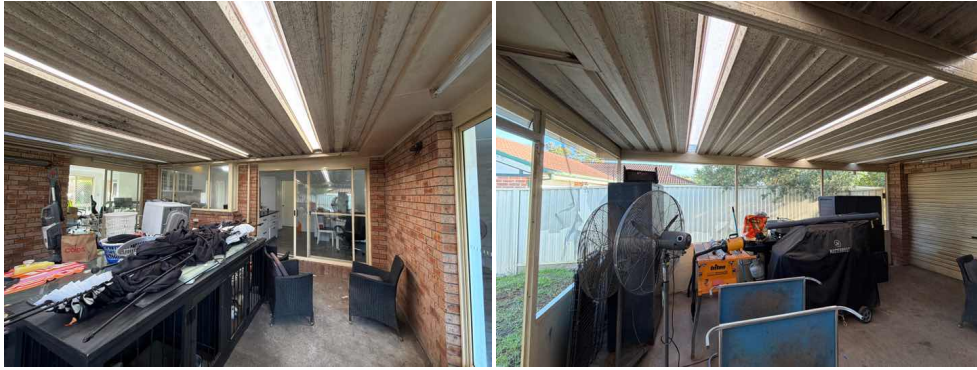
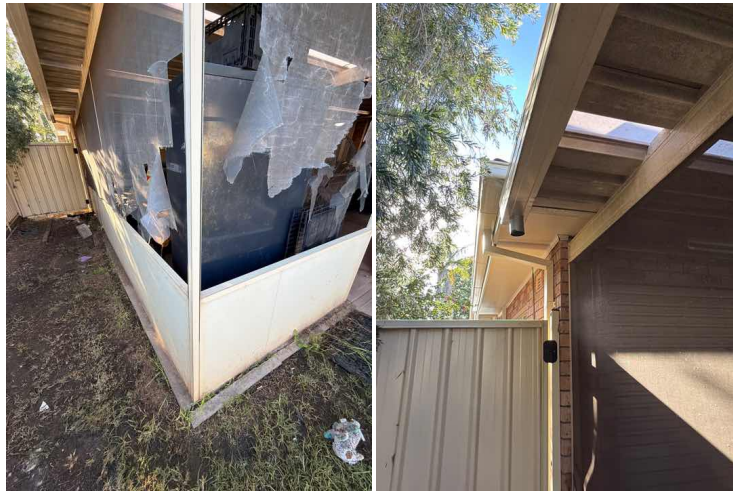
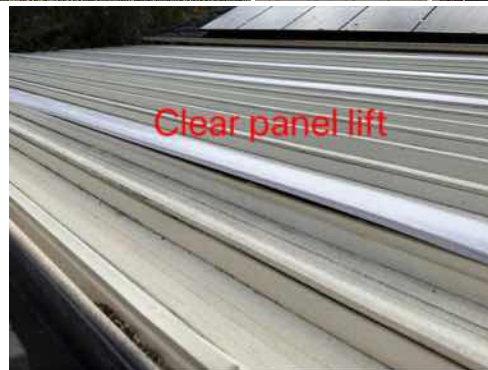
Downpipes not connected. Engage a plumber to connect

Flyscreens damages

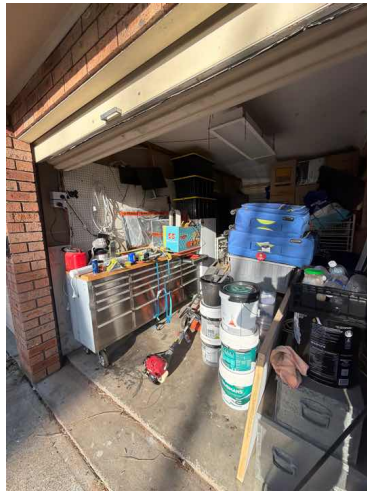
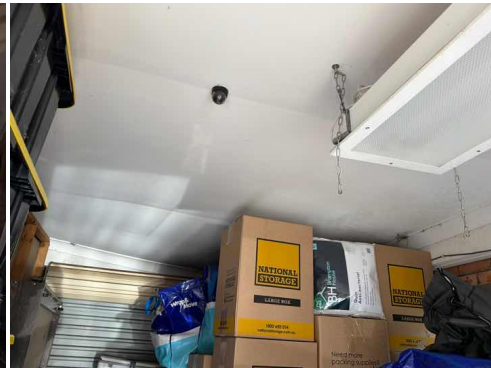
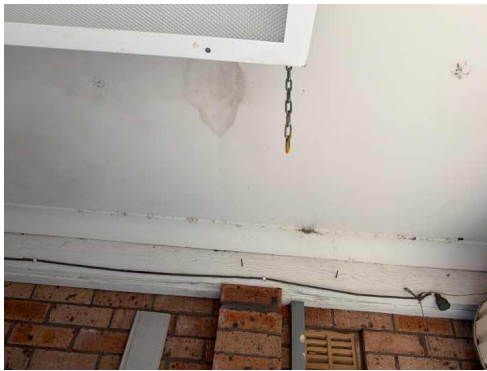
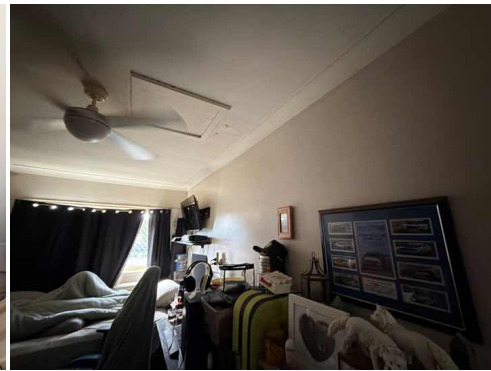
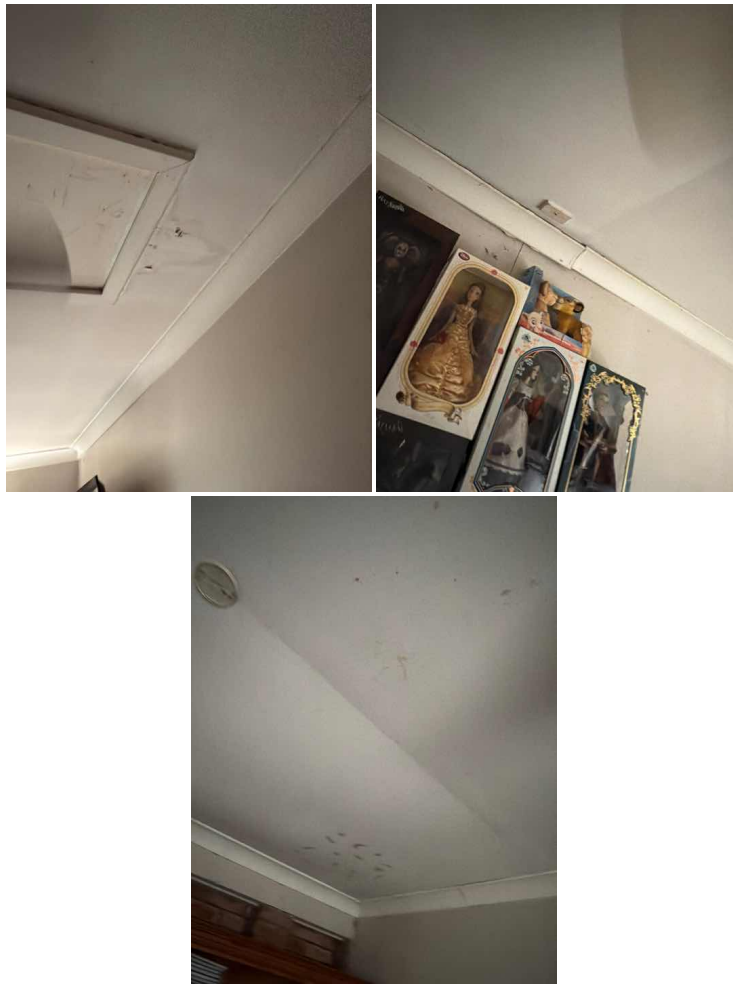
#4. General age deterioration of the garage door/components. Recommendations: General repairs/maintenance as required.

Ceiling sagging - Requires repair from a safety perspective - Recommendations: I recommend you contact a licensed plasterer for further advice and recommendations. Considered a Safety Hazard.

#5. Ceiling stains - No moisture readings obtained from same. Recommendations: These may have been repaired, however, you will need to monitor after a prolonged period of rainfall - If leaking persists, a qualified plumber should be engaged for advice and recommendations. It is strongly recommended that all water damaged plaster replaced by a qualified plasterer due to potential detachment or collapse. Considered a Safety Hazard

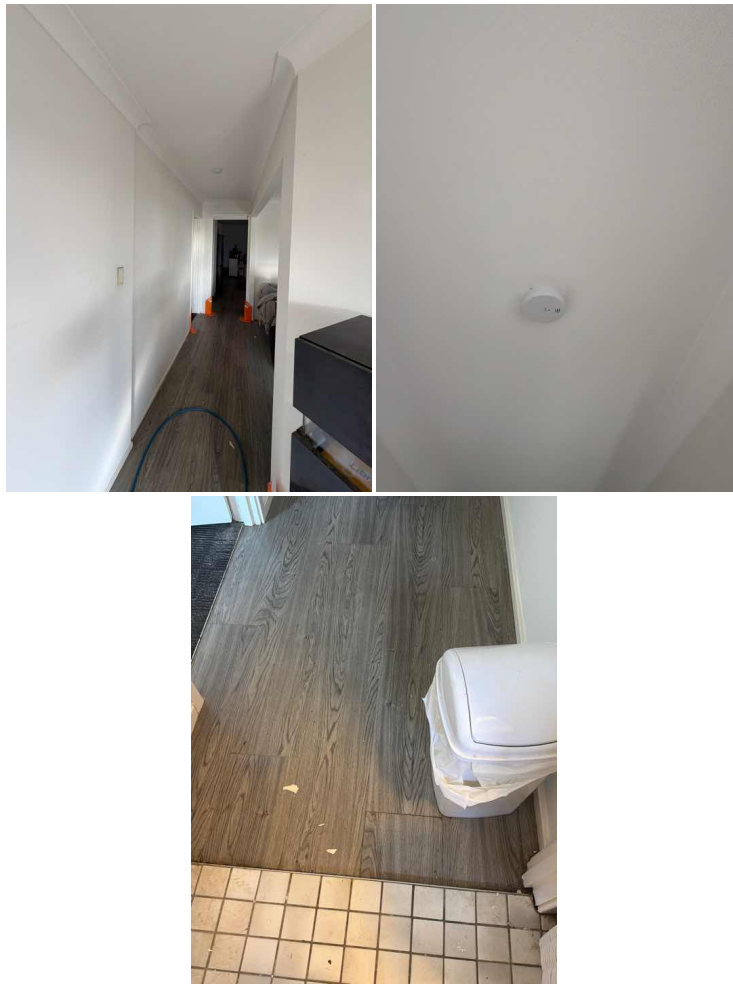
General Wear and tear noted to the floor covering

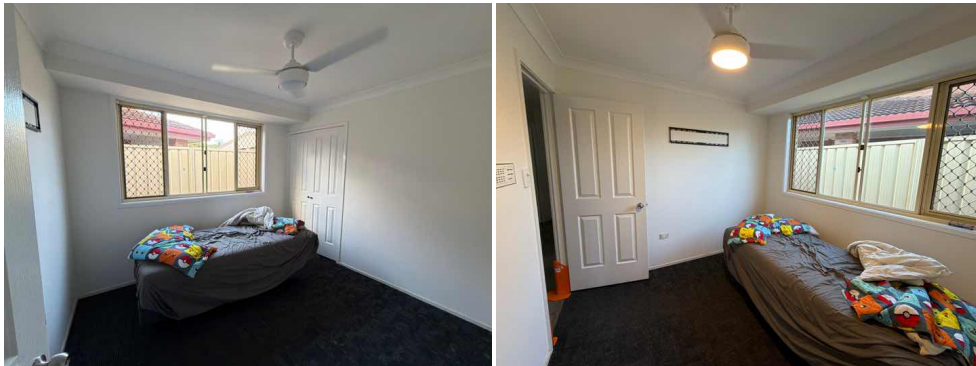
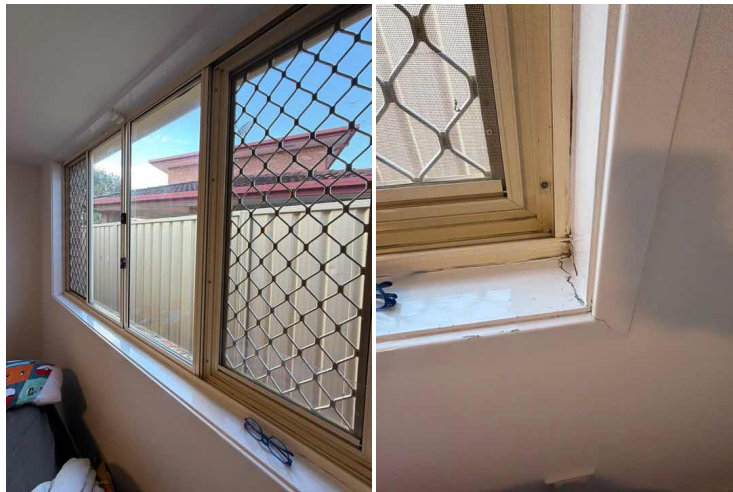
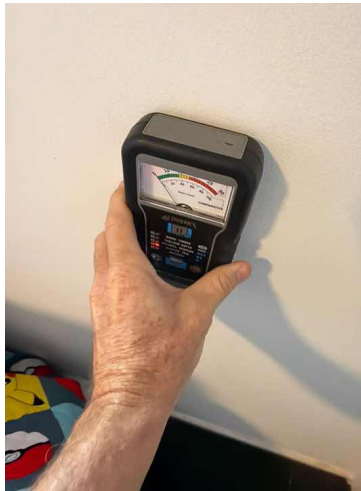
General window ageing has occurred. Repairs as required.

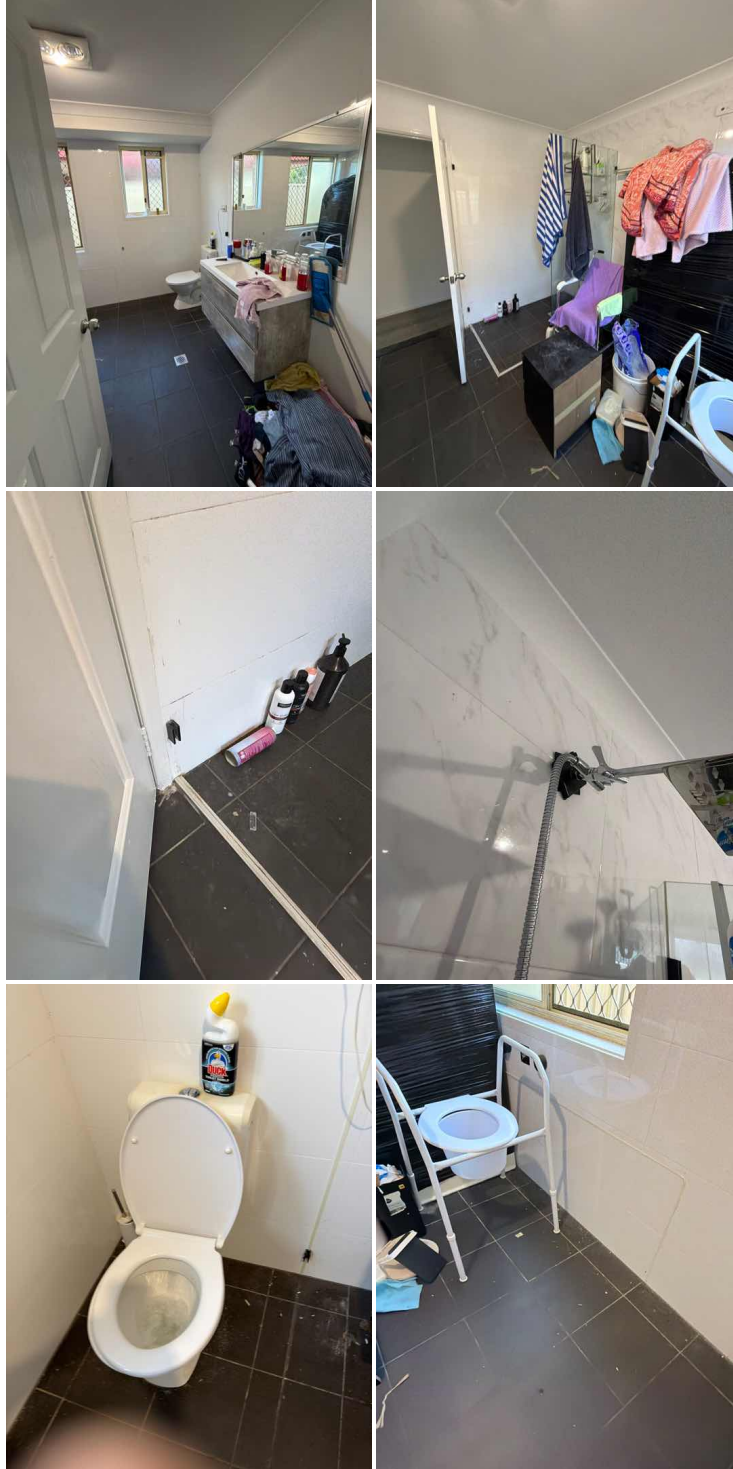
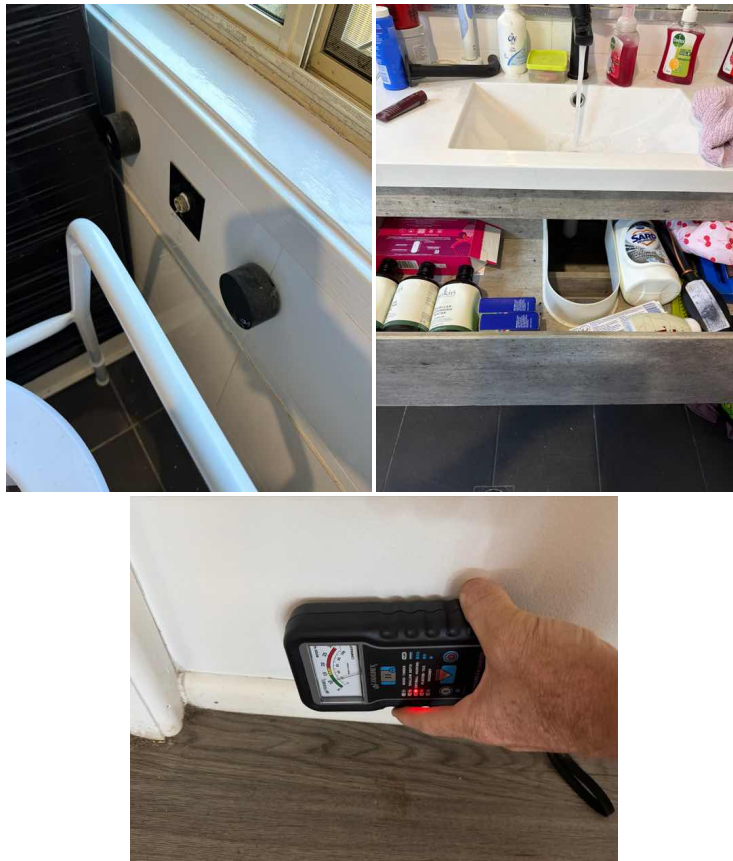
#6. Shower head is loose. A qualified plumber should be engaged for advice and recommendations.

Shower screen has been removed. Replace shower is recommended

Bath has been removed. Engage a plumber to replace bathtub.

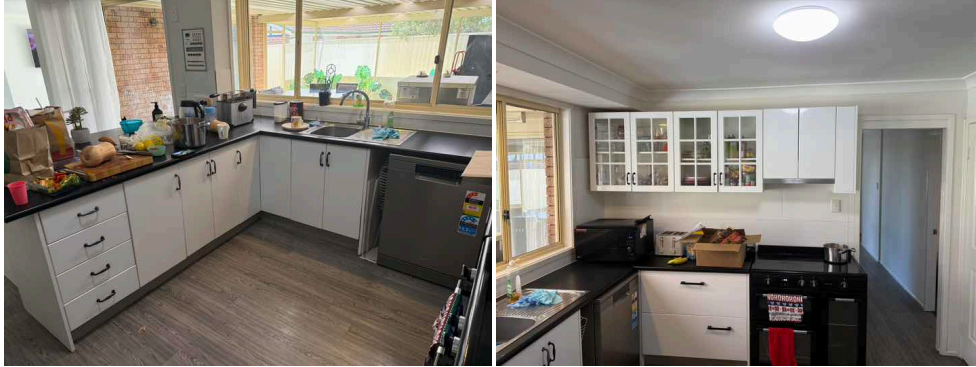
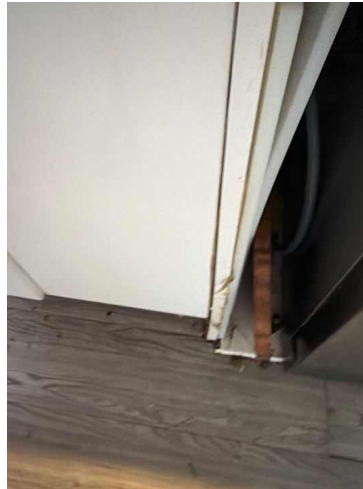
General wear/tear to cupboards and bench tops noted

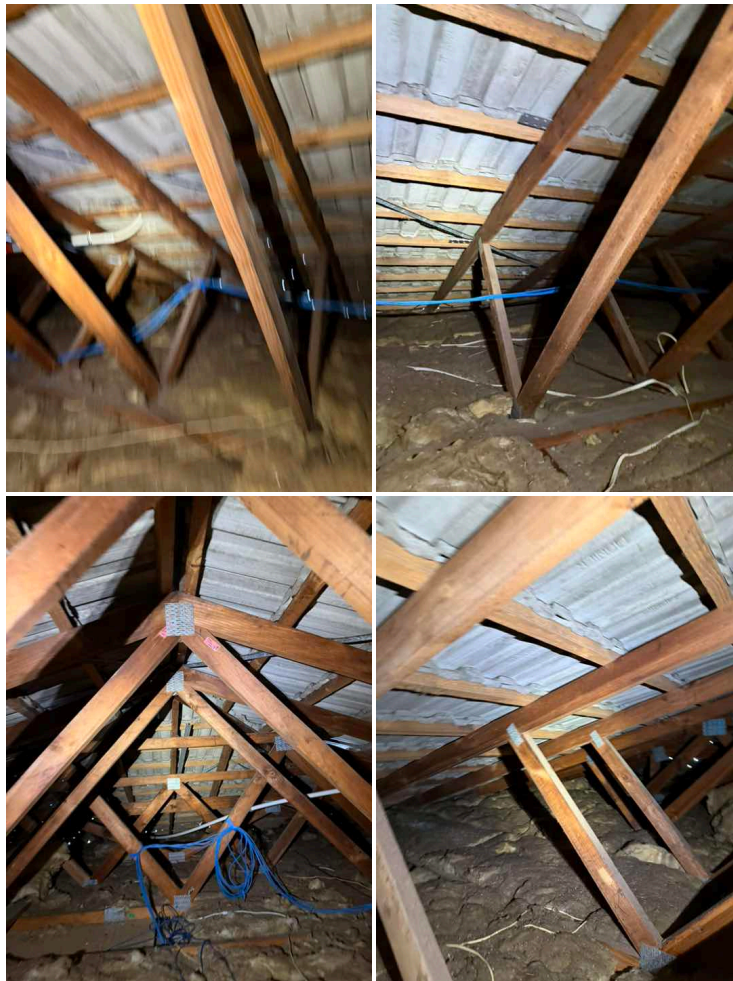
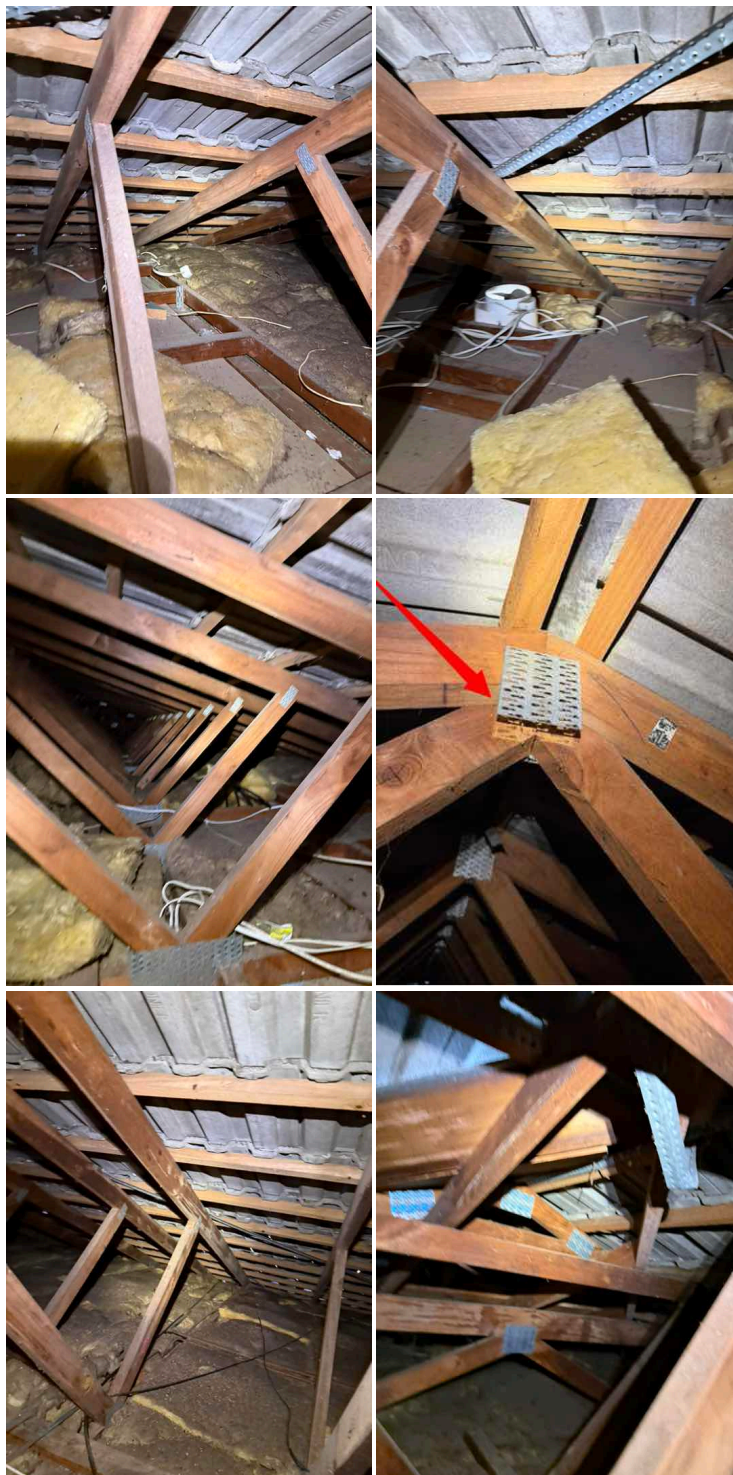
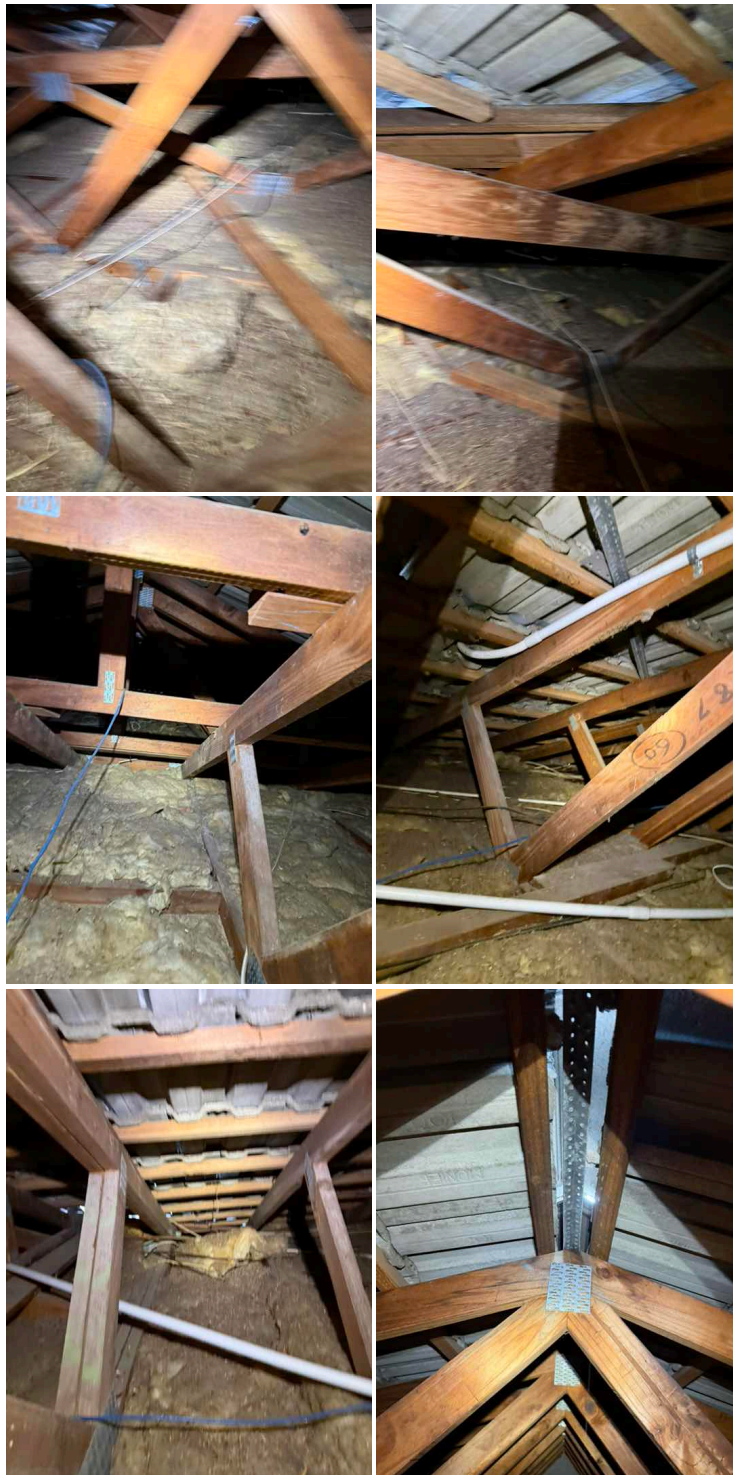
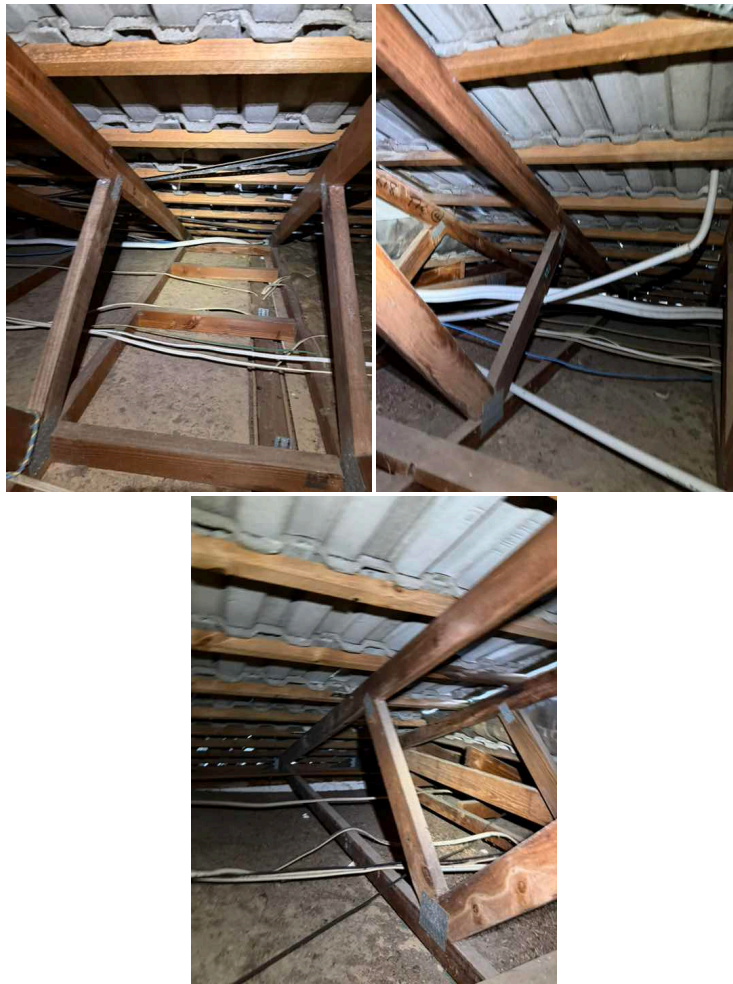
Gang nail has let go. Reattachment is required. Seek advice from a qualified carpenter for advice and recommendations. re-attach required

Cracked tile section visible. Recommendations: A qualified roof tiler should be engaged for advice and recommendations.
