Inspection Report

Coastal Building Inspections

15 Mimosa Road , Budgewoi, NSW, 2262

Pest And Building Inspection

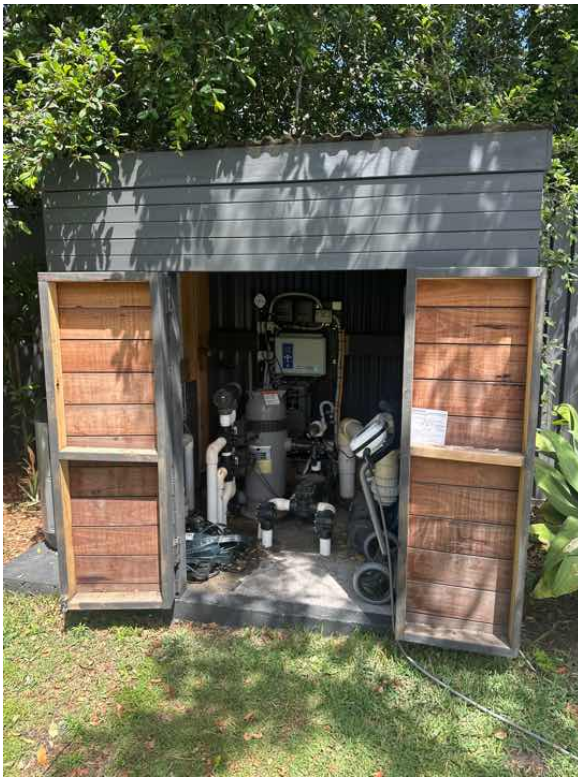
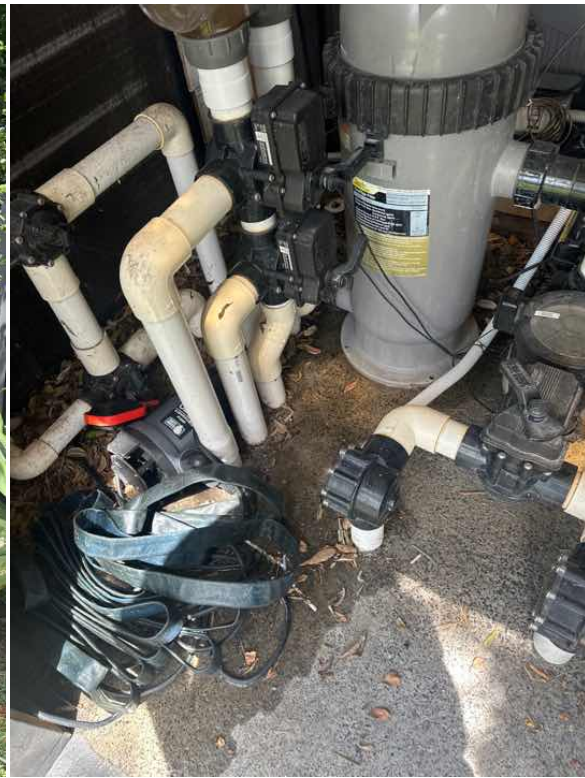
Leak noted from the pool pump. Repairs as required

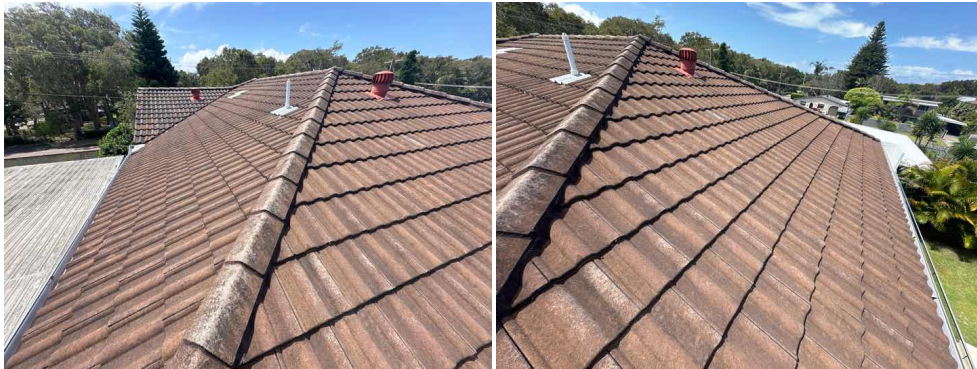
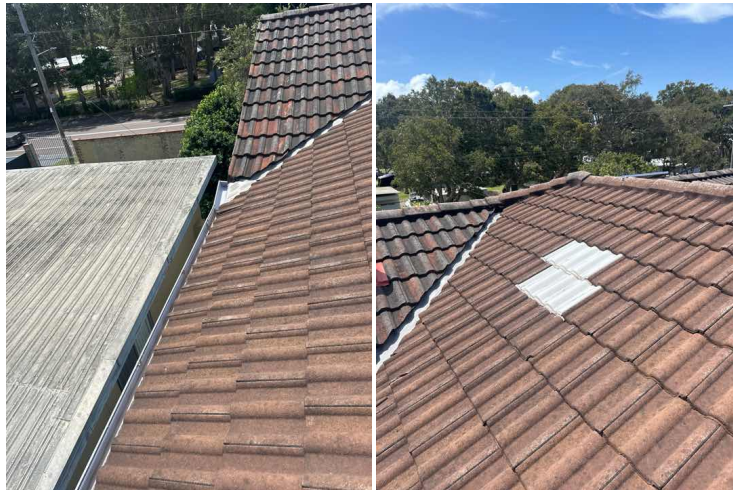
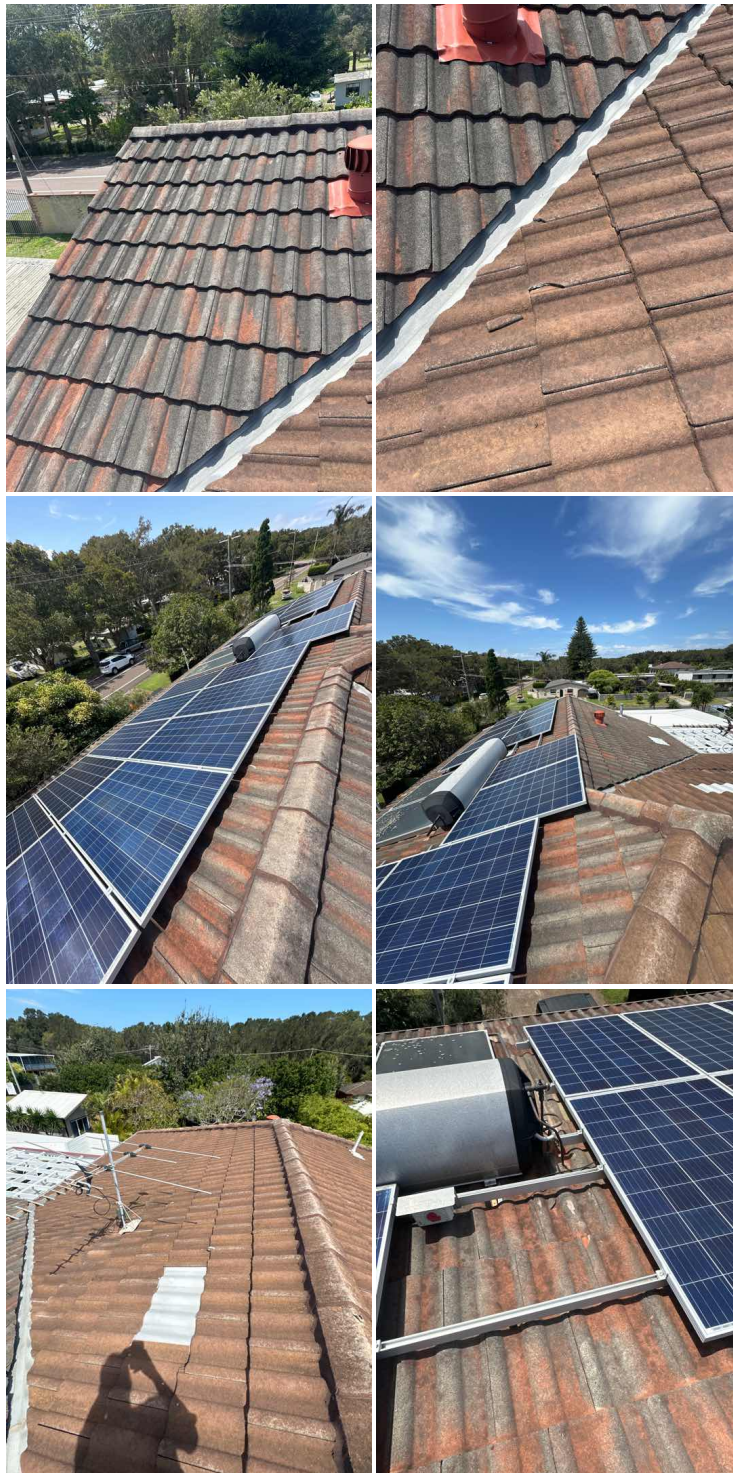
Some Cracked tile ends visible - Recommendations: A qualified roof tiling contractor should be engaged for advice and recommendations.

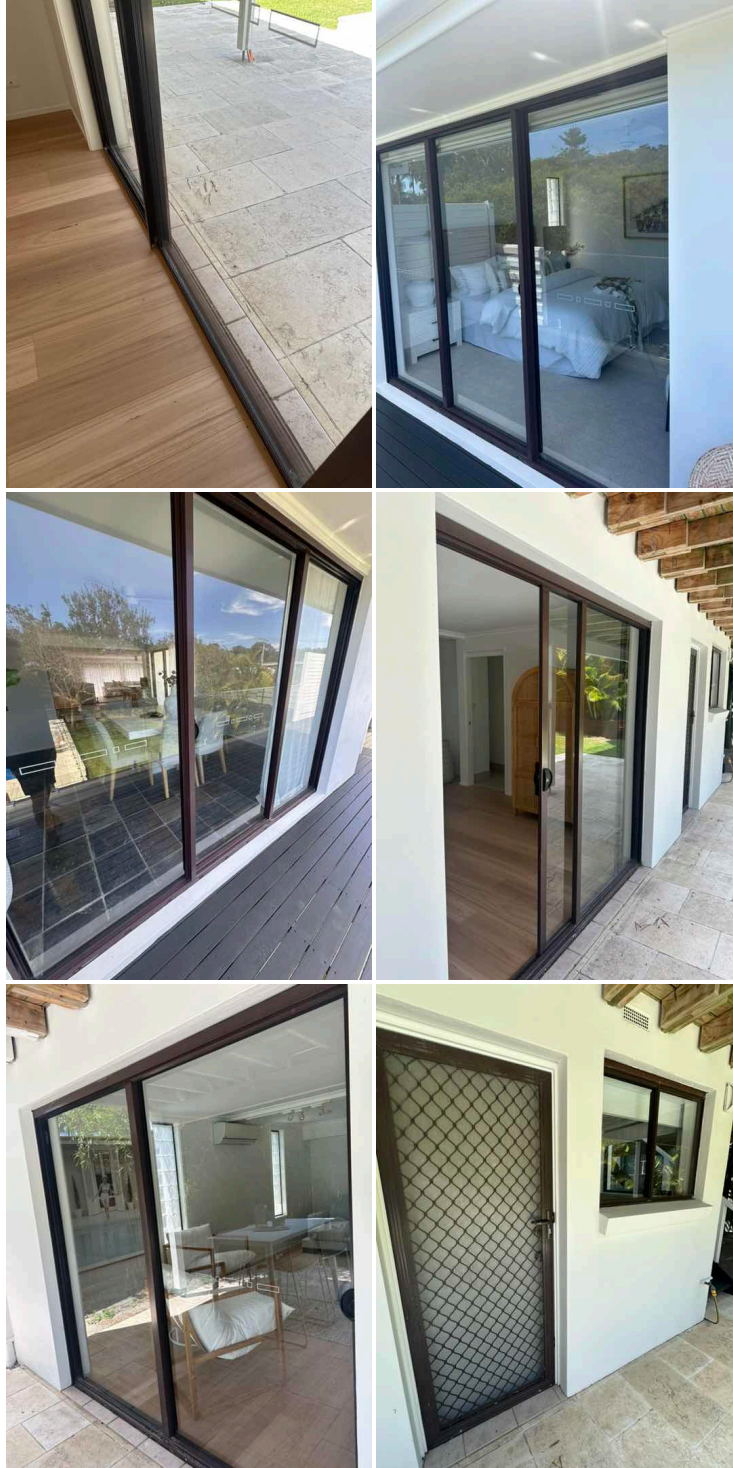
General age/damage has occurred to door frame, face or components. Recommendations: A qualified carpenter should be engaged for advice and recommendations.

Adjust/Replace rollers as required

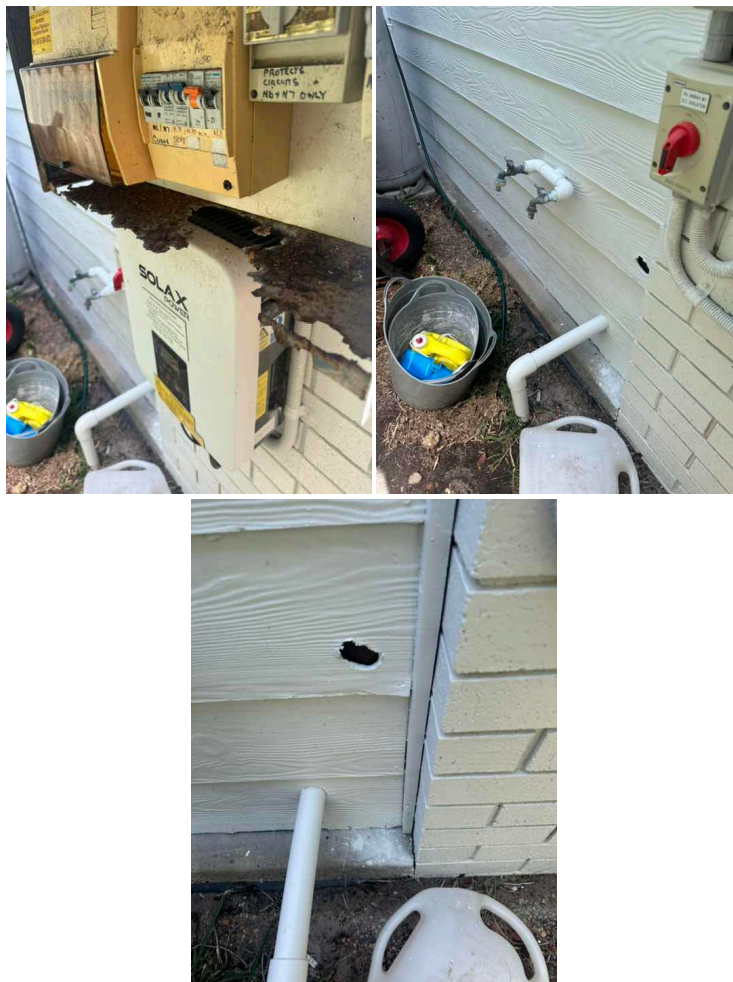
Penetration openings observed. I recommend sealing these off so as to avoid vermin and other pest infestation.

External cladding is in contact with the ground. This is a conducive condition for moisture penetration causing decay and/or concealed termite entry.

the electrical box shows signs of wear/rust,

It is recommended to engage a licensed electrician to assess the condition, ensure compliance with current electrical standards, and perform necessary repairs or upgrades to maintain safety and functionality.

Regular maintenance by a professional is advised to prevent future issues.

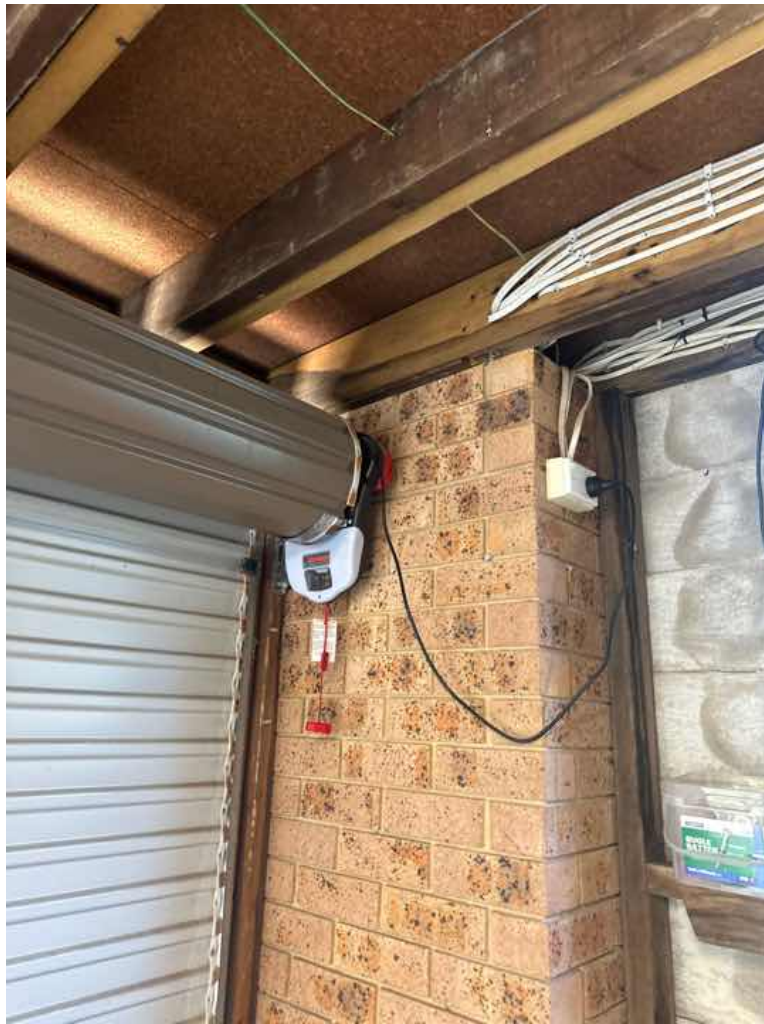
Motor is not functional. Repairs/replacement is required

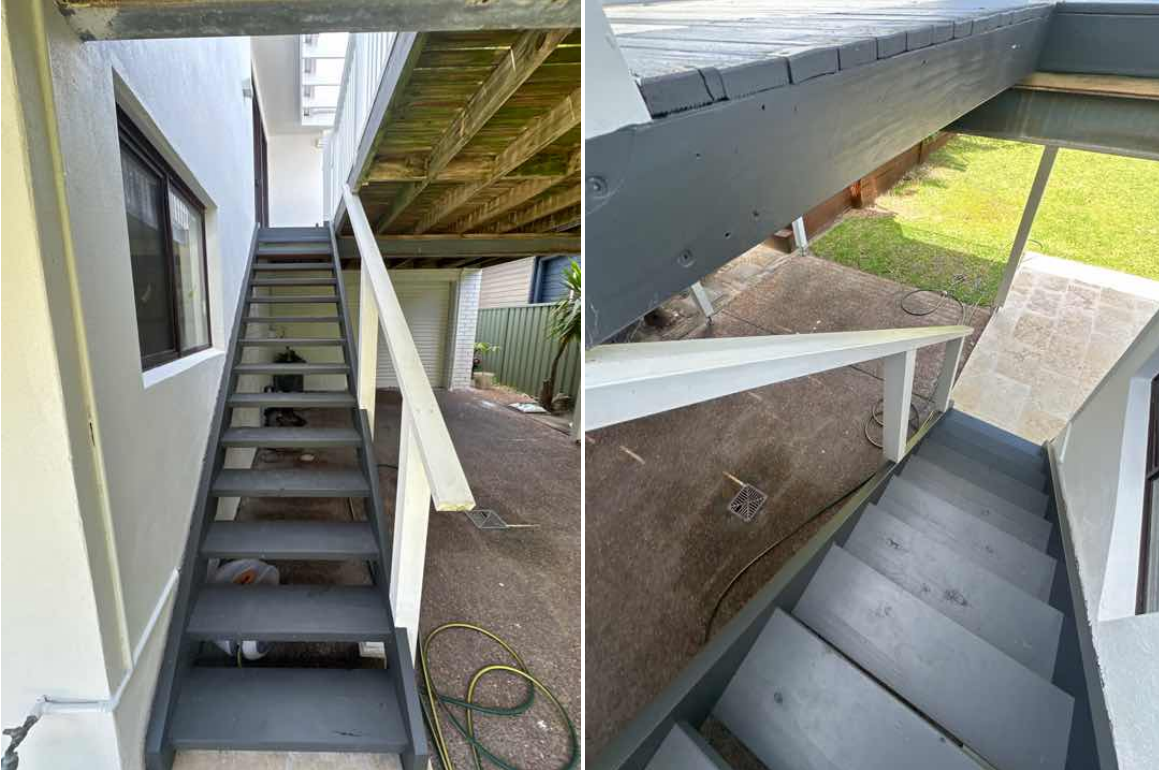
Rails may not comply with current standards.

Recommendations: We advise you rectify to comply for safety concerns to young children.

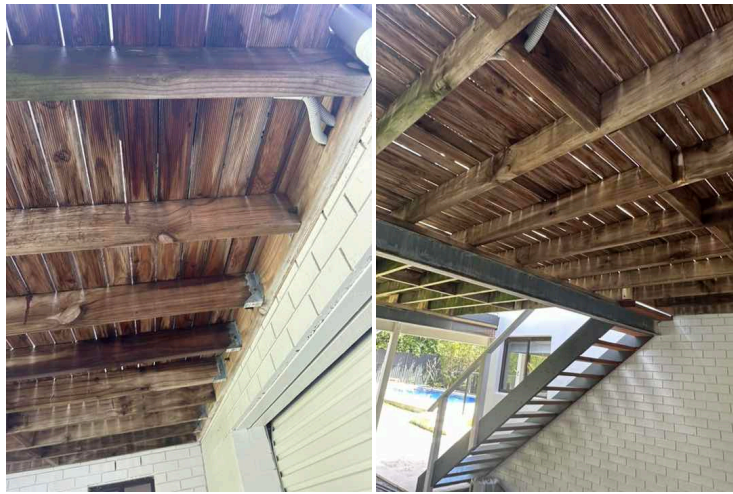
Decking board surfaces are weathered - Recommendations: We recommend cleaning and maintenance as needed.

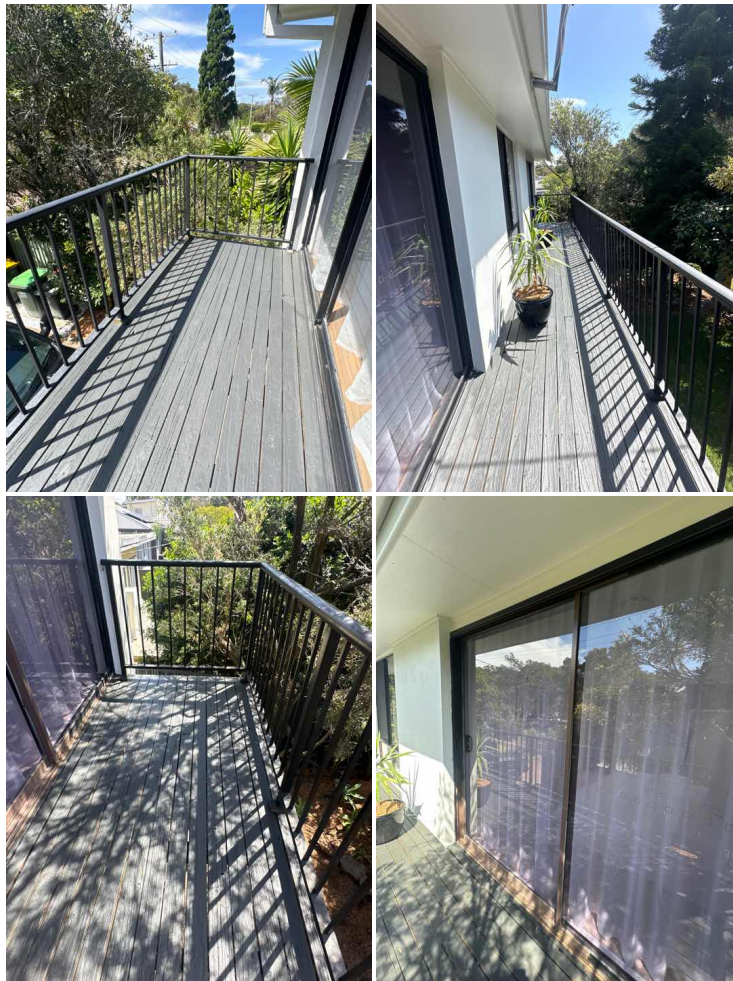
Decking board surfaces are weathered - Recommendations: We recommend cleaning and maintenance as needed.

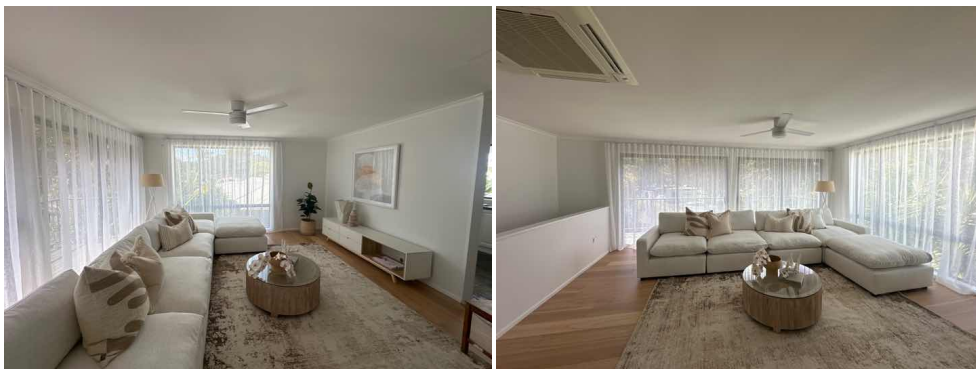
Settlement Cracks Noted. These are typical and generally patch and paint will suffice

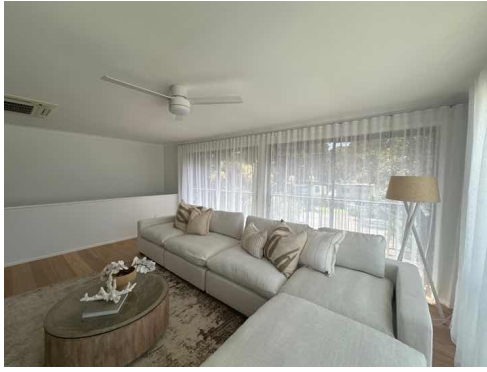
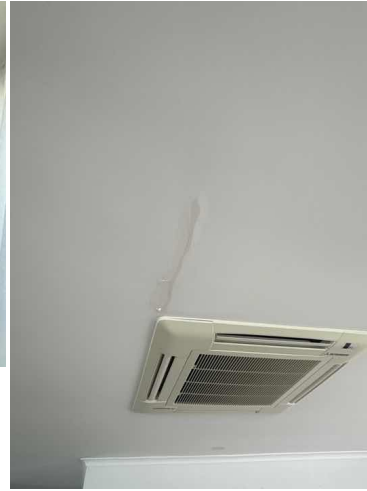
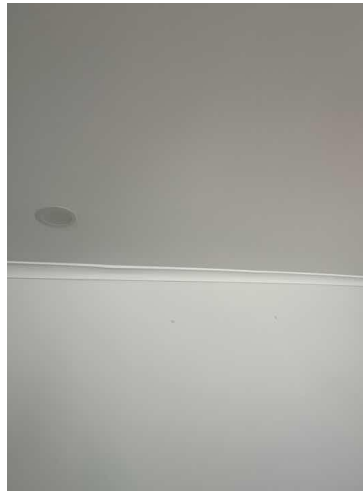
minor damage to the cornice was noted, because of the location this is likely due to roof truss movement.

Repairs as required.

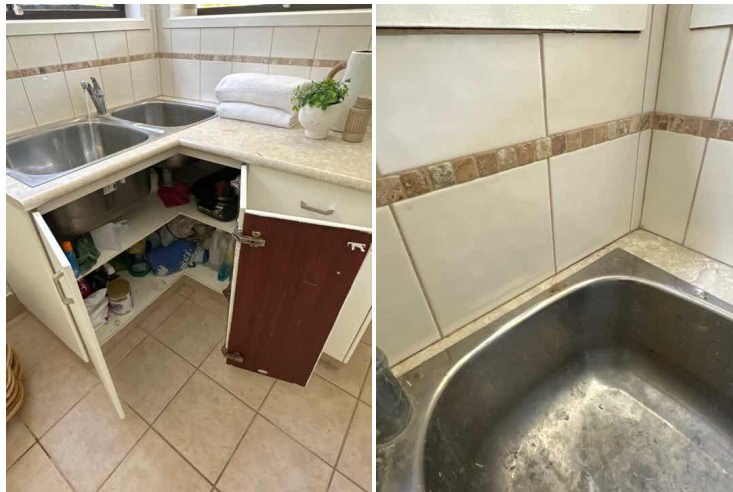
General deterioration and wear to sink, cupboards and benches. Repair/replace as required.

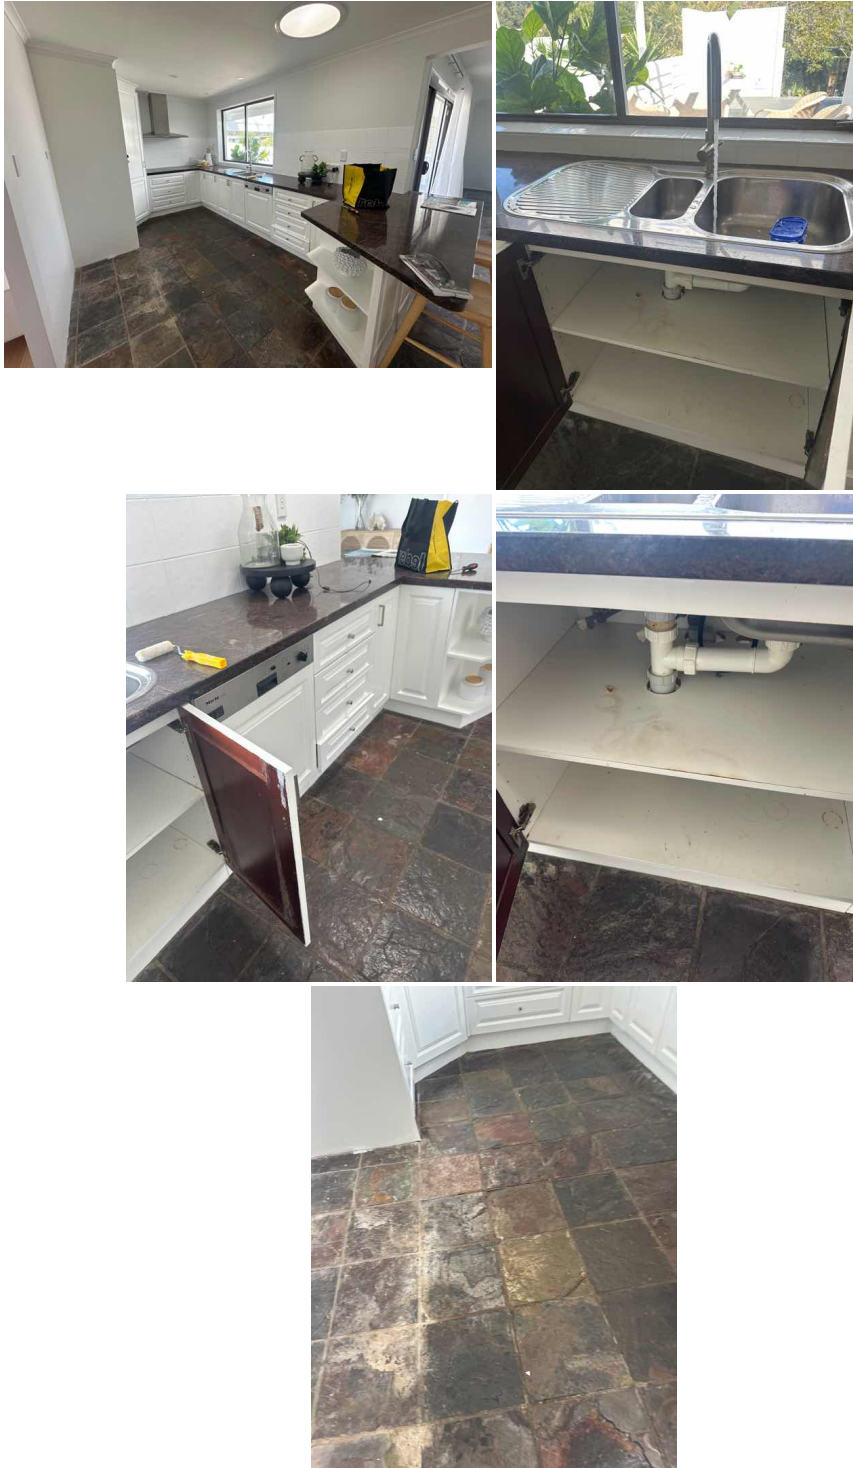
General age, wear and tear - Recommendations: General repair and maintenance advised.
