Inspection Report

4 Ourringo street, Budgewoi, Budgewoi, NSW, 2262

Pest And Building Inspection

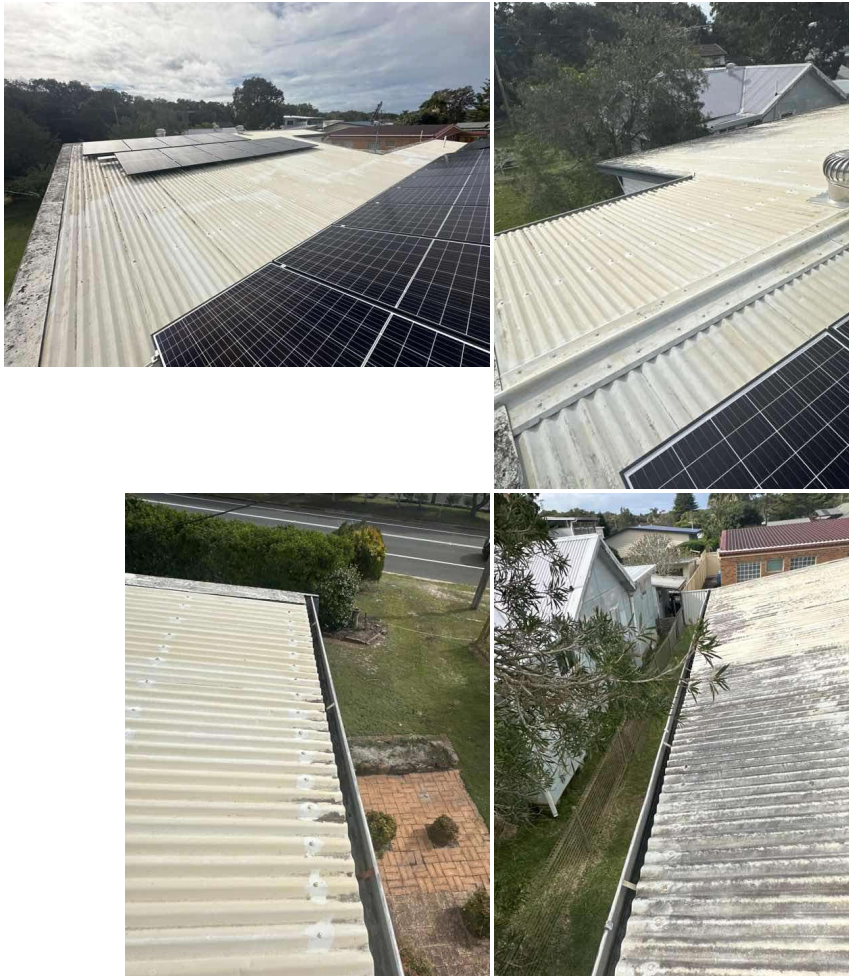
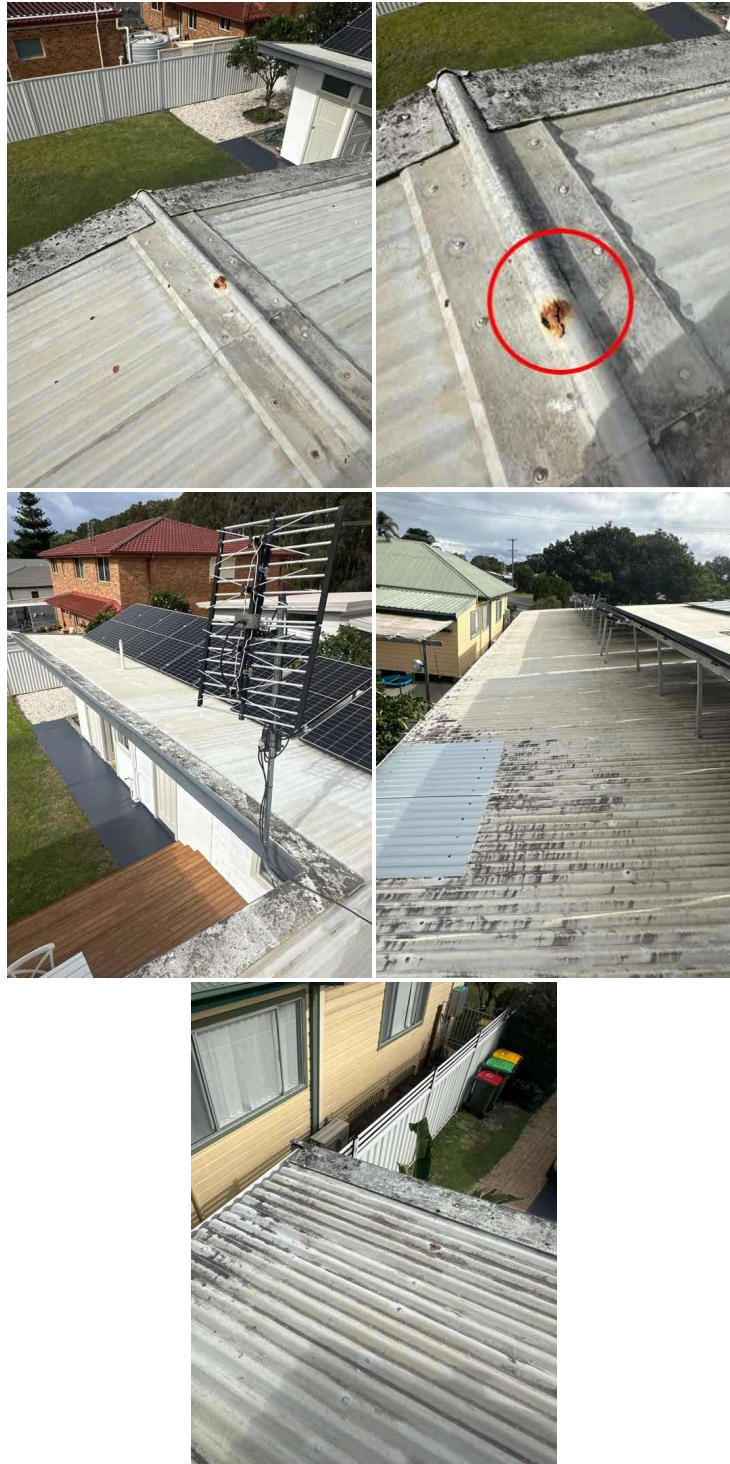
Flashing Conditions

flashing/capping rust sections - Recommendations: A qualified roofer should be engaged for repairs and recommendations

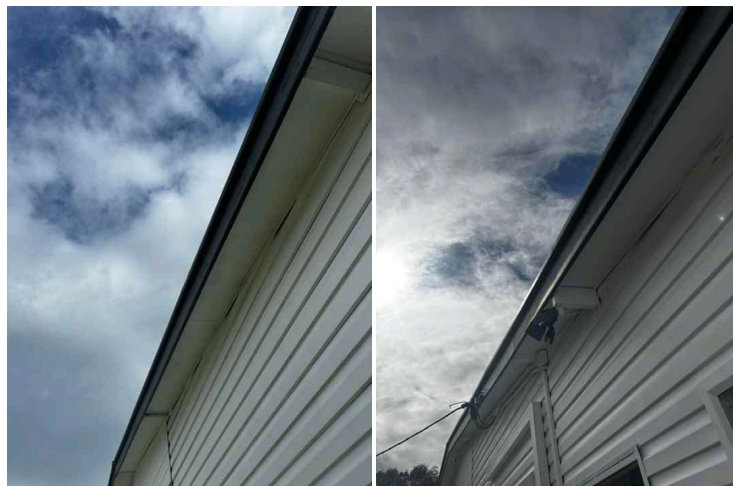
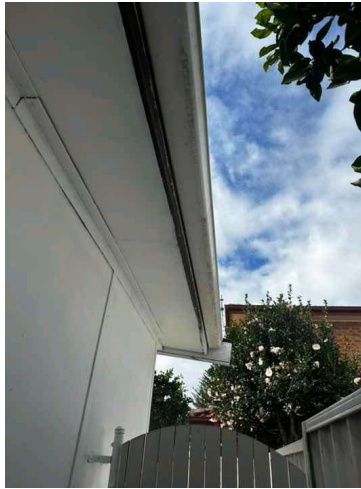
Minor deterioration & ageing evident. Recommendations: Maintenance works, general upkeep should be carried out.

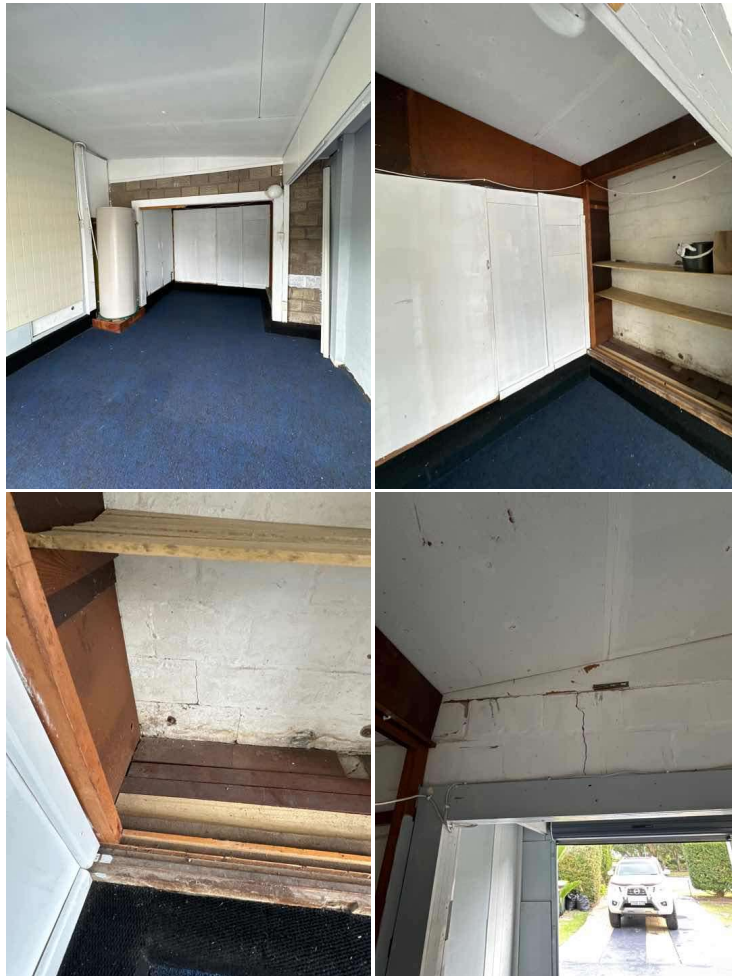
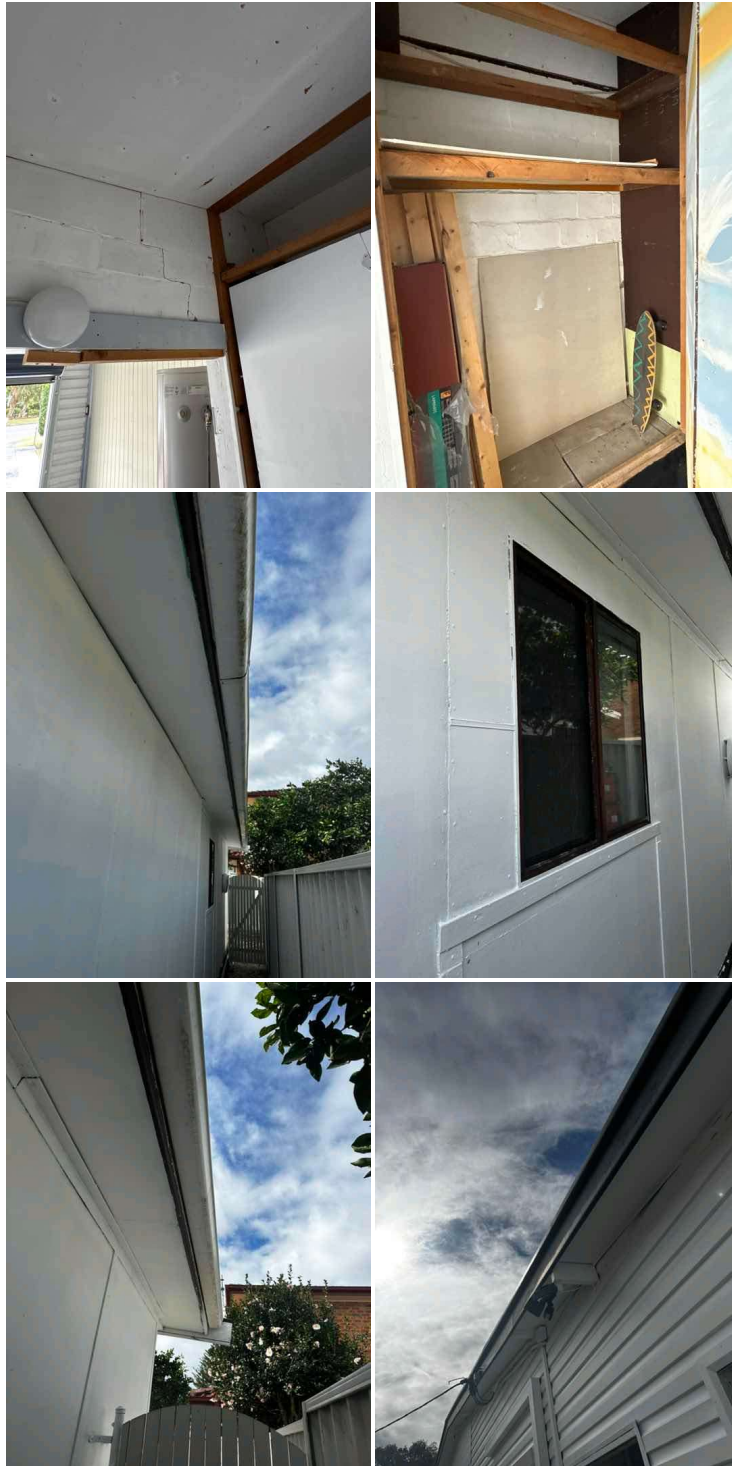
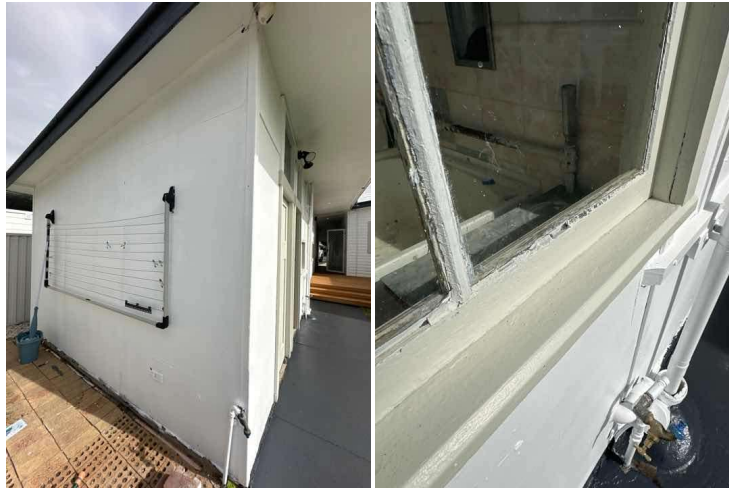
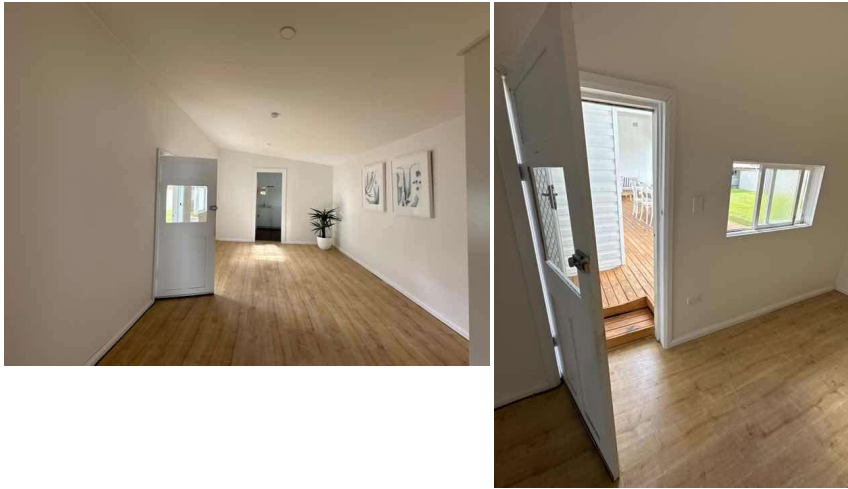
General age deterioration of the garage door/components. Recommendations: General repairs/maintenance as required.

Water entering at the front door step down (previous garage door) noted.

Settlement Cracks Noted. These are typical and generally patch and paint will suffice, however we recommend monitor these cracks and if become wider or longer, you will need to contact a structural engineers to assess.

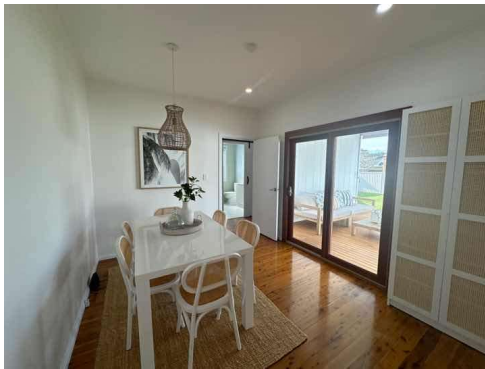
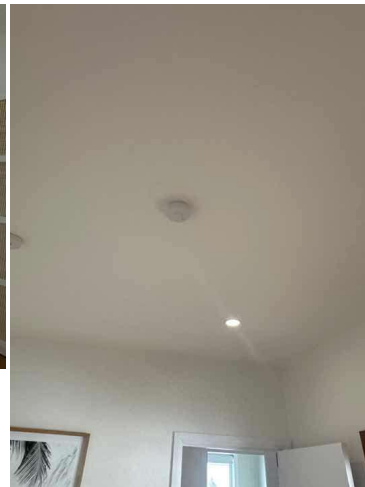
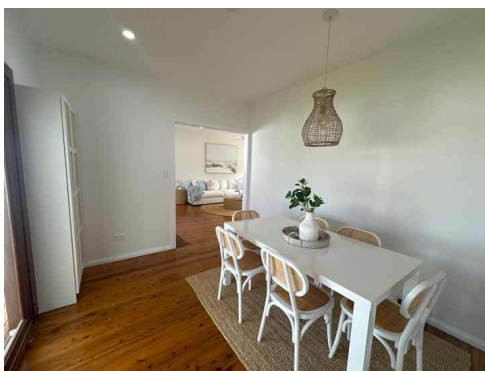
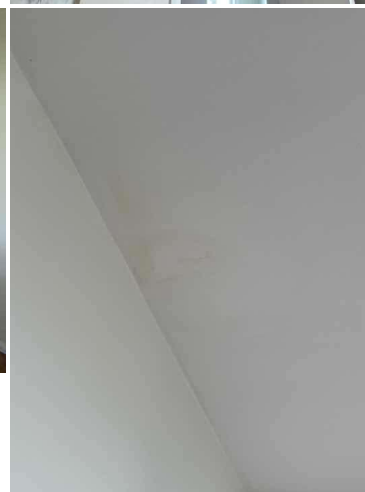
Ceiling

Ceiling stains - No moisture readings obtained. Recommendations: These may have been repaired, however, you will need to monitor after a prolonged period of rainfall - If leaking persists, a qualified plumber should be engaged for advice and recommendations. All water damaged plaster replaced by a qualified plasterer.

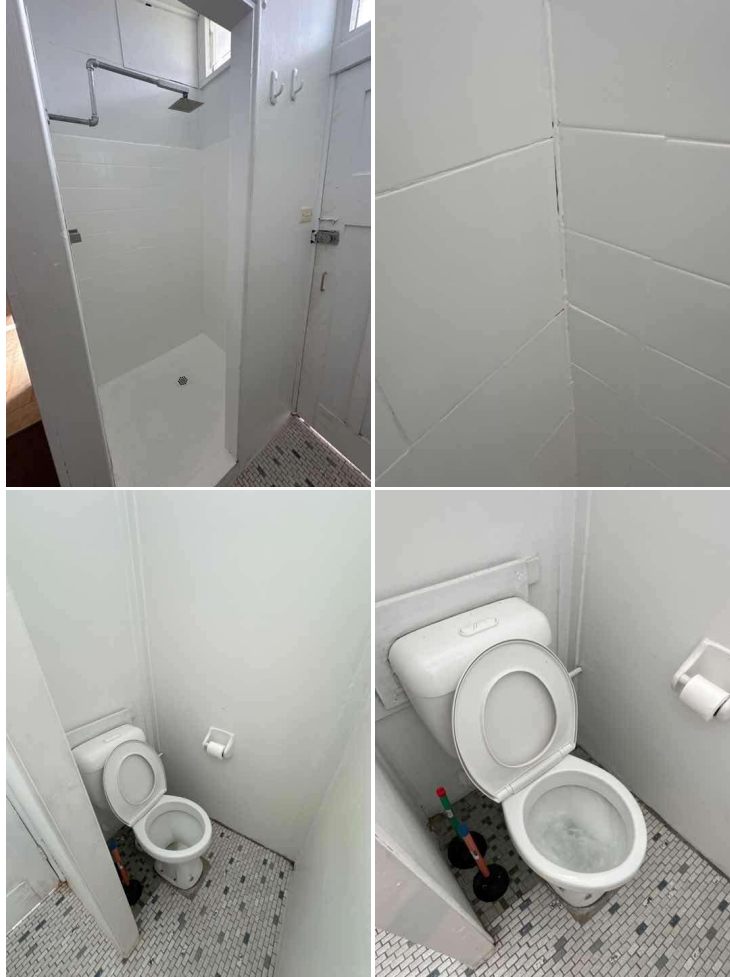
There are loose/delaminating tiles. Repairs required

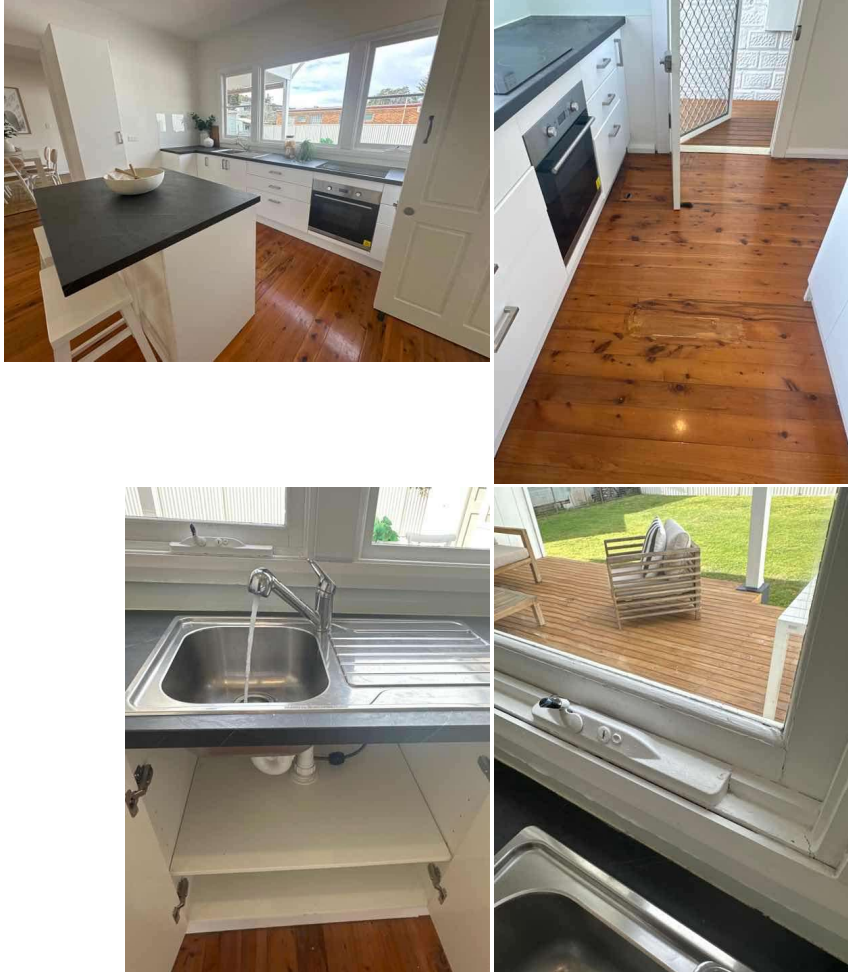
Painted Shut unable to operate.

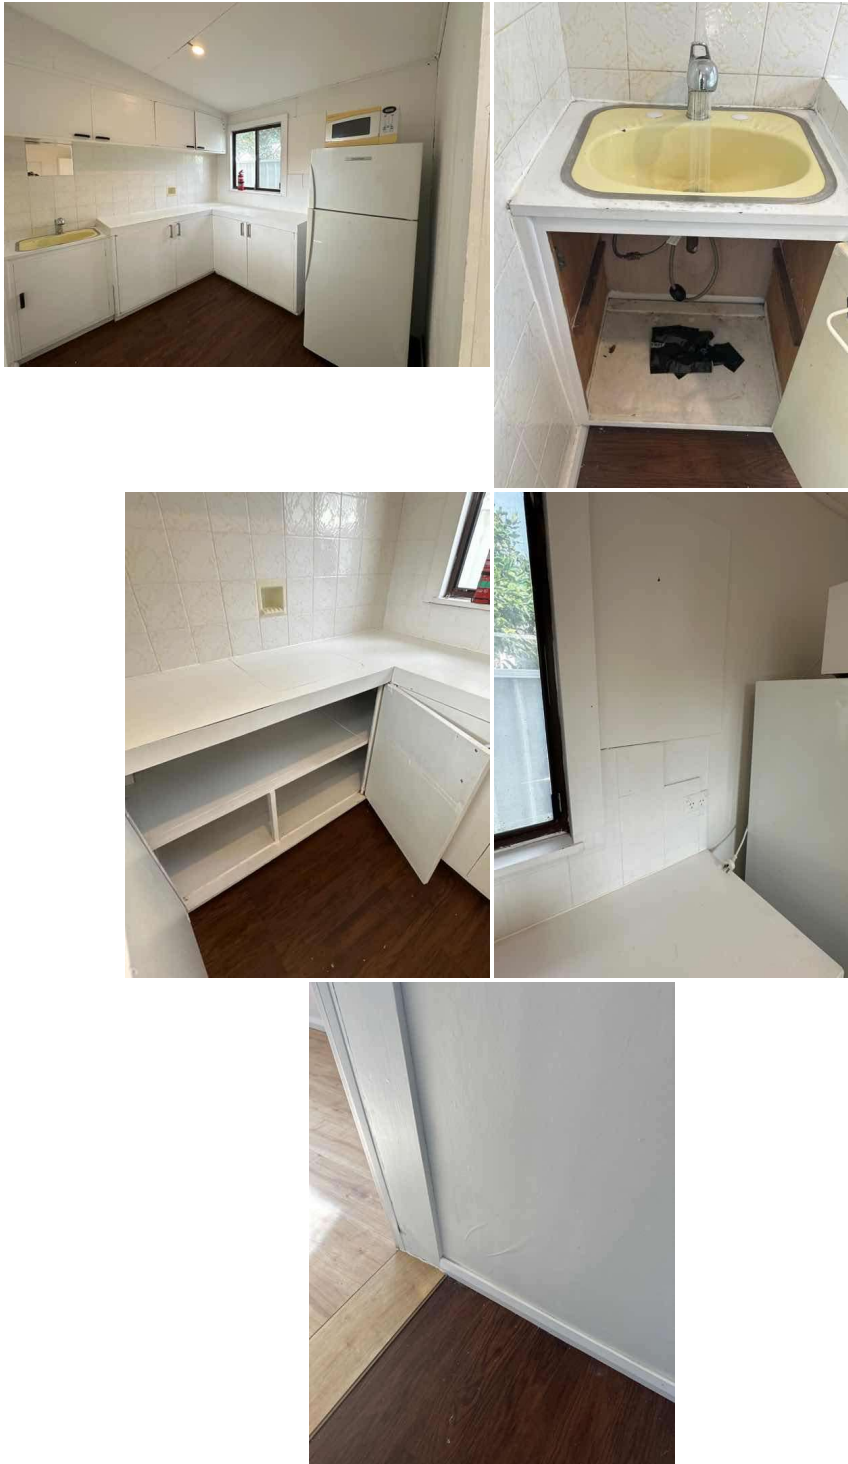
General ageing and/or denting and/or wear and/or previous wall patching and the like is evident on wall linings -
 Recommendations: A qualified painter should be engaged to assess and repair as required.

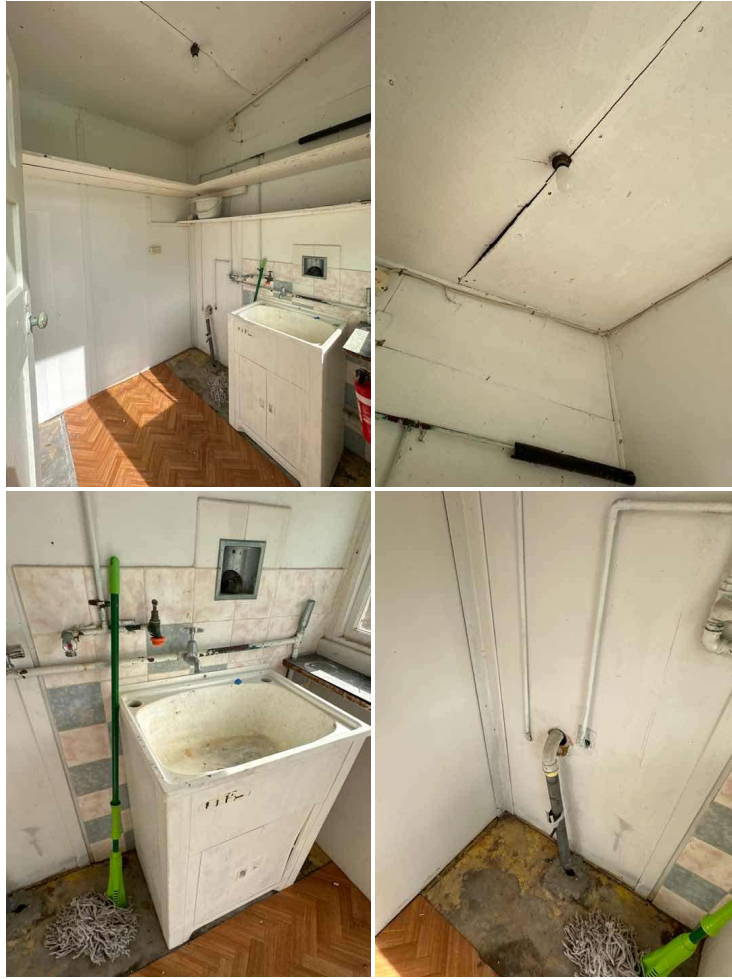
Ceiling sagging - Recommendations: I recommend you contact a licensed plasterer for further advice and recommendations.

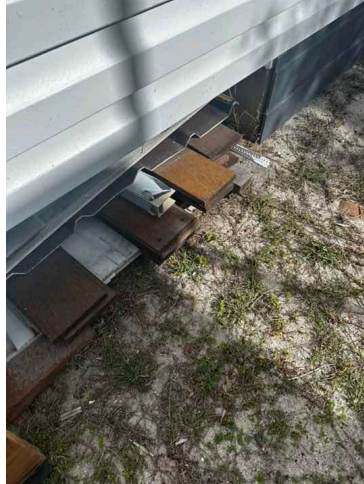
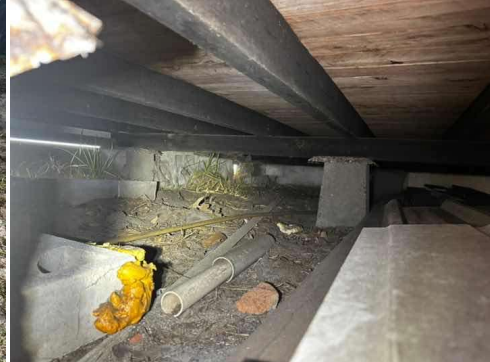
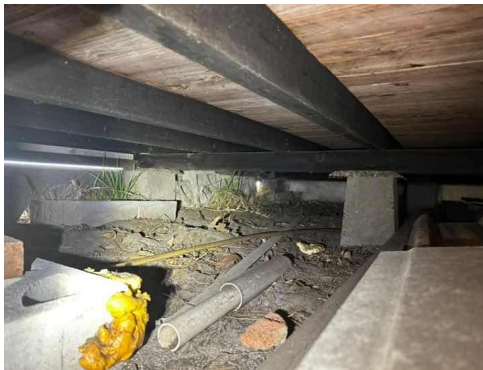
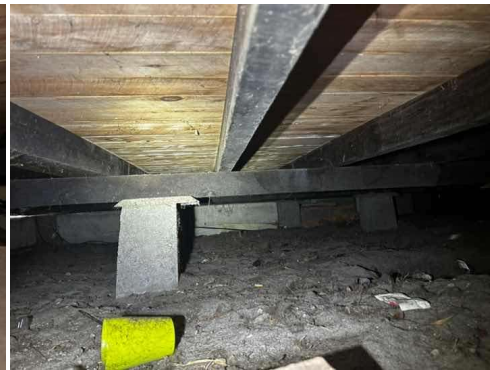
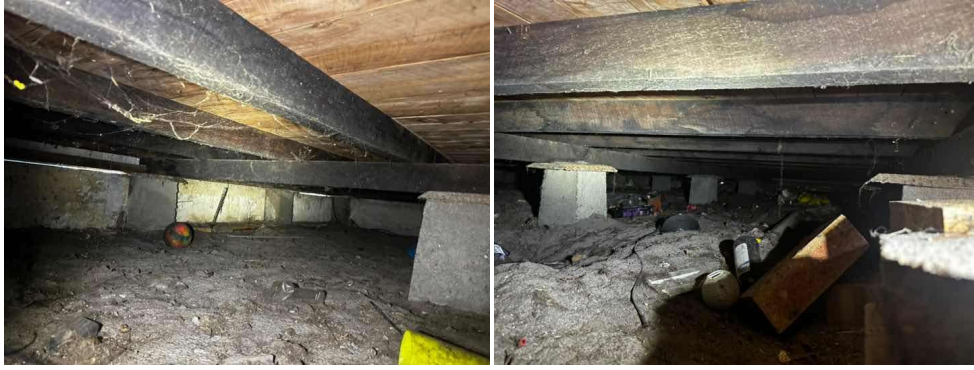
Rusted ant capping noted. Ant capping is not designed to prevent termite entry but to force the termites to show themselves by means of mud packing. Rusted, missing or defective ant capping will allow the termites to enter the building undetected. This should be repaired. Contact a licensed brick layer for further advice
