# Inspection Report

## Coastal Building Inspections

**19 Kallaroo Rd San Remo, New South Wales, Australia, San Remo, New South Wales, Australia**

### Pest And Building Inspection

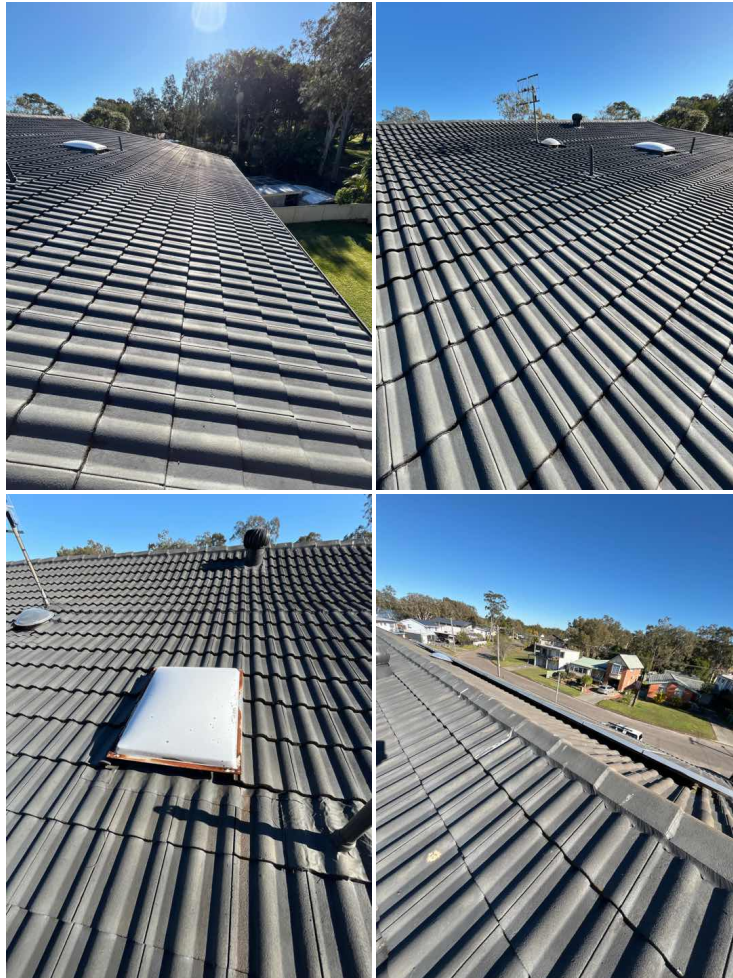
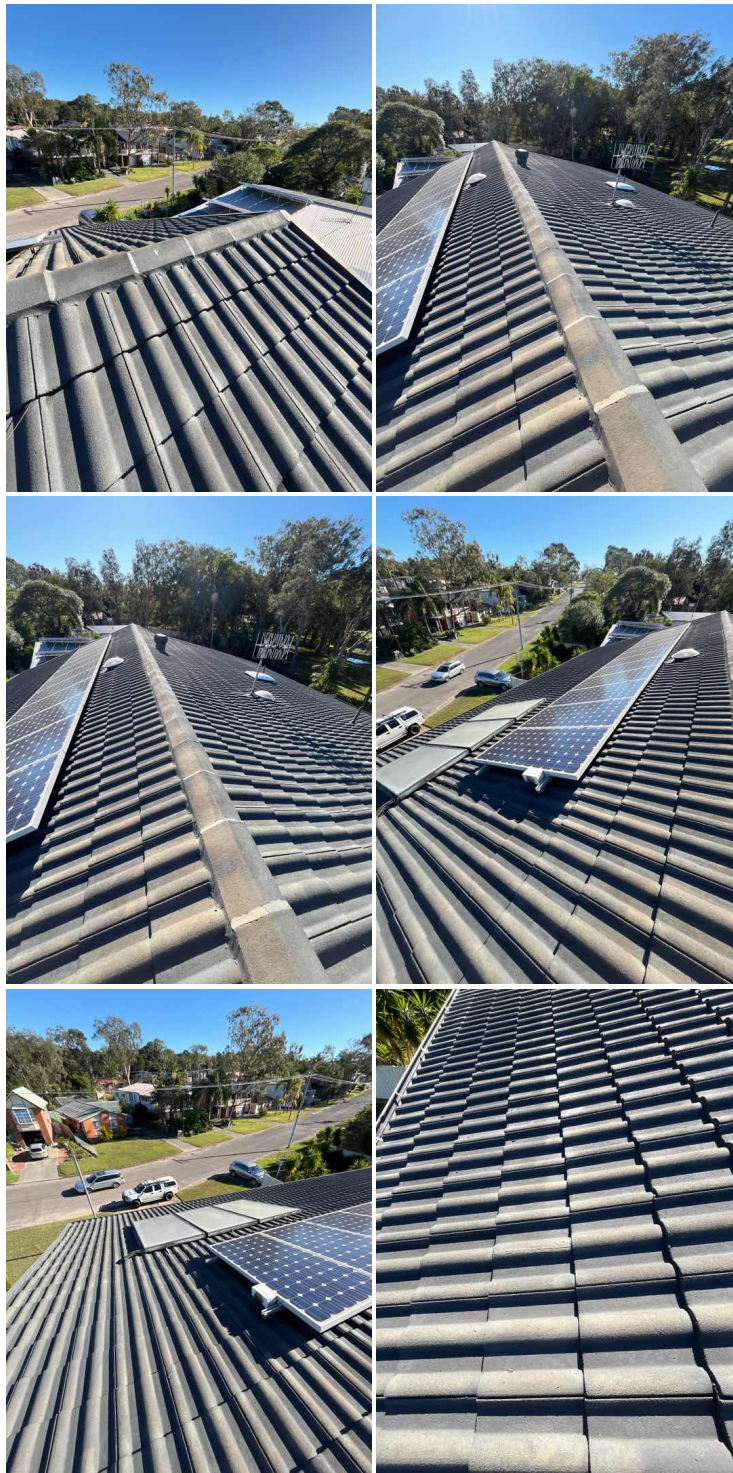
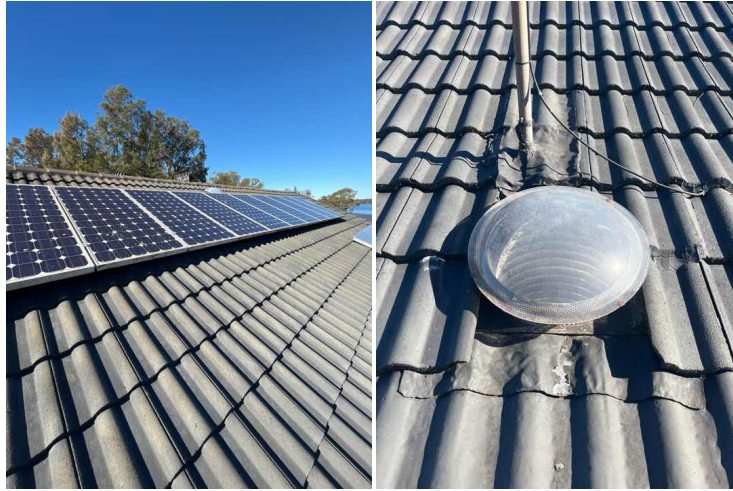
Minor Chipped/ Cracked tiles visible. Contact a roof tiler for maintenance and repairs.

rust noted around skylight. Engage skylight specialist to prepare and treat affected areas or replace if required.

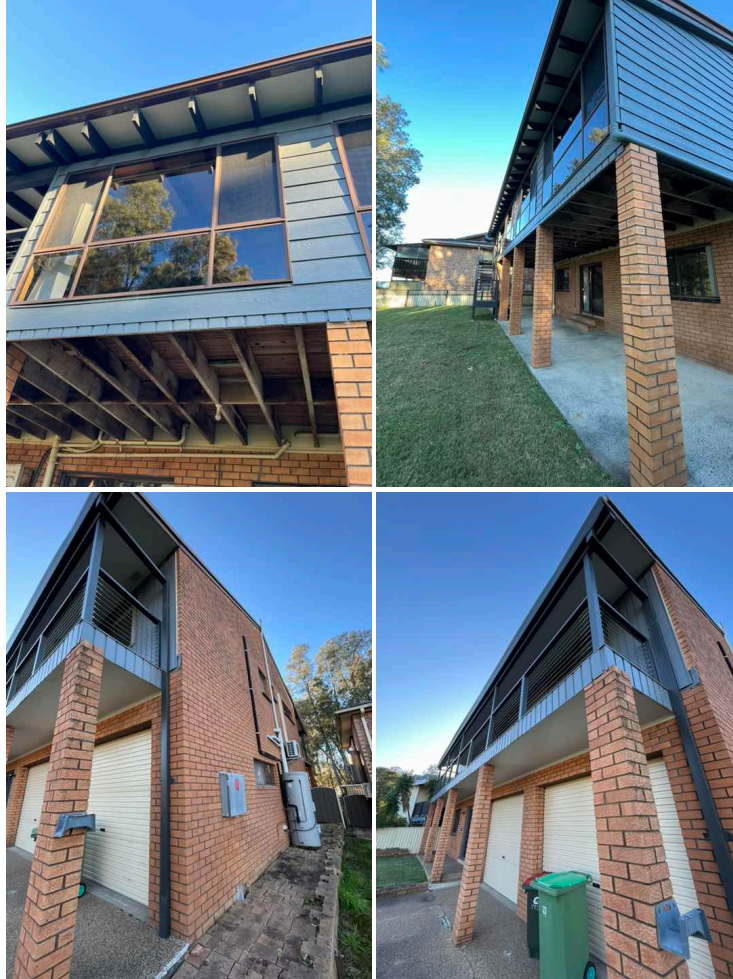
Minor eave deterioration & ageing evident. Recommendations: Maintenance works, general upkeep should be carried out.

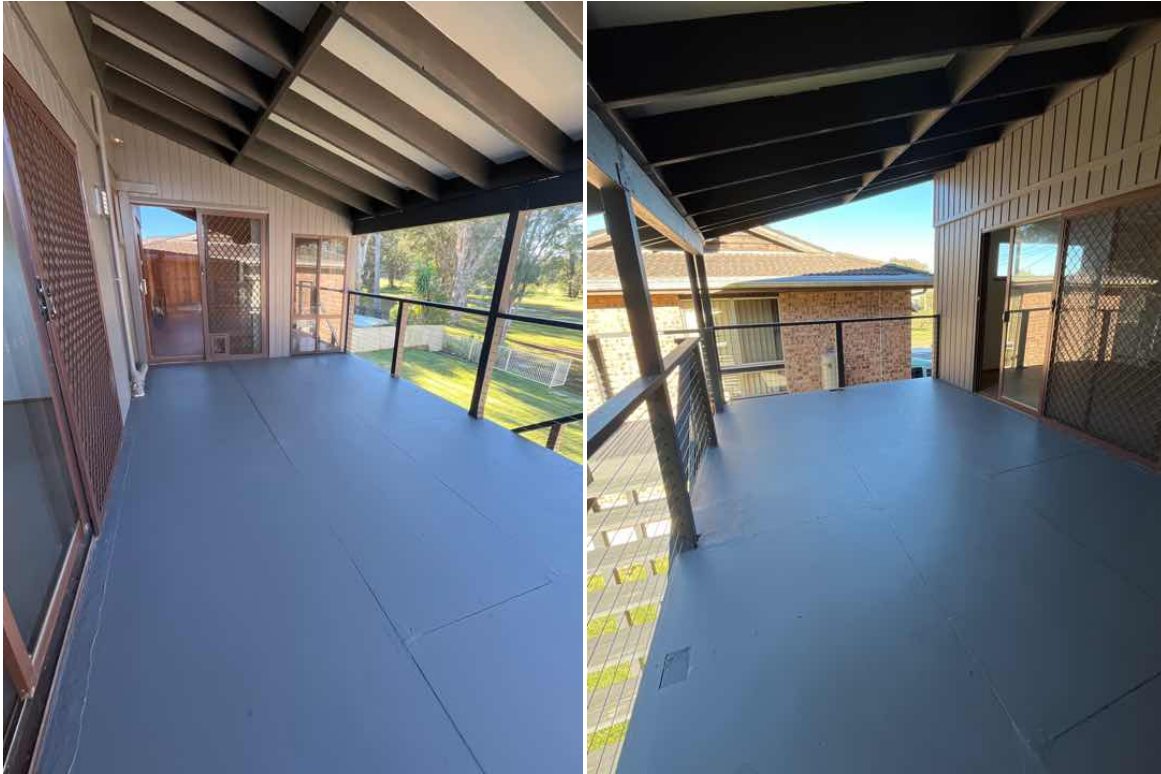
Flashing noted along the bottom of cladding.

Recommendation: monitor this area in periods of heavy rainfall, if ingress becomes evident engage a builder for advice and recommendations.

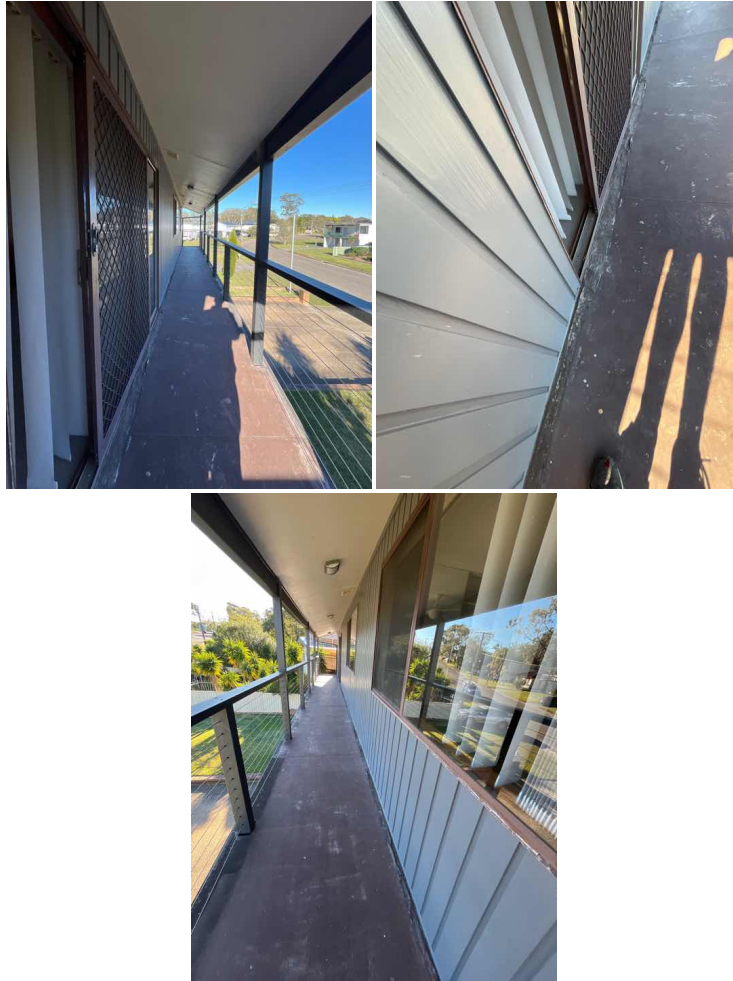
Flashing noted along the bottom of cladding.

Recommendation: monitor this area in periods of heavy rainfall, if ingress becomes evident engage a builder for advice and recommendations.

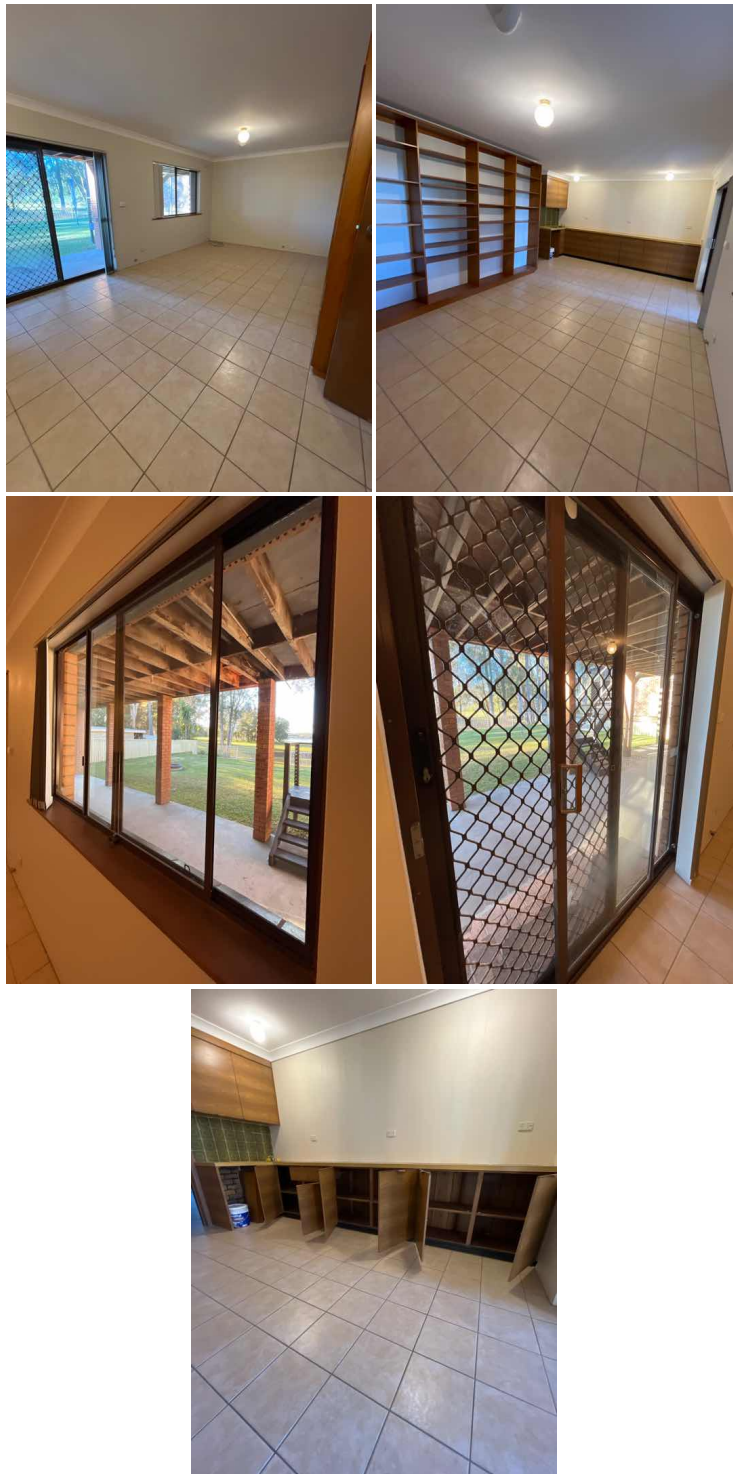
General age/wear/tear was noted to the walls and ceiling. Patch/paint as required.

Age/ wear and damage to cabinets. Engage a cabinet maker for advice and recommendations.

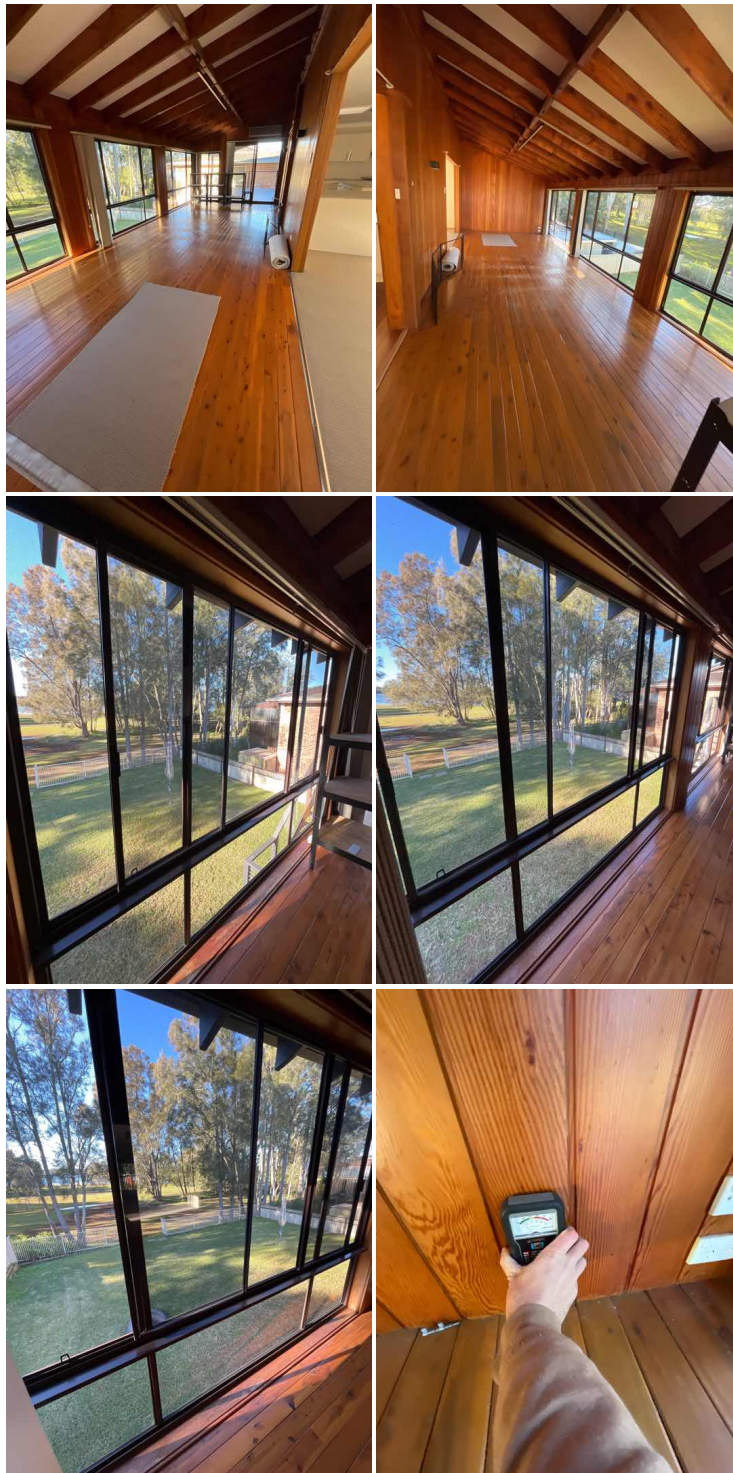
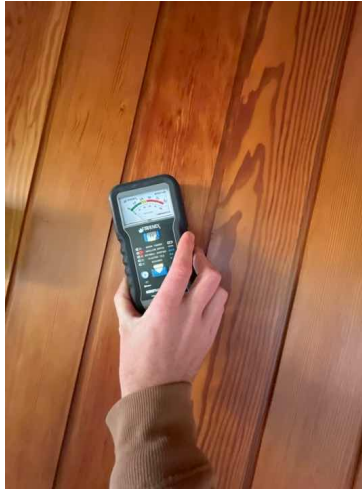
General age/wear/tear was noted to the walls. Patch/paint as required.

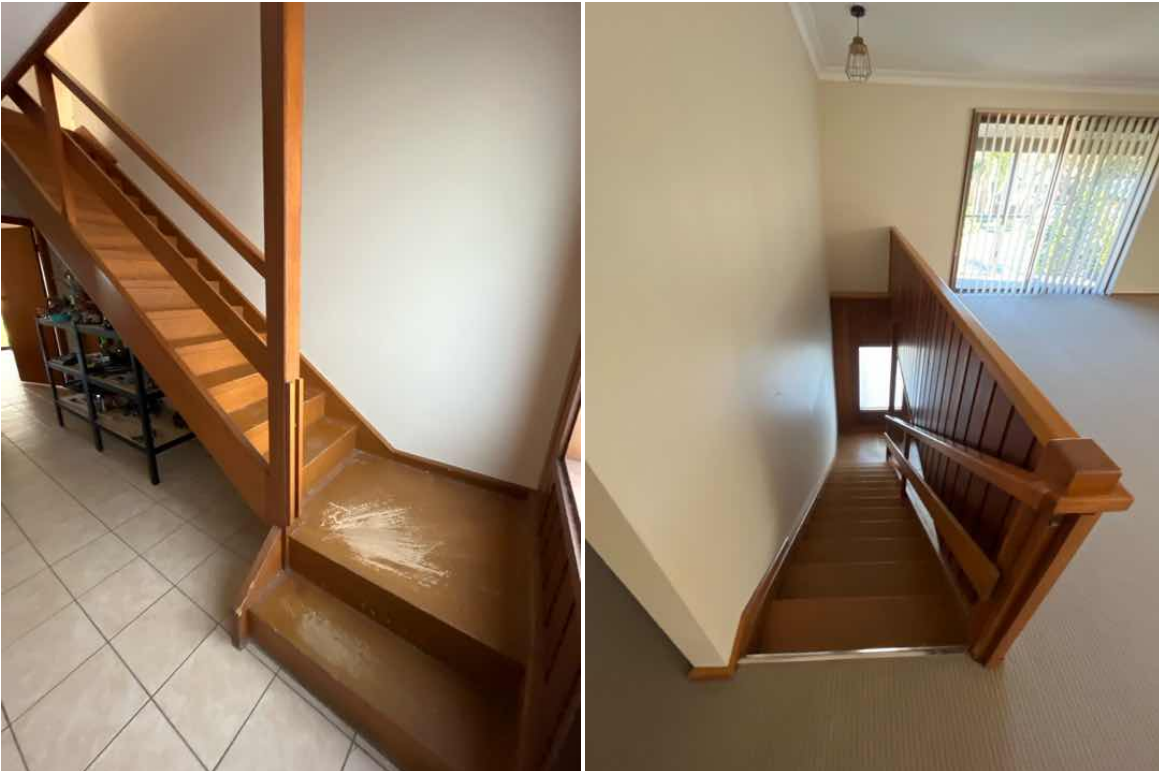
The hand rail is loose. Re-fixing required to avoid unsafe conditions.

Wear and tear noted to stair treads engage a floor sander for maintenance and repairs.

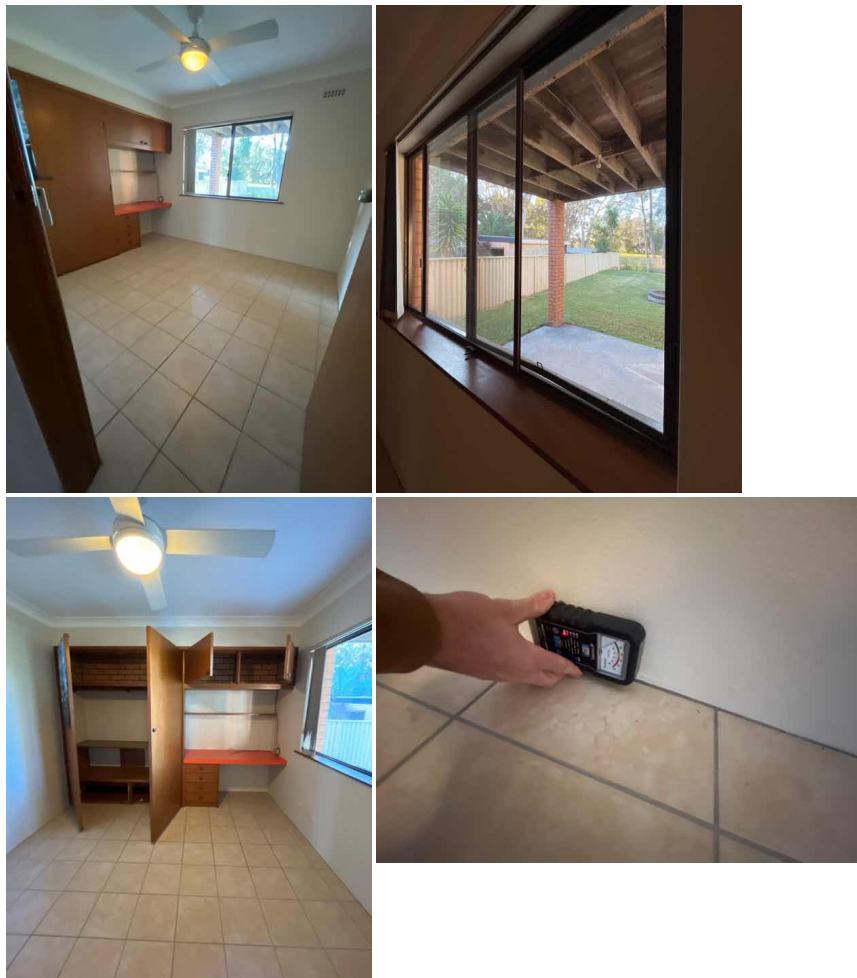
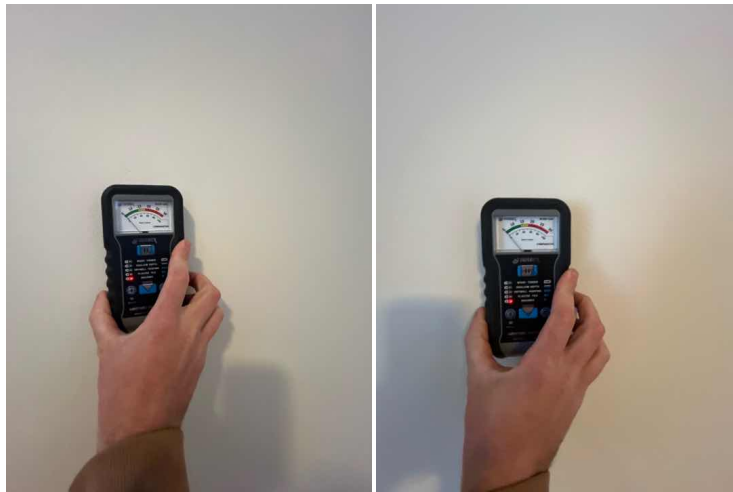
Uneven / out of square door causing binding. A qualified carpenter should be engaged to adjust/ refit.

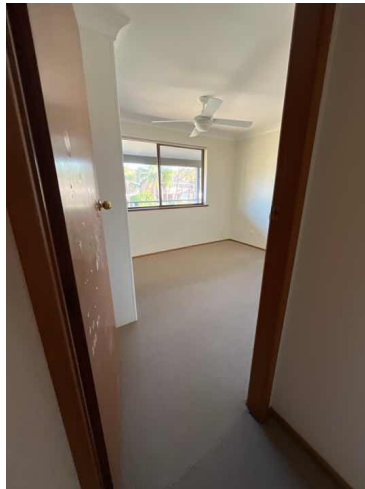
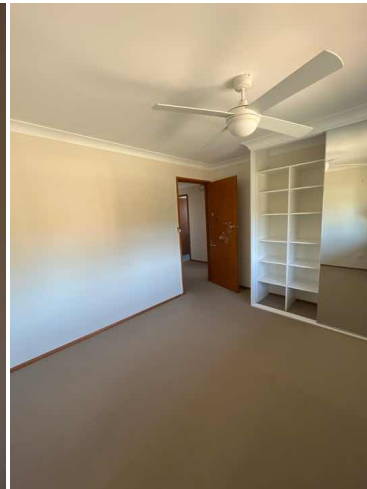
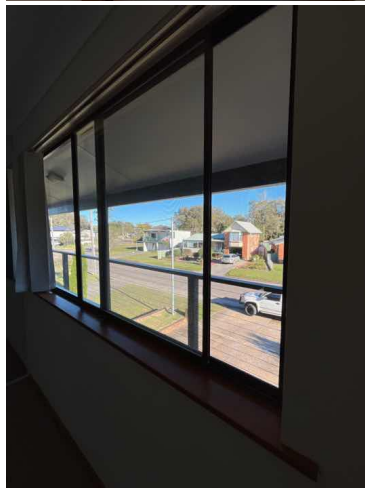
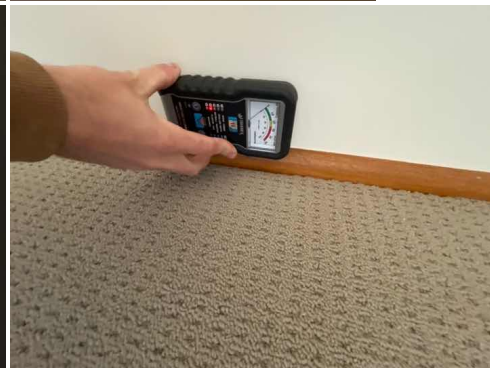
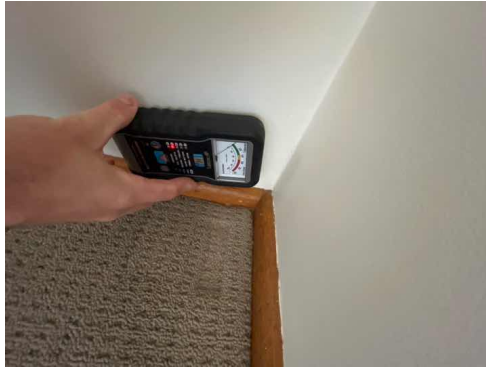
Uneven / out of square door causing binding. A qualified carpenter should be engaged to refit.

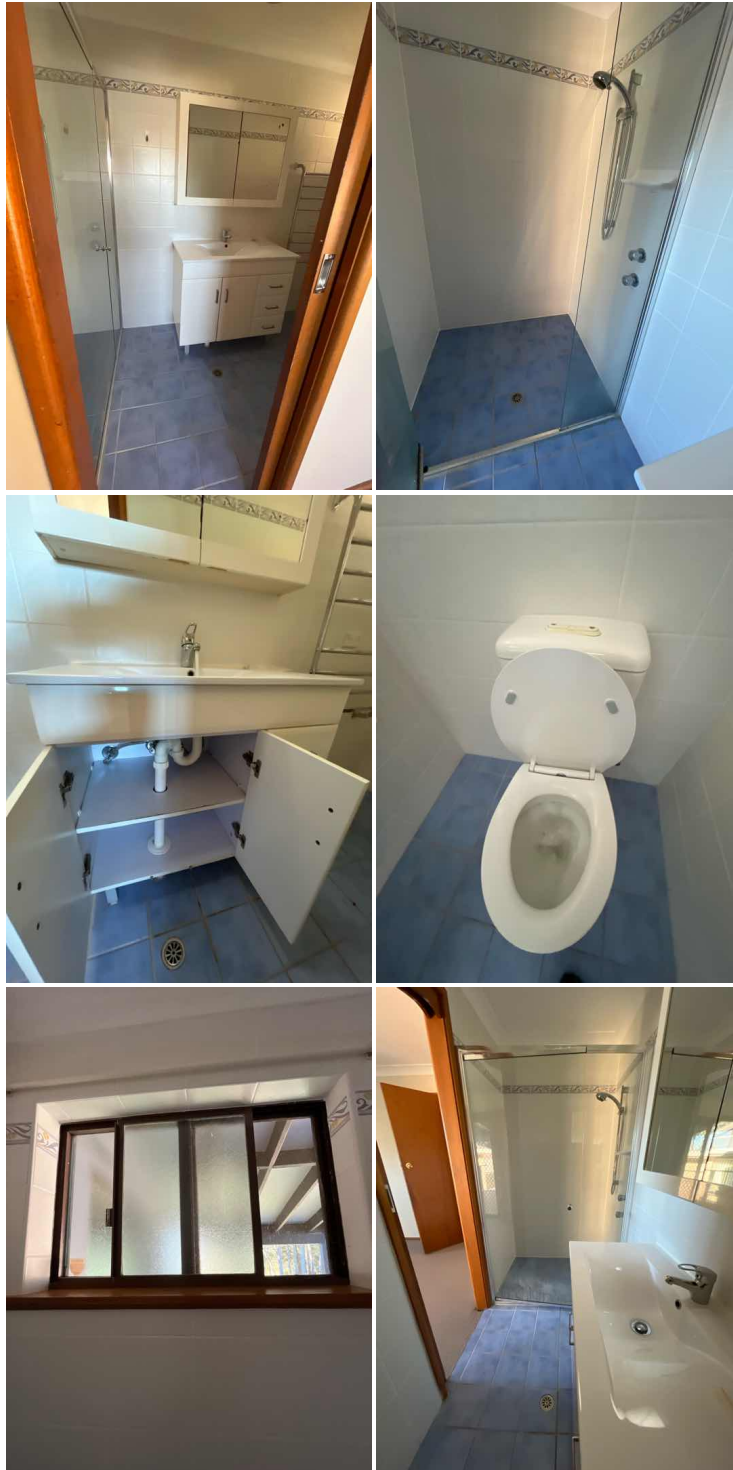
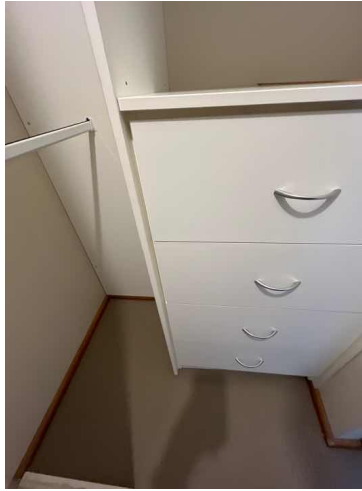
General ageing and/or denting and/or wear and/or previous patching and the like is evident on ceiling linings -  
Recommendations: A qualified painter should be engaged to assess and repair as required.

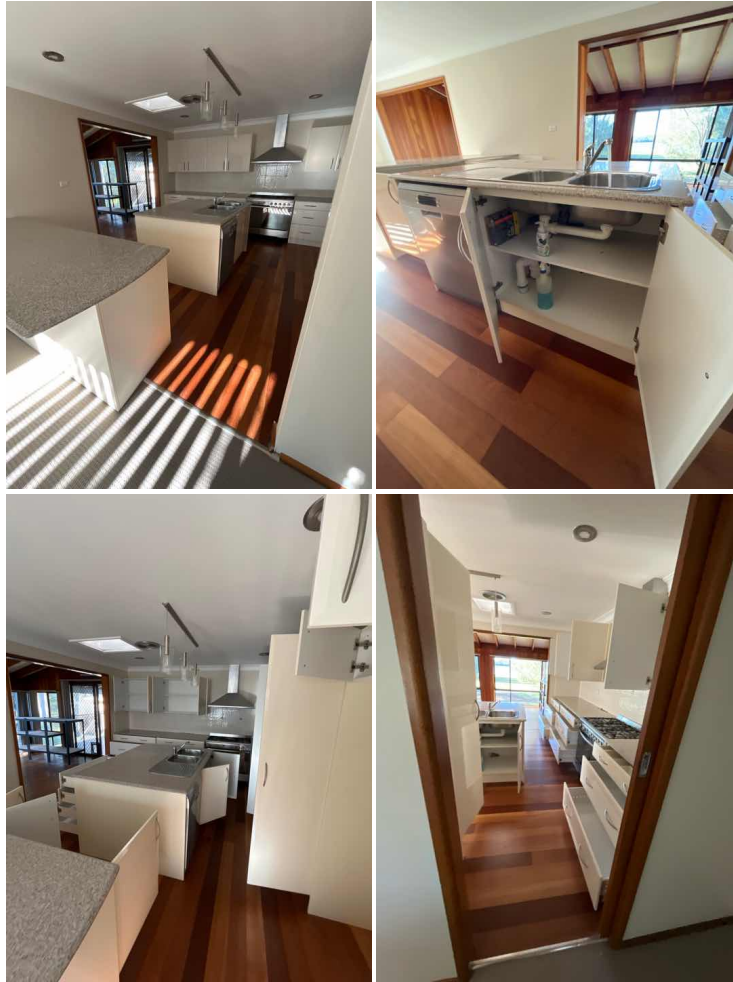
General wear and tear were observed on the ceiling and wall linings, consistent with the home's age.

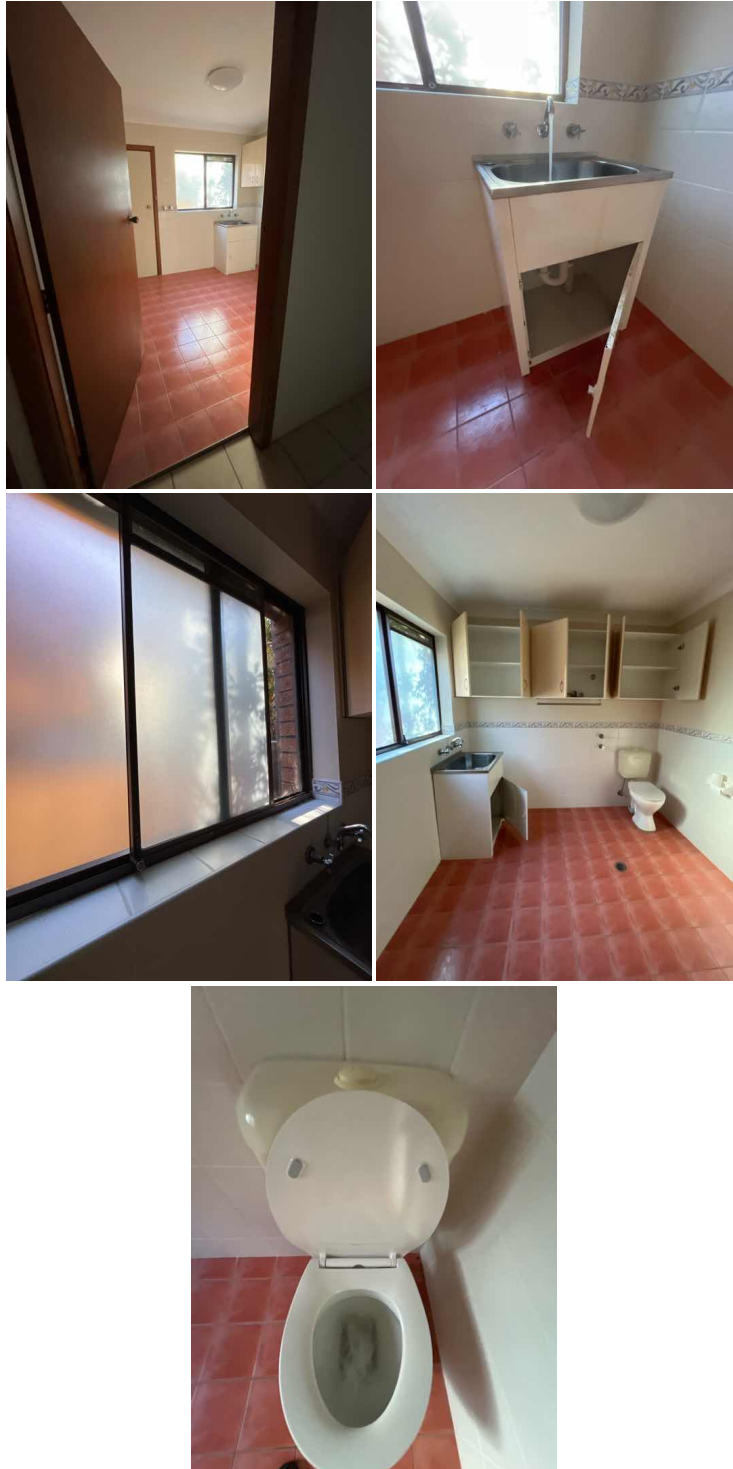
General wear and tear were observed on the ceiling and wall linings, consistent with the home's age.

Engage painter for repairs and recommendations.
