# Inspection Report

**KR Building and Pest Inspections Pty Ltd**

**55 Waikiki Av , Palm Beach, QLD**

Inspection Date:                21 Oct 2025

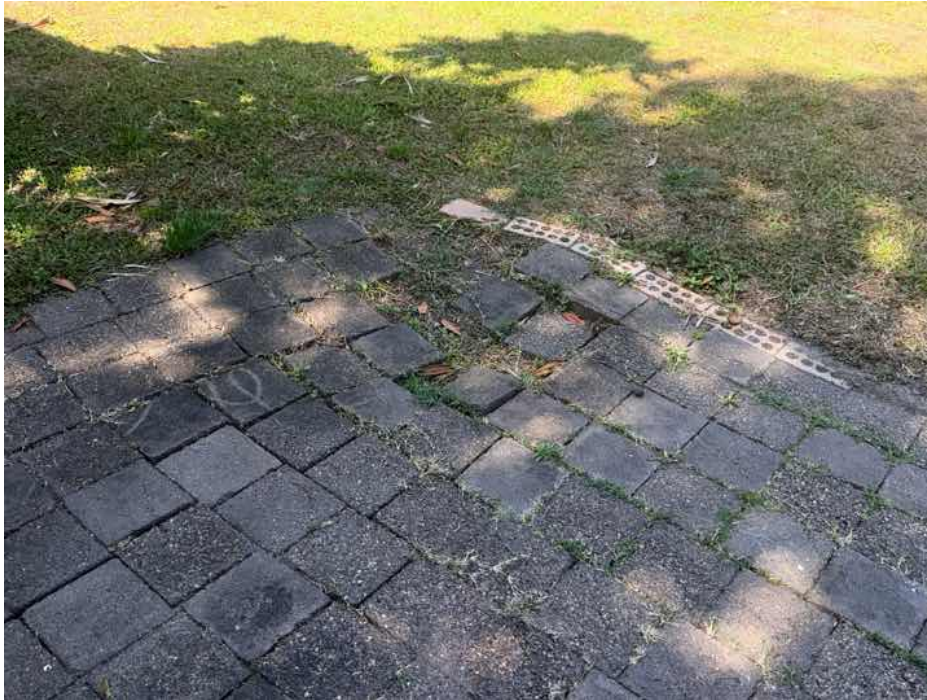
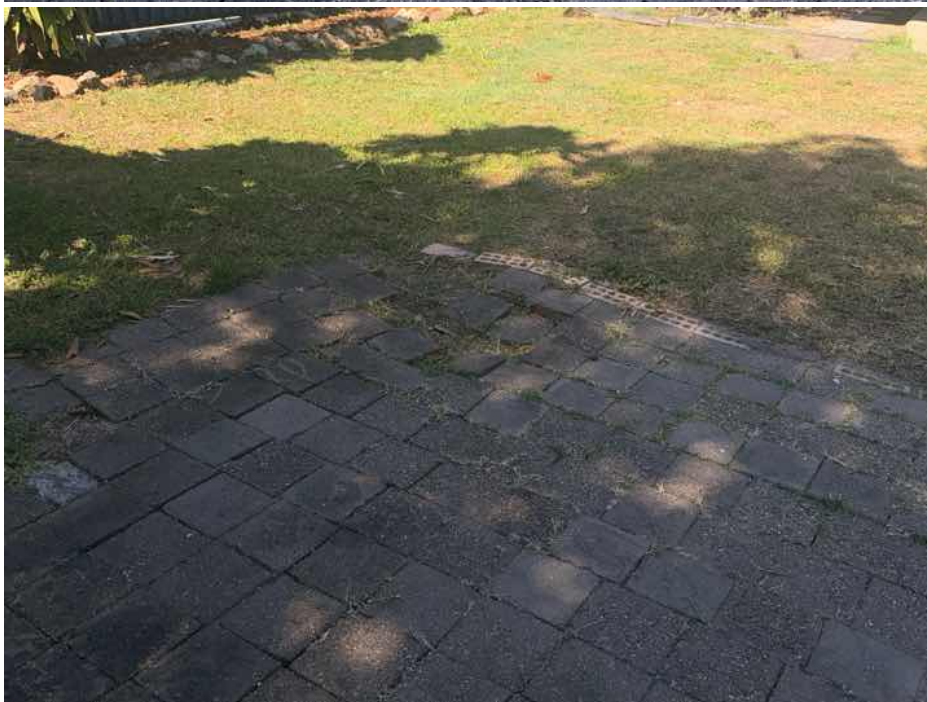
#### Pathways Condition

#1. Surface raised and settled in some areas. This can cause water ponding. Relaying recommended.

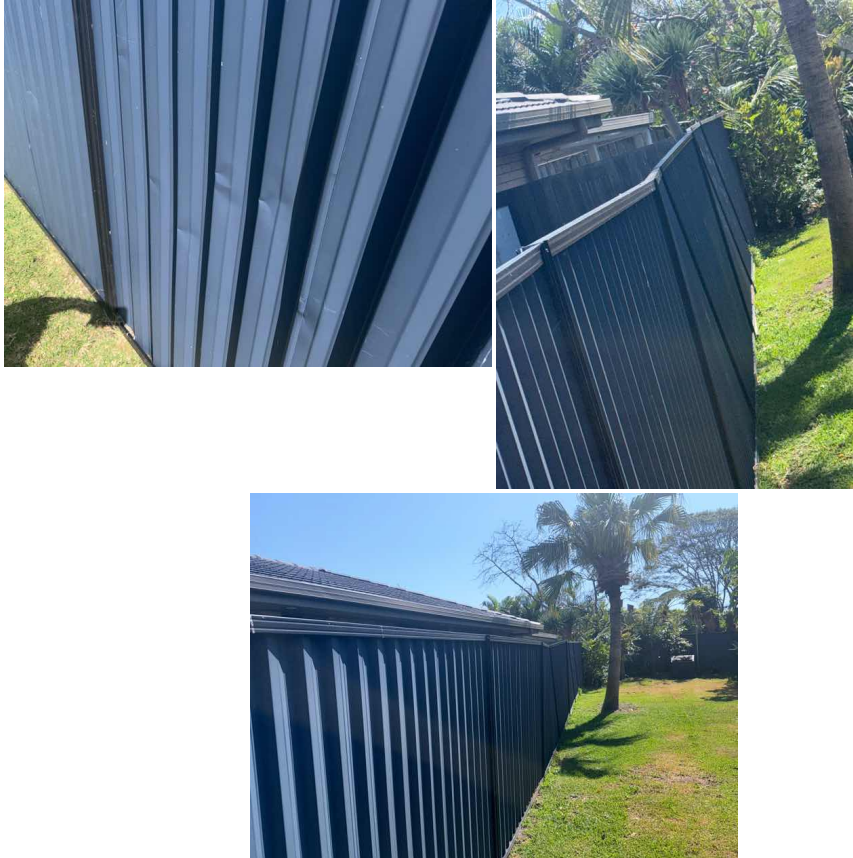
### **Overall Condition**

Damage was noted to the metal fence. Contact a fencing contractor for repairs.

#2. Fence leaning. Repairs are required by fencing contractor to avoid unsafe conditions.

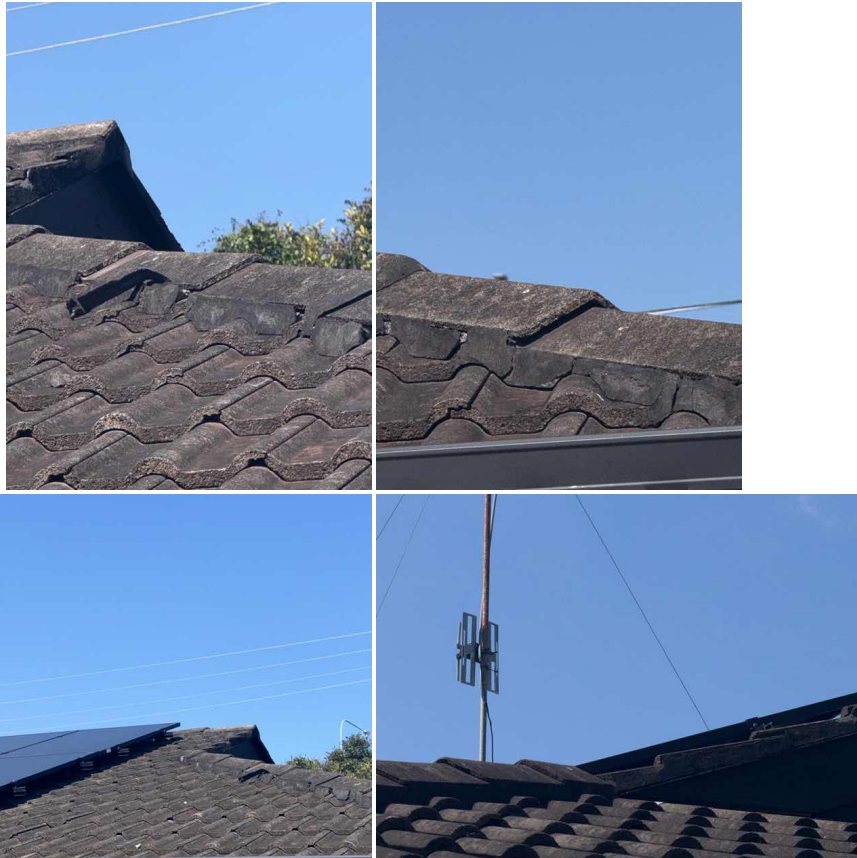
#### Roof Clad Condition

#3. Deterioration & ageing evident. I recommend you contact a roof restorer to clean, seal, and repoint the mortar.

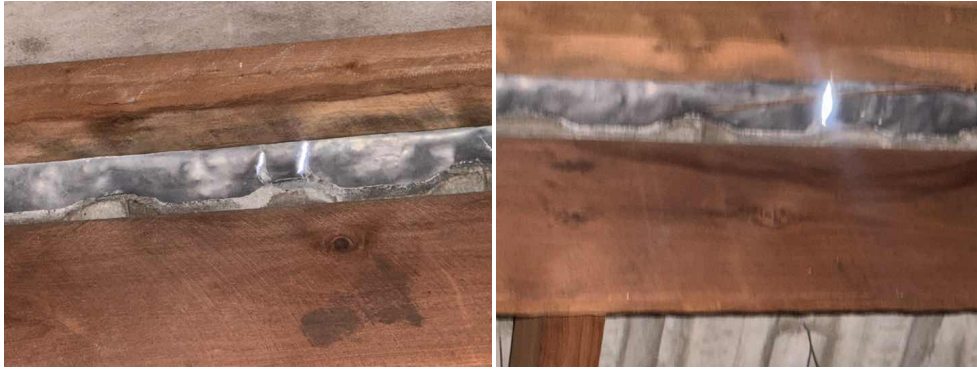
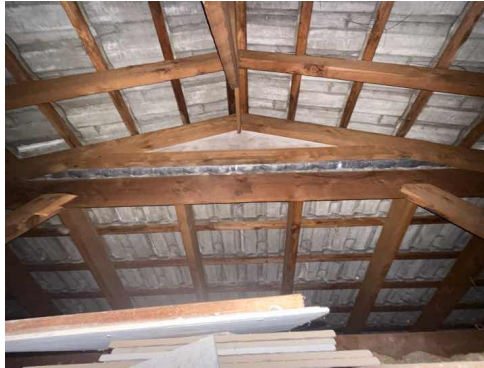
#### Flashing Conditions

#4. Flash cracking observed. Contact a roofing contractor for repairs. This has potential to become a serious issue if repairs aren't carried out immediately due to water ingress into the roof cavity.

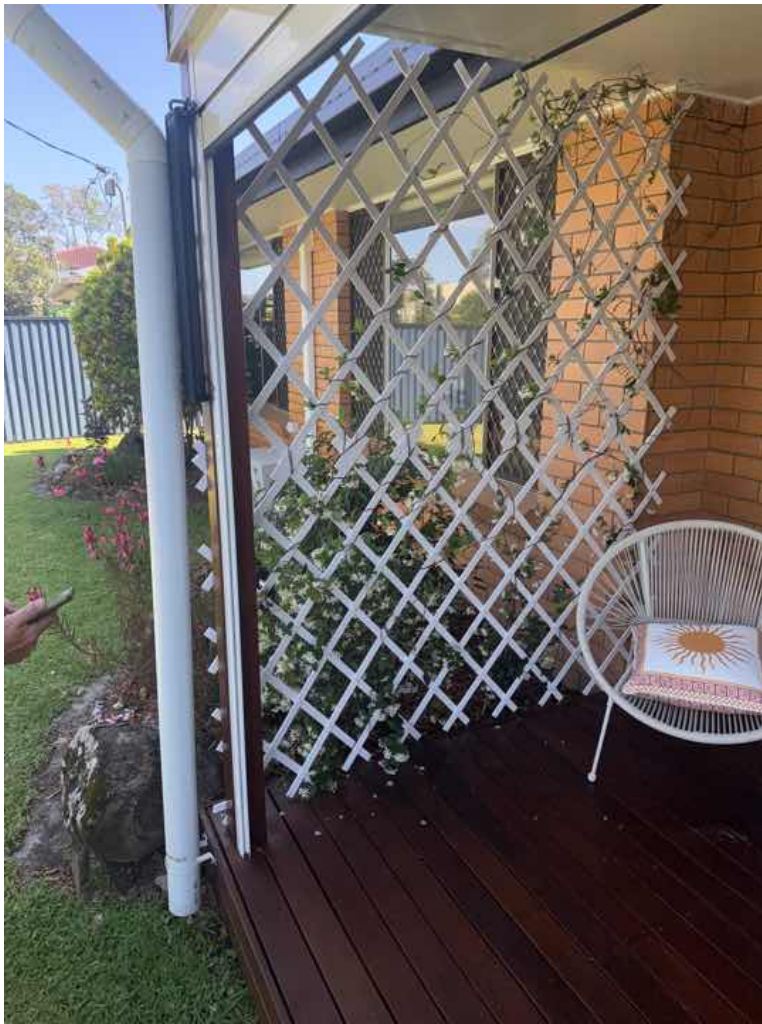
### **Downpipe Findings**

#5. Downpipe/s not connected to storm water discharge - Downpipes not connected to storm water have the potential to cause differential settlement to the footings, cause rising damp and is also conducive to termite infestation. A qualified roof plumber should be engaged for advice and recommendations.

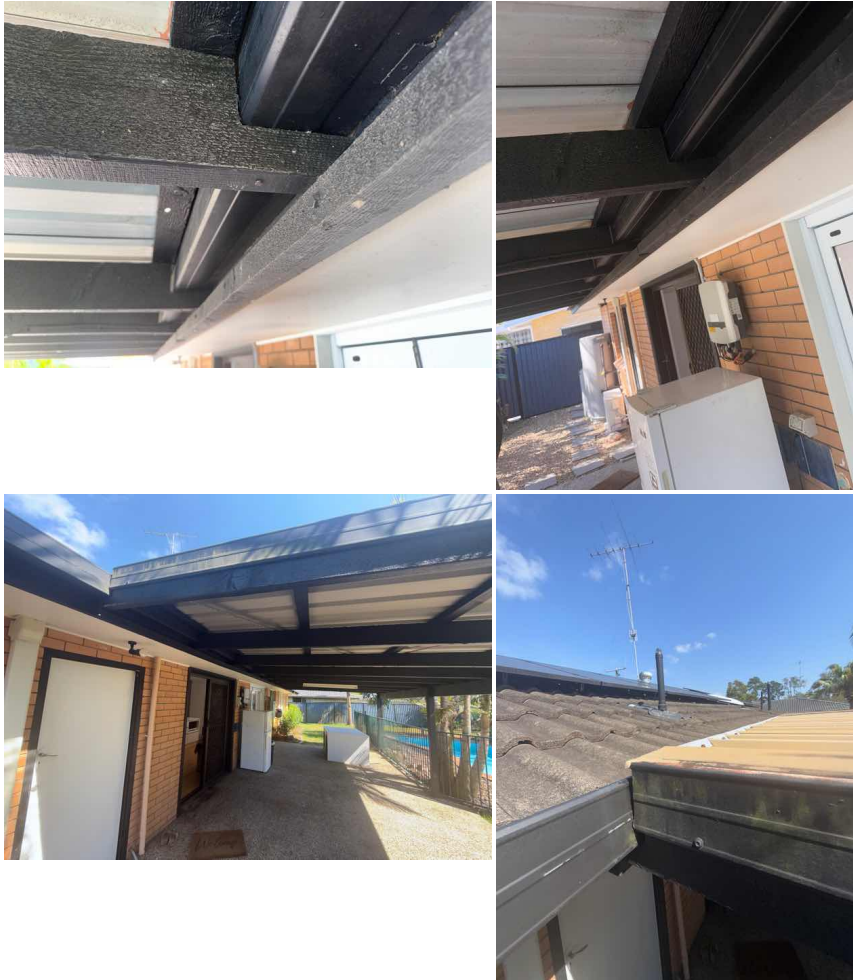
#### Overall Condition

Defects exist to an area or component/s requiring assessment by a specialised field. Please read below for details.

#6. The external structure has not been built to code.

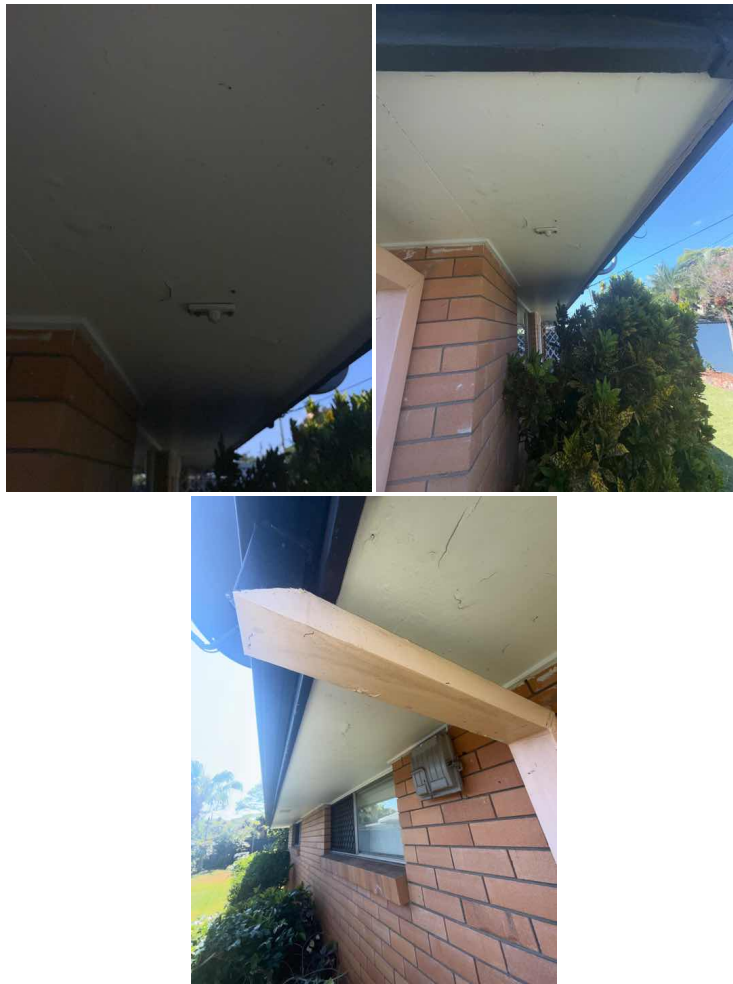
#### Eave Condition

#7. Bubbling eave lining paint. Normally due to overflowing/blocked or leakage guttering. A qualified roof plumber should be engaged for advice and recommendations.

#8. Paint flake/deterioration is evident. Recommendations: General maintenance / painting as required.

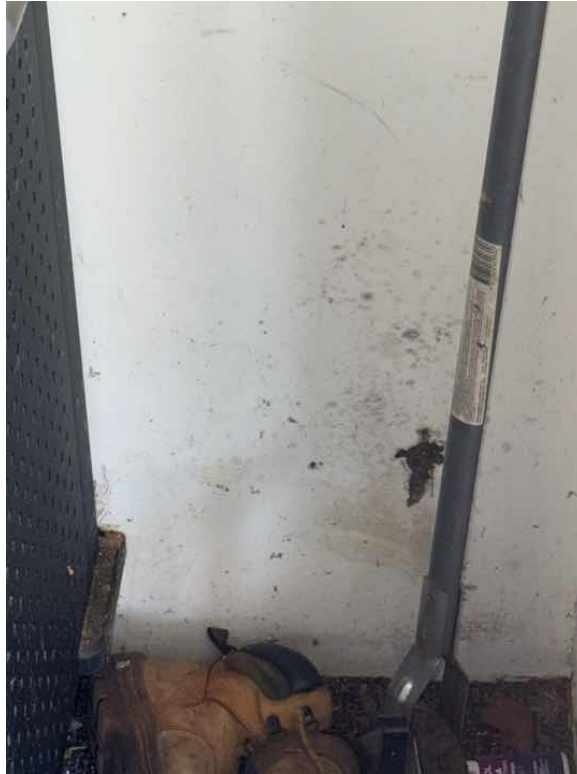
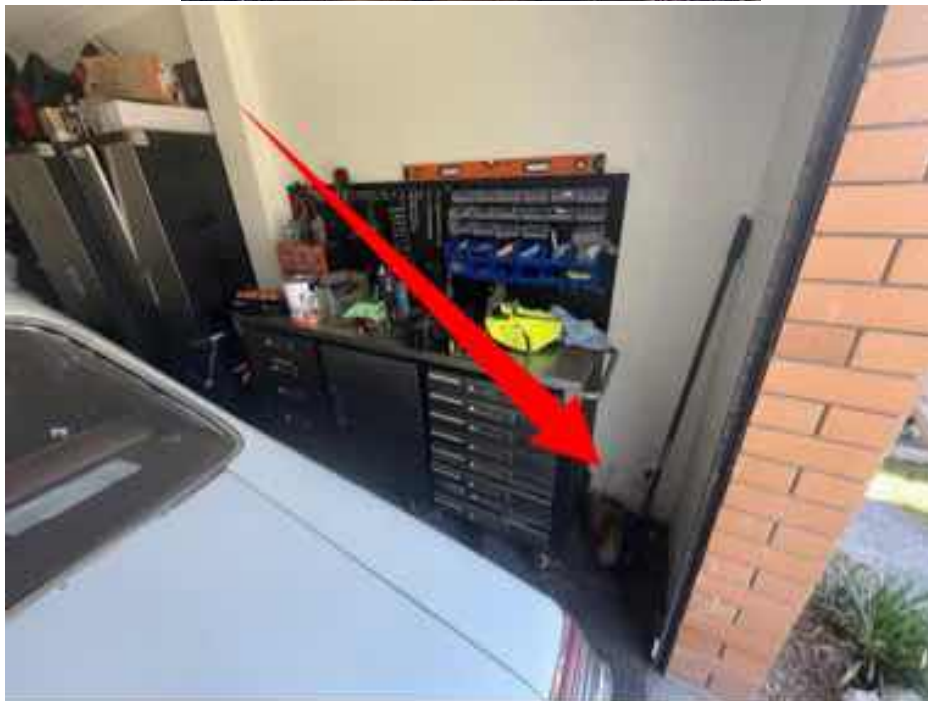
#### Wall Cladding Findings

#9. Mould to the wall and high moisture levels.

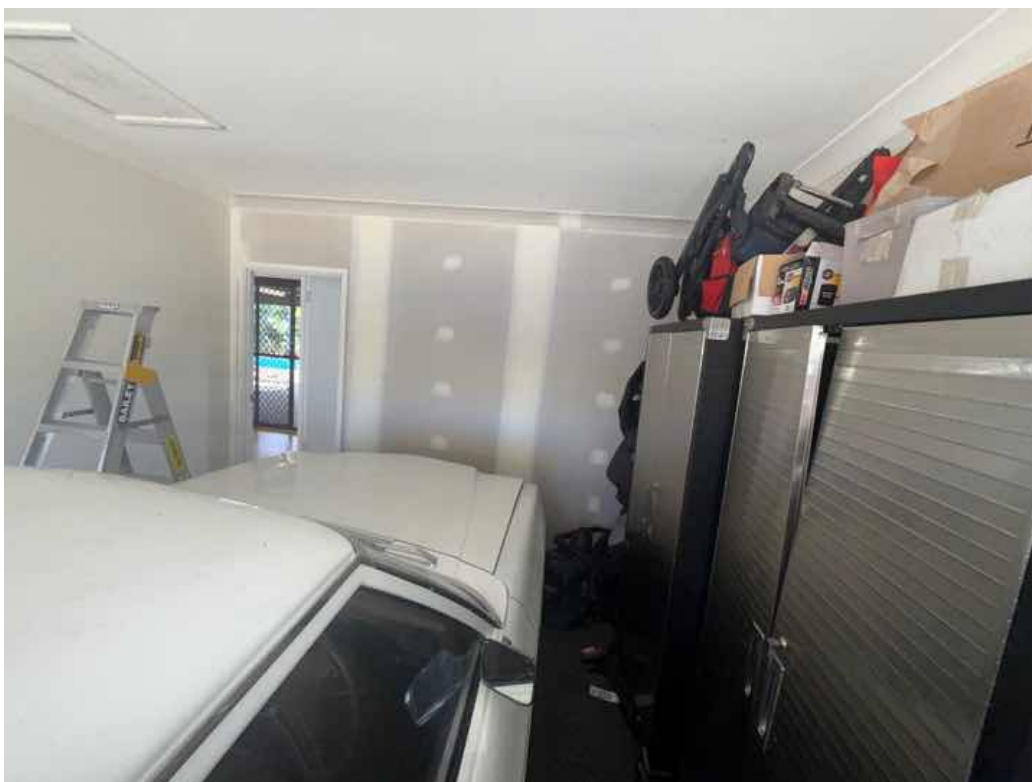
#### Internal Wall Findings

#10. Incomplete repairs noted. Contact a licensed builder for repairs.

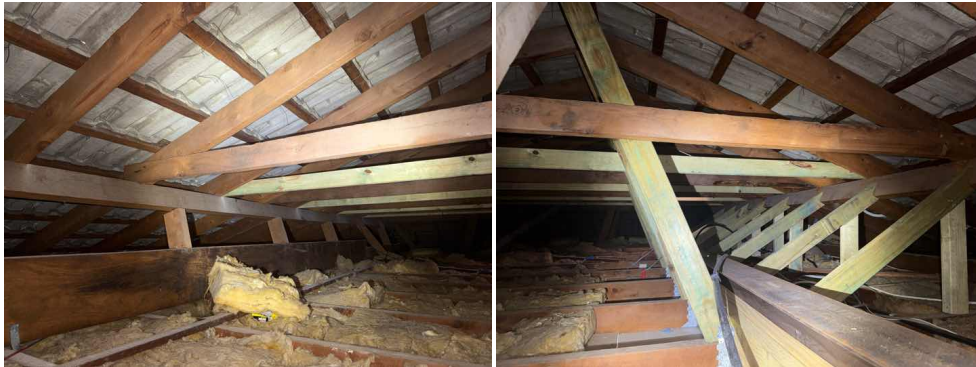
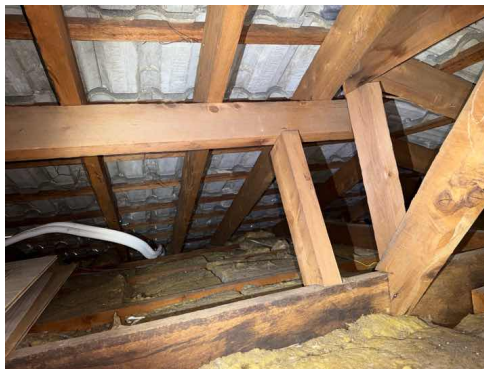
#### Truss Webbing

Construction methods restricted full access.
