## Visual Timber Pest Inspection & Report in accordance with AS 4349.3 – 2010

55 Waikiki Ave  
Palm Beach

**Visual Timber Pest Inspection & Report in accordance with AS 4349.3-2010**  
**(For use in all States & Northern Territory but not the Australian Capital Territory)**

Inspection Date: 21 Oct 2025

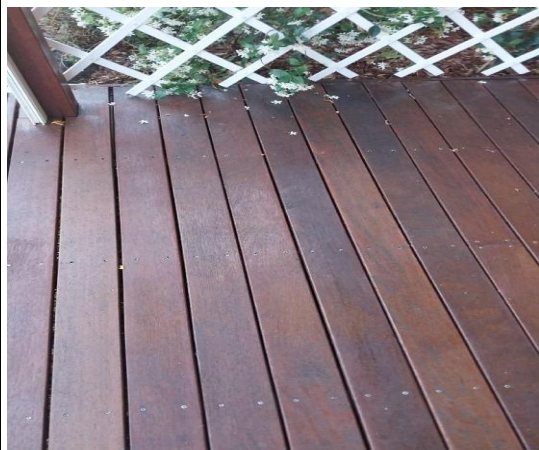
No access or visibility possible under decking areas.

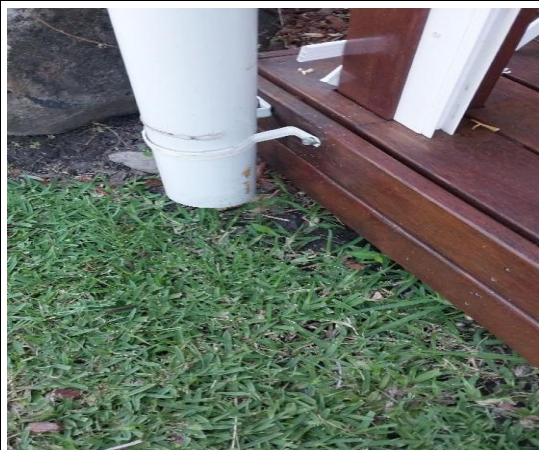
Down pipe off front patio is not connected to main drainage-  
contact a plumber for advice

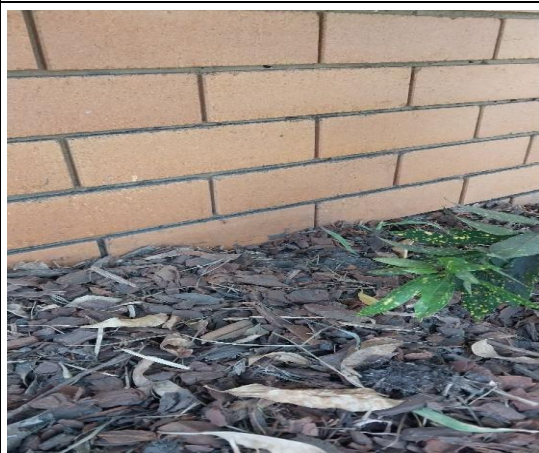
Drop ground / mulch levels against external walls to allow  
75mm visual inspection zone below weep holes.

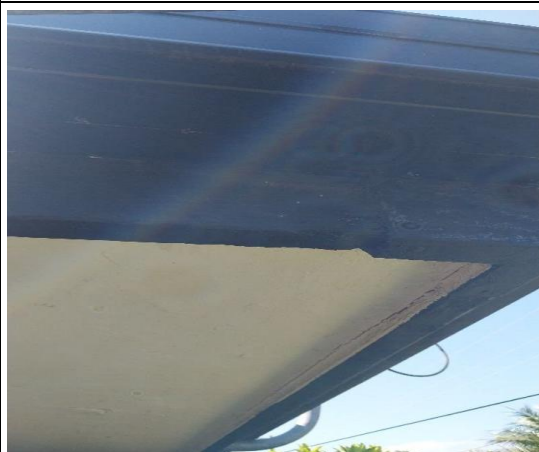
Decay to fascia boards corners and patched up corners

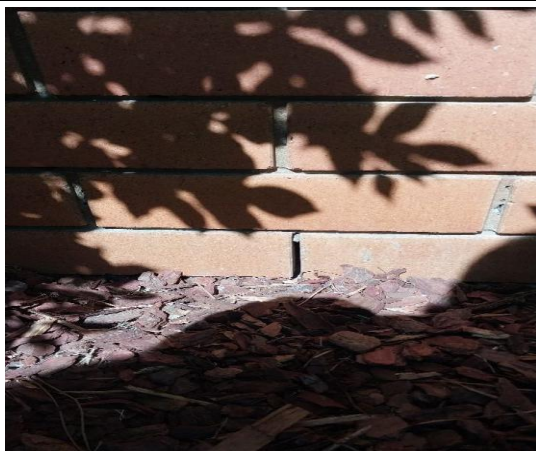
Drop ground/mulch levels against external walls to allow 75mm visual inspection zone below weep holes.

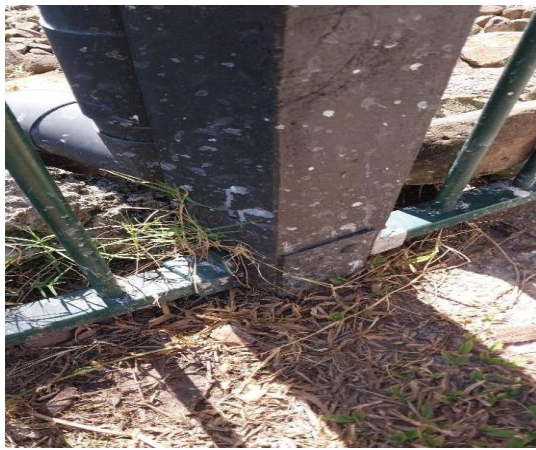
**5.9** The fitness for purpose of the visible structural timber exposed to weather and/or water appears **adequate** for the situation they have been used in. **However back pergola timbers appear to be Oregon which is not suitable for external use however it is in good condition - monitor.**

Back pergola posts in contact with ground creating a higher risk area for decay and termites if timbers are untreated timbers - ground clearance recommended

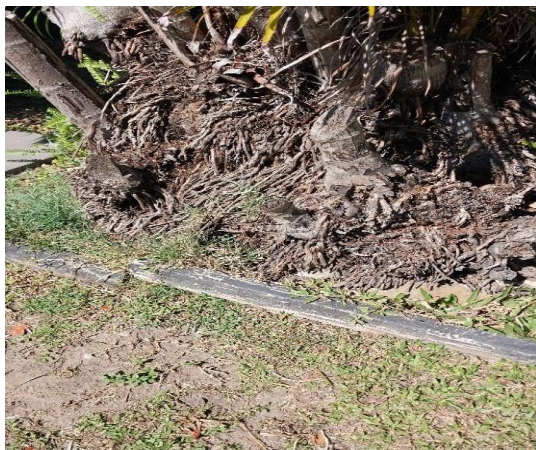
Any stumps in gardens, remove – HIGH RISK for termites.

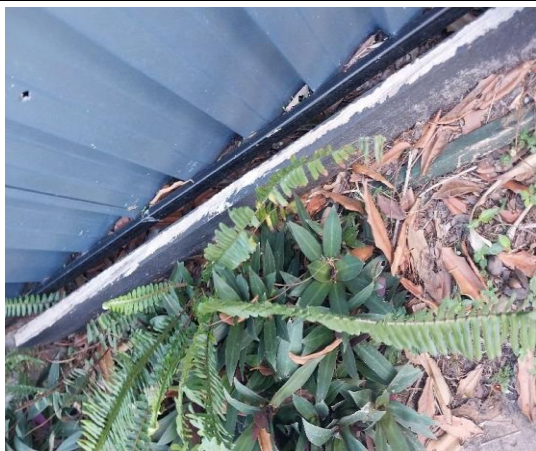
Any untreated timbers on ground in gardens, remove – HIGH RISK for termites.

**Any untreated landscaping timbers, remove & replace with non-susceptible material.**

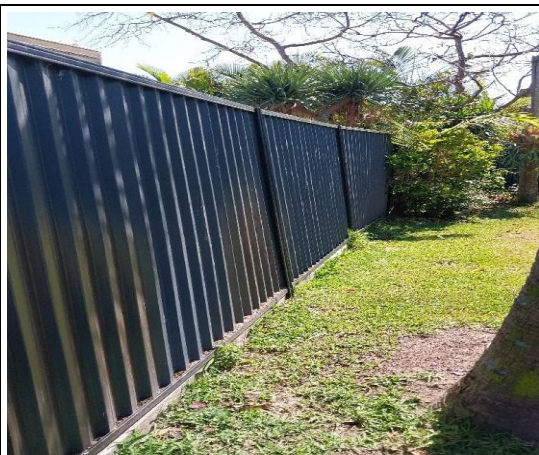
Fences are leaning in areas

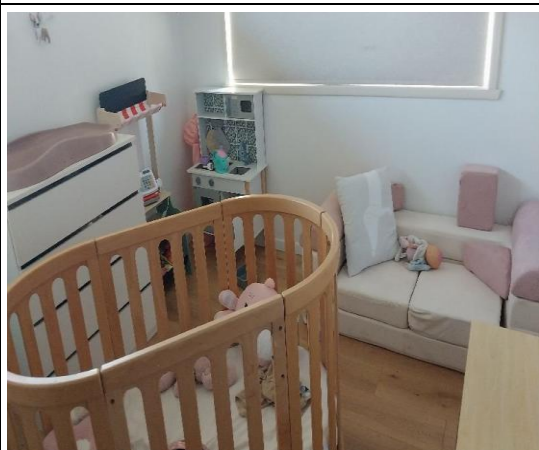
Furniture and items against walls in all bedrooms restricting access and visibility

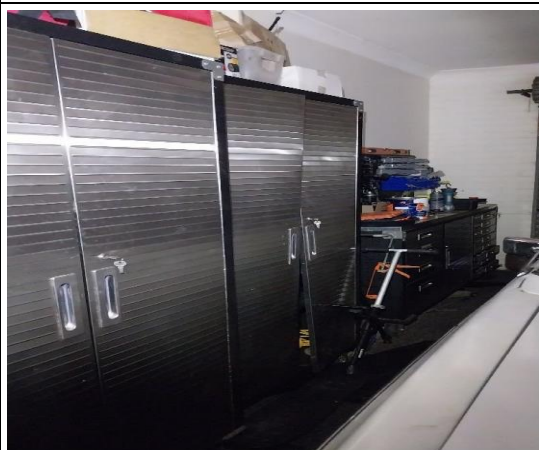
Stored items against walls in garage restricting access and visibility

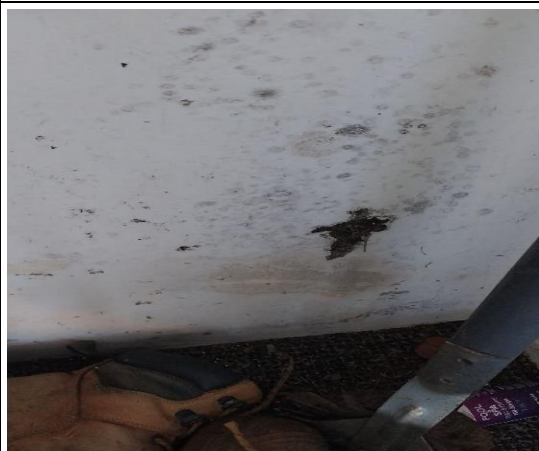
**5.4** At the time of the inspection **high moisture readings were found. Higher than normal moisture readings to walls in garage - front right corner and left side - Termatrac used in these areas only but no signs of movement however recommend installing snap vents for ventilation and future inspection.**

**5.8** Mould was found in the following area(s): **Mould to gyprock sheeting in front right corner of garage.**

Mould to front right corner of garage with higher than normal moisture readings - Termatrac used but no signs of movement

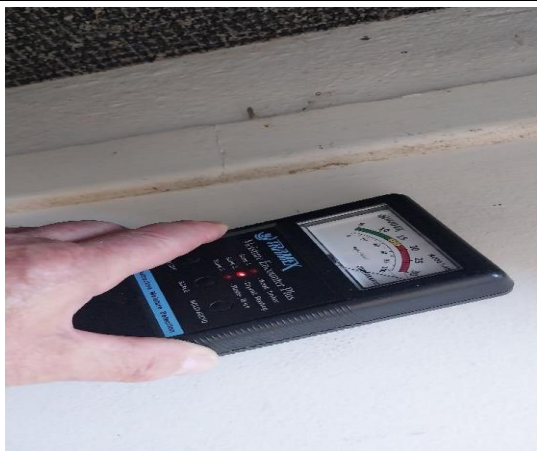
Higher than normal moisture readings to wall garage -  
Termatrac used but no signs of movement however  
recommend installing snap vent for ventilation and future  
inspection

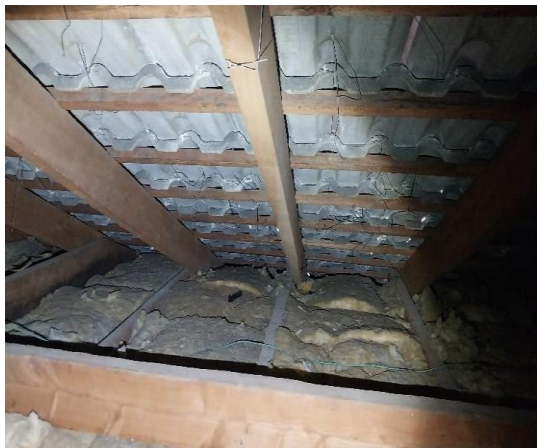
Insulation covering top plate & timbers restricting visibility.

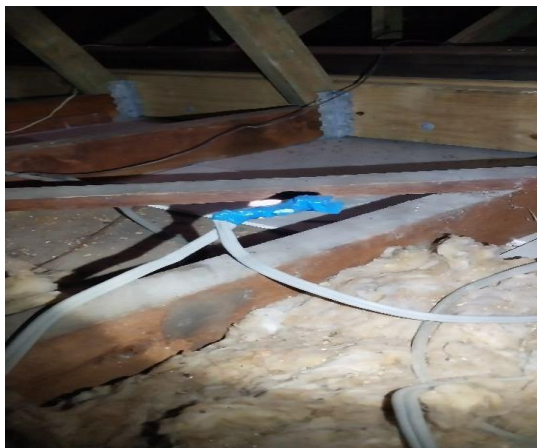
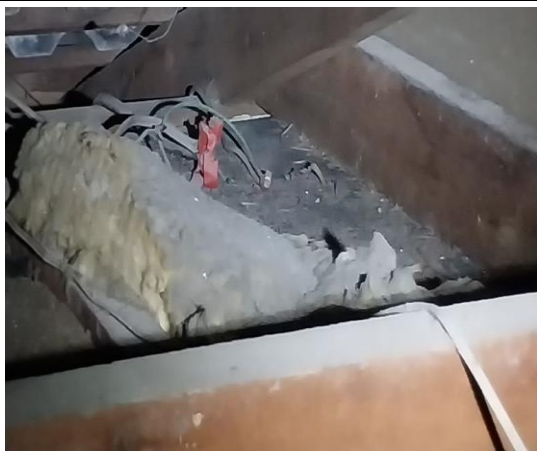
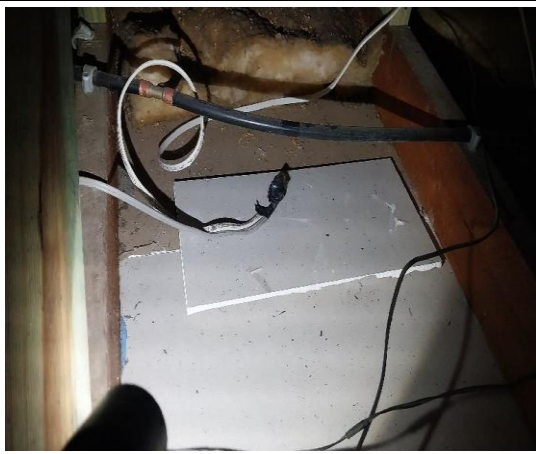
For safety purposes contact an electrician to assess and  
rectify if required taped up electrical wiring in roof void in a  
few areas

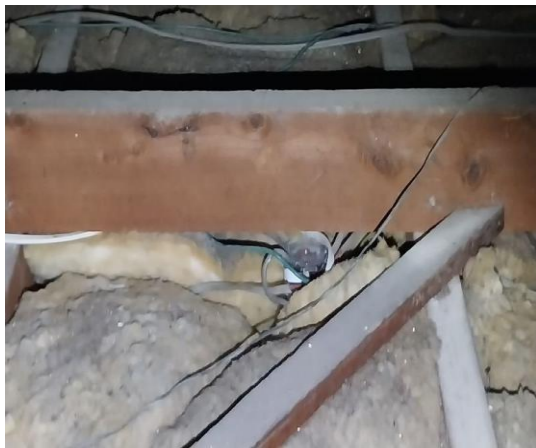
For safety purposes contact an electrician to assess and rectify if required down lights in roof void in contact or covered by insulation

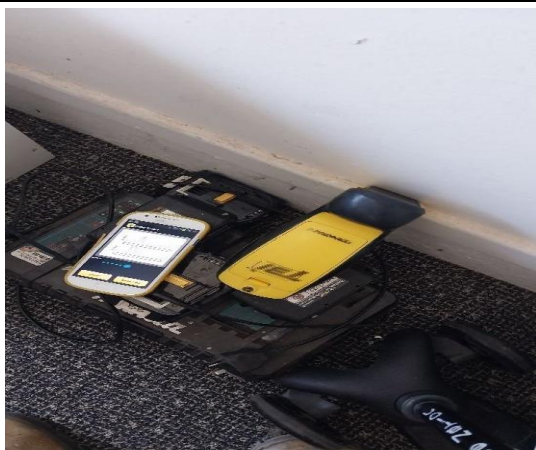
Termatrac used in areas of high moisture readings only - no signs of movement however recommend installing snap vents for ventilation and future inspection.

Termatrac used in area of high moisture readings only - no signs of movement however recommend installing snap vent for ventilation and future inspection
