11 Malton st The Gap

Pre-Purchase Standard Property & Timber Pest Report

03rd Sep, 2024

Report number:	24/507
Inspection Date:	03rd Sep, 2024
Property Address	11 Malton st The Gap

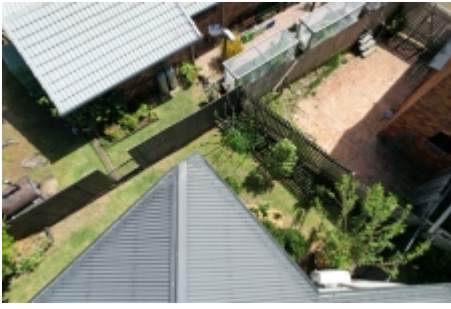
Roof Sheeting appears to be in reasonable condition

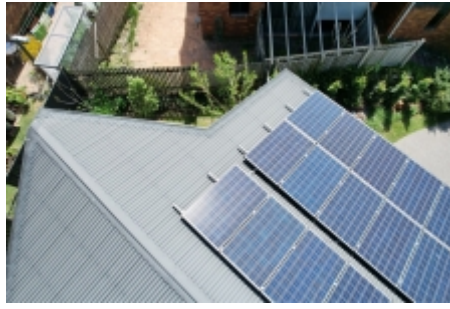
Roof Sheeting appears to be in reasonable condition

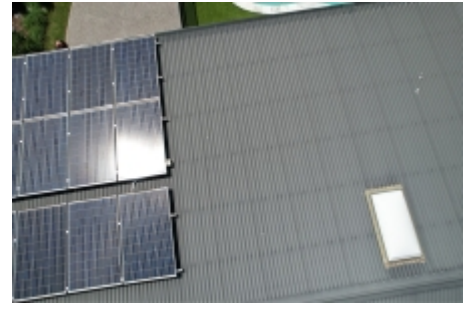
Roof Sheeting appears to be in reasonable condition

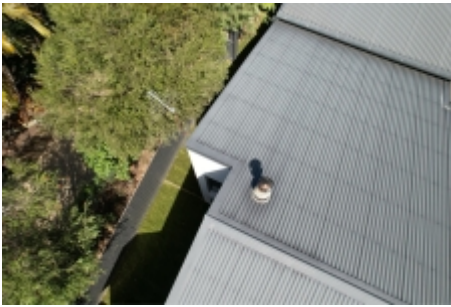
Roof Sheeting appears to be in reasonable condition

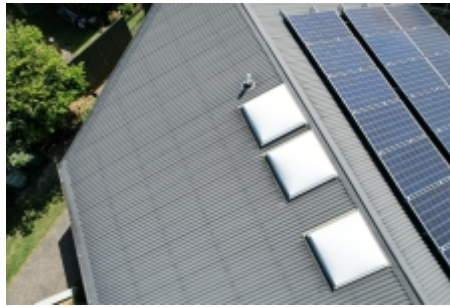
Roof Sheeting appears to be in reasonable condition

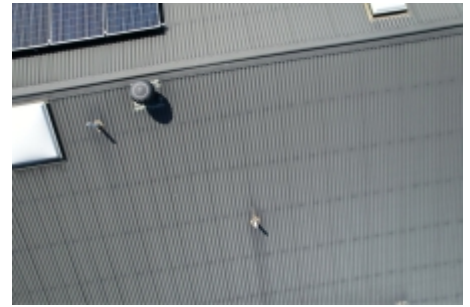
Roof Sheeting appears to be in reasonable condition
