# BUILDING SURVEY

92 JOHN WHITEWAY DRIVE,  
GOSFORD NSW 2250

QUAY NORTH APARTMENTS

# General Building Survey Report

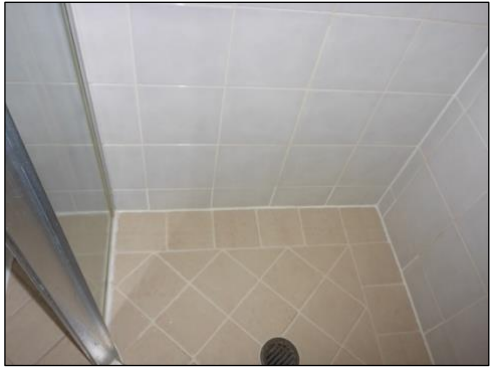
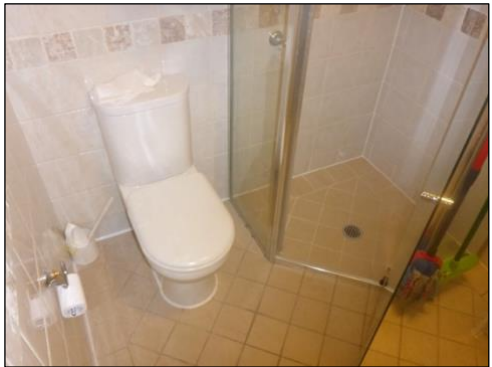
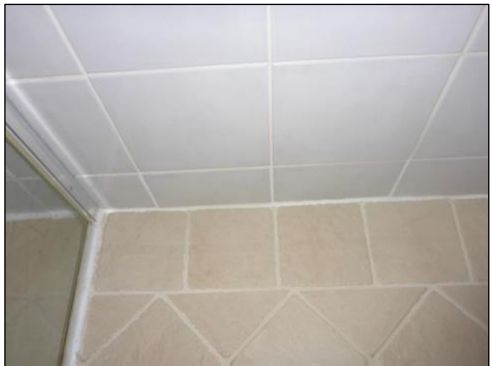
| ITEM | LOCATION | DESCRIPTION & PHOTOGRAPH(S) |
|---|---|---|
| 9 | Ensuite | <ol style="list-style-type: none"> <li>1. The shower recess has received a silane/siloxane <i>Megasealed</i>®-type surface coating as a temporary solution to the water penetration defect affecting the adjoining internal common foyer.</li> <li>2. Refer to Item 84, indicating that the temporary waterproofing has not proven successful.</li> <li>3. <i>Unit 10</i> ensuite requires re-waterproofing in full to achieve a positive outcome.</li> </ol> |

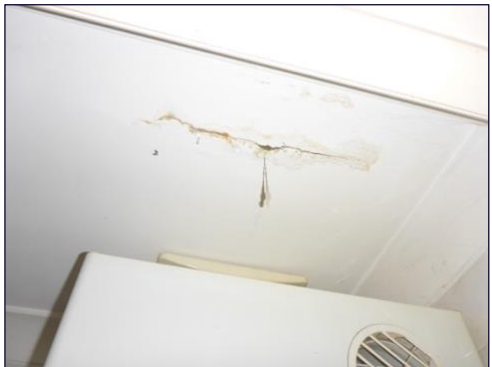
| ITEM | LOCATION | DESCRIPTION & PHOTOGRAPH(S) |
|---|---|---|
| 10 | Laundry | <ol style="list-style-type: none"> <li>1. Evidence of water penetration in the form of staining, mould growth, and stalactite formation to the suspended plasterboard ceiling lining.</li> <li>2. Water was actively dripping from the ceiling lining onto the washing machine at the time of inspection.</li> <li>3. Instructed by the lot occupant at the time of inspection that the leak commenced approximately one month prior to our inspection.</li> <li>4. <i>Unit 18</i> is located immediately above, and it would appear the leak relates to an internal wet area within that lot.</li> </ol> |

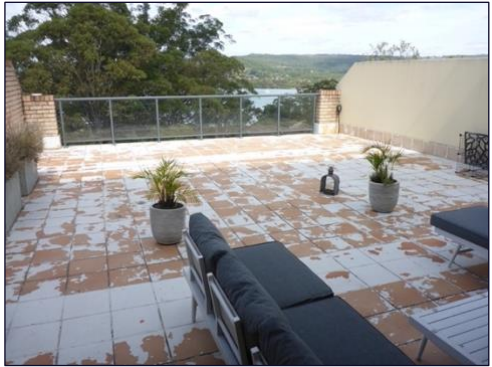
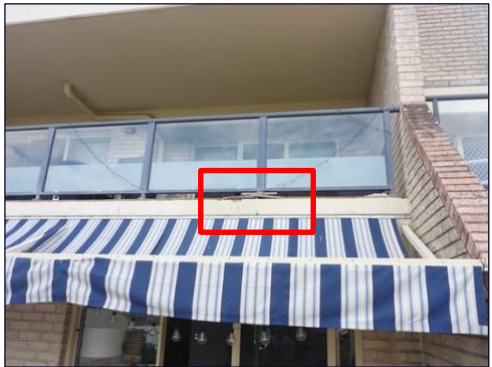
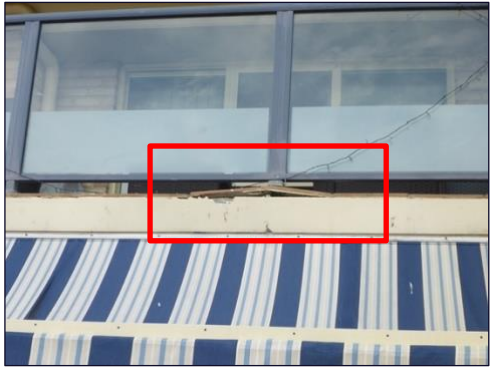
| ITEM | LOCATION | DESCRIPTION & PHOTOGRAPH(S) |
|---|---|---|
| 20 | Southern terrace | <p>1. The terracotta tiled terrace has been painted, however the coatings have failed and are blistering and flaking throughout.</p> <p>2. Tenting/hogged balcony tiles surrounding the balustrade posts are evident on <i>Unit 22</i> southern balcony (above) as viewed from <i>Unit 15</i> southern terrace.</p> |

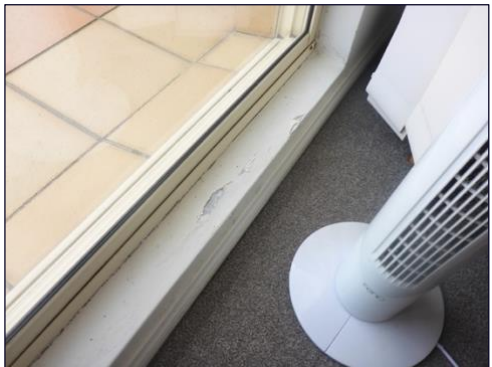
| ITEM | LOCATION | DESCRIPTION & PHOTOGRAPH(S) |
|---|---|---|
| 21 | Living room | <p>1. Evidence of water penetration in the form of blistering and flaking paint at the lower left-hand and right-hand sides of the south-facing glass sliding door assembly.</p> <p>2. High-level moisture meter readings in the vicinity of 23.6% were recorded in the rendered masonry hob.</p> |

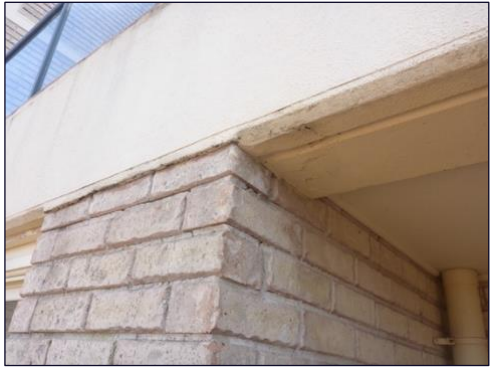
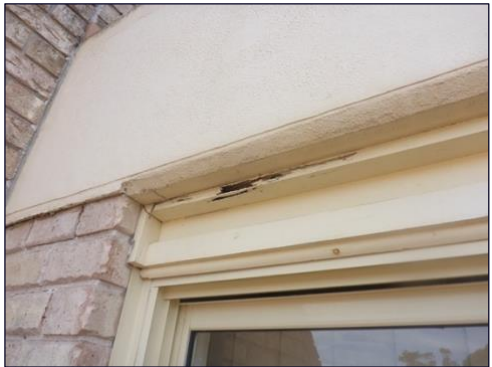
| ITEM | LOCATION | DESCRIPTION & PHOTOGRAPH(S) |
|---|---|---|
| 23 | Southern façade | <ol style="list-style-type: none"> <li>1. Minor concrete spalling to the reinforced concrete soffit at the south-eastern external corner outside the dining room.</li> <li>2. Rot-affected beading to the reinforced concrete soffit at the interface of the south-facing glass sliding door assembly.</li> </ol> |

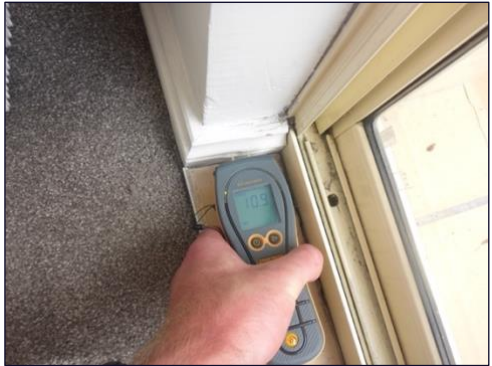
| ITEM | LOCATION | DESCRIPTION & PHOTOGRAPH(S) |
|---|---|---|
| 24 | Main bedroom | <ol style="list-style-type: none"> <li>1. Evidence of minor water penetration to the southern wall in the form of a swollen length of medium-density fibreboard (MDF) skirting board at the lower left-hand side of the glass sliding door assembly.</li> <li>2. Low-level (normal) moisture meter readings in the vicinity of 10.9% were recorded in the skirting board.</li> <li>3. The damage appears to be related to condensation formation only.</li> </ol> |

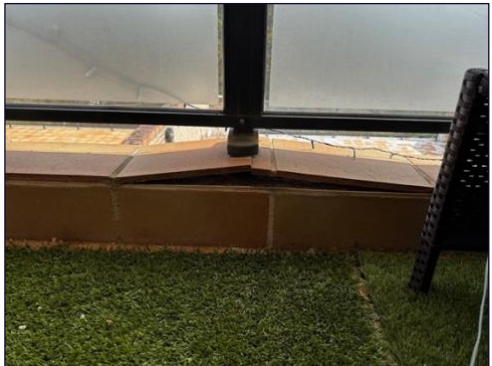
| ITEM | LOCATION | DESCRIPTION & PHOTOGRAPH(S) |
|---|---|---|
| 25 | Southern balcony | <ol style="list-style-type: none"> <li>1. Tenting/hogged terracotta floor tiles on the upper surface of the balcony hob adjacent to the balustrade baluster at the western end.</li> <li>2. <i>Unit 22</i> southern balcony is leaking into <i>Unit 15</i> living room immediately below.</li> </ol> |

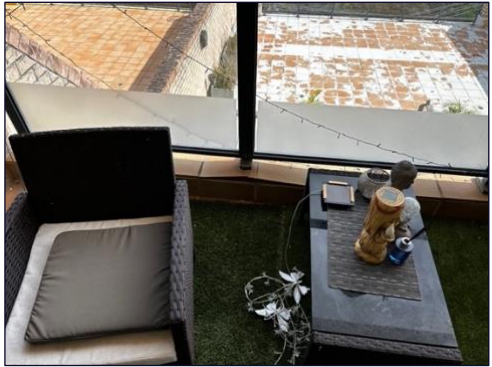
| ITEM | LOCATION | DESCRIPTION & PHOTOGRAPH(S) |
|---|---|---|
| | | <p><u>NOTE ONLY:</u></p> <p>Advised by the lot occupant at the time of inspection of previous water penetration issues relating to the suspended plasterboard ceiling lining within the adjoining living room; however, we understand this issue has since been rectified. There was no internal water penetration damage apparent at the time of inspection.</p> |

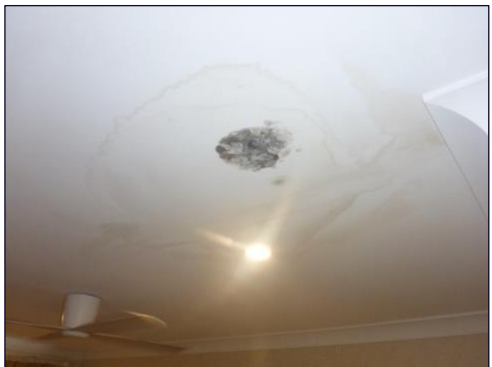
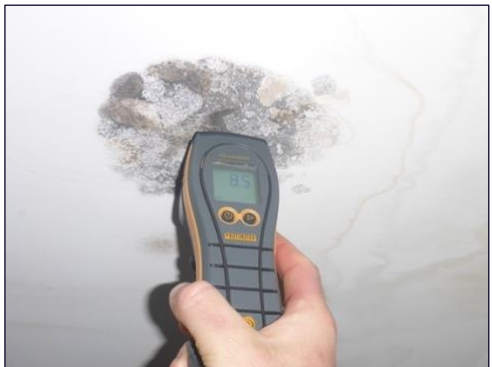
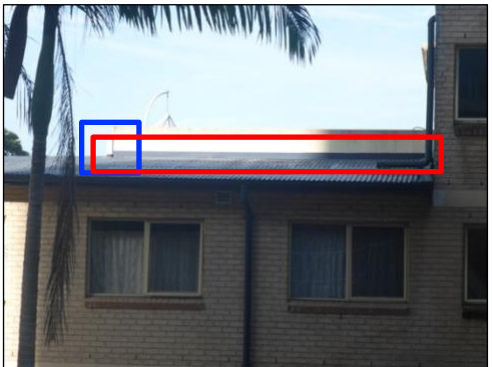
| ITEM | LOCATION | DESCRIPTION & PHOTOGRAPH(S) |
|---|---|---|
| 26 | Main bedroom | <ol style="list-style-type: none"> <li>1. Evidence of significant water penetration in the form of staining and mould growth to the suspended plasterboard ceiling lining.</li> <li>2. Low-level (normal) moisture meter readings in the vicinity of 8.5% were recorded in this location.</li> <li>3. <i>Unit 29</i> eastern terrace and the northern section of the curved-sprung metal-deck roof are located above.</li> <li>4. The curved-sprung metal-deck roof is located above the damage.</li> <li>5. The damage appears to be caused by a defective <i>Dek-Tite</i> vent stack penetration (outlined in blue) or apron flashing (outlined in red) servicing the curved-sprung metal-deck roof.</li> </ol> |

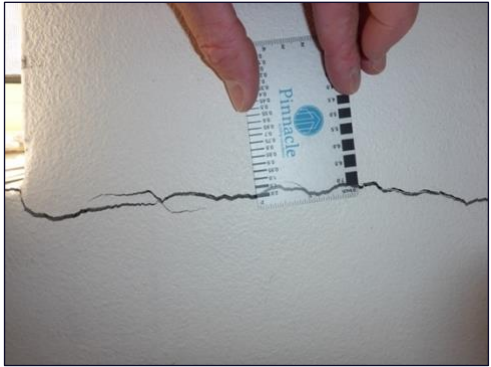
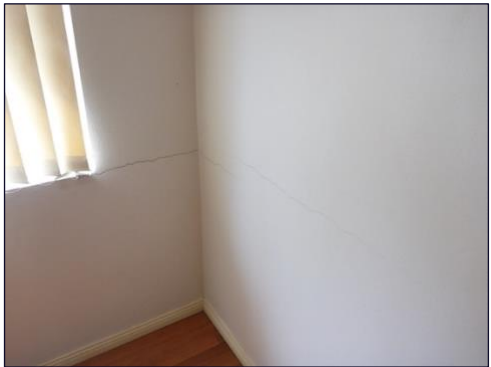
| ITEM | LOCATION | DESCRIPTION & PHOTOGRAPH(S) |
|---|---|---|
| 30 | Main bedroom | <p>1. 2.0mm wide horizontal cracking to the northern and eastern rendered masonry walls in the north-eastern corner at the lower right-hand side of the north-facing window aperture.</p> |

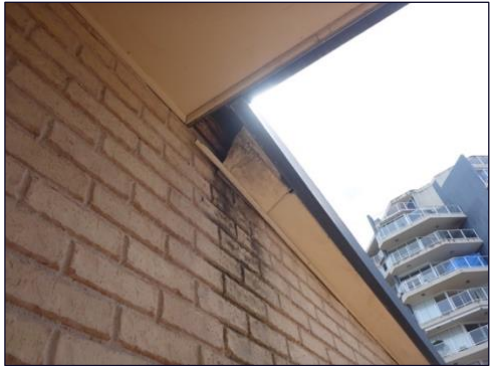
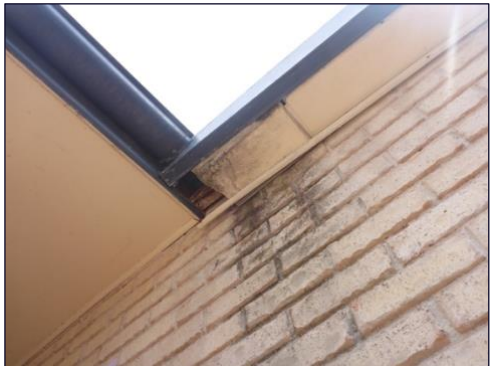
| ITEM | LOCATION | DESCRIPTION & PHOTOGRAPH(S) |
|---|---|---|
| 32 | External common foyer landing servicing Units 24 & 25 | <ol style="list-style-type: none"> <li>1. Evidence of water penetration in the form of water damaged and displaced fibre-cement (FC) sheet soffit lining and exposed and rot-affected timber framing.</li> <li>2. Staining to the eastern brickwork façade beneath the displaced FC sheet soffit lining indicates long-term water penetration.</li> <li>3. This damage is reflected within the entry hallway of Unit 24, immediately adjacent.</li> <li>4. The water penetration damage is possibly related to a defective or poorly detailed barge capping, or wind-driven rainwater penetrating beneath the sheet laps in the curved-sprung metal-deck roof.</li> <li>5. May require further destructive and non-destructive investigation.</li> </ol> |

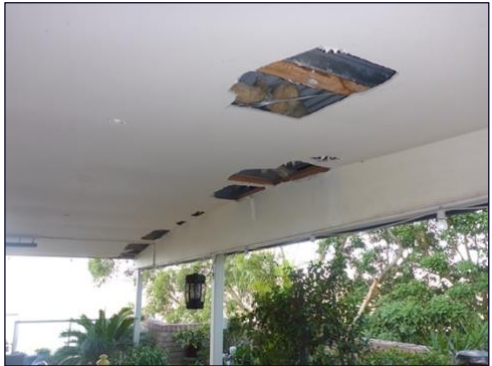
| ITEM | LOCATION | DESCRIPTION & PHOTOGRAPH(S) |
|---|---|---|
| 34 | Level 8 rooftop terrace alfresco area | <ol style="list-style-type: none"> <li>Several holes have been cut in the fibre-cement (FC) sheet lining to the curved-sprung roof over the alfresco area.</li> <li>Instructed by the lot owner at the time of inspection that this was necessary to repair a burst pipe within the ceiling cavity.</li> <li>The FC sheet linings require short-term repair.</li> </ol> |

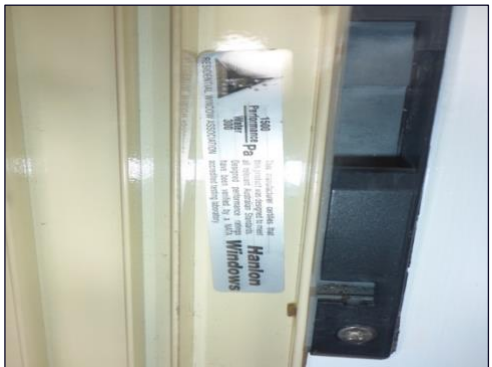
| ITEM | LOCATION | DESCRIPTION & PHOTOGRAPH(S) |
|---|---|---|
| 35 | Glass sliding door assemblies | <ol style="list-style-type: none"> <li>The glass sliding door assemblies were manufactured by <i>Hanlon Windows</i> with a 300Pa water rating and 1500Pa wind rating.</li> <li>Instructed by the lot owner at the time of inspection that there have been no instances of internal water penetration.</li> <li><i>Unit 26</i> (Level 7) is located beneath <i>Unit 27</i> Level 8 rooftop terrace.</li> <li><i>Unit 19</i> (Level 6) is located beneath the Level 7 part of <i>Unit 27</i>.</li> </ol> |

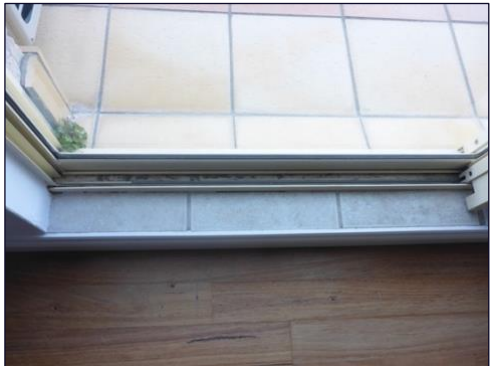
| ITEM | LOCATION | DESCRIPTION & PHOTOGRAPH(S) |
|---|---|---|
| 36 | Living room | <ol style="list-style-type: none"> <li>Evidence of water penetration in the form of blistering and bubbling paint at the lower left-hand and right-hand side of the south-facing glass sliding door assemblies.</li> <li>Low-level (normal) moisture meter readings ranging between 8.9% and 14.8% were recorded in this location at the time of inspection.</li> <li>Instructed by the lot owner at the time of inspection that the south-facing glass sliding door assemblies have been spray-tested and found to leak.</li> </ol> |

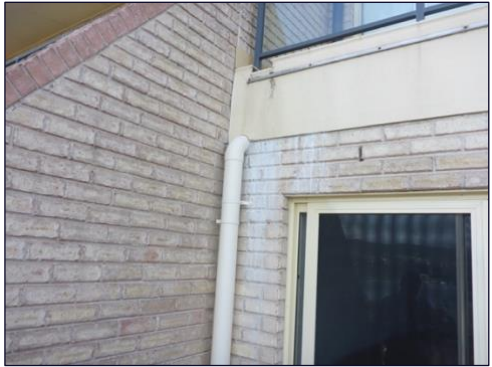
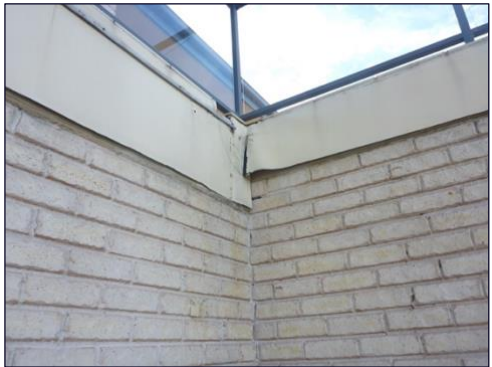
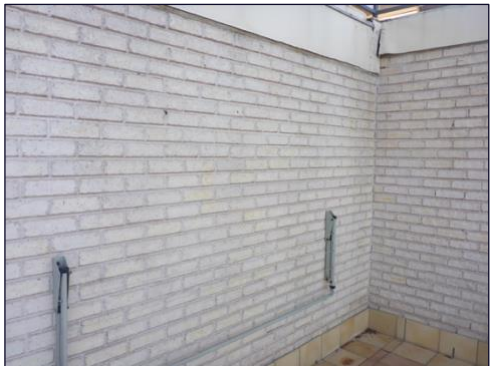
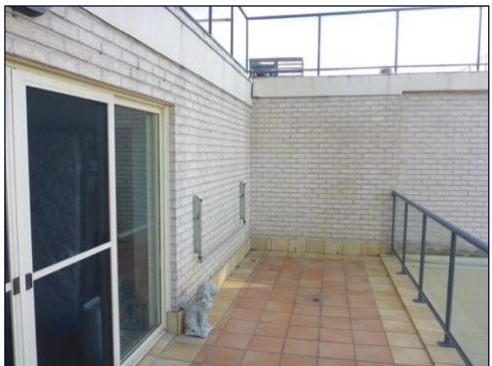
| ITEM | LOCATION | DESCRIPTION & PHOTOGRAPH(S) |
|---|---|---|
| 37 | Southern terrace | <ol style="list-style-type: none"> <li>1. Evidence of surface water runoff from <i>Unit 30</i> southern balcony, above, in the form of efflorescence to the southern face brickwork façade at the western end.</li> <li>2. <i>Unit 30</i> southern balcony and the adjoining narrow southern return of <i>Unit 30</i> eastern terrace are located above.</li> <li>3. The eastern terrace has been provided with what appears to be a painted bituminous sheet apron that has been loosely dressed down over the slab edge and onto the face brickwork façade. Surface water runoff is/or has possibly charged the wall cavity during extended periods of heavy, wind-driven rainfall (for example, an east-coast low-pressure system (ECLPS) storm event).</li> <li>4. One weephole exists at the western side of the south-facing glass sliding door servicing the living room, and generally throughout the southern façade.</li> </ol> |

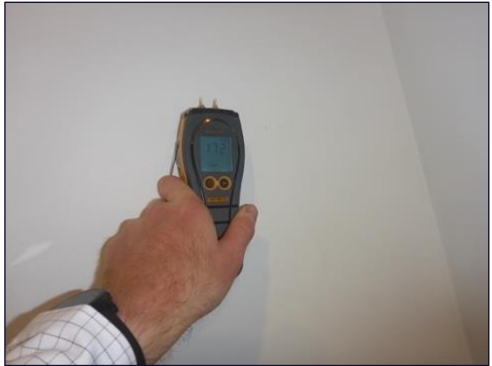
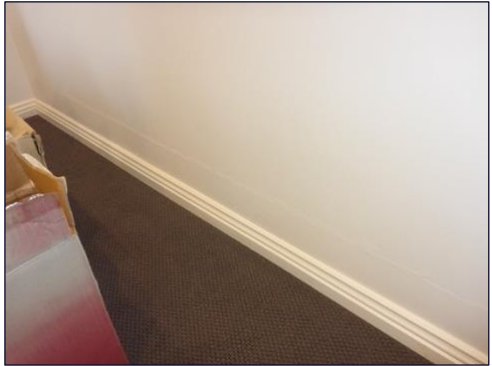
| ITEM | LOCATION | DESCRIPTION & PHOTOGRAPH(S) |
|---|---|---|
| 38 | Walk-in-robe (WIR) | <ol style="list-style-type: none"> <li>1. Evidence of water penetration in the form of blistering and bubbling paint to the southern and eastern walls.</li> <li>2. High-level moisture meter readings in the vicinity of 17.2% were recorded in this location at the time of inspection.</li> <li>3. Instructed by the lot owner at the time of inspection that he had recently repainted and laid new carpet due to previous unresolved water penetration issues.</li> <li>4. The southern balcony extends along the full width of the southern façade and requires re-waterproofing.</li> </ol> |

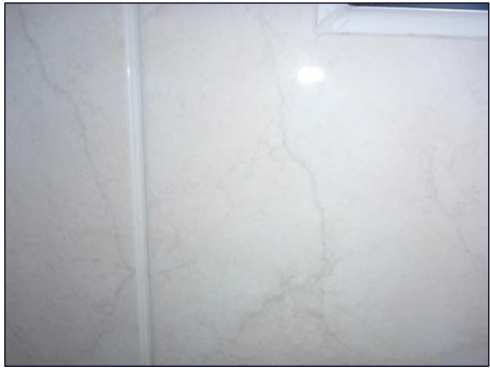
| ITEM | LOCATION | DESCRIPTION & PHOTOGRAPH(S) |
|---|---|---|
| 40 | Ensuite | <ol style="list-style-type: none"> <li>Cracked grout and drummy tiles to the eastern and southern walls within the shower recess.</li> <li>Instructed by the lot owner at the time of inspection that water leaks from the base of the shower recess.</li> </ol> |

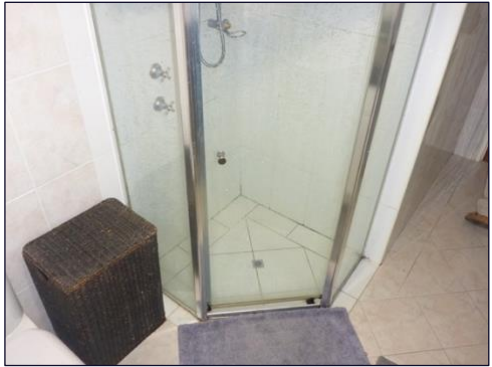
| ITEM | LOCATION | DESCRIPTION & PHOTOGRAPH(S) |
|---|---|---|
| 45 | Bathroom | <p>1. Instructed by the lot occupant at the time of inspection that the shower tray was re-waterproofed and retiled; however, water leaks from both sides of the shower screen.</p> |

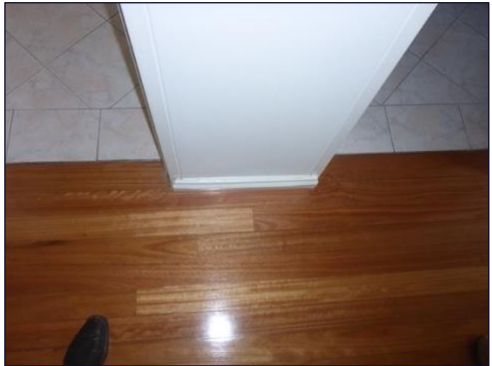
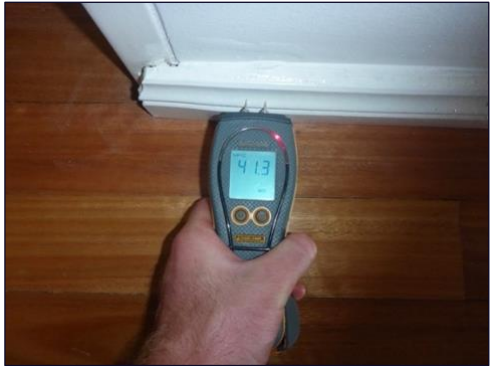
| ITEM | LOCATION | DESCRIPTION & PHOTOGRAPH(S) |
|---|---|---|
| 46 | Hallway | <p>1. Evidence of water penetration in the form of blistering and bubbling paint, and swollen medium density fibreboard (MDF) skirting boards extending along the hallway between the wet areas.</p> <p>2. High-level moisture meter readings in the vicinity of 41.3% were recorded in the affected length of skirting.</p> |

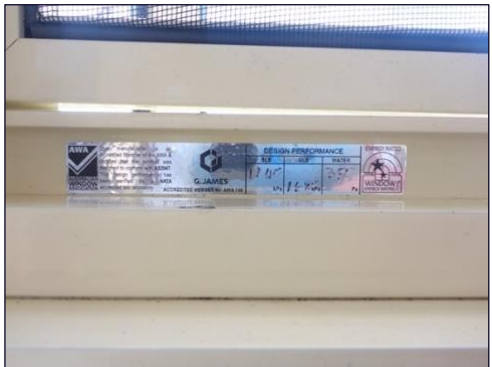
| ITEM | LOCATION | DESCRIPTION & PHOTOGRAPH(S) |
|---|---|---|
| 47 | Aluminium windows | <p>1. The new windows provided within the southern façade were manufactured by <i>G James Glass &amp; Aluminium</i> and provided with a 350Pa water rating and an 1140Pa wind rating.</p> <p>2. A reinforced concrete upstand extends along the base of the southern façade.</p> |

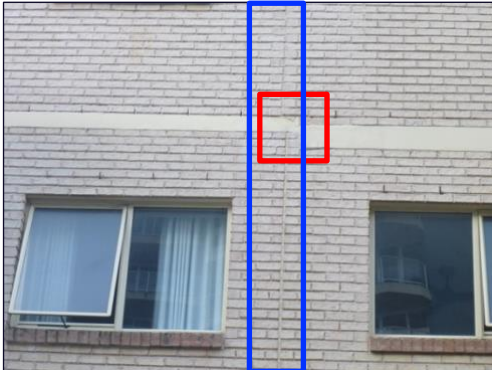
| ITEM | LOCATION | DESCRIPTION & PHOTOGRAPH(S) |
|---|---|---|
| 52 | Second bedroom | <ol style="list-style-type: none"> <li>Evidence of water penetration in the form of bubbling/disturbed paintwork to the cornice along the western wall in the north-western corner.</li> <li>A step in the floor slab above (red box) exists externally.</li> <li>A full-height construction joint (blue box) exists in the face cavity brickwork façade in this location.</li> <li>Likely defective weatherproofing provisions in the vicinity of the construction joint within the rainscreen façade.</li> <li>The disturbed section of cornice within the second bedroom may also be movement-related.</li> </ol> |

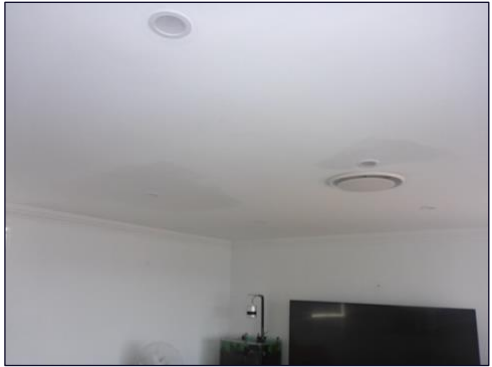
| ITEM | LOCATION | DESCRIPTION & PHOTOGRAPH(S) |
|---|---|---|
| 54 | Living room | <p>1. Evidence of previous “patch painting” to the suspended plasterboard ceiling.</p> |

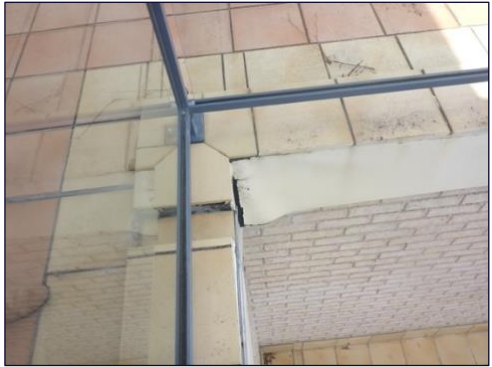
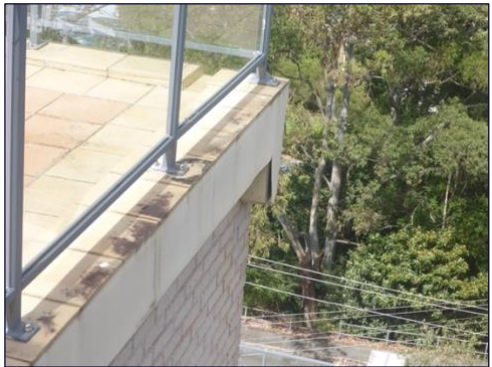
| ITEM | LOCATION | DESCRIPTION & PHOTOGRAPH(S) |
|---|---|---|
| 56 | Southern narrow return of south-eastern terrace | <ol style="list-style-type: none"> <li>1. A loose-laid painted bitumen sheet membrane has been dressed down over the slab edge to <i>Unit 28</i>, below.</li> <li>2. It is not clear what the purpose of this highly unusual and unsightly work is.</li> <li>3. <i>Unit 28</i>, however, is affected by significant water penetration.</li> </ol> |

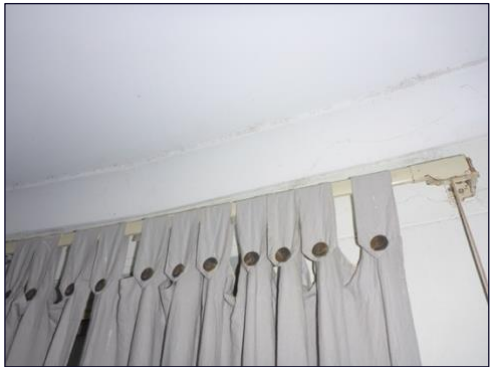
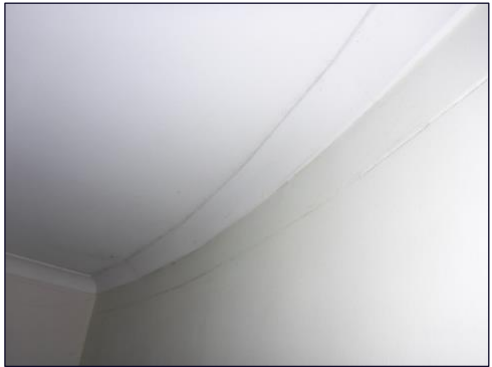
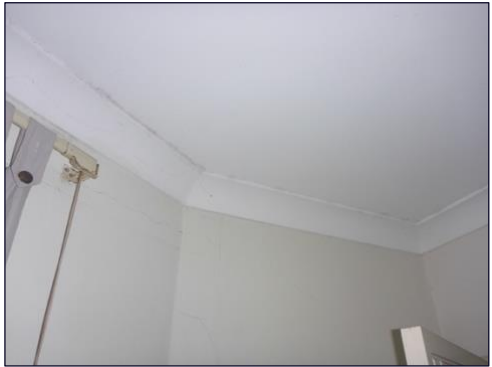
| ITEM | LOCATION | DESCRIPTION & PHOTOGRAPH(S) |
|---|---|---|
| 61 | Main bedroom | <ol style="list-style-type: none"> <li>Evidence of water penetration in the form of mould growth and general dampness, discolouration and staining of the carpet at the base of the curved south-eastern rendered masonry wall and northern rendered masonry wall.</li> <li>High-level moisture meter readings ranging from 24.8% to 30.2% were recorded in the carpet at the time of inspection.</li> <li>Minor horizontal and vertical cracking to the northern, and curved south-eastern walls.</li> <li>This room is positioned on the building's lowest floor (Level 1) adjoining the heavily shaded, benched side of the site.</li> <li>Leaf litter and debris adjoins the curved south-eastern face brickwork façade, however, it is possible that a step in the floor slab exists, and that the concrete protrusion at the base of the façade indicates the lower courses are "wet courses".</li> <li>Instructed by the lot occupant at the time of inspection that the dining room has been previously flooded, however the adjoining building façade was "damp-proofed". The exact scope of these works was not disclosed.</li> <li>Possible ground water issue.</li> <li>Possible bridging of the cavity flashings in the external face cavity brick façade.</li> <li>The following photographs depict the site conditions to the north and east of <i>Unit 34</i>:</li> </ol> |

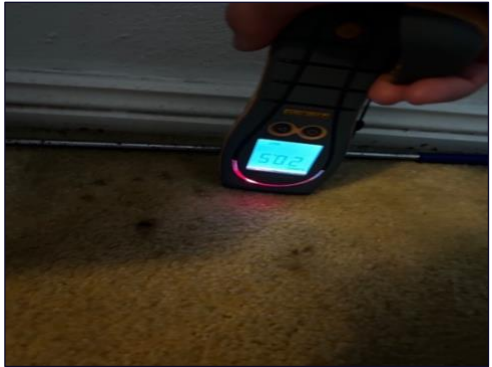
| ITEM | LOCATION | DESCRIPTION & PHOTOGRAPH(S) |
|---|---|---|
| 62 | Study | <ol style="list-style-type: none"> <li>Evidence of water penetration in the form of mould growth and general dampness to the carpet along the curved south-eastern rendered masonry wall and adjoining northern rendered masonry wall.</li> <li>High-level moisture meter readings in the vicinity of 20.5% were recorded in the carpet at the time of inspection.</li> </ol> |

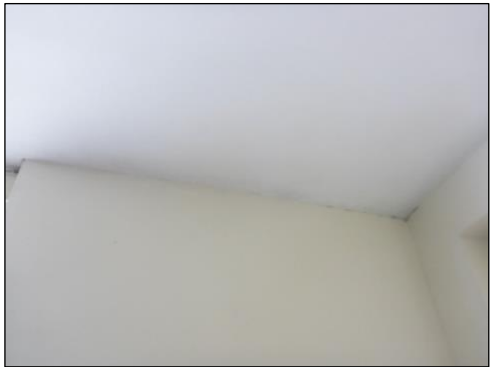
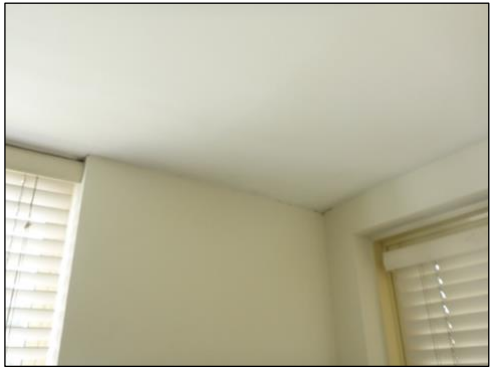
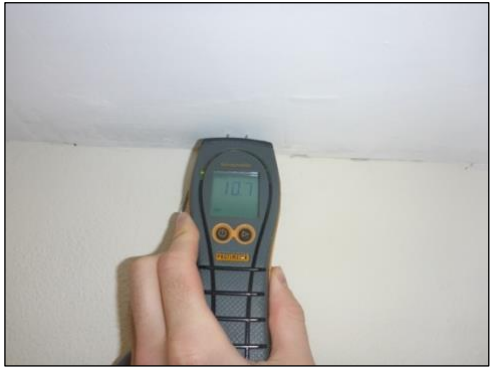
| ITEM | LOCATION | DESCRIPTION & PHOTOGRAPH(S) |
|---|---|---|
| 63 | Living room | <ol style="list-style-type: none"> <li>Evidence of minor mould growth at the head of the southern wall in the south-western corner adjacent to the casement door servicing the southern balcony.</li> <li>Low-level (normal) moisture meter readings in the vicinity of 10.7% were recorded in this location at the time of inspection.</li> <li>Instructed by the lot occupant at the time of inspection that mould growth regularly occurs on the suspended plasterboard bulkhead, however it is regularly removed.</li> <li>There was no evidence of mould growth on the suspended plasterboard bulkhead at the time of inspection.</li> </ol> |

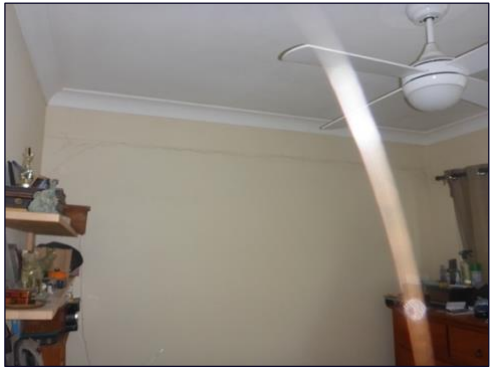
| ITEM | LOCATION | DESCRIPTION & PHOTOGRAPH(S) |
|---|---|---|
| 65 | Second bedroom | <ol style="list-style-type: none"> <li>1. Horizontal cracking, and drummy and delaminating render to the eastern masonry wall at the interface of the slab edge beam and masonry wall.</li> <li>2. The V-joint provided at this interface between building elements has not been scribed through the full depth of the render, and the predictable building movement in this location has not been sufficiently accommodated.</li> </ol> |

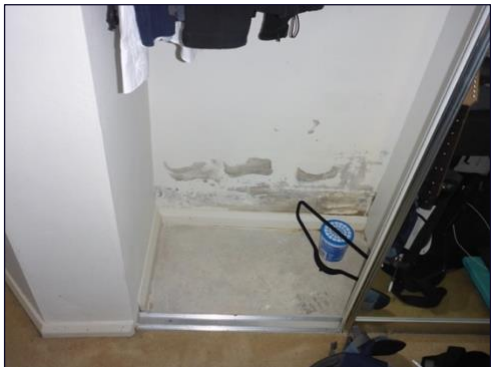
| ITEM | LOCATION | DESCRIPTION & PHOTOGRAPH(S) |
|---|---|---|
| 71 | Second bedroom | <ol style="list-style-type: none"> <li>1. Evidence of water penetration in the form of blistering, flaking and bubbling paint to the southern wall of the built-in-robe (BIR).</li> <li>2. High-level moisture meter readings in the vicinity of 46.8% were recorded in this location at the time of inspection.</li> <li>3. The carpet has been removed from within the BIR, and the carpet outside the BIR is stained.</li> <li>4. The lot occupant is attempting to mitigate against dampness and mould growth with the use of desiccant crystals.</li> </ol> |

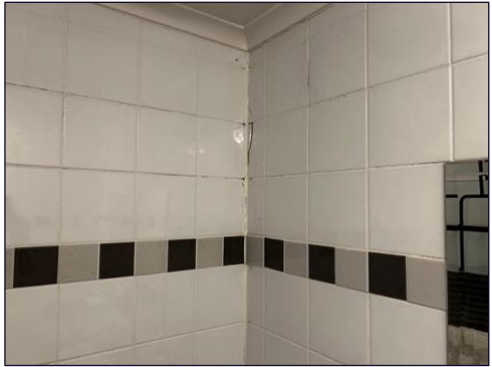
| ITEM | LOCATION | DESCRIPTION & PHOTOGRAPH(S) |
|---|---|---|
| 77 | Bathroom | <ol style="list-style-type: none"> <li>1. Vertical cracking and drummy and delaminating tiles at the junction of walls in the north-eastern corner.</li> <li>2. The cracking is reflected in the south-eastern corner of the adjoining living room.</li> </ol> |

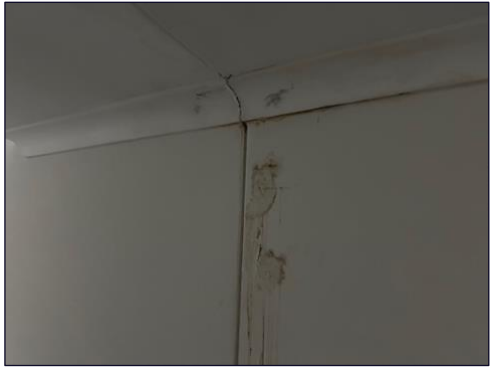
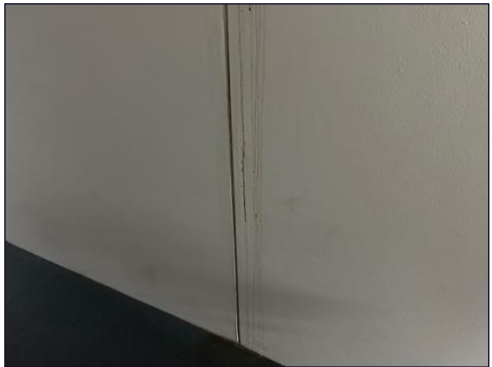
| ITEM | LOCATION | DESCRIPTION & PHOTOGRAPH(S) |
|---|---|---|
| 83 | Level 4 foyer | <ol style="list-style-type: none"> <li>1. Evidence of water penetration in the form of staining, mould growth, blistering and flaking paint and staining to the northern and southern walls, cornice and suspended plasterboard ceiling lining.</li> <li>2. The carpet is also stained in this location.</li> <li>3. The southern wall of the Level 4 foyer forms the northern wall of <i>Unit 9</i> immediately adjacent.</li> <li>4. The units featuring the large southern terraces are located immediately above, and it would appear the waterproofing provisions have failed in the vicinity of the construction joint.</li> </ol> |
