## Visual Pre-Purchase Building Condition Report

To comply with Australian Standard  
Building - AS4349.1-2007

CLIENT & INSPECTION DETAILS:	
Client	Georgie K
Address:	9 Walker Ave Wyoming
Contact Phone:	Details withheld
Contact Email:	Details withheld
Inspection Date / Report Number:	28 <sup>th</sup> November 2025
Inspection Time:	11:00am
Weather Conditions	Sunny
Building Furnished:	Yes
Building Tenancy:	Occupied
Persons present at time of inspection:	Vendor

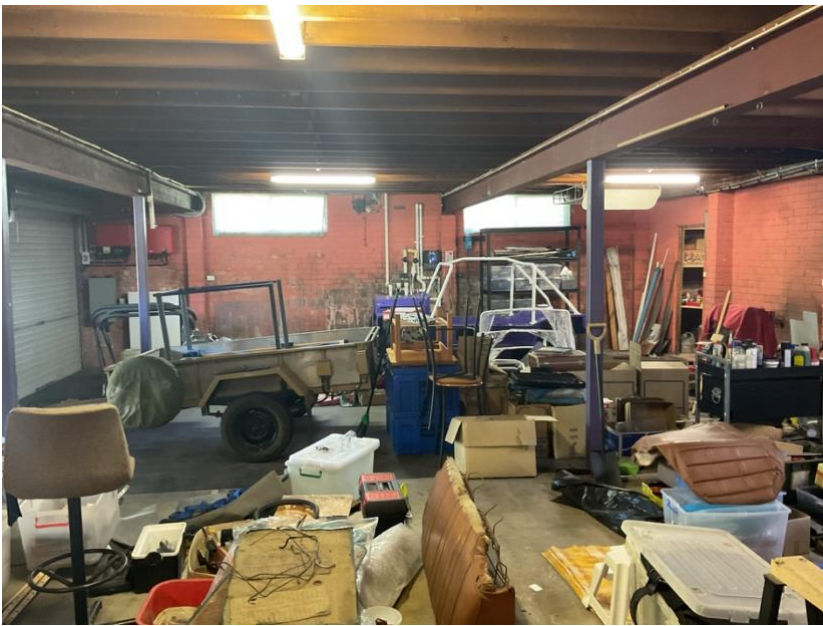
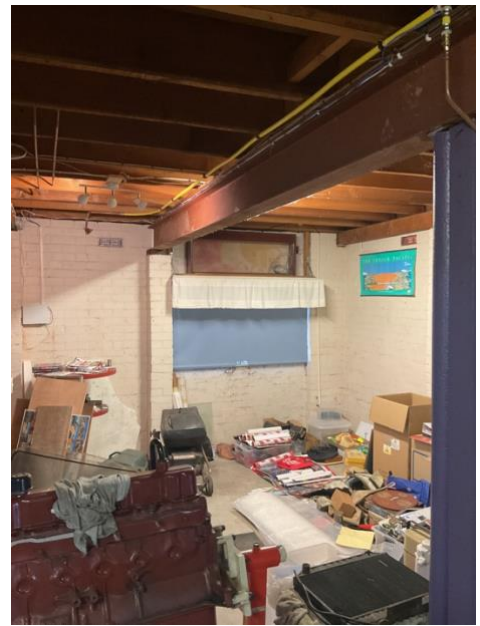
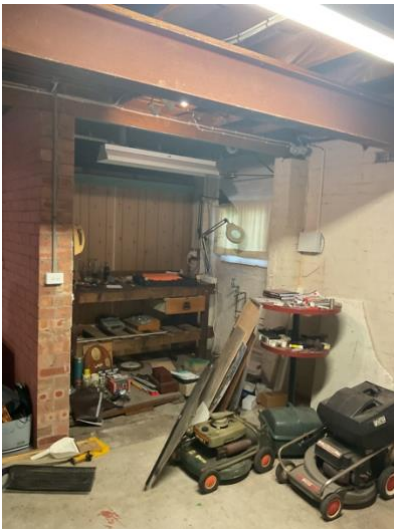
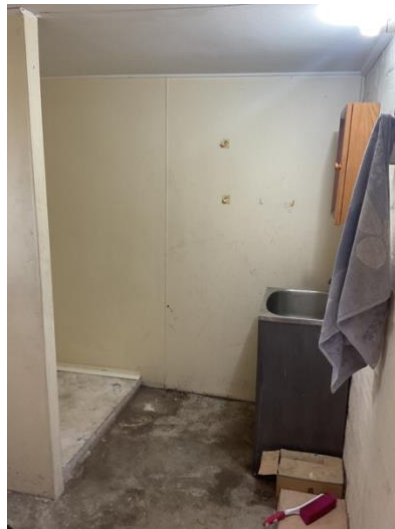
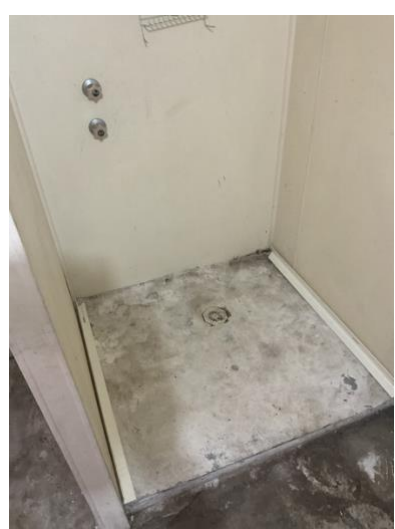
GARAGE	CONDITION & COMMENTS
Access	Satisfactory
Floor	Satisfactory
Walls	(Garage) Evidence of moisture staining to internal brick work face various locations. This is most likely related to the subsidence of concrete paths externally which is allowing rain to seep through the walls. High moisture readings not detected at time of inspection, however this may change during rain events. Please refer to external section of report under "paths" for more details
Ceilings	Satisfactory
Windows	Satisfactory
Door	Satisfactory
Garage Door	Satisfactory

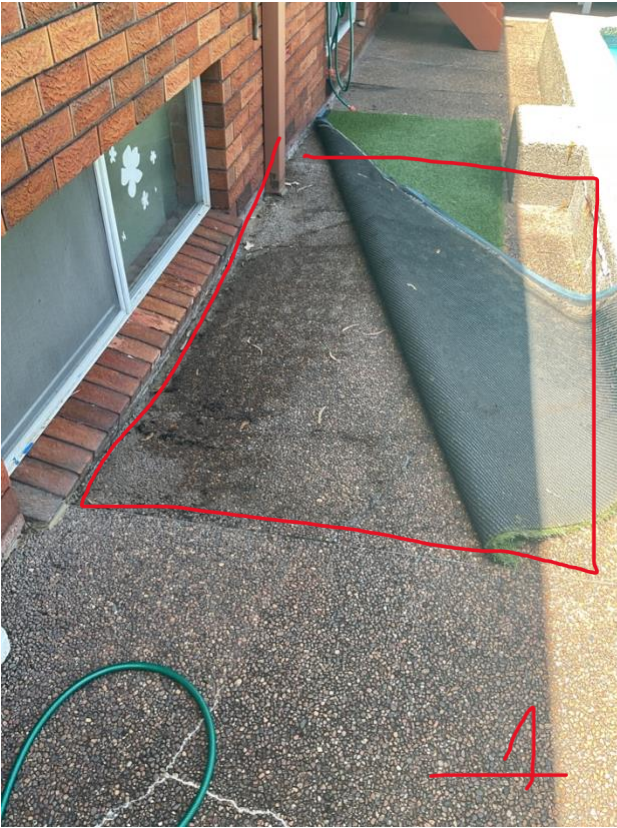
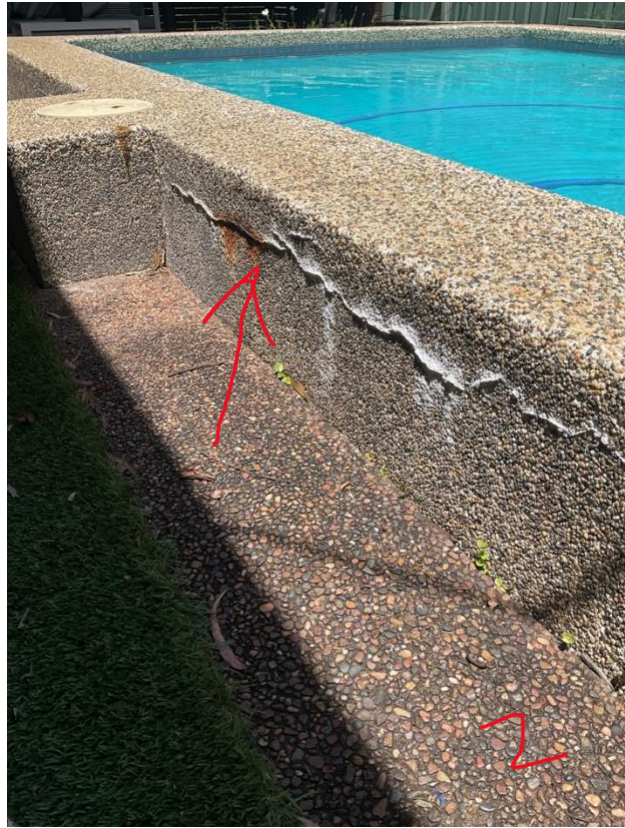
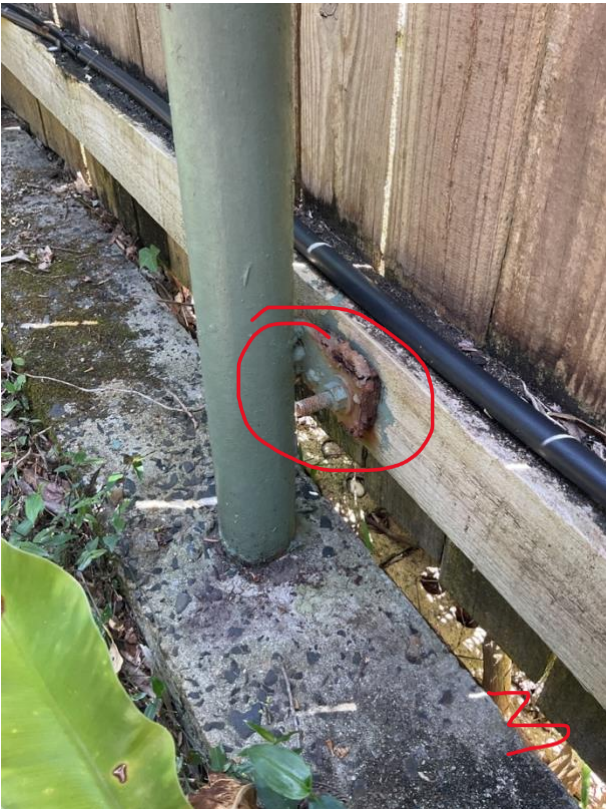
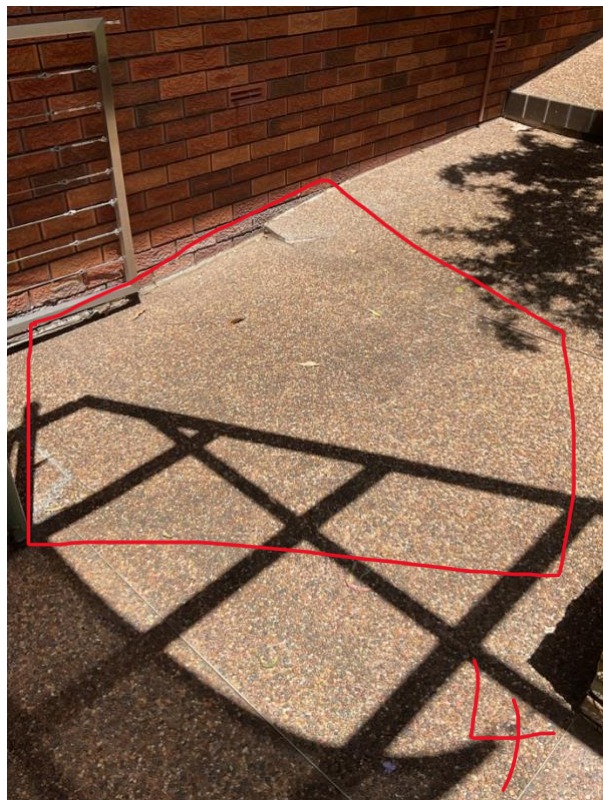
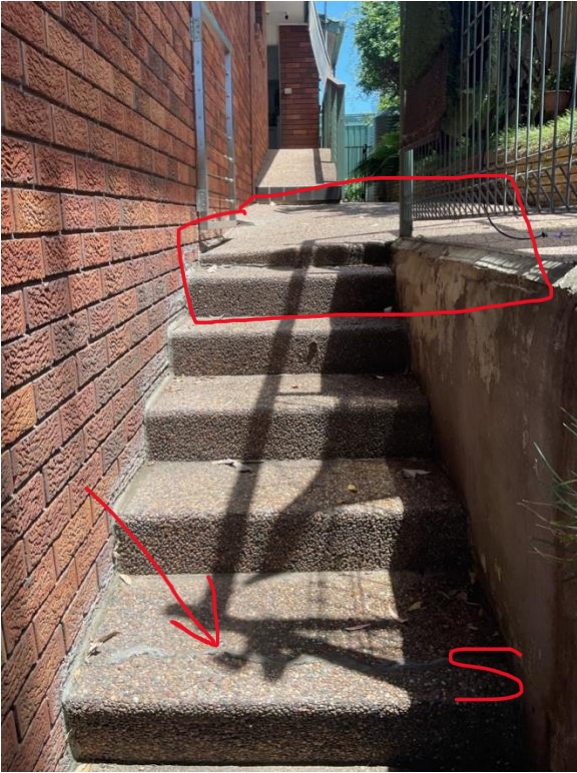
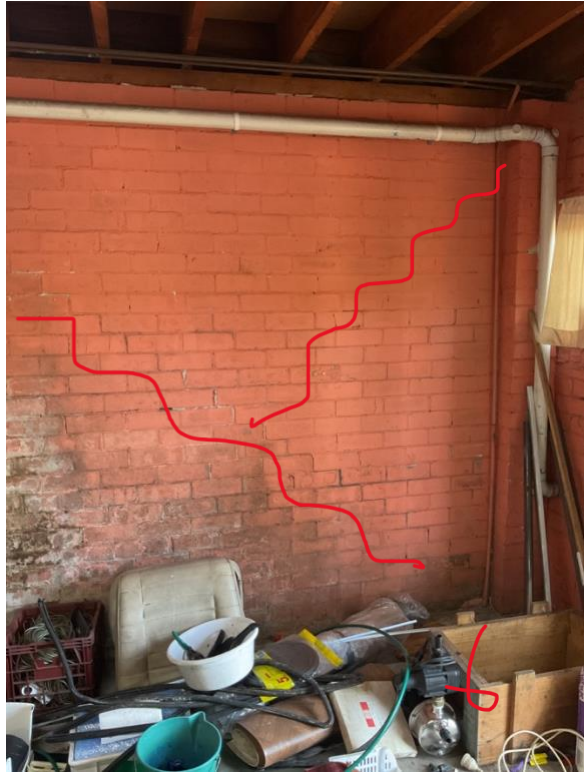
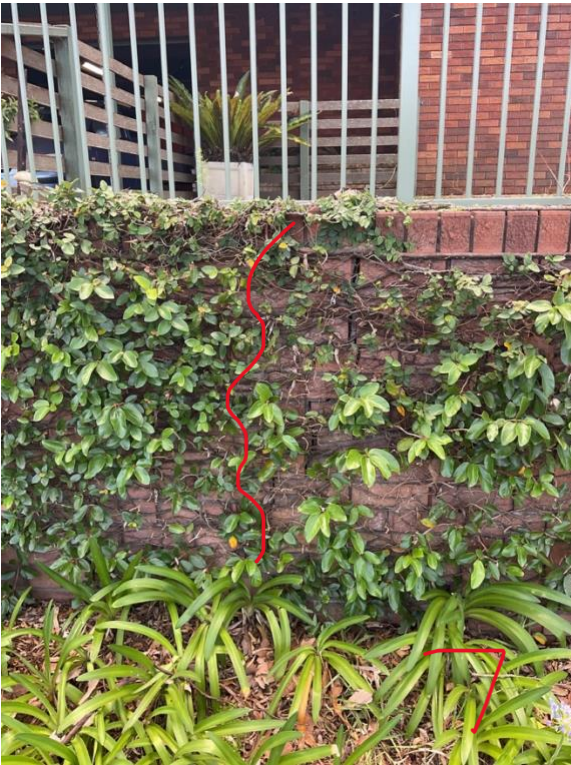
Evidence of rust corrosion to fence brackets, recommend replacing as required. Photo 3

Evidence of cracking to front boundary walls various locations. Wall does not appear to be leaning, therefore may be caused by the tree vine roots. Difficult to assess in detail, therefore recommend to remove vegetation off the wall so a better visual inspection can take place. Photo 7

Evidence of rust corrosion and efflorescence seeping out of concrete pool edge. Most likely caused by steel reinforcement being installed too close to edge, however what seeps out could also seep in, therefore it is recommended to engage a pool builder to inspect in more detail to confirm if issue is superficial. Photo 2

Decking Areas	Satisfactory
Tiled Areas	Satisfactory
Fences	Evidence of rust corrosion to fence brackets, recommend replacing as required. Photo 3
Gates	Satisfactory
Steps within garden areas	Satisfactory
Retaining walls	Evidence of cracking to front boundary walls various locations. Wall does not appear to be leaning, therefore may be caused by the tree vine roots. Difficult to assess in detail, therefore recommend to remove vegetation off the wall so a better visual inspection can take place. Photo 7
Other 1	Evidence of rust corrosion and efflorescence seeping out of concrete pool edge. Most likely caused by steel reinforcement being installed too close to edge, however what seeps out could also seep in, therefore it is recommended to engage a pool builder to inspect in more detail to confirm if issue is superficial. Photo 2
<p><b>Note:</b> In general: All veranda's, decking, balconies and any internal void area railings, if applicable to this property must be a minimum height of 1.0metre high for compliance with the most recent Australian Standards. (If under 1.0m this is a safety hazard.)</p>
