Inspection Report

Thorough Check Building Inspections

67 Georgia Avenue , Wyoming, NSW, 2250

Pest And Building Inspection

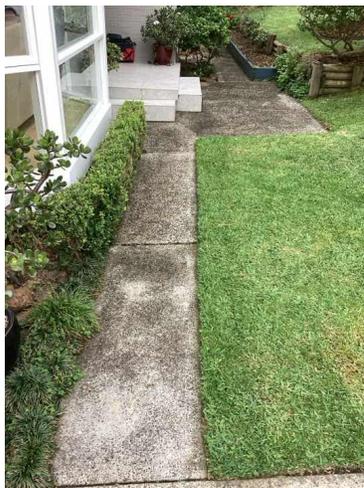
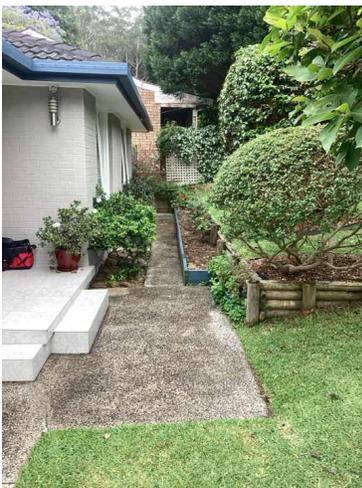
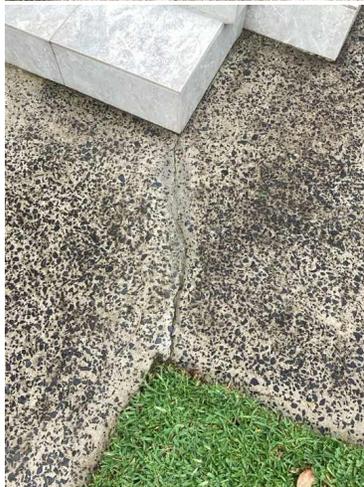
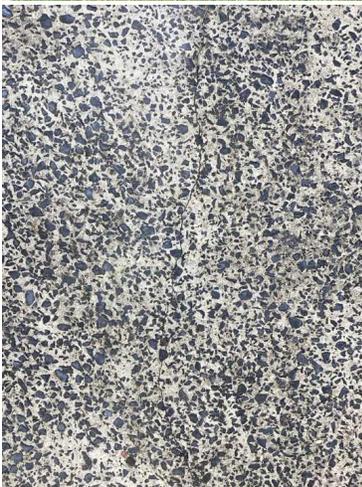
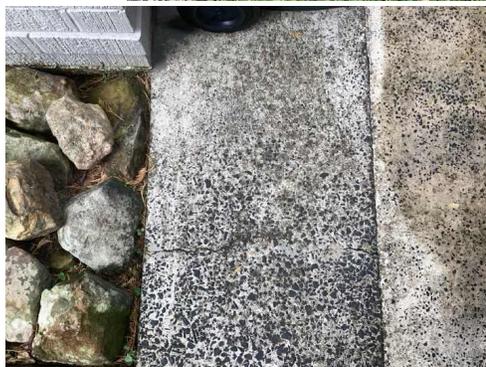
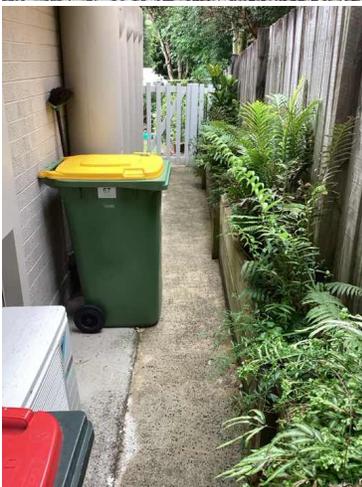
Common cracks and settlement were observed on paths. Whilst these cracks appeared to be typical at the time of inspection, we strongly recommend you monitor these cracks and if worsening occurs contact a concreter for further advice.

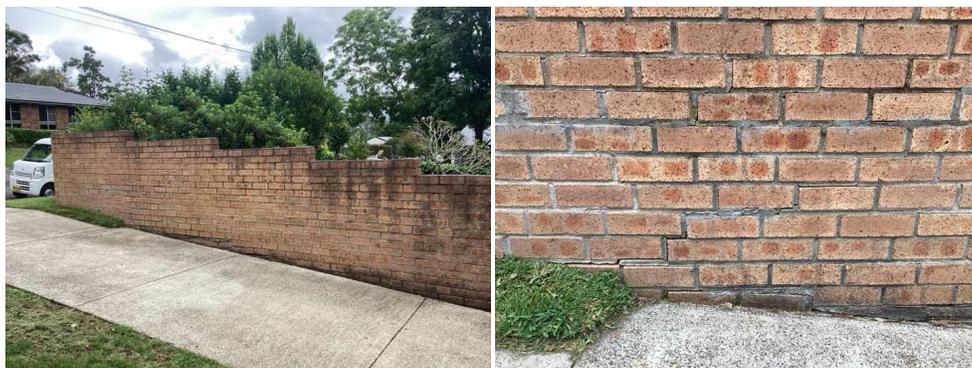
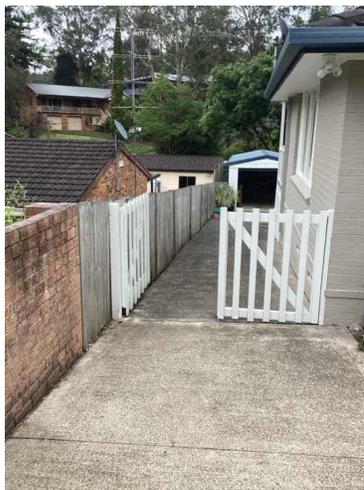
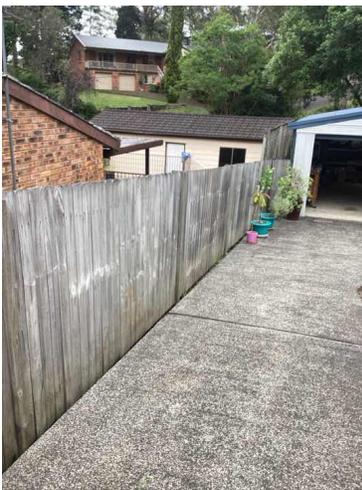
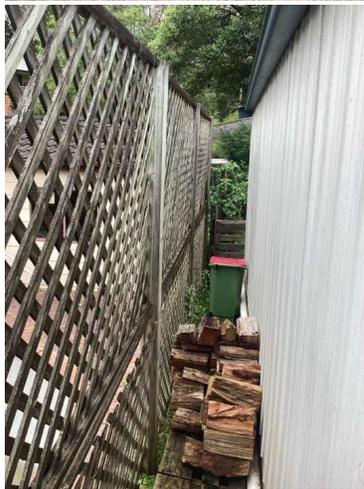
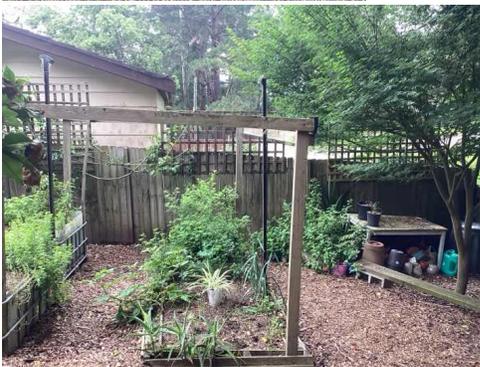
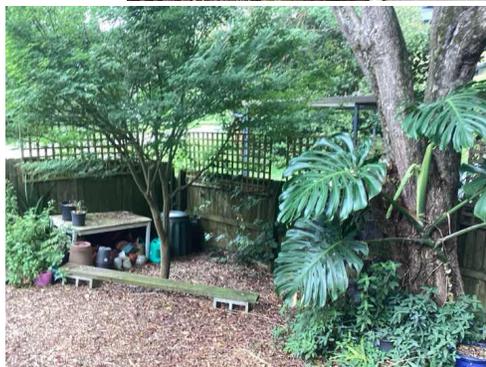
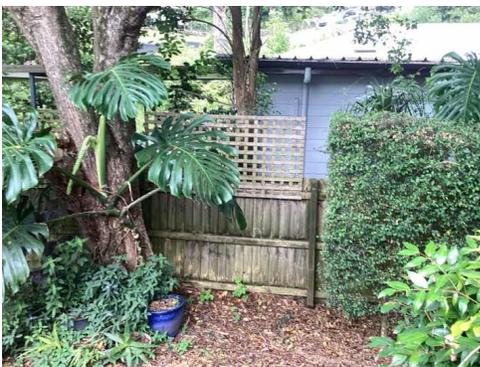
Damage was noted to the timber fence. Contact a fencing contractor for repairs.

General fence components have rot. Repairs are required by fencing contractor.

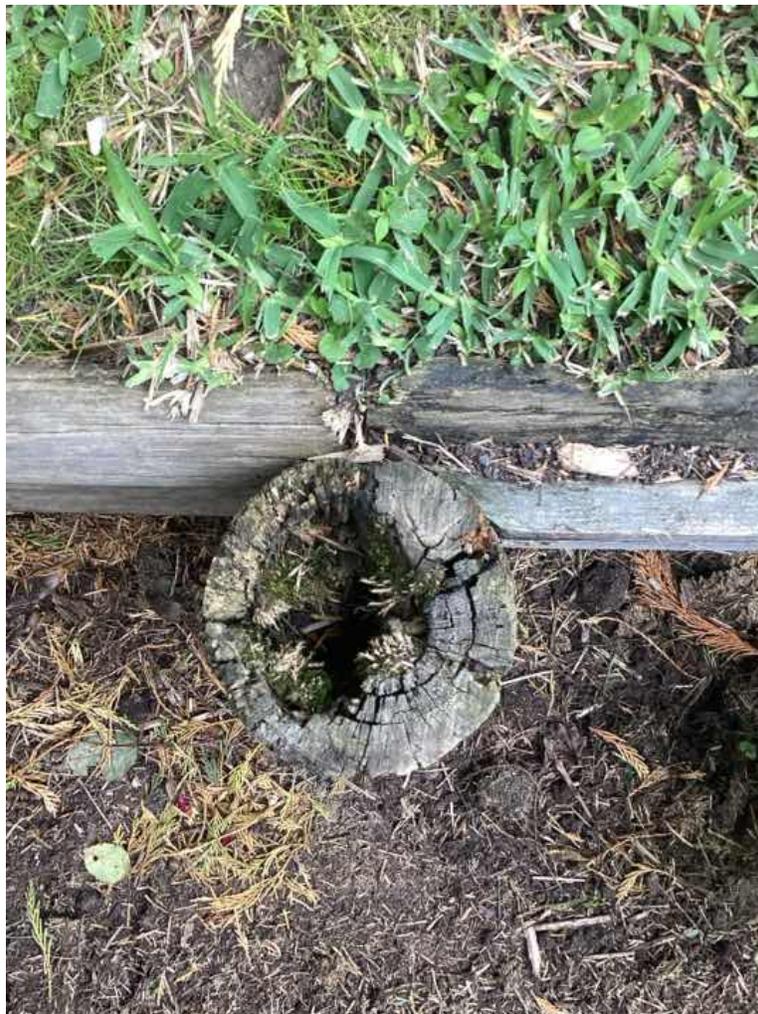
Timber fungal decay evident. Recommendations: A qualified landscaping contractor should be engaged for repairs and recommendations.

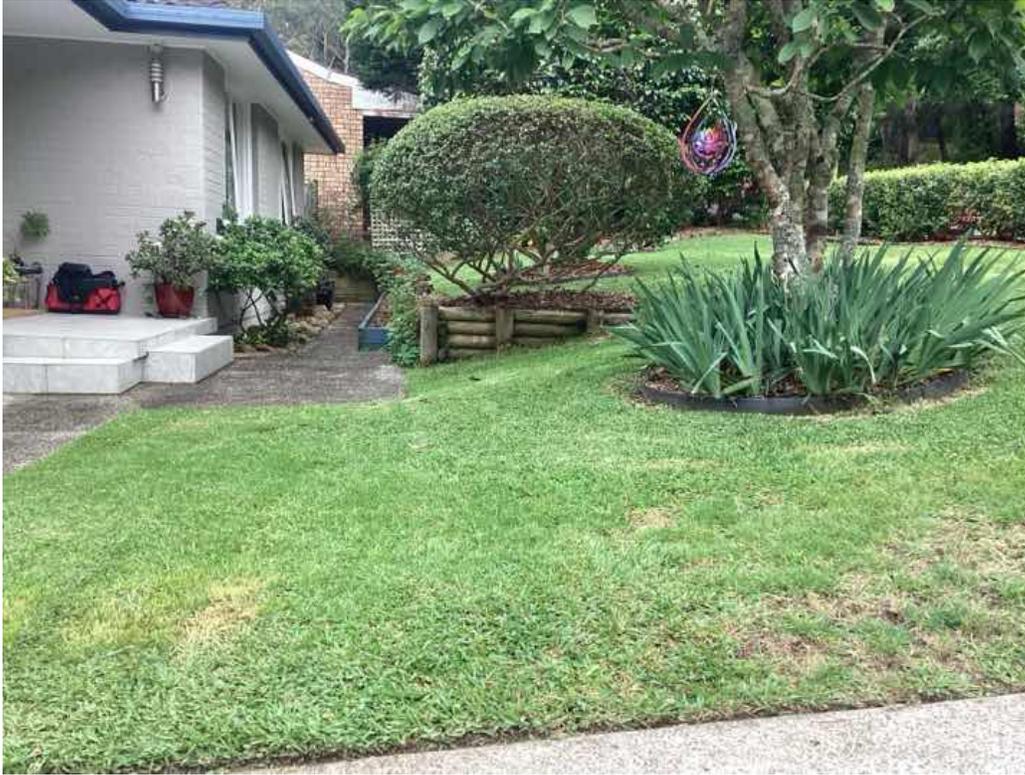
The ground levels along the perimeter walls at the front of the home did not appear to fall away from the property walls sufficiently due to the natural landscape and contour. This will need to be assessed during a period of rainfall and if surface water appears to be entering the sub floor if applicable or ponding against the perimeter walls, engage a plumber or landscaper to assess and rectify as required. All drains should be regularly checked by a plumber and kept clean of debris to allow surface water to be carried away from the dwelling.

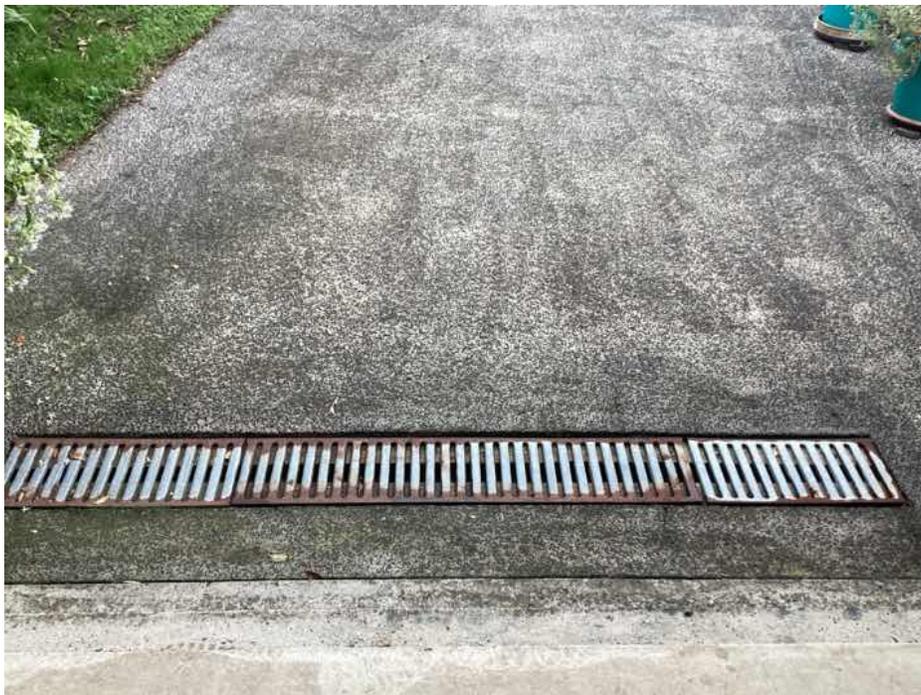
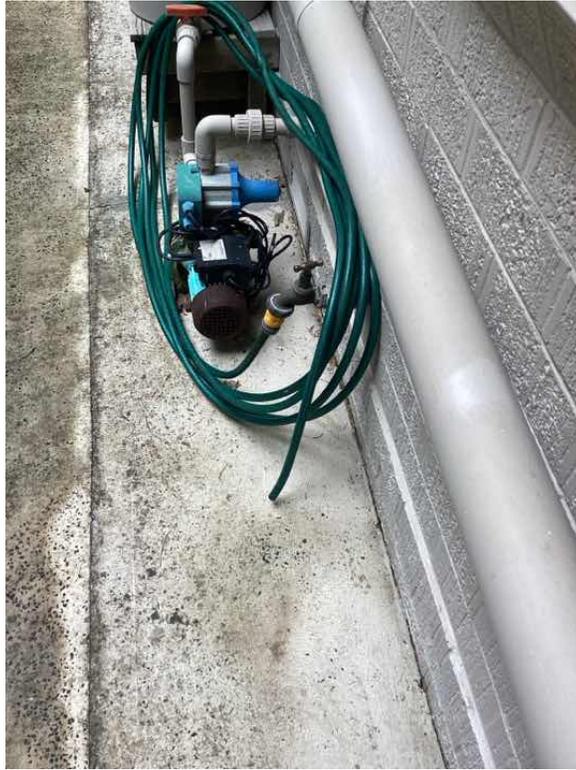
Recommend installing a drainage point under the tap to assist with drainage.

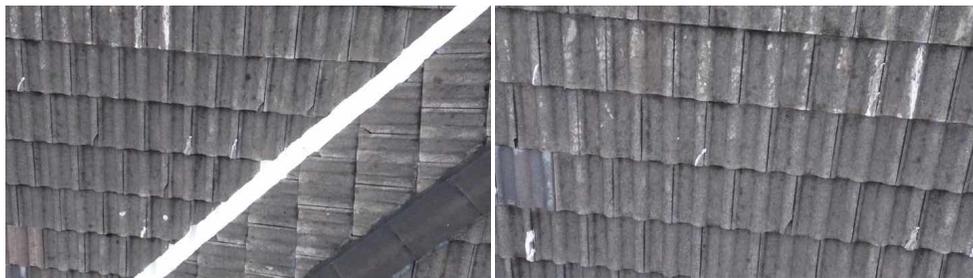
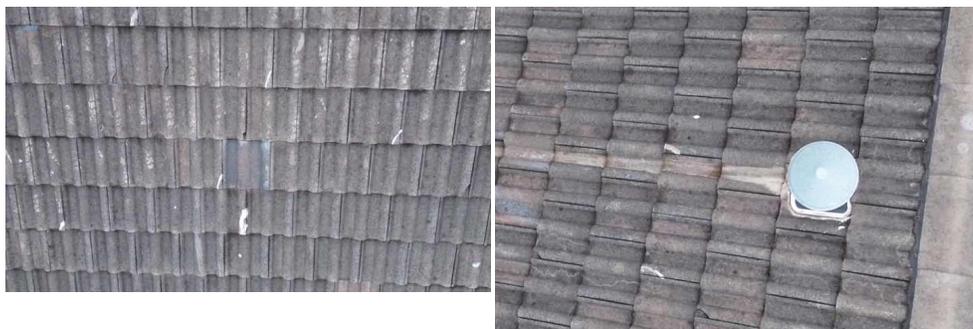
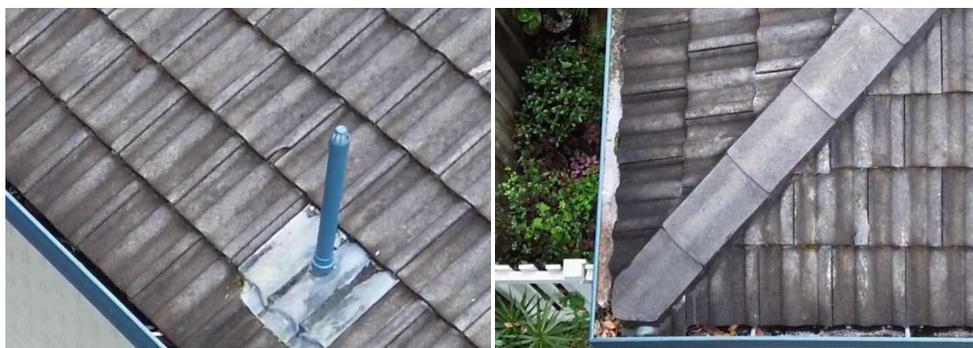
Cracked tiles visible. Contact a roof tiler for repairs. This has potential to become a serious issue if repairs aren't carried out due to water ingress into the roof cavity.

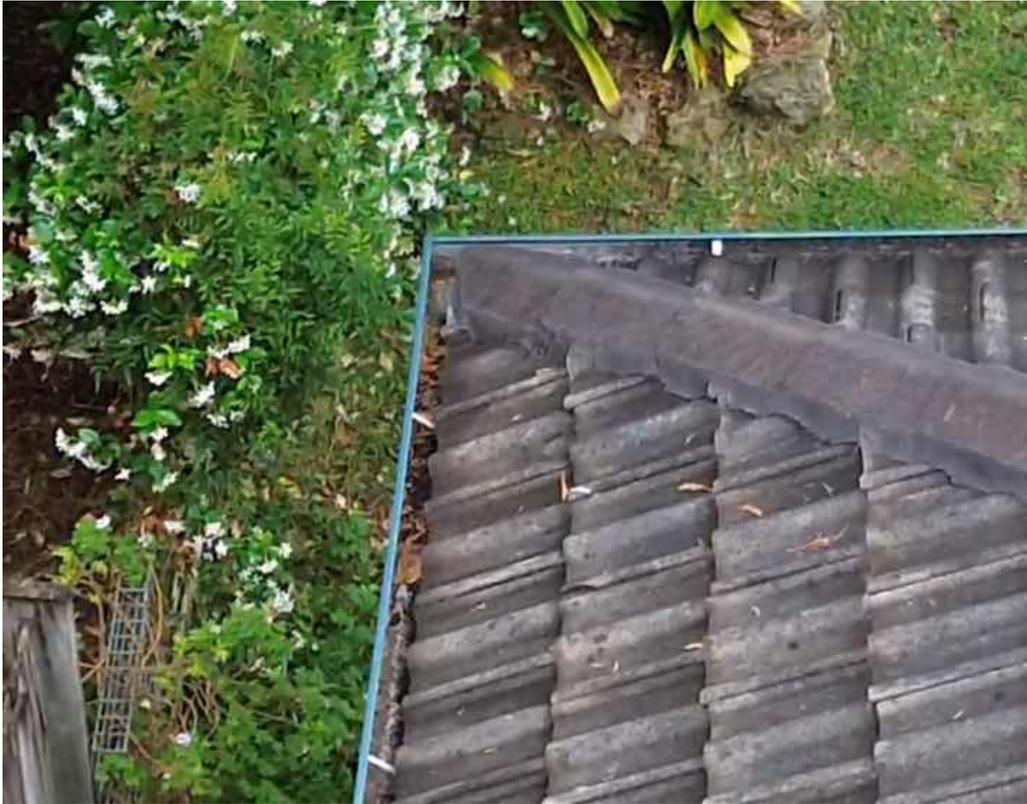
Debris in guttering areas- this requires cleaning out to prevent blocking of downpipes and leaking into eaves and fascia. Have gutters cleaned and assessed by a plumber for adequate fall. Regularly clean to prevent ponding. Ponding water will contribute to rust.

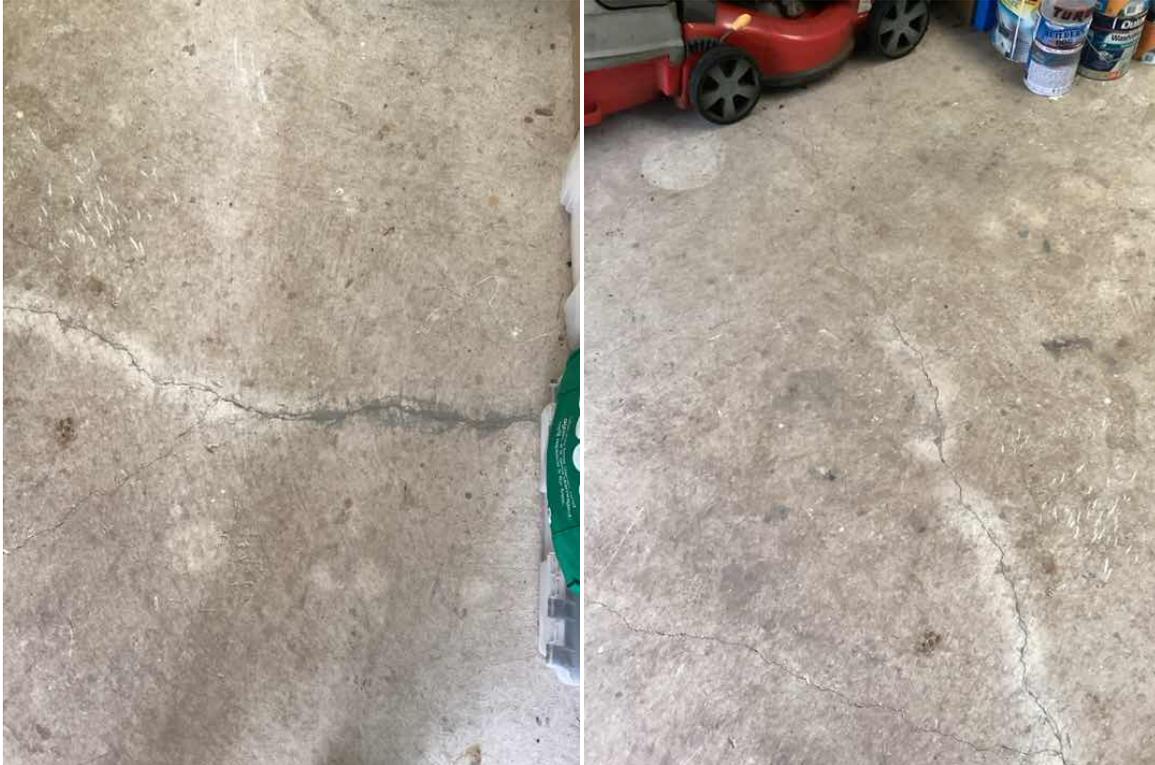
Minor hairline slab cracks - Note. Whilst these cracks appeared to be minor at the time of inspection, we strongly recommend you monitor these cracks and if worsening occurs contact a qualified concreter for further advice.

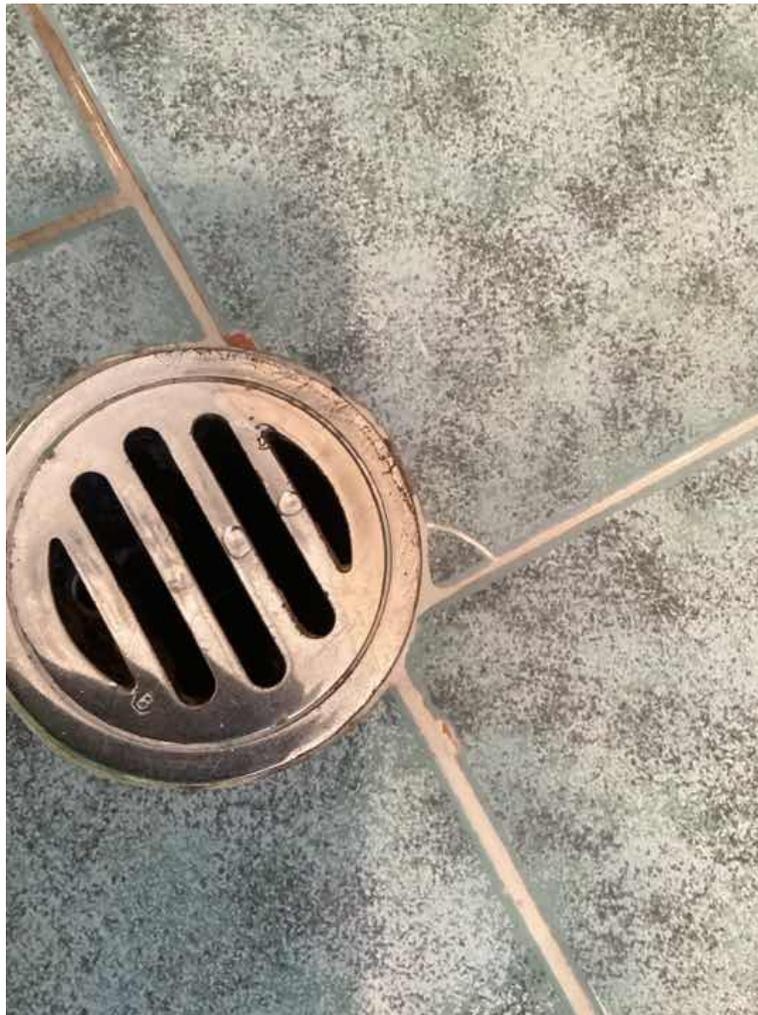
Cracked tile/s noted. This can cause extensive floor and floor frame damage and is conducive to termite infestation if water is leaking through the cavity. A qualified tiler should be engaged for advice and recommendations.

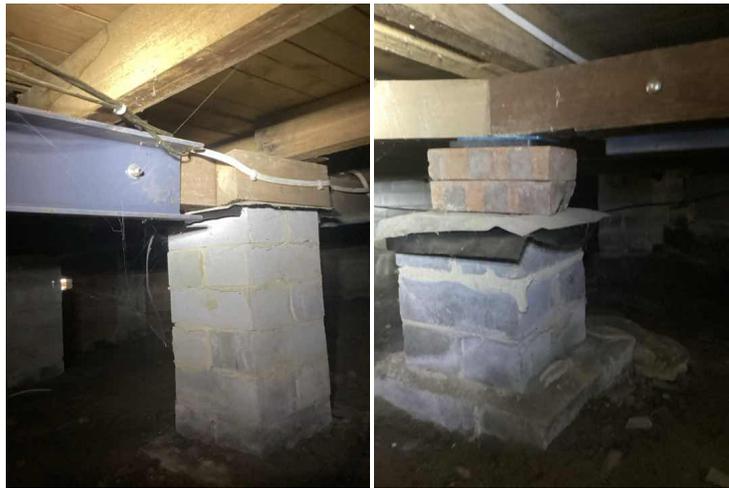
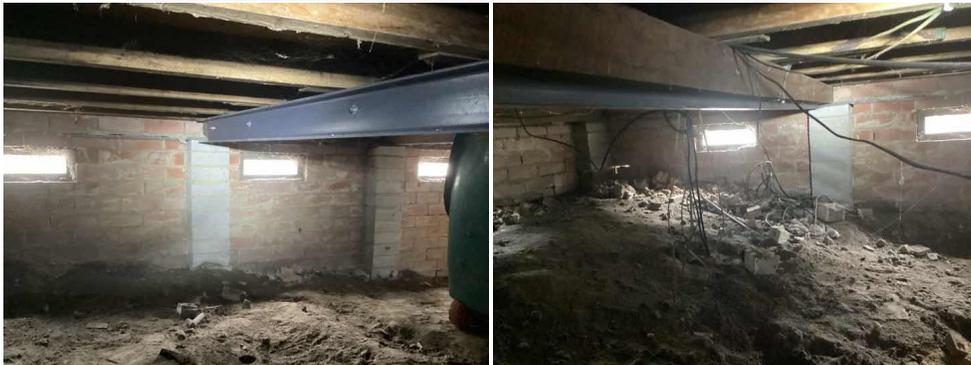
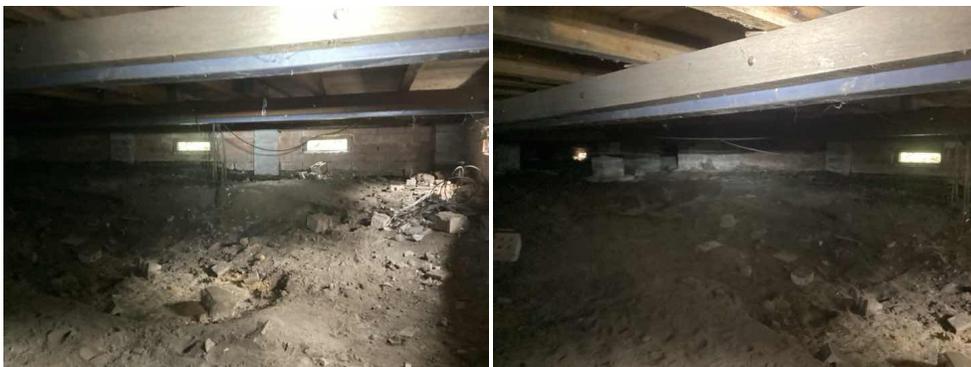
Missing brick piers. Recommend bricklayer to assess and repair accordingly.

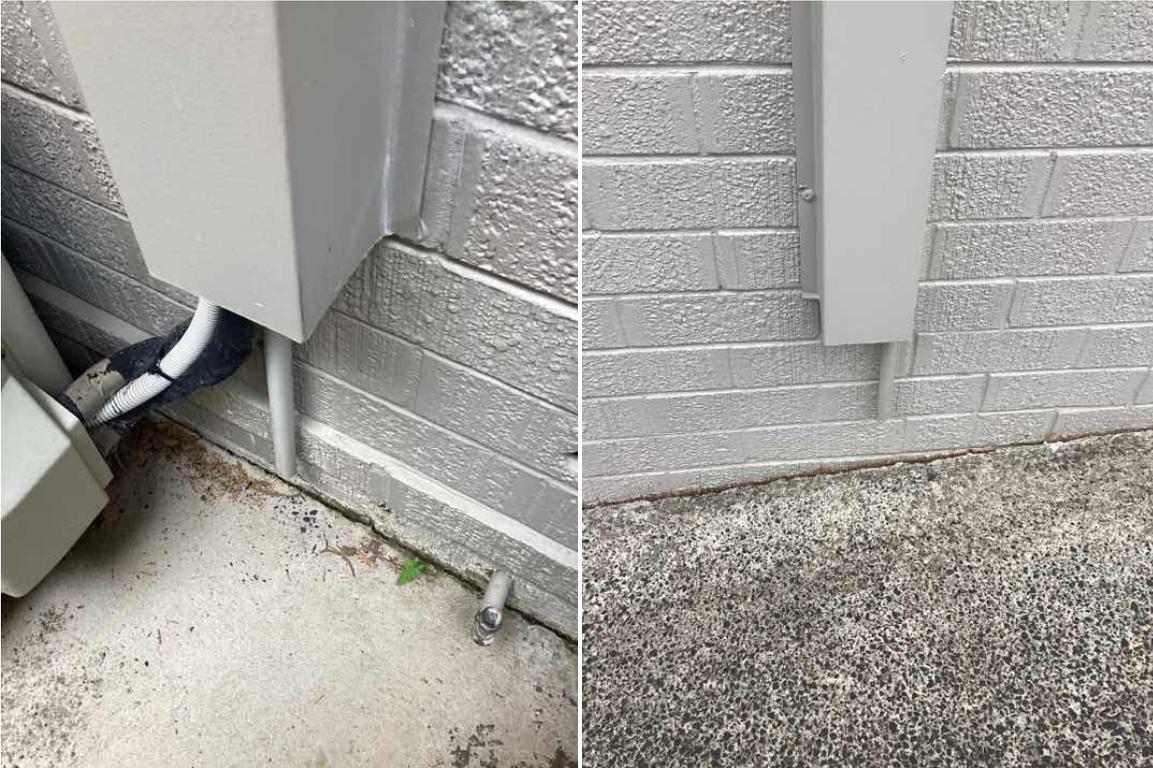
No - Divert A/C overflow away from the building perimeter.
