# Inspection Report

## Thorough Check Building Inspections

**83 Wagstaffe Avenue, Wagstaffe, NSW, 2257**

### Pest And Building Inspection

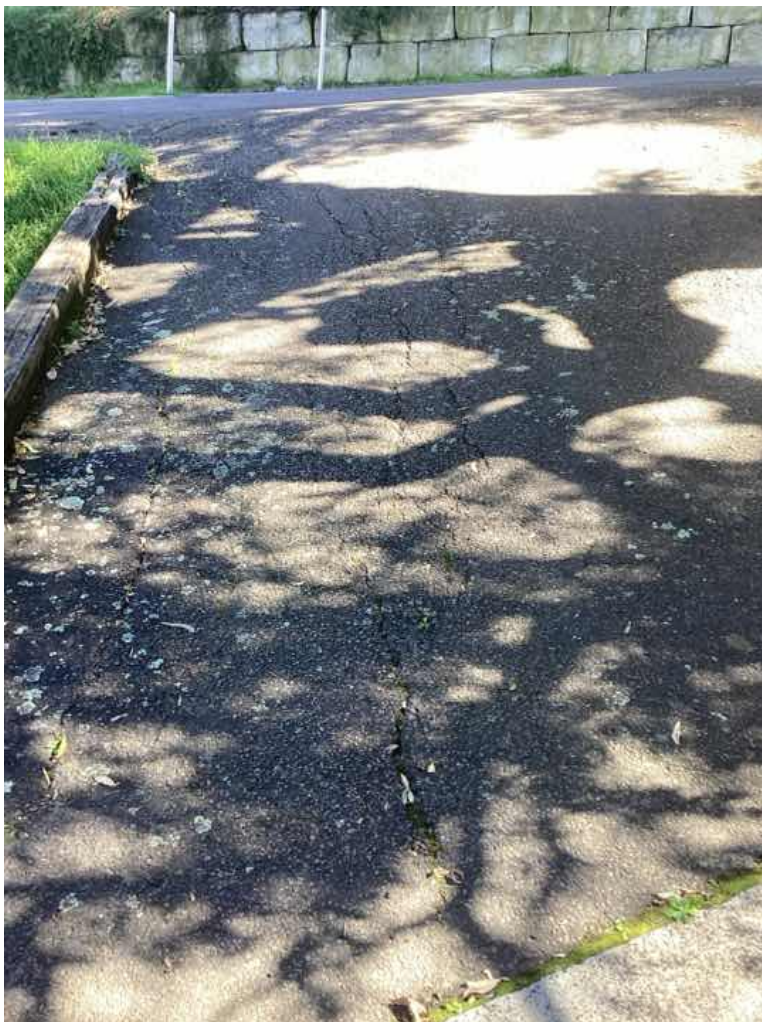
Common cracks were observed on the driveway. Whilst these cracks appeared to be typical at the time of inspection, we strongly recommend you monitor these cracks and if worsening occurs contact a concreter for further advice.

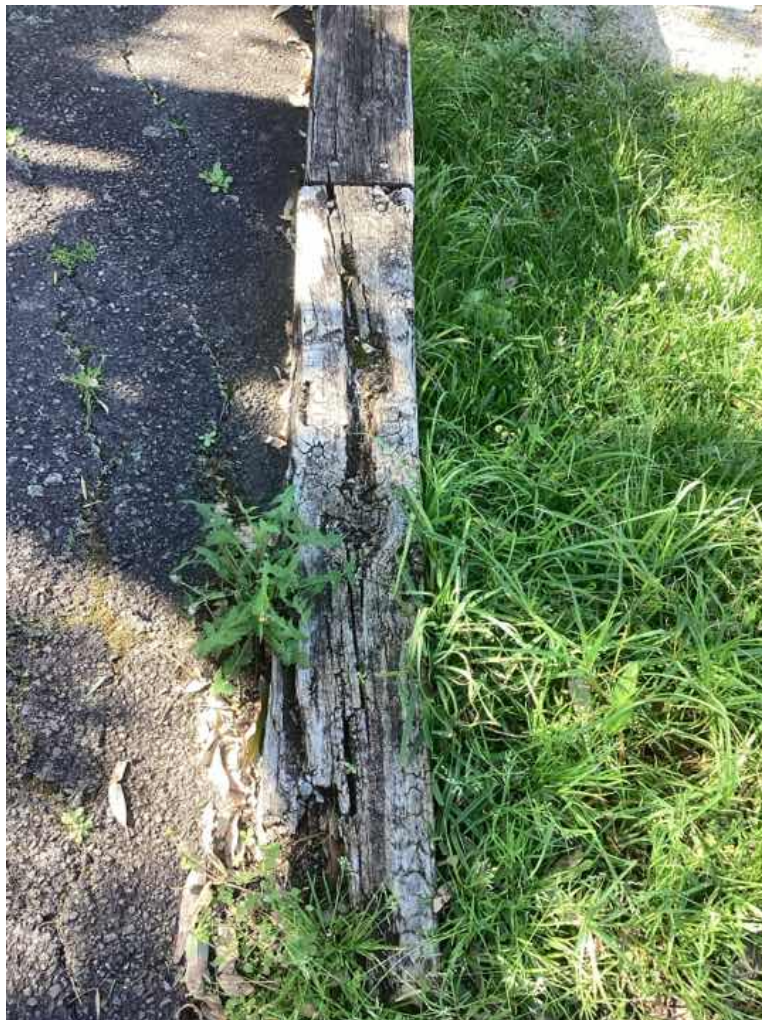
Timber fungal decay evident. Recommendations: A qualified landscaping contractor should be engaged for repairs and recommendations.

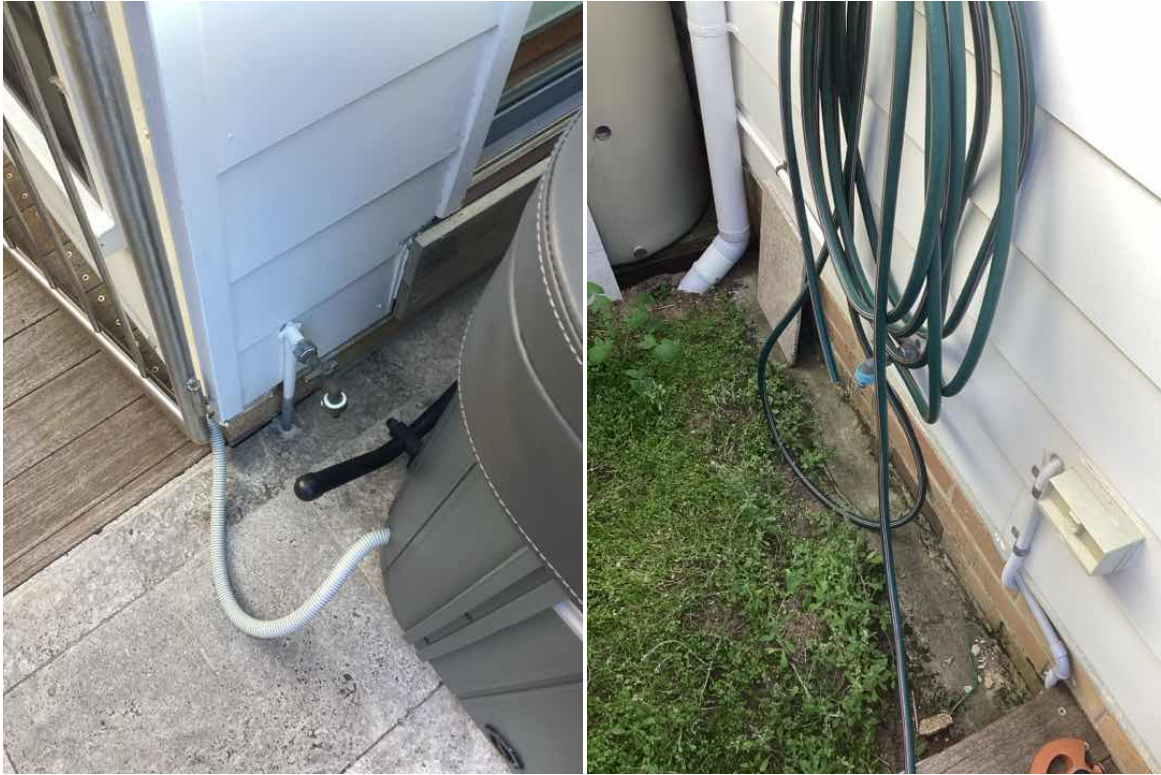
Recommend installing a drainage point under the tap to assist with drainage.

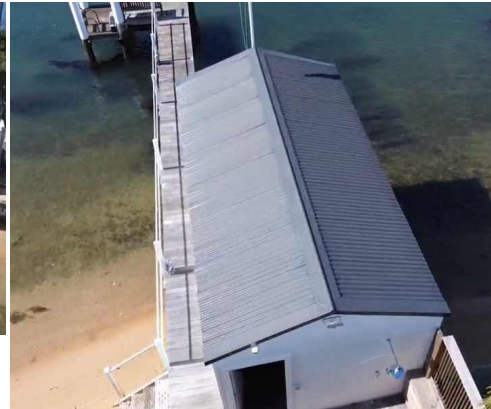
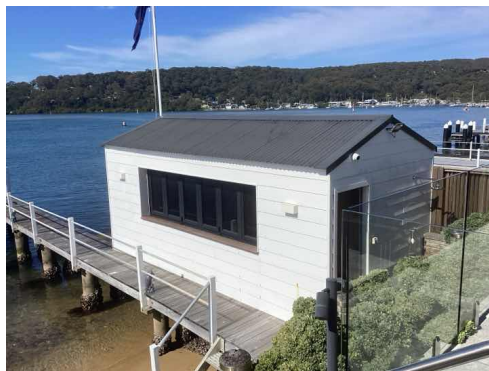
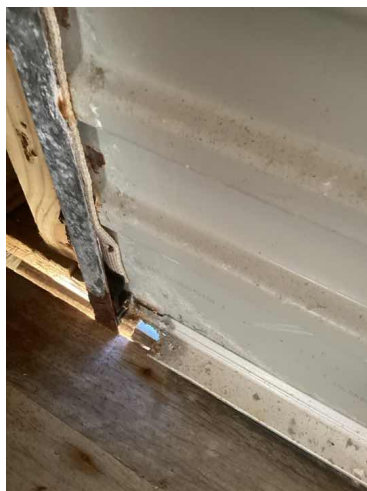
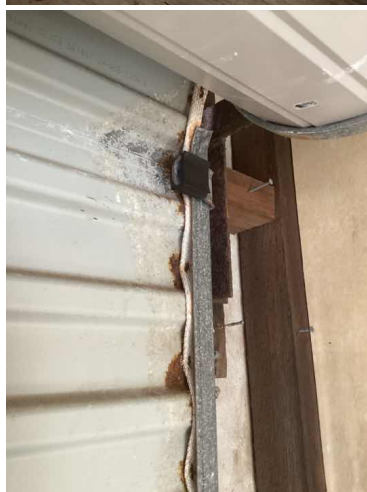
Rust developing on roller door. Repairs to restrict rust required.

Corrosion to subfloor bolts. Recommend carpenter to assess and repair accordingly.

Corrosion to boat shed cladding fixings. Recommend carpenter to assess and repair accordingly.

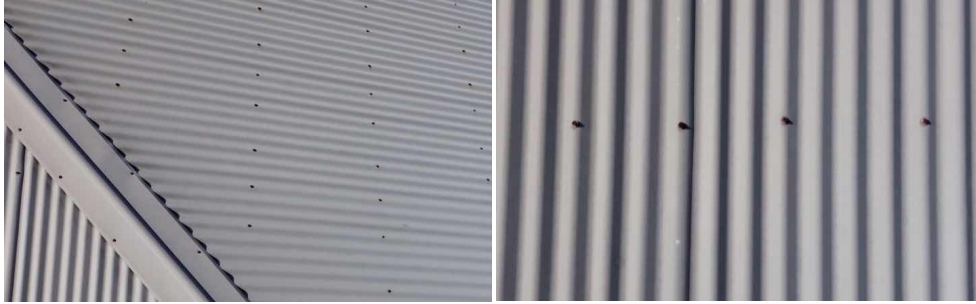
Corrosion noted to the screw fixings of the metal roof. Have these checked and replaced by qualified roofing contractor.

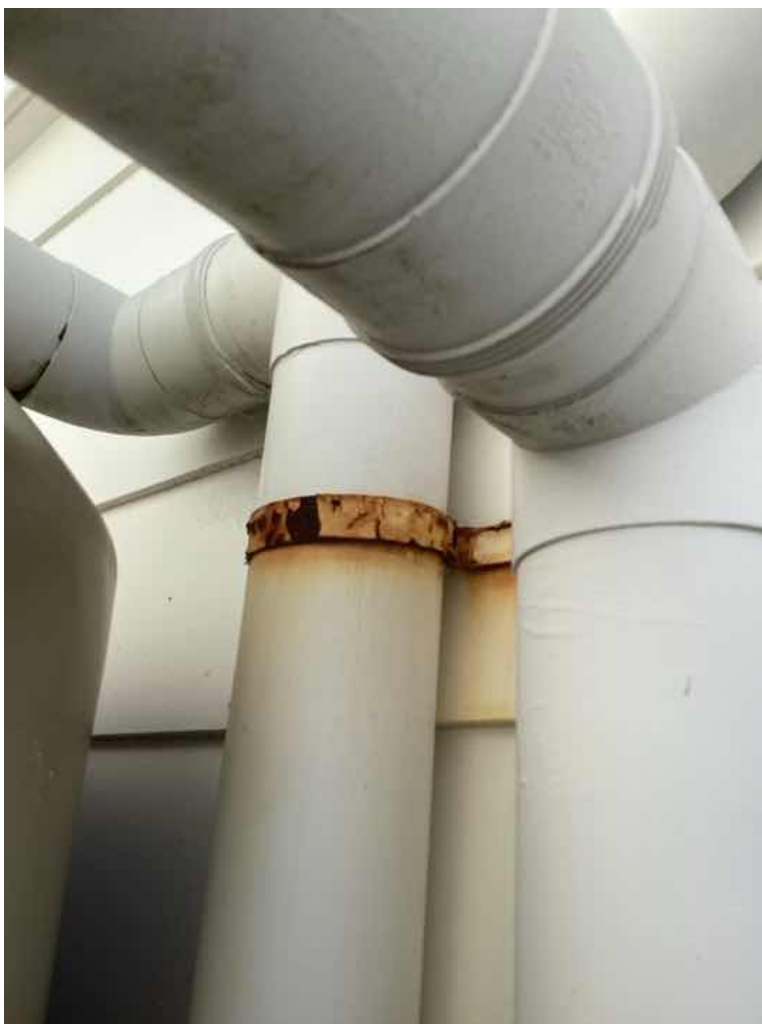
Minor downpipe bracket rust visible. A qualified plumber should be engaged for advice and recommendations.

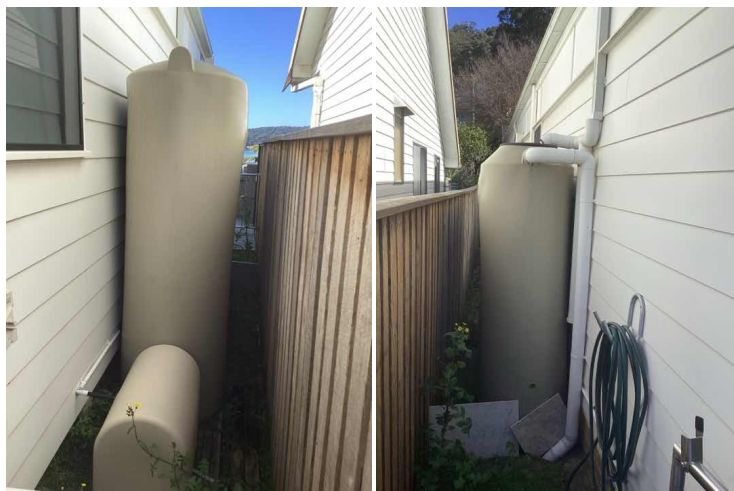
Leaking section. Recommendations: Assessment conducted by a licensed plumber advised.

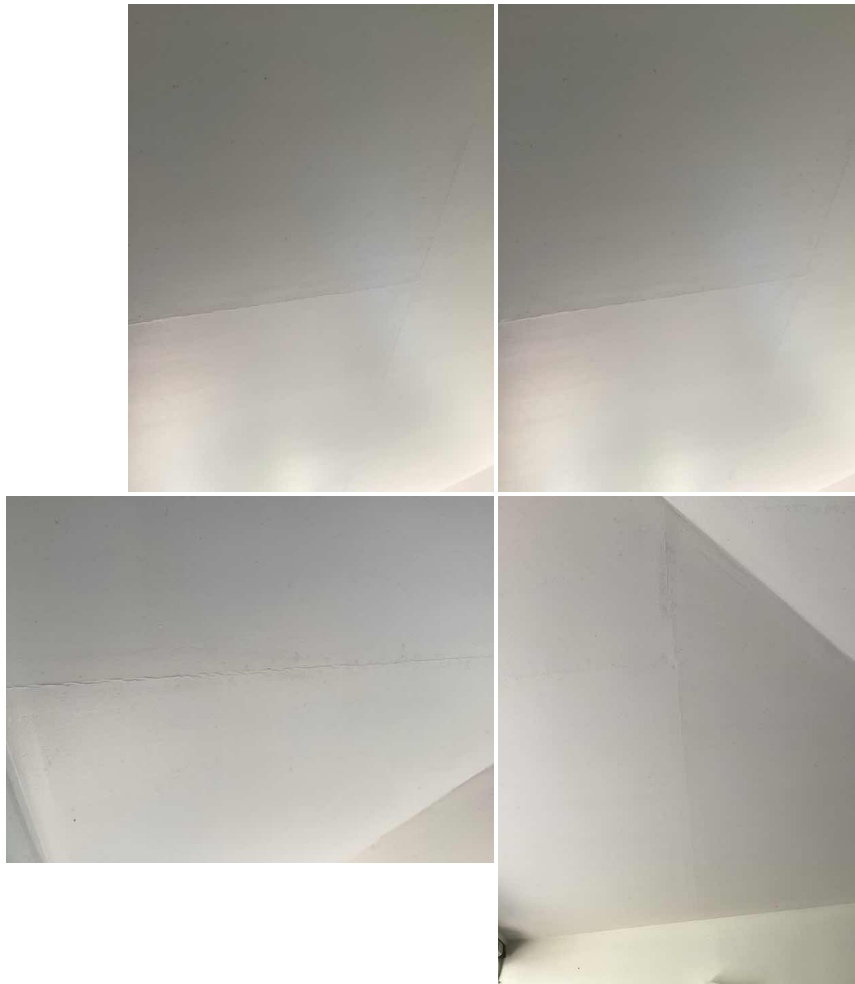
Ceiling lining join cracks. Contact a licensed plasterer fo repairs.

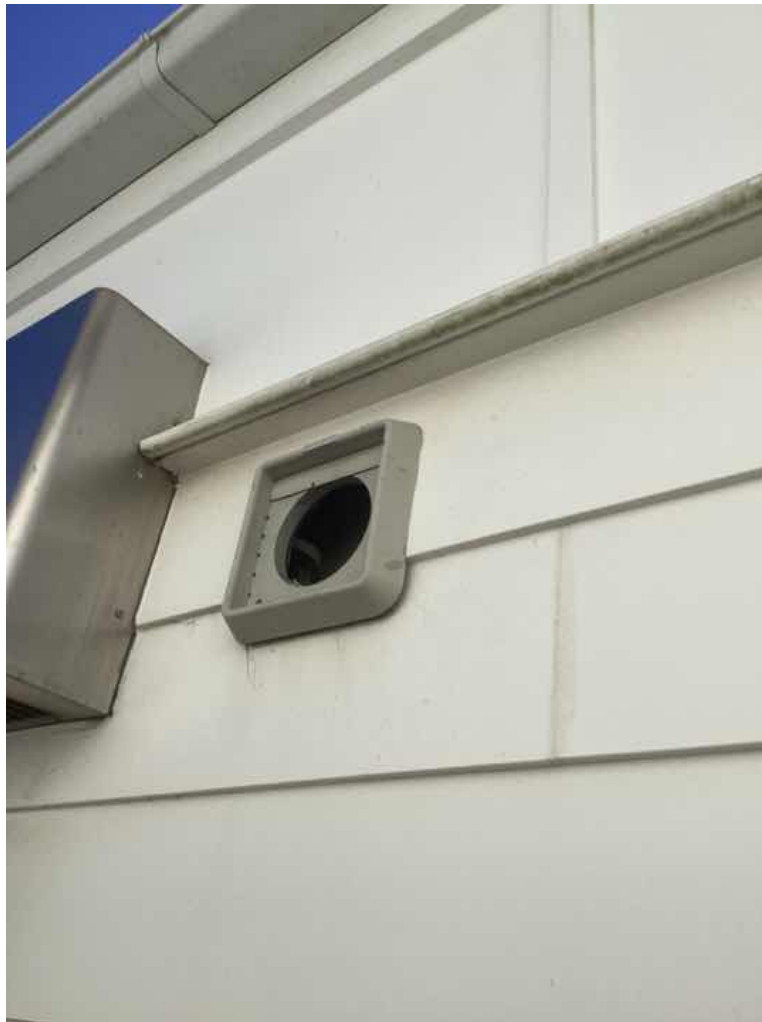
Penetration openings observed. I recommend sealing these off so as to avoid vermin and other pest infestation.

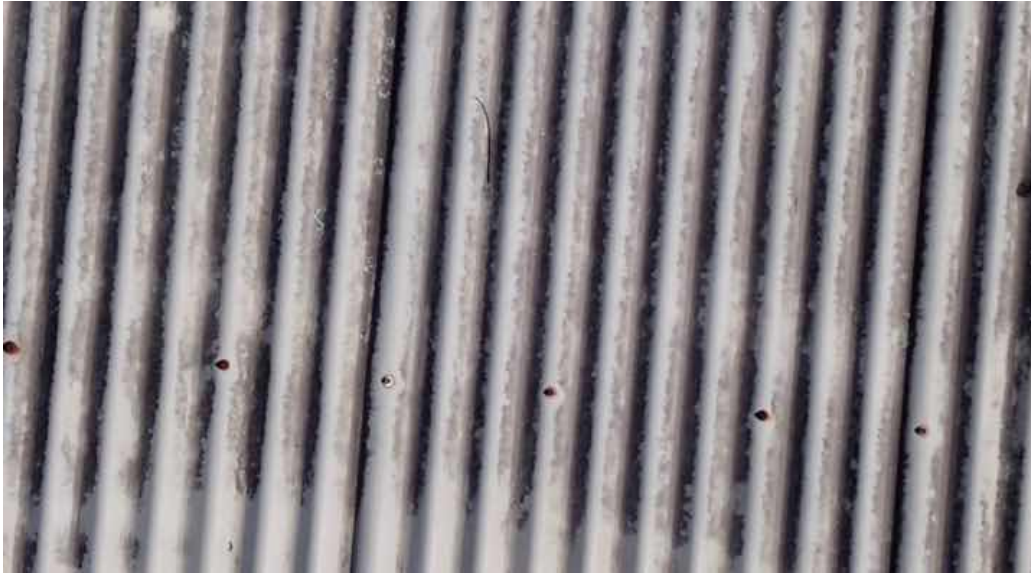
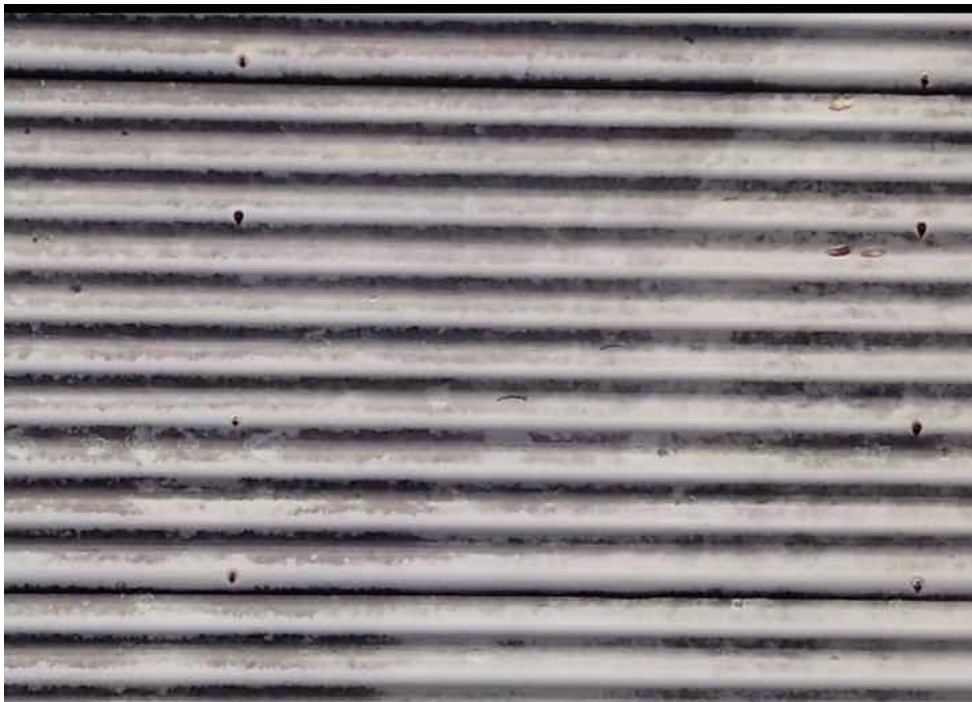
Corrosion noted to the screw fixings of the metal roof. Have these checked and replaced by qualified roofing contractor.

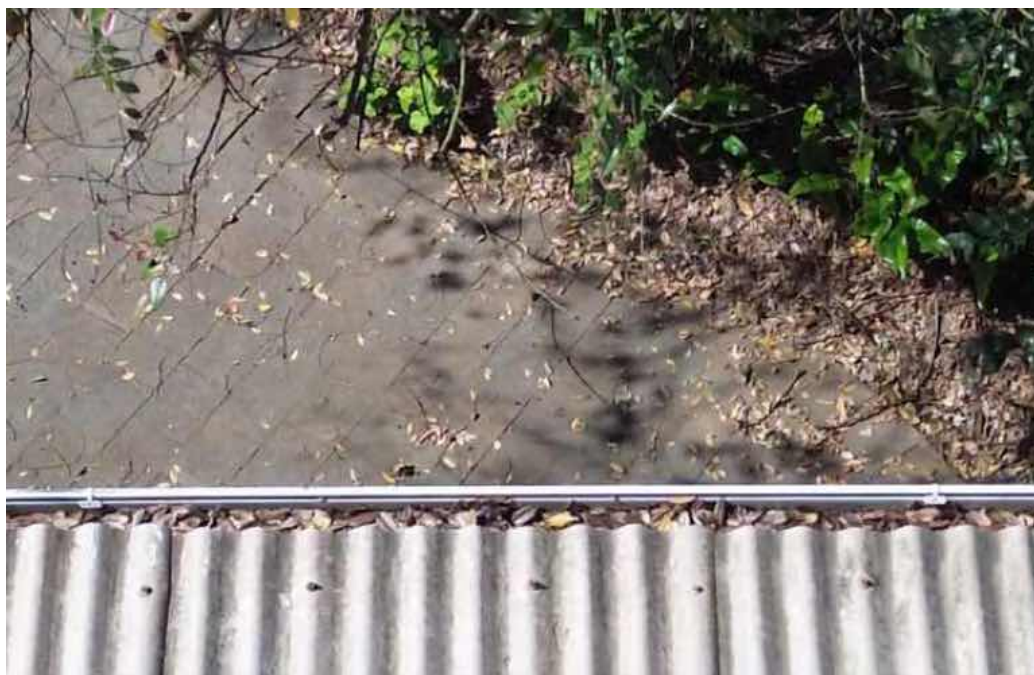
Debris in guttering areas- this requires cleaning out to prevent blocking of downpipes and leaking into eaves and fascia. Have gutters cleaned and assessed by a plumber for adequate fall. Regularly clean to prevent ponding. Ponding water will contribute to rust.

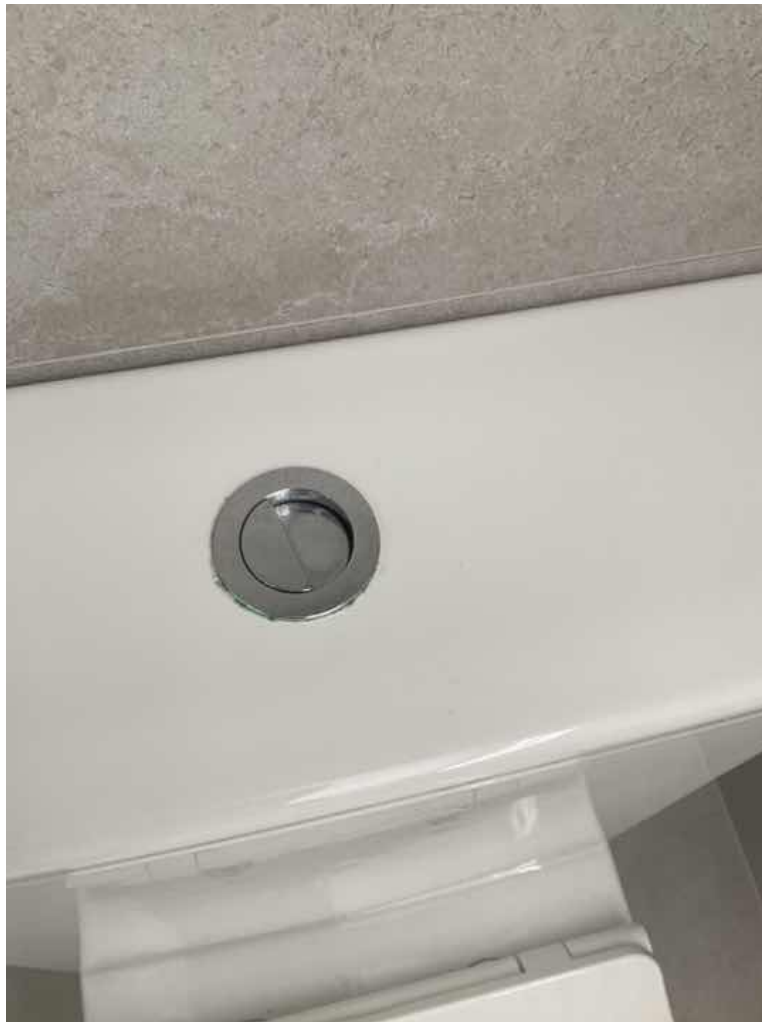
Half flush inoperable. Recommend plumber to assess and repair accordingly.

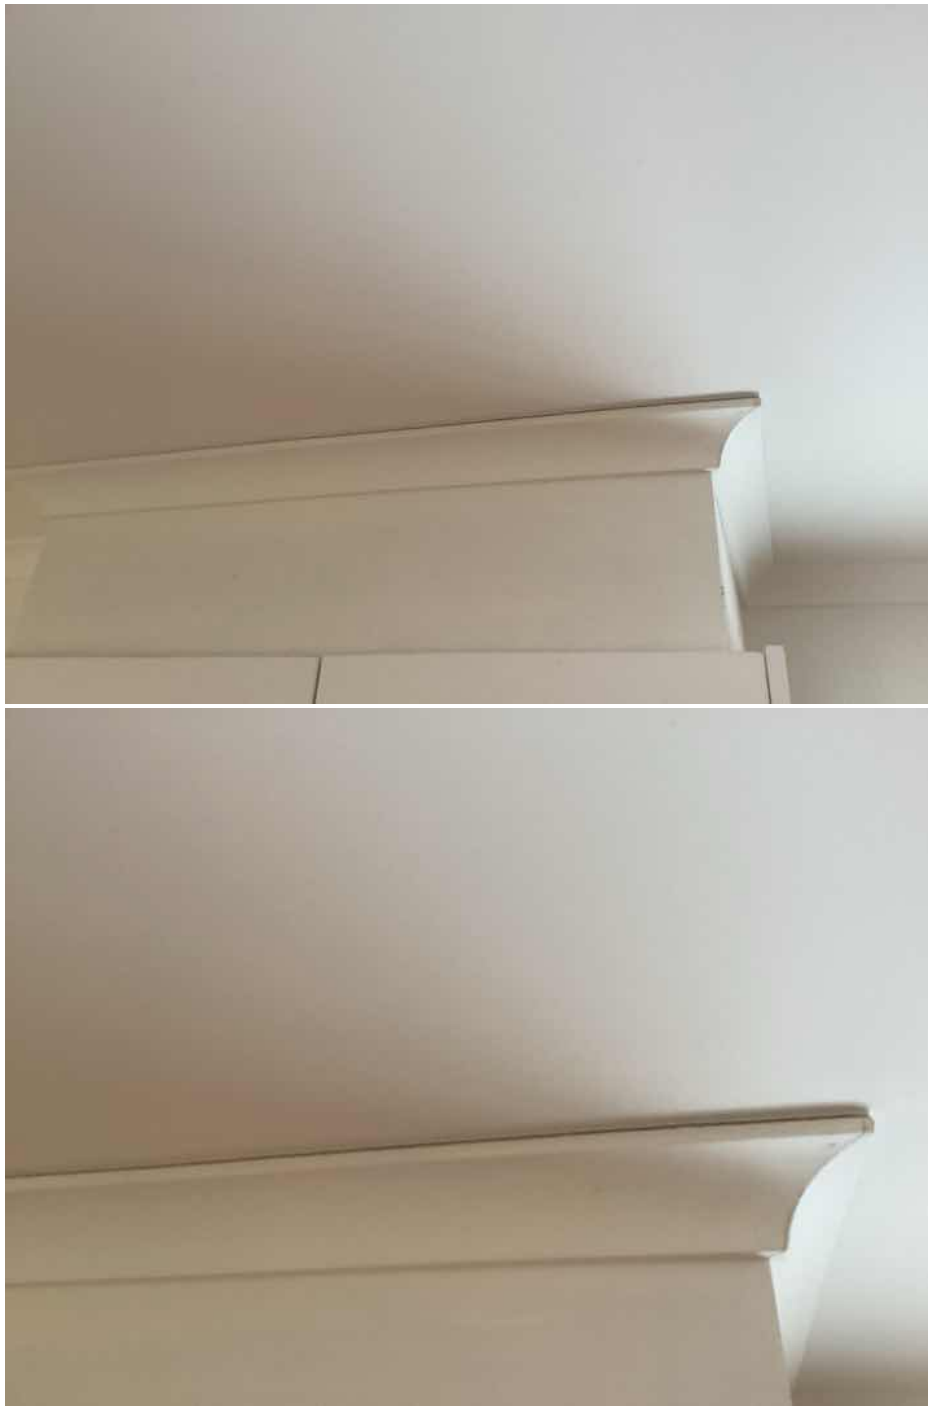
Settlement Cracks Noted. These are typical and generally patch and paint will suffice, however monitoring these cracks advised for 12 months and if they become wider or longer, you will need to contact a structural engineer to assess.

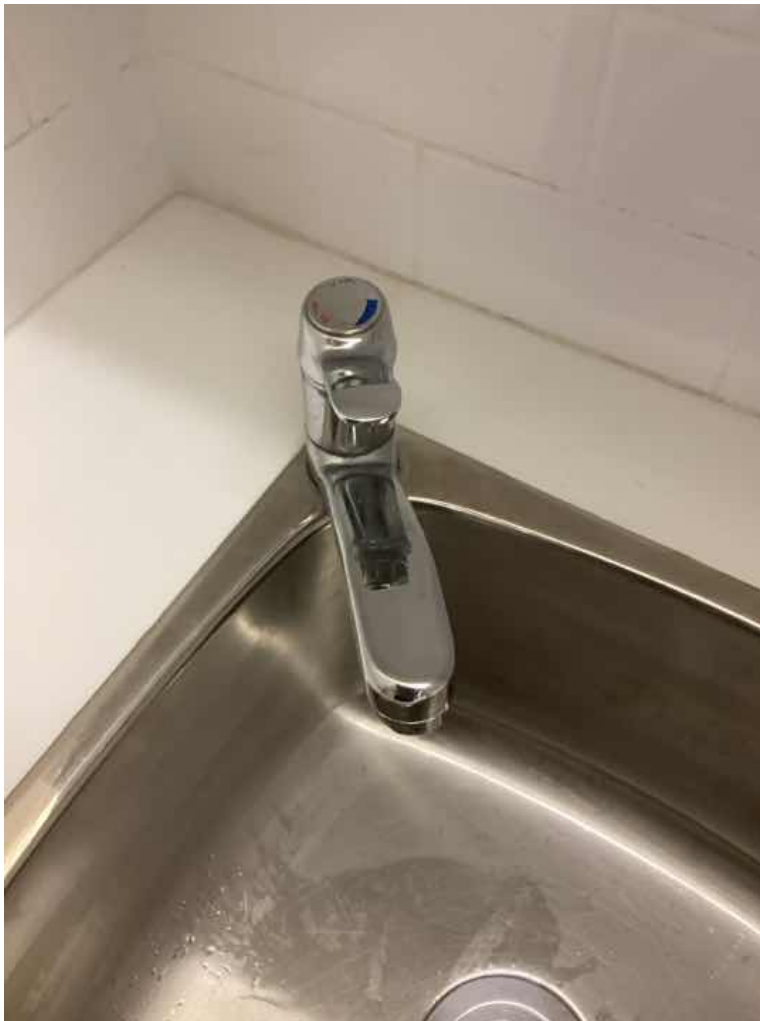
The tap / tap head is loose. Might be as simple as tightening or a replacement maybe required. A qualified plumber should be engaged for assessment and recommendations.

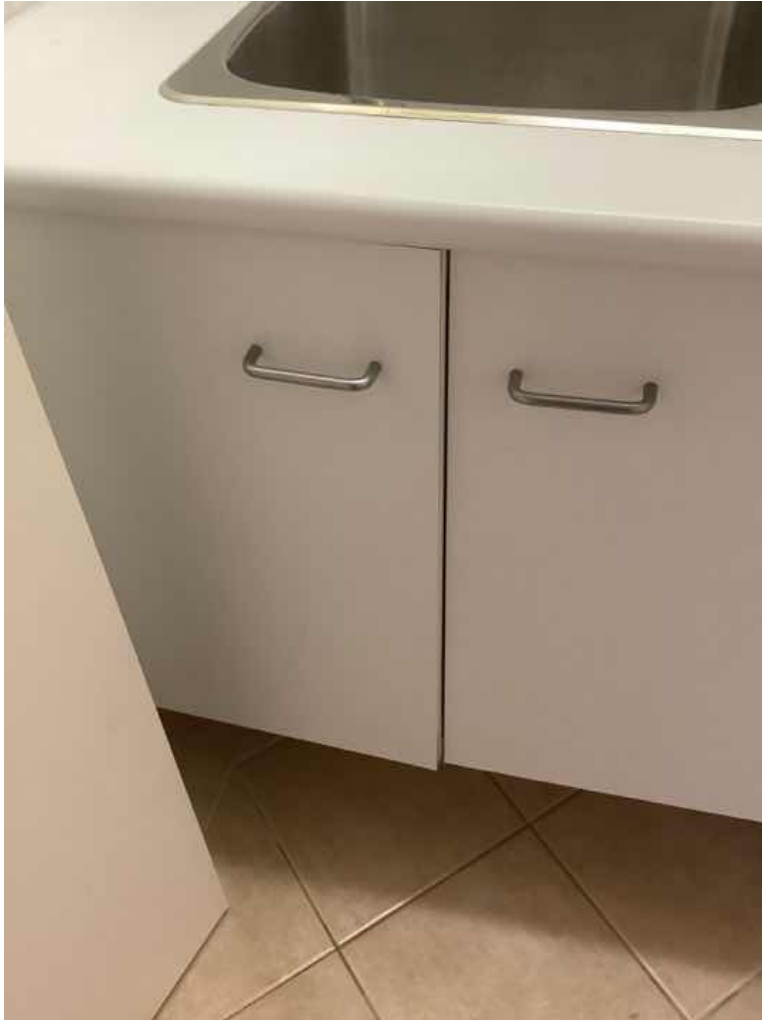
Adjustment to cabinet doors required, in some instance hinges may need to be replaced.

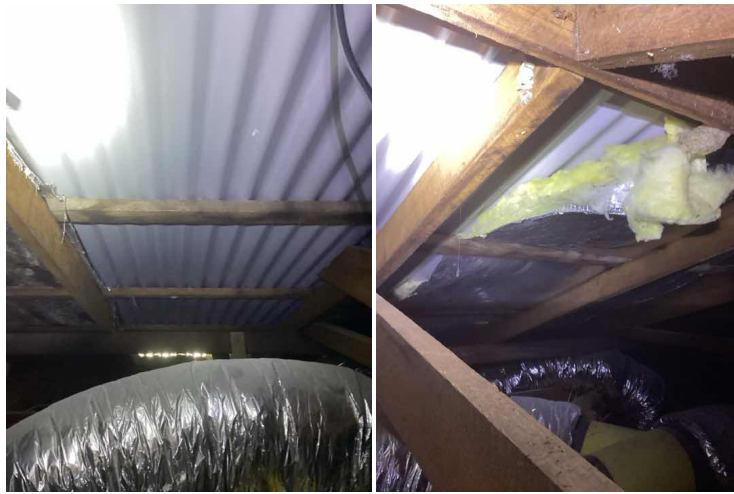
Sarking deteriorated/ damaged / aged in some sections. A qualified roofing contractor should be engaged for advice and recommendations.

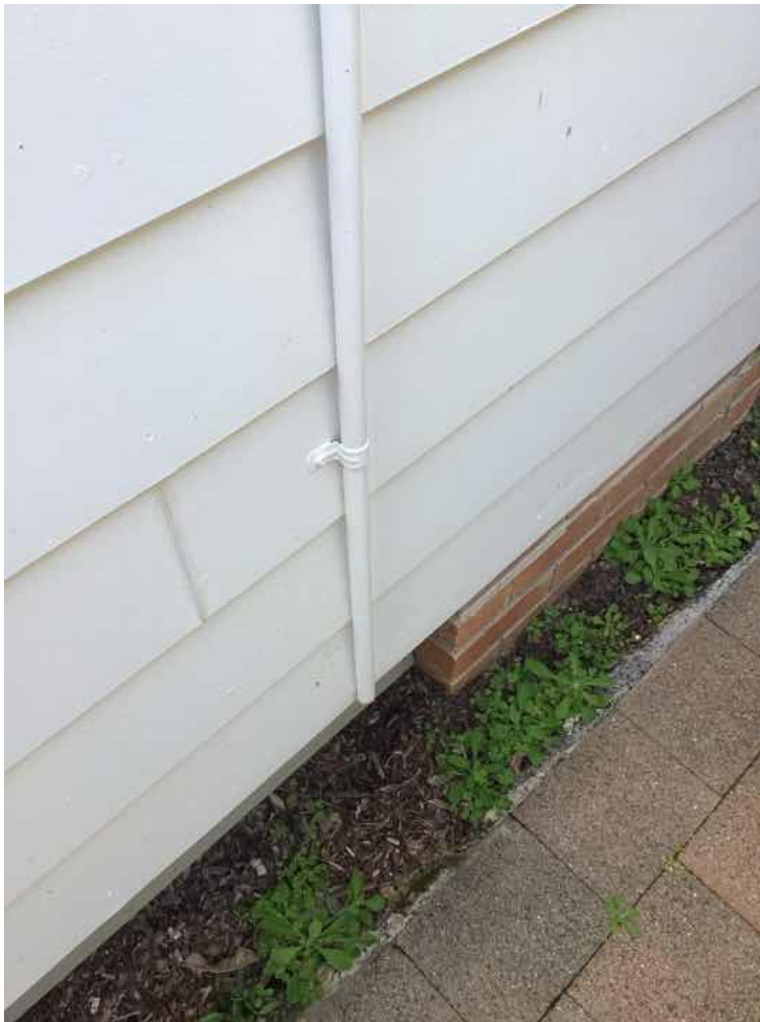
No - Divert A/C overflow away from the building perimeter.
