TIMBER PEST REPORT

442 Orange Grove Rd
Blackwall, NSW 2256

Peter McFadyen
12/03/2026

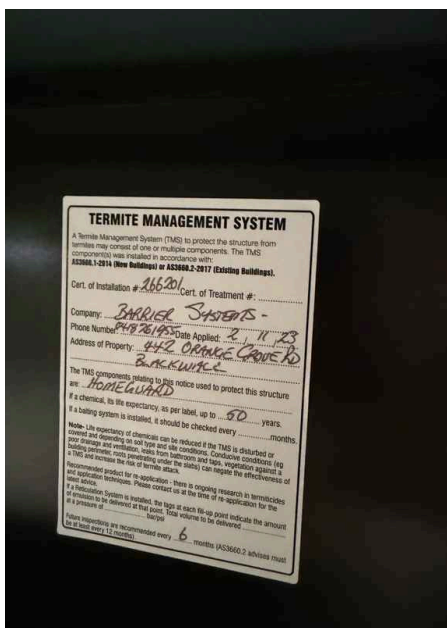
Was there evidence of Termite Treatment?

Yes - termite management notice in meter box

You should obtain copies of all relevant paperwork and make your own inquiries about the quality of the treatment when it was carried out, as well as warranty information.

In most cases, you should arrange for treatment in accordance with "Australian Standard 3660.2" to reduce the risk of further attack.
