BUILDING & TIMBER PEST INSPECTION REPORT

51240
Report Number

78 Timbertop Drive, Umina Beach NSW 2257
Inspection Address

05 December 2025
Date of Inspection

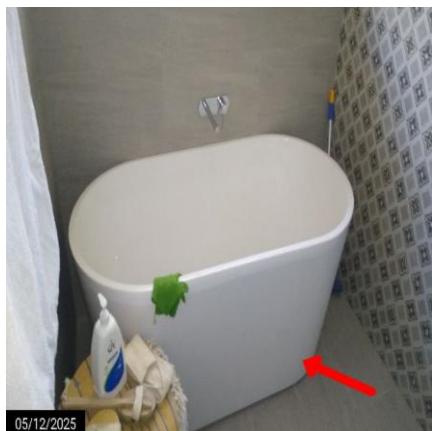
Stand alone bath is not fixed to floor and/or firmly secured into position. This can be a tripping/safety hazard and excess movement can also cause leaks/ cracking to bath floor waste pipes/outlets etc. Rectification is highly recommended.

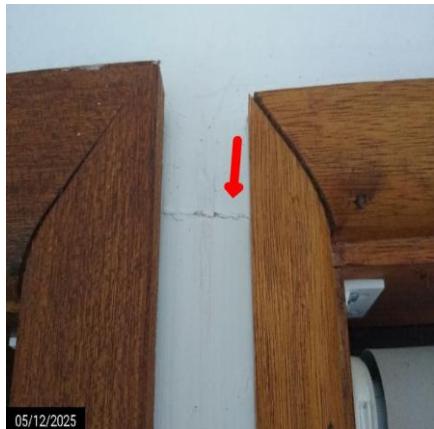
Patching and painting will improve overall appearance.

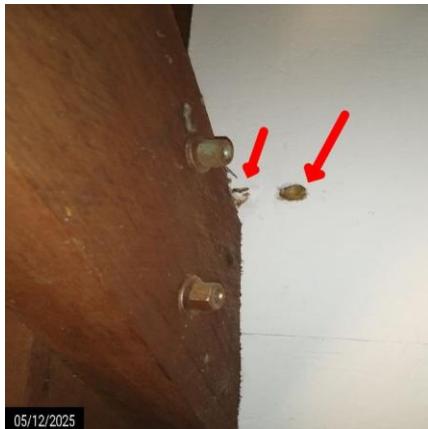
Patching and painting will improve overall appearance.

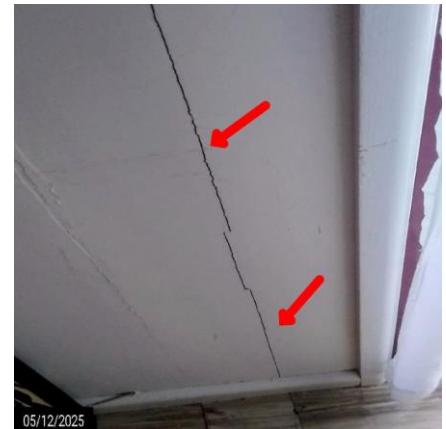
Re-fixing, painting and patching will improve defect noted.

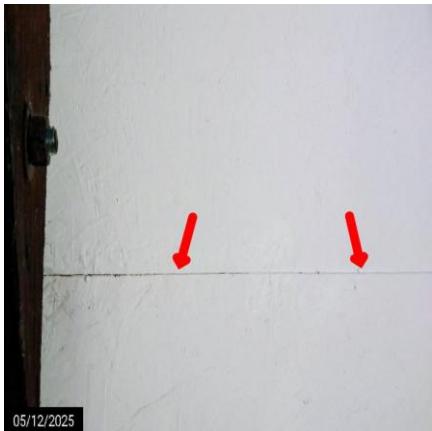
Minor cracking and paint defects to (walls), patching and painting will improve appearance.

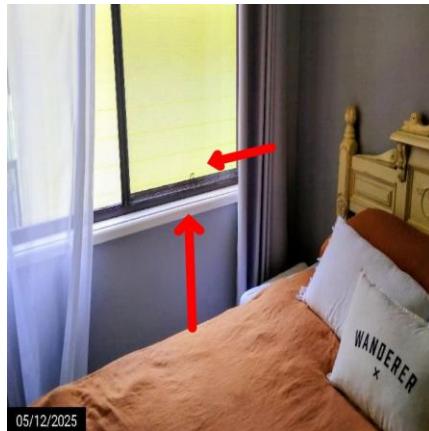
Bedroom floor level windows or windows with a sill height of less than (1.7m) metre that have a drop of more than (2) metre to external ground should be fixed closed or fitted with a suitable security screen to prevent small children falling through opening.

Whilst there is no legislated requirement to bring older homes up to current standards, we recommend, in the interests of safety, that they be brought up to current standards where a fall of 2m or more exists from any bedroom window. Refer to BCA2013 Vol.2 section D2.24 for further information/clarification of this issue. Floor level windows or windows with a sill height of less than (1.7) metre and have a drop of more than two (2) metre to external ground from internal floor level should be fixed closed or fitted with a suitable security screen to prevent small children falling through opening. Windows with a sill height of less than 1.7 m from finished floor level should be fitted with a device to restrict the window opening or a screen, with secure fittings. The device or screen is defective if it permits a 125 mm sphere to pass through the window or screen. In cases where the screen or device can be removed, unlocked or over ridden, the installations are defective if they are not fitted with a child resistant release mechanism. Windows are defective if they do not meet provision 3.9.2.5 of Volume 2 of the BCA that requires that a window opening must have protection if the floor below the window in a bedroom is 2 m or more above the ground surface beneath. Windows that are located 1.7 m above the floor level are not required to be protected.

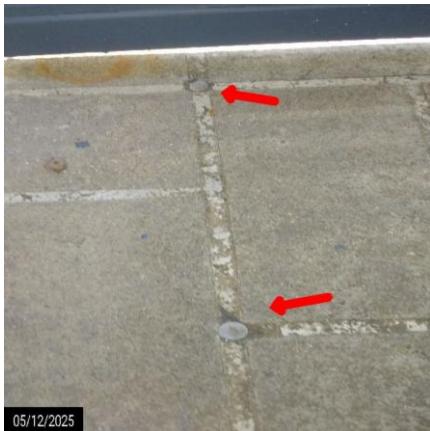
Visual evidence was found of drilling which is consistent with a termite treatment.

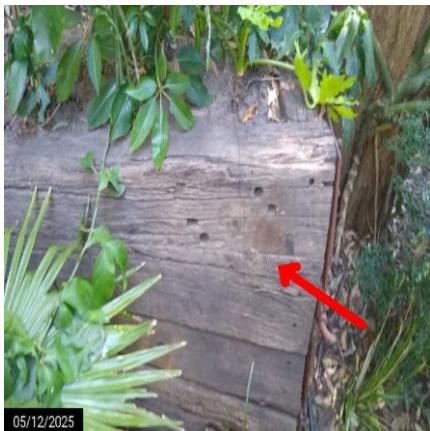
Non-treated timber retaining walls and landscaping timbers should be replaced with non-susceptible/termite resistant material.

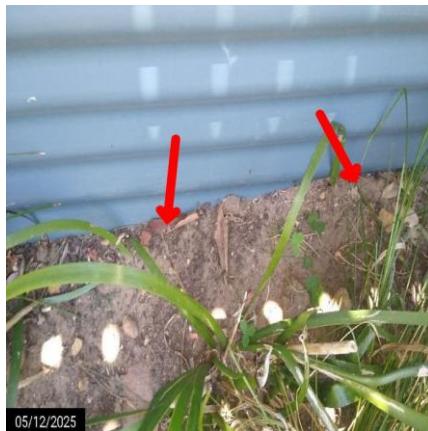
The external cladding is in direct ground contact at various locations around the dwelling and it is advised to provide at least 75mm ground clearance from bottom of cladding to ground level to prevent possible decay and/or deterioration of installed materials. Close monitoring will be required to detect decay and or termite activity before damage occurs. If cladding does not have this clearance it is considered essential to install a termite management system as a matter of urgency to control any undetected termite entry. Recommend further investigation to the inside of the wall cavity to inspect timbers for damage.

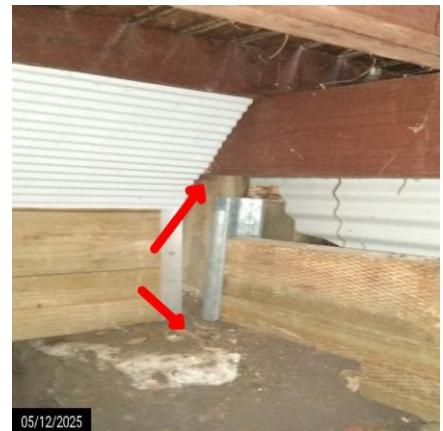
Retaining wall and timbers etc attached to the building/s. Recommend 75mm clearance or the installation of a termite management system where achieving 75mm clearance is impractical.

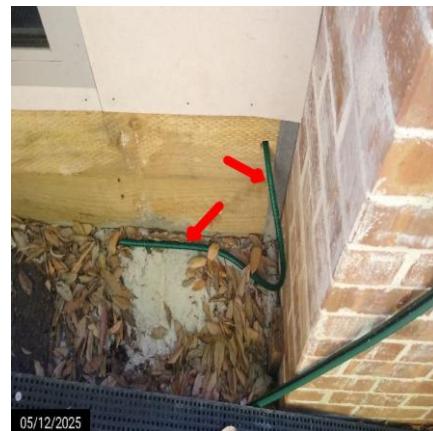
05/12/2025

Recommend to divert hot water system/air-conditioner overflow away from building foundations. Refer to Timber Pest Inspection Report.

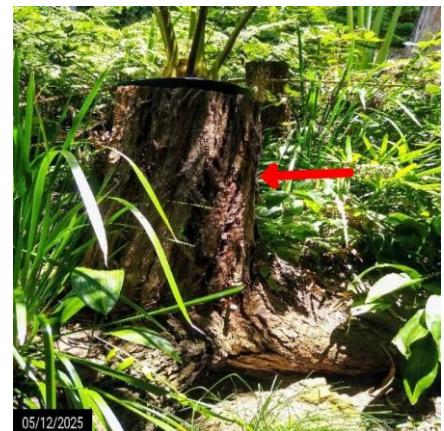
05/12/2025

Large trees/ stumps should be test drilled and monitored for termite activity. Where evidence of termite attack exists to any trees and/or tree stumps, a more conclusive search should be undertaken. This may require the tree or stump to be drilled to determine the existence of a termite nest. In addition, the soundness and stability of any standing trees identified as being affected by termite attack should be further investigated.
