# Inspection Report

## Coastal Building Inspections

**534 the entrance road , erina heights, NSW, 2260**

### Pest And Building Inspection

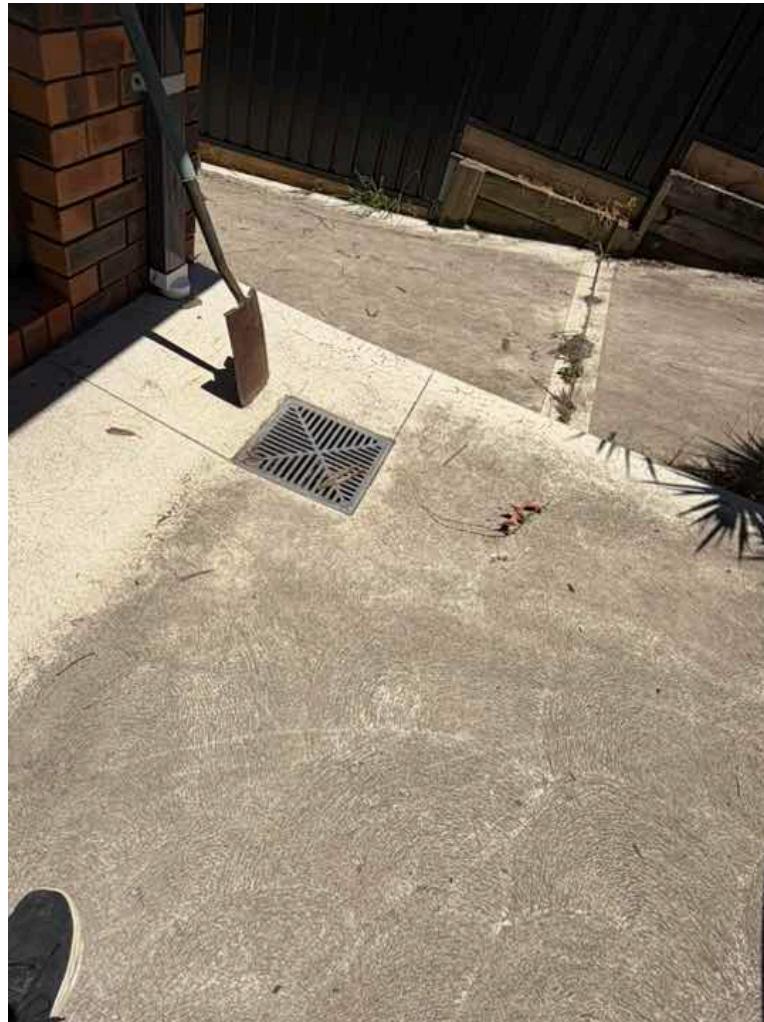
No evidence of slow or blocked drains at the time of inspections.

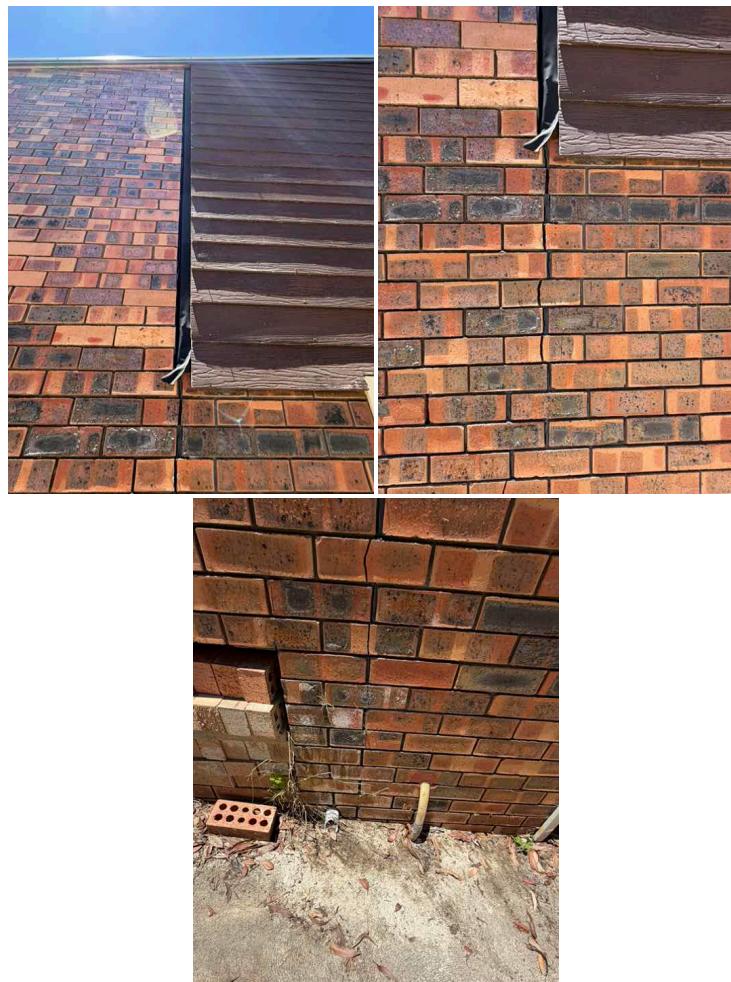
Cracks noted (Damage Category 3 to 4)

Possible causes may be foundation movement. Support structure deflection. Thermal movement and moisture uptake or loss, failure under external loads. In the inspectors opinion these cracks require further assessment. A structural engineer should be consulted for further evaluation and advice.

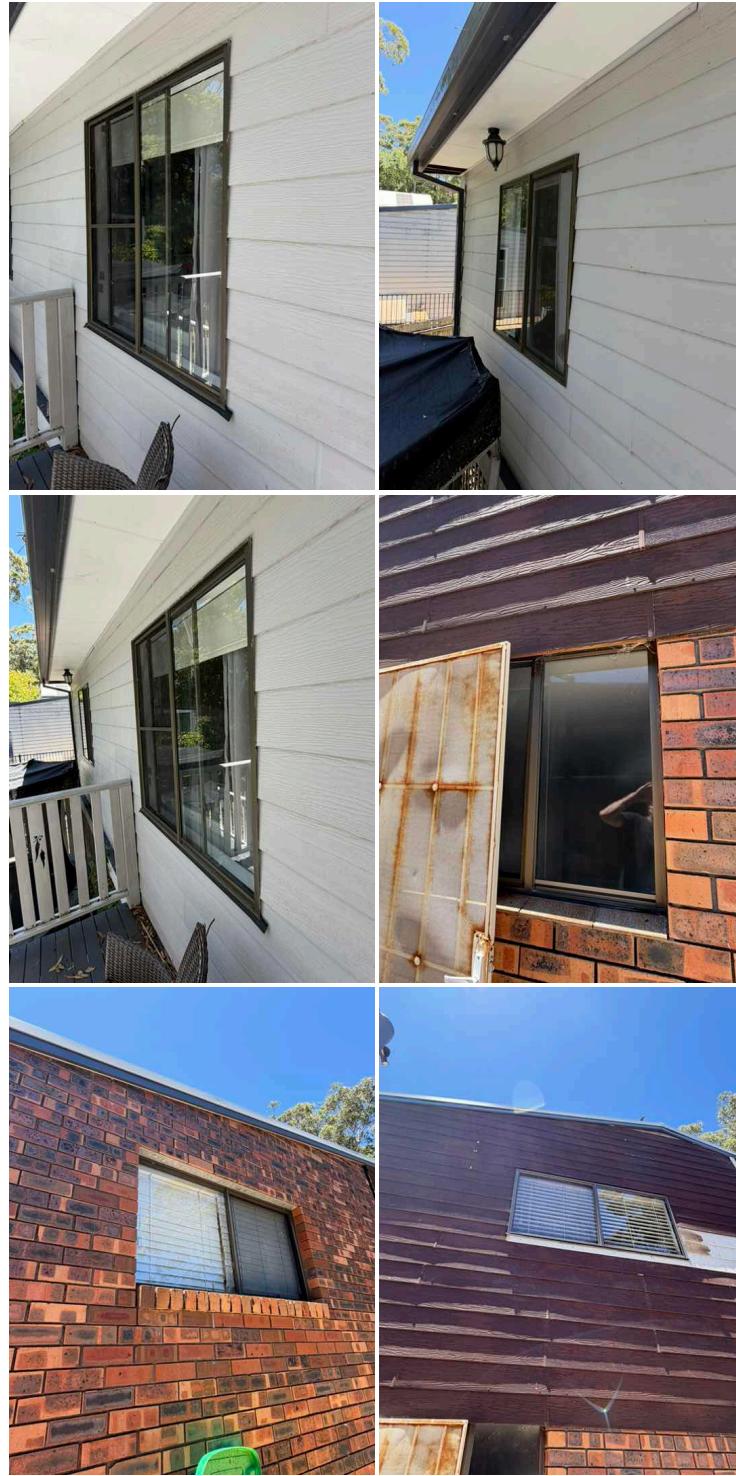
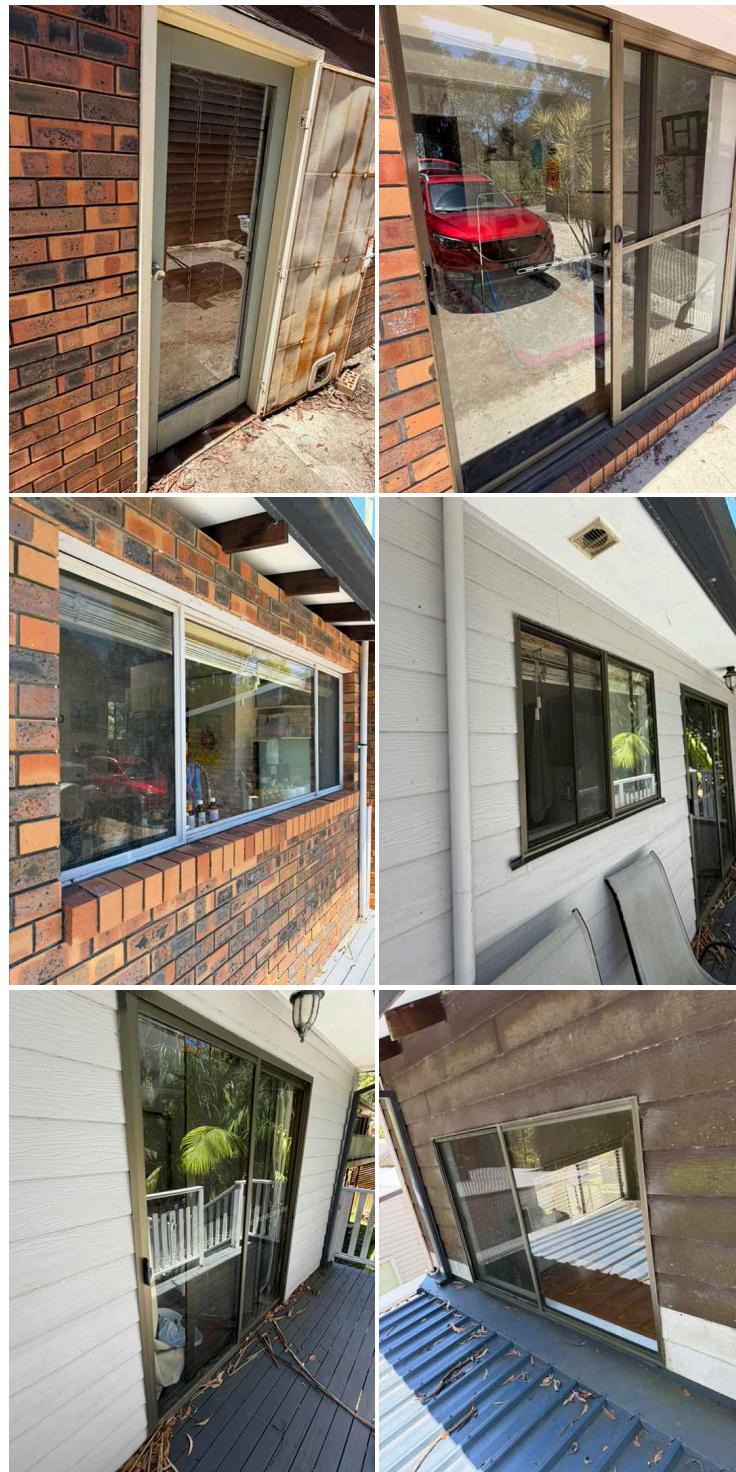
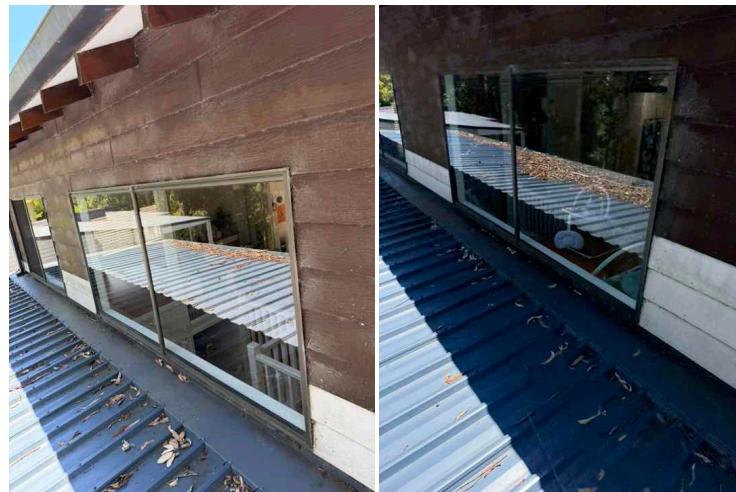
General age/damage has occurred to window components. Recommendations: Restoration work recommended. A qualified carpenter should be engaged for advice and recommendations.

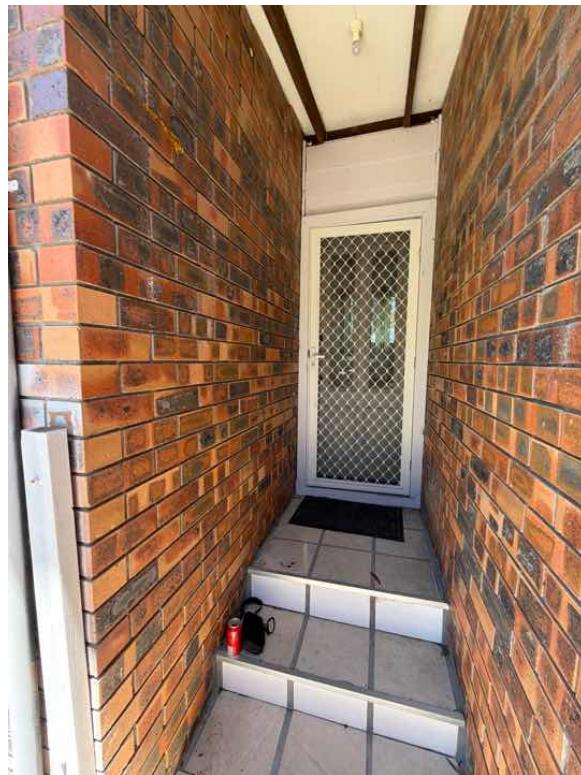
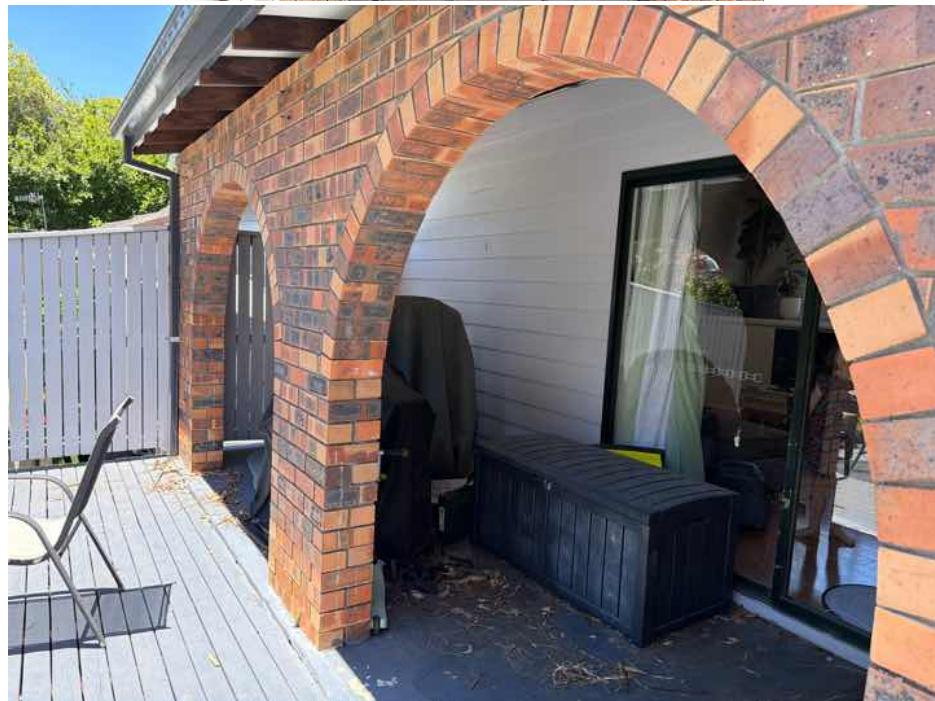
Defects exist to an area or component/s requiring assessment by a specialised field. Please read below for details.

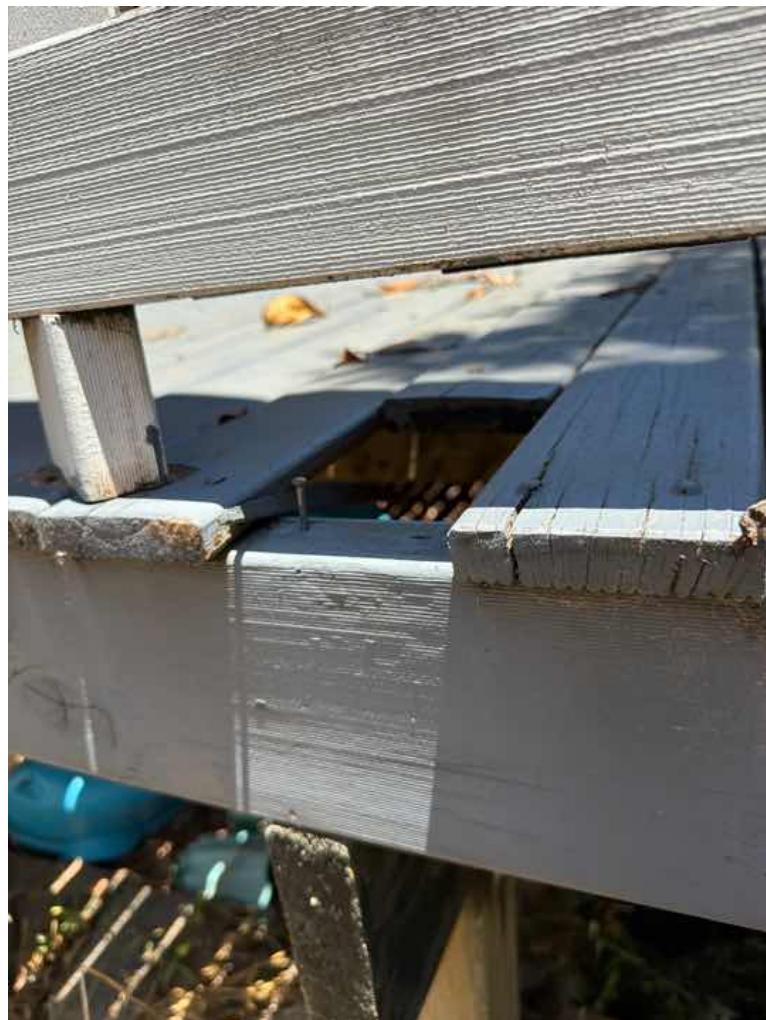
#2. Decking board surfaces are weathered - Recommendations: We recommend cleaning and maintenance as needed.

decking timbers are found to be loose, posing a safety risk. A suitably licensed carpenter or decking specialist should be engaged to secure the loose boards with appropriate screws or fasteners, ensuring all decking is stable.

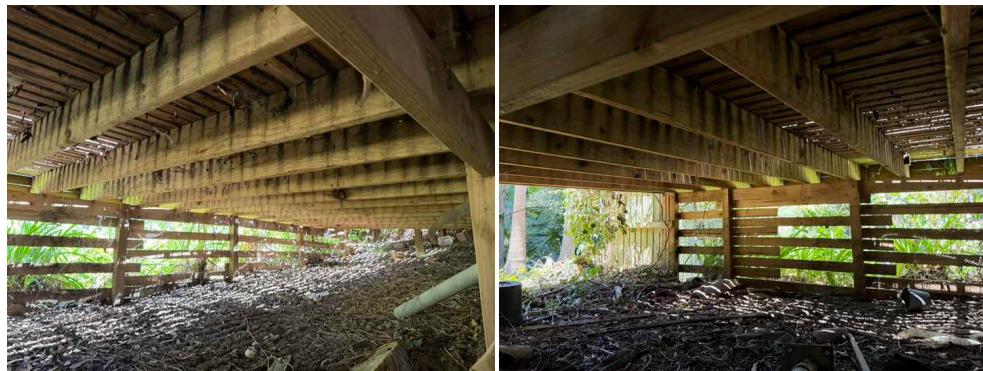
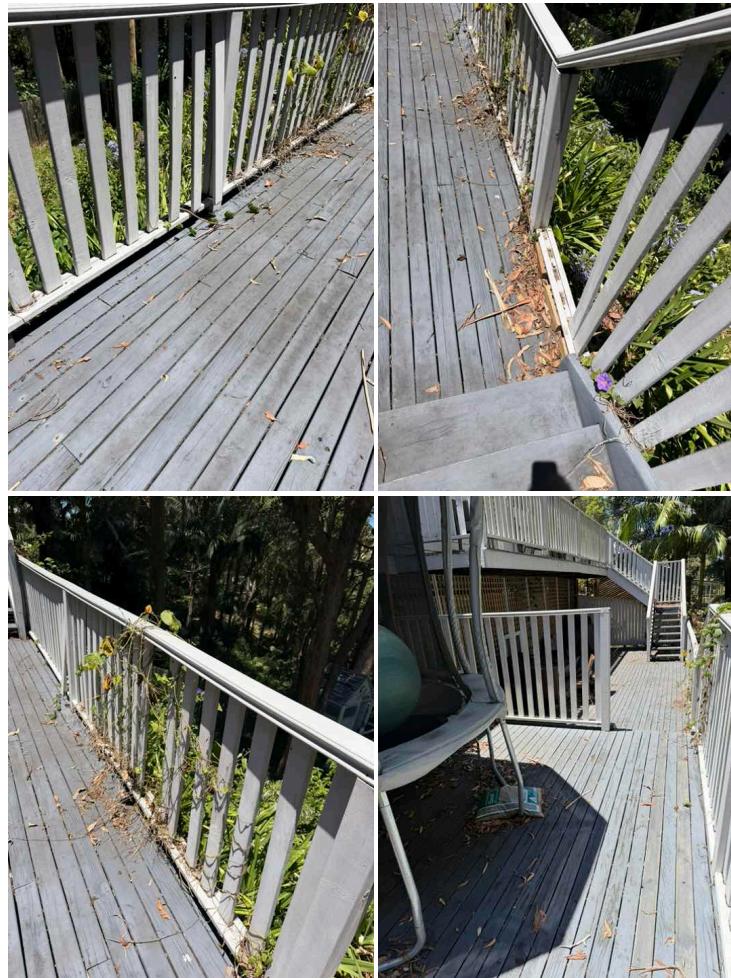
#3. Rot to balustrade noted. Engage a carpenter for repairs.

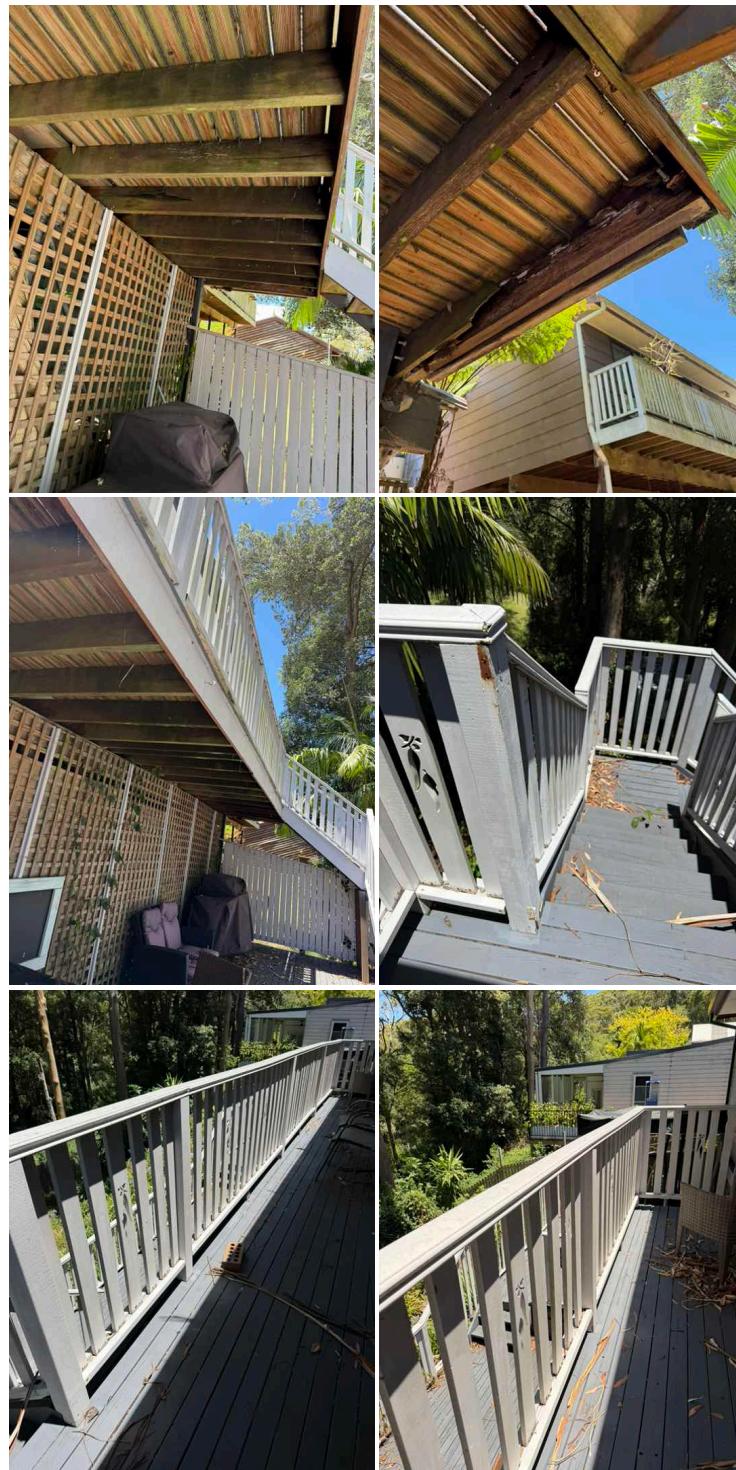
Timber fungal decay in section of bearers or joists. This is a safety hazard and repair is required.  
Recommendations: A qualified carpenter should be engaged to replace all affected timbers.

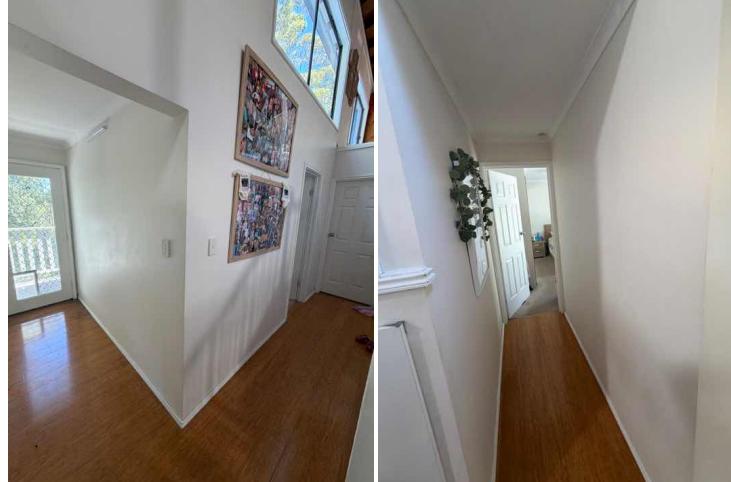
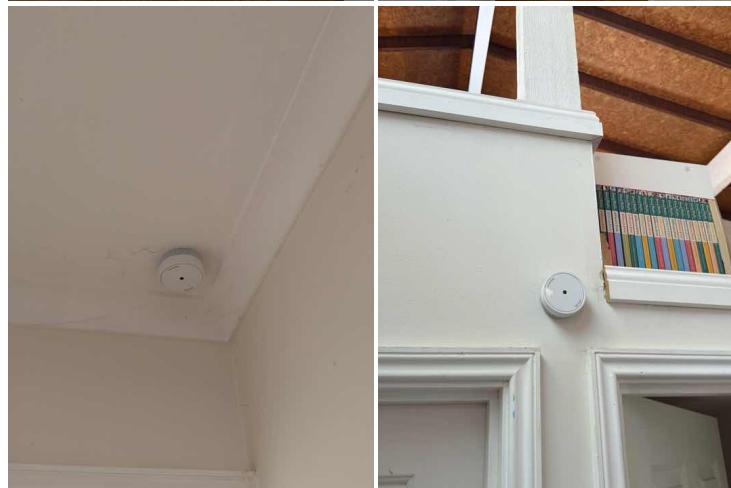
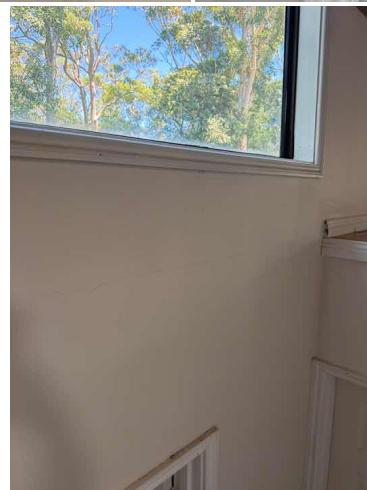
Settlement Cracks Noted. These are typical and generally patch and paint will suffice

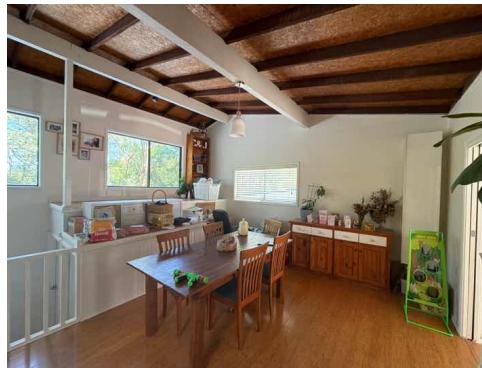
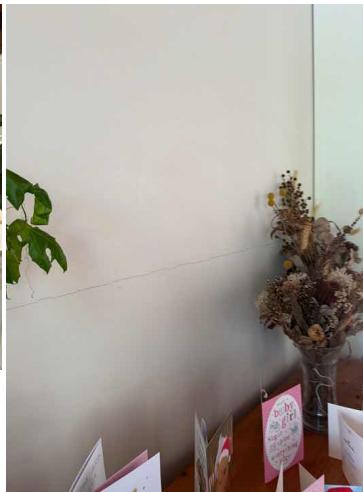
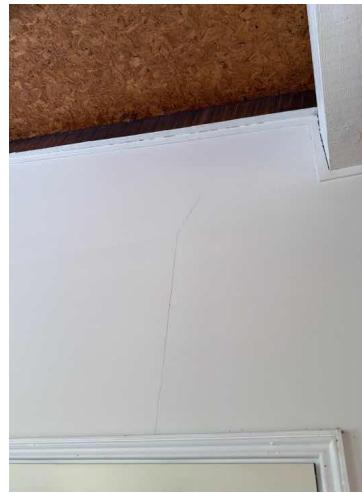
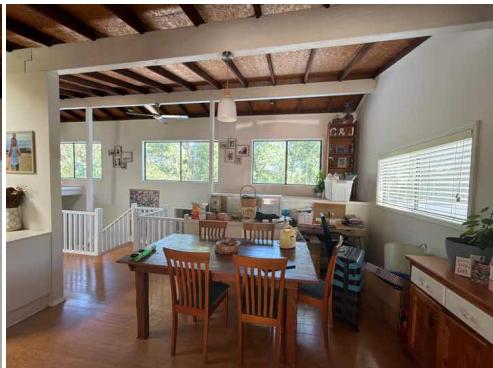
Settlement Cracks Noted. These are typical and generally patch and paint will suffice

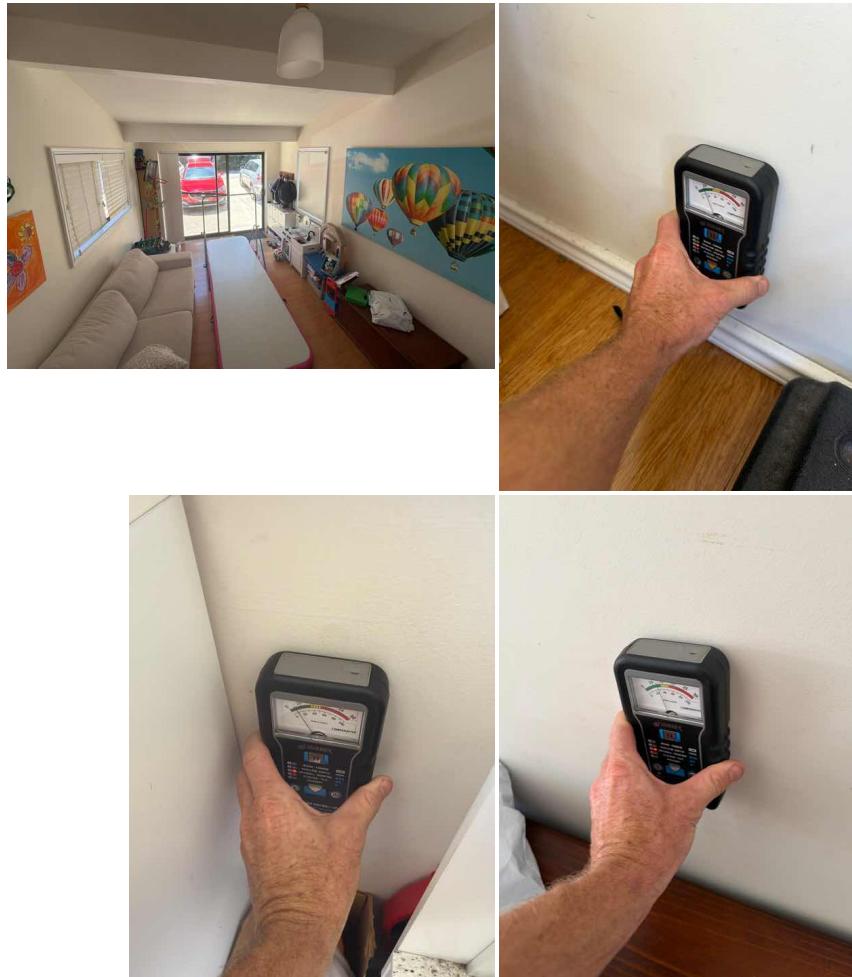
General age wear and tear noted to the walls. Recommendations: Patch/paint as required

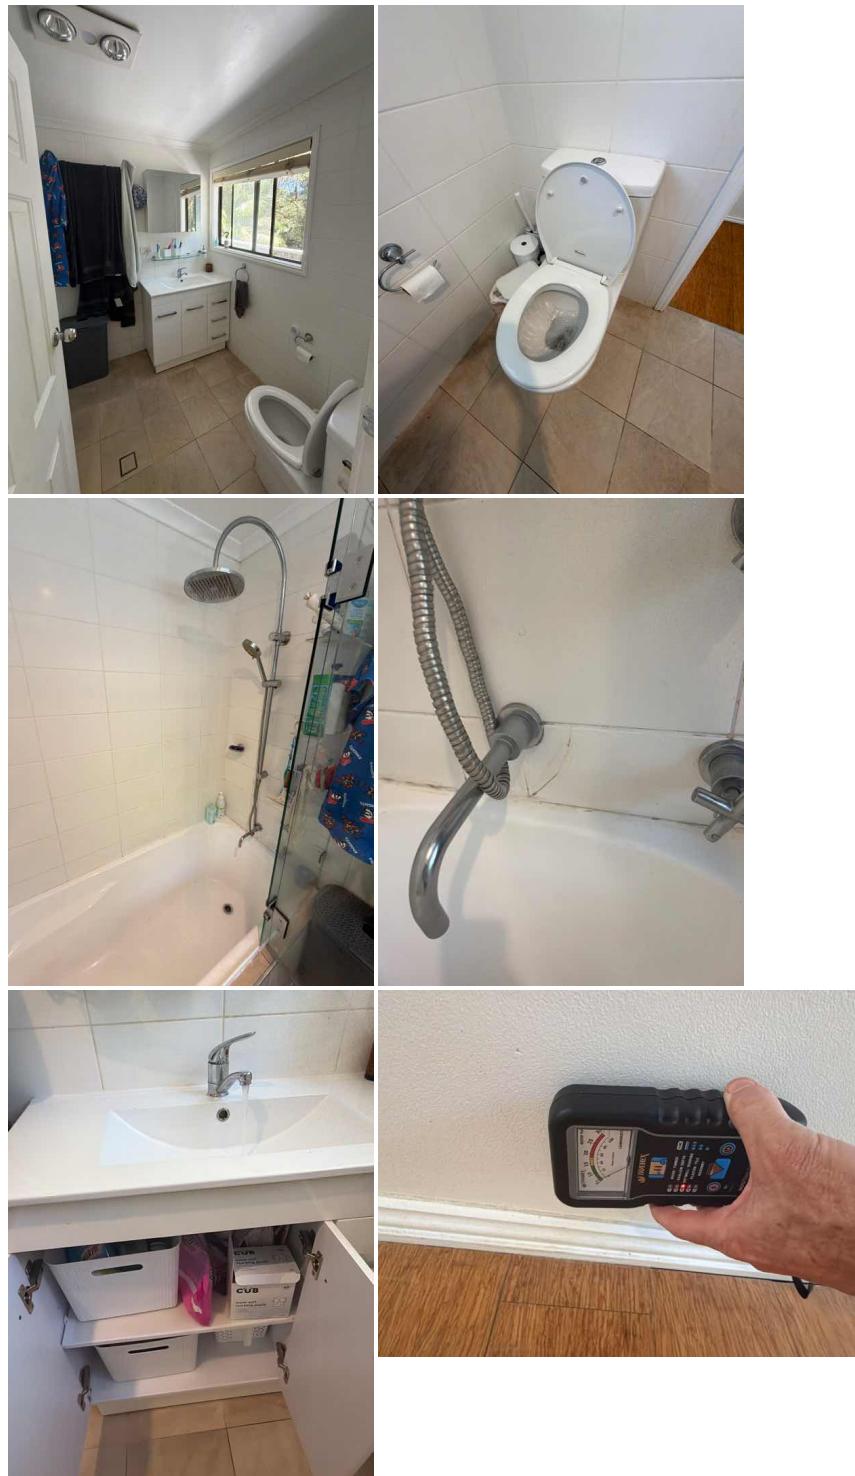
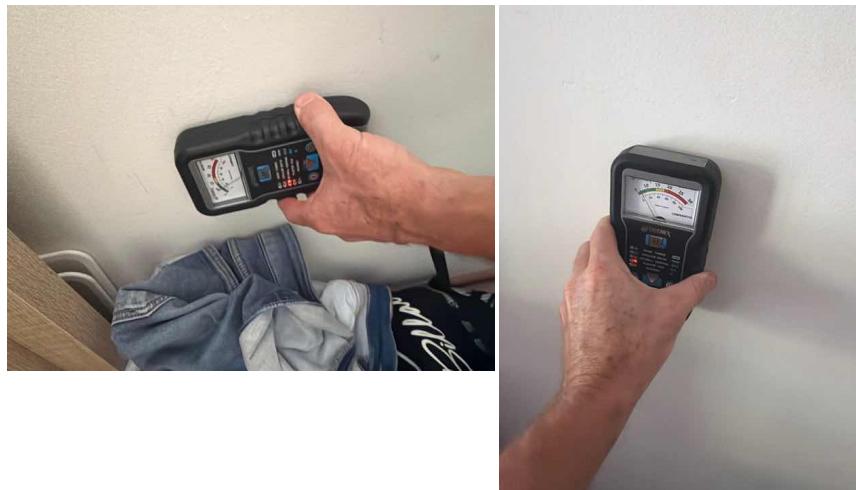
No moisture obtained from the back of the shower

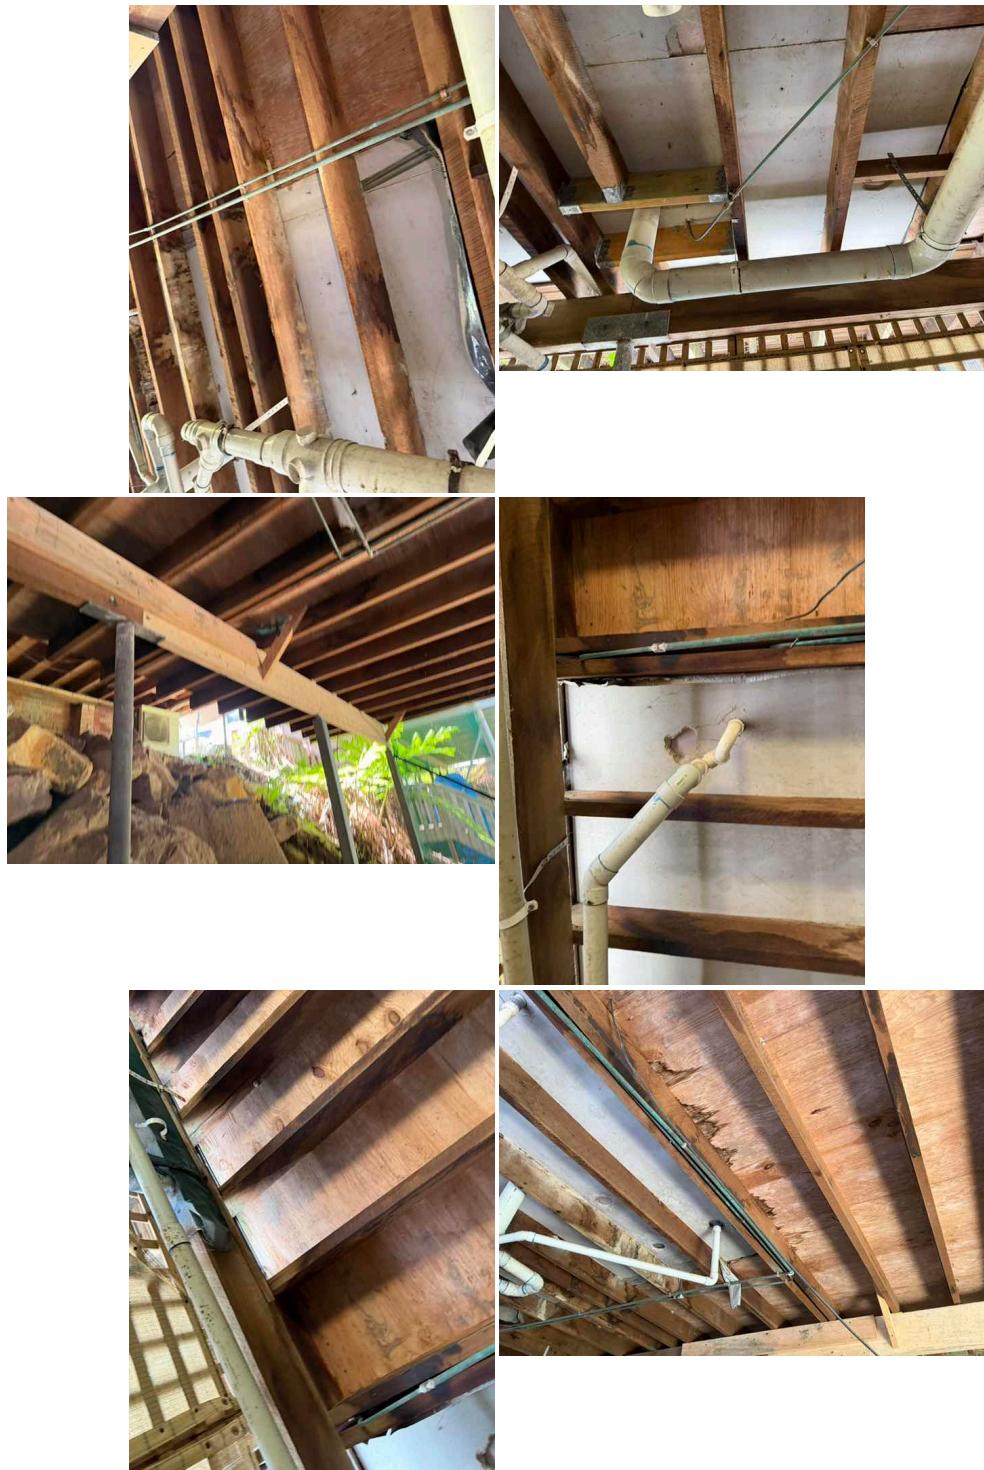
Evidence of water penetration and its associated damage is present to sub floor timbers below the bathroom. Water stains appear dry and maybe caused from previous plumbing leaks. (No moisture readings ) continued Monitoring during regular use for signs of water leaks is recommended. Engage a plumber/bathroom speaclist if further leaking is noted.

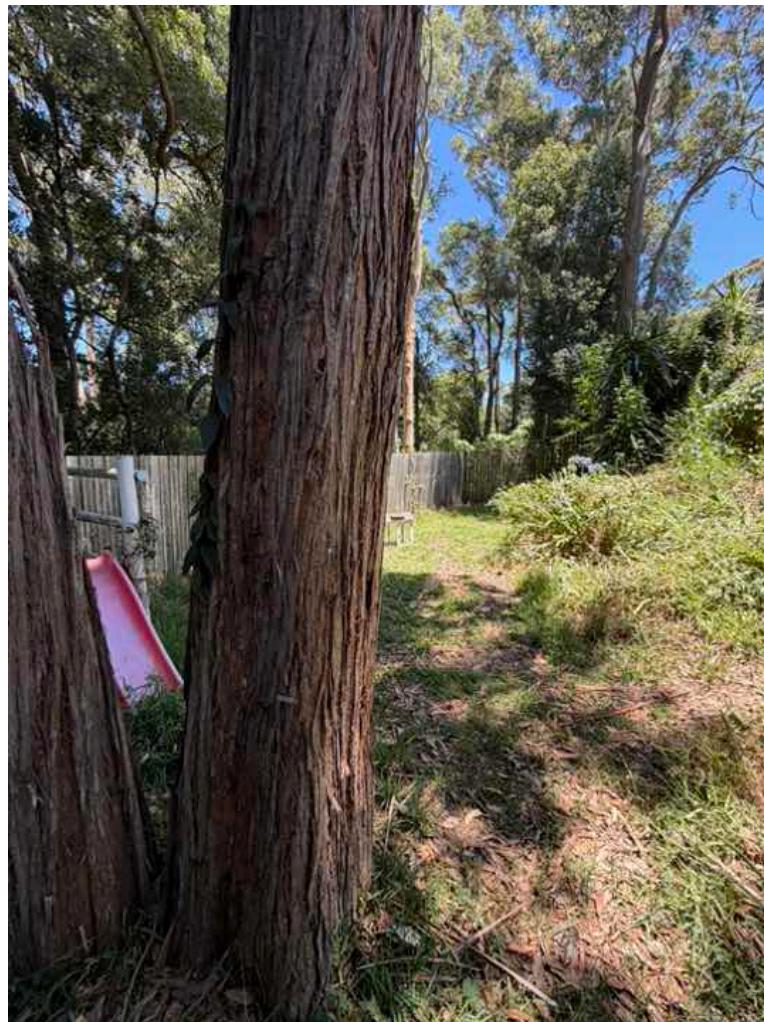
Yes, termite damage was found in the following

Trees

Where evidence of termite activity was found in the grounds then the risk to buildings is very high. A treatment to eradicate the termites and to protect the building(s) should be carried out. Where the evidence of termite workings was found in the grounds or the building(s) then the risk of a further attack is very high.
