# Inspection Report

## Thorough Check Building Inspections

**7 Eucalyptus Place, Green Point, NSW, 2251**

### Pest And Building Inspection

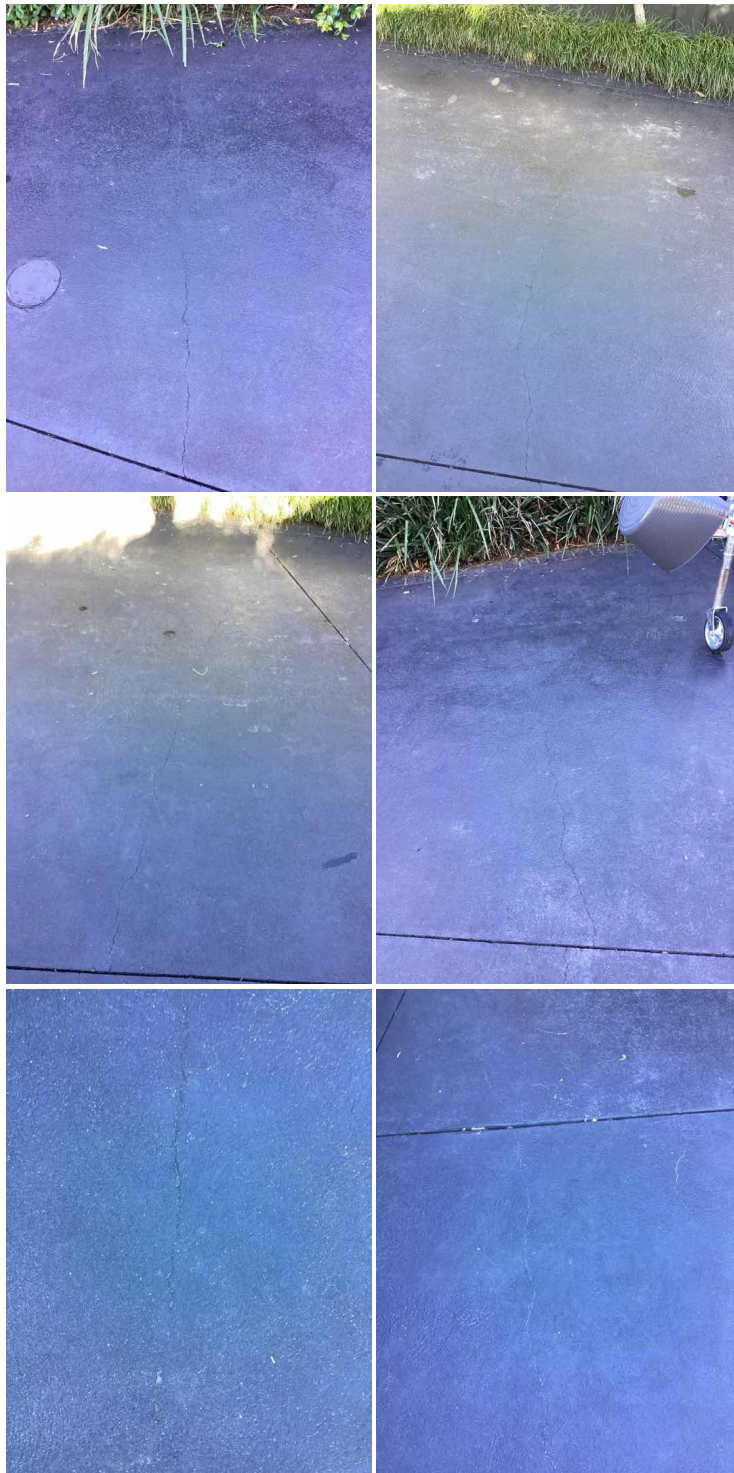
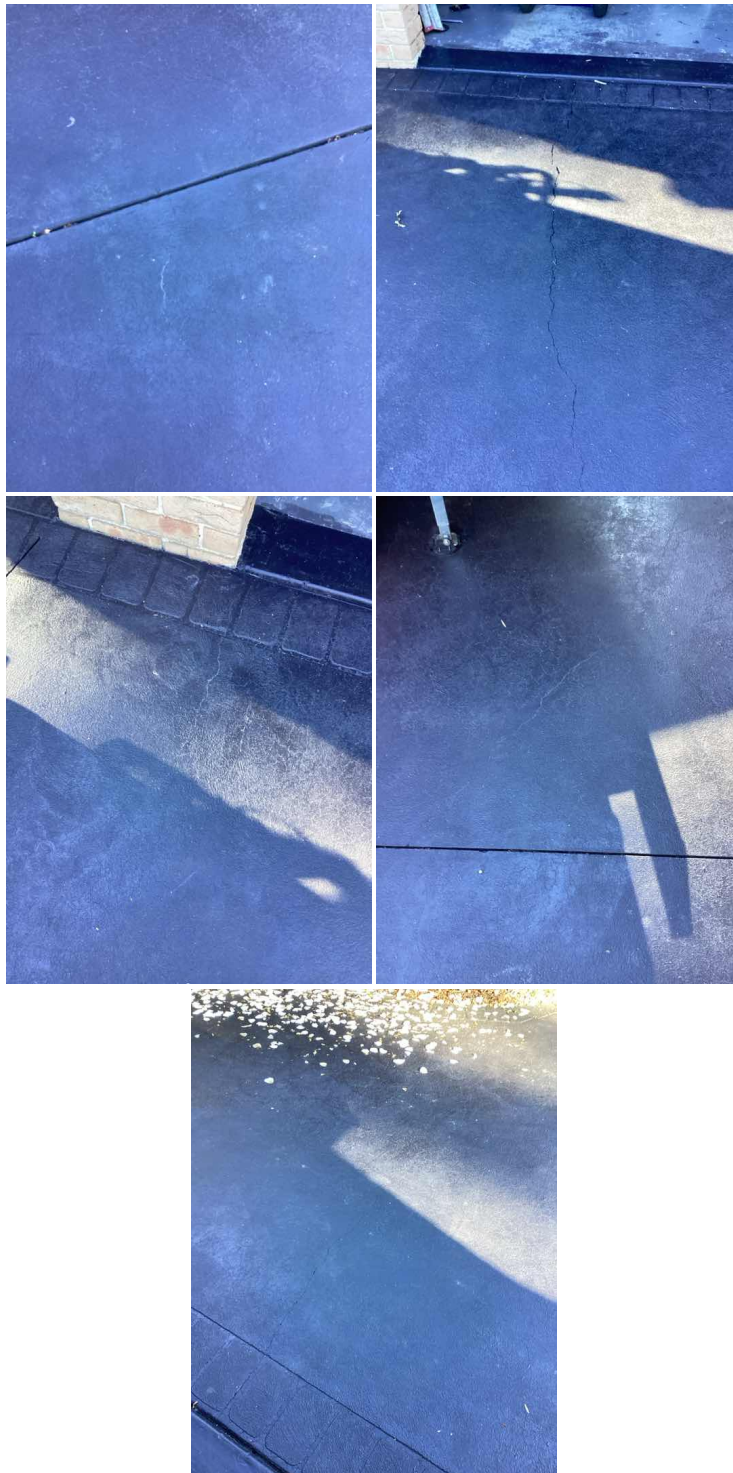
Common cracks were observed on the driveway. Whilst these cracks appeared to be typical at the time of inspection, we strongly recommend you monitor these cracks and if worsening occurs contact a concreter for further advice.

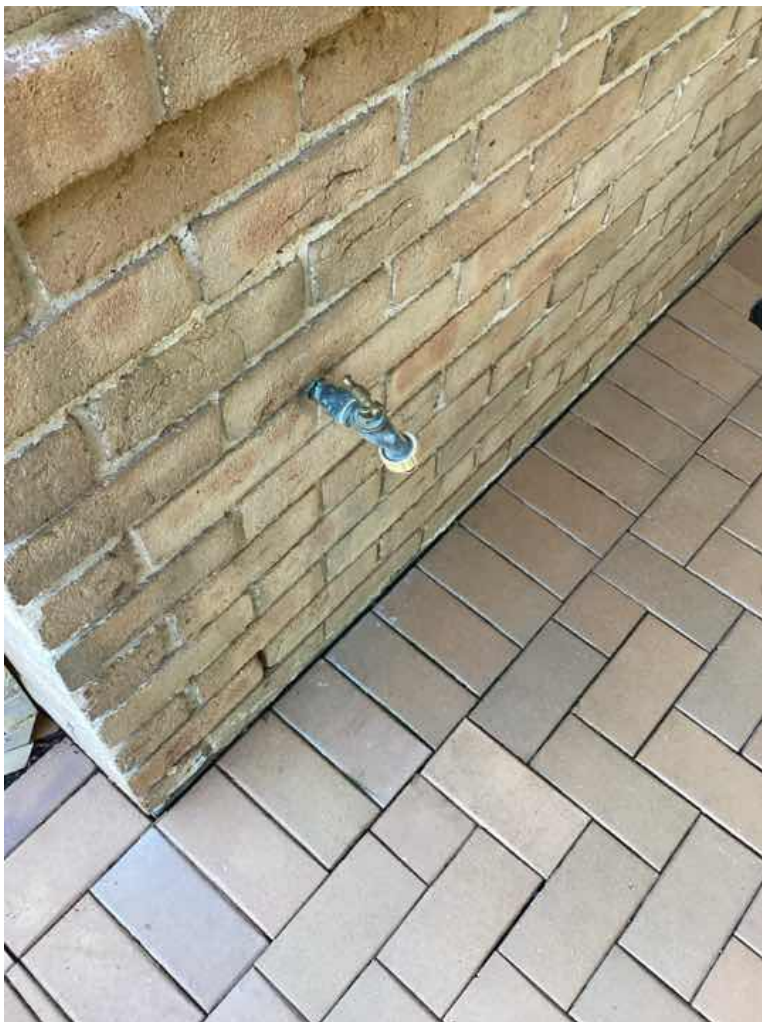
Recommend installing a drainage point under the tap to assist with drainage.

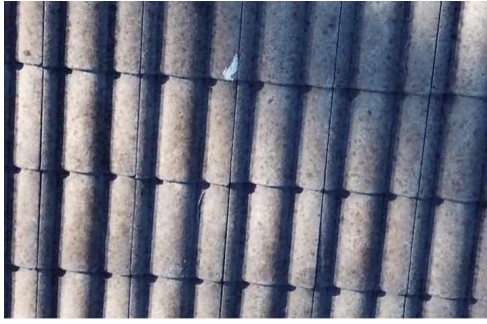
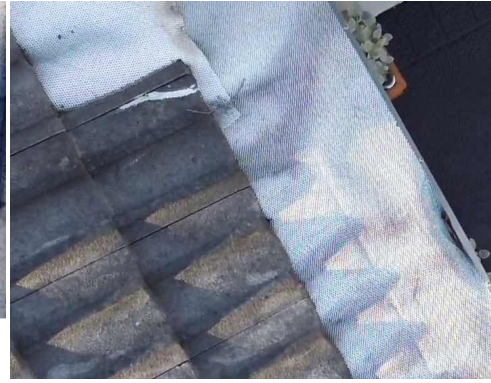
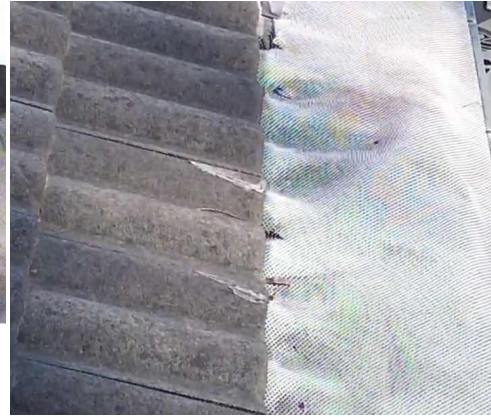
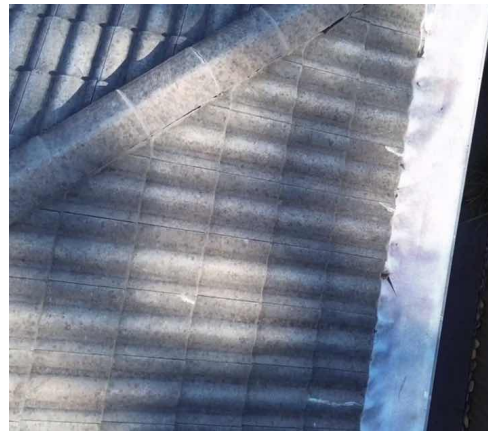
Mortar cracks visible. We recommend having these repaired by a qualified roofer as they may contribute to water ingress.

Cracked tile ends visible. A qualified roof tiling contractor should be engaged for advice and recommendations. Considered a minor defect but has the potential to become a Major defect if repairs aren't carried out immediately due to water ingress into the roof cavity.

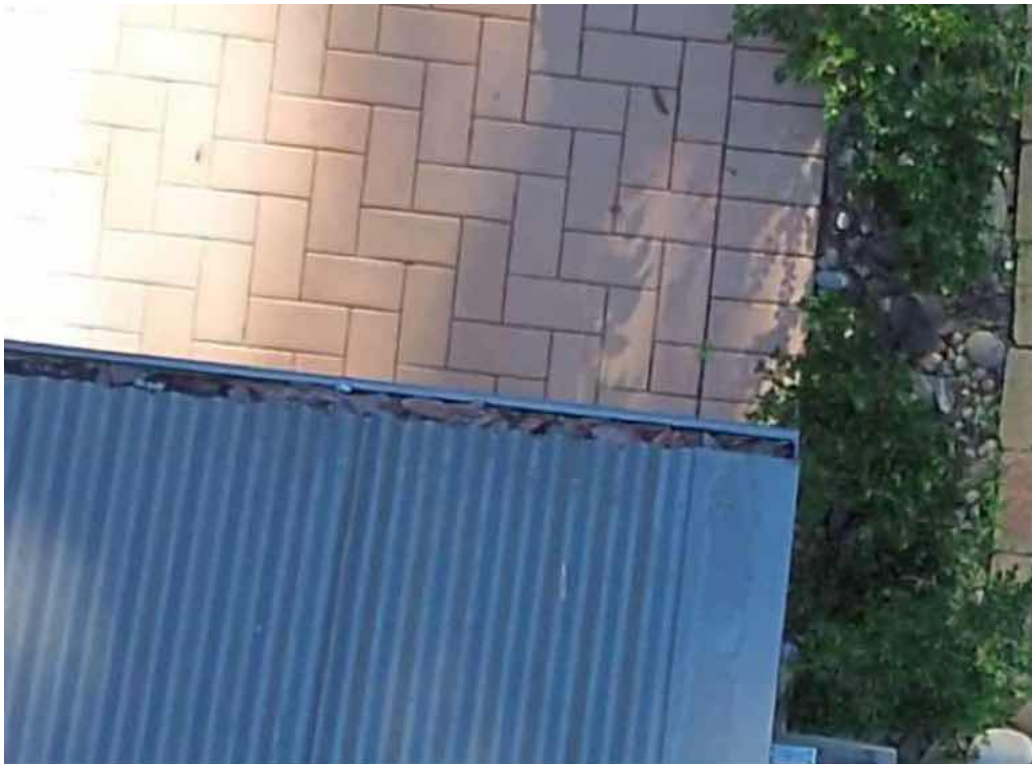
Debris in guttering areas- this requires cleaning out to prevent blocking of downpipes and leaking into eaves and fascia. Have gutters cleaned and assessed by a plumber for adequate fall. Regularly clean to prevent ponding. Ponding water will contribute to rust.

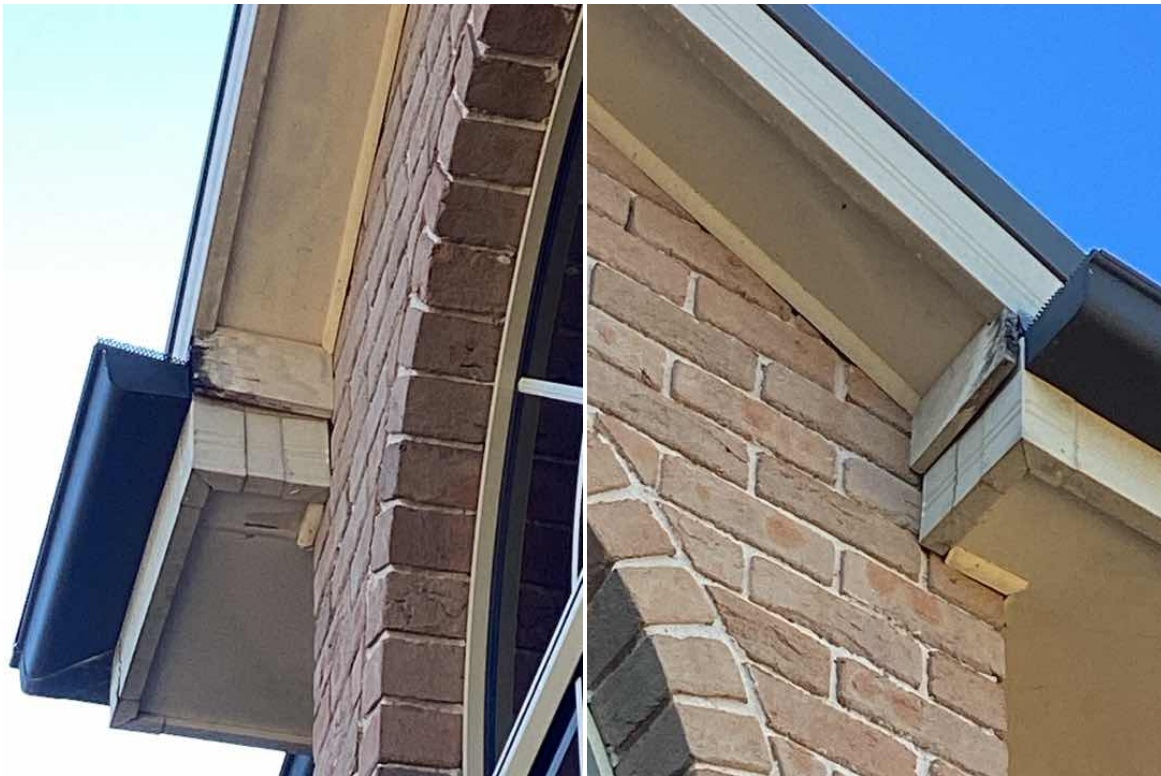
Paint / finish was deteriorated in areas and is in need of maintenance - Sanding back affected areas and painting required.

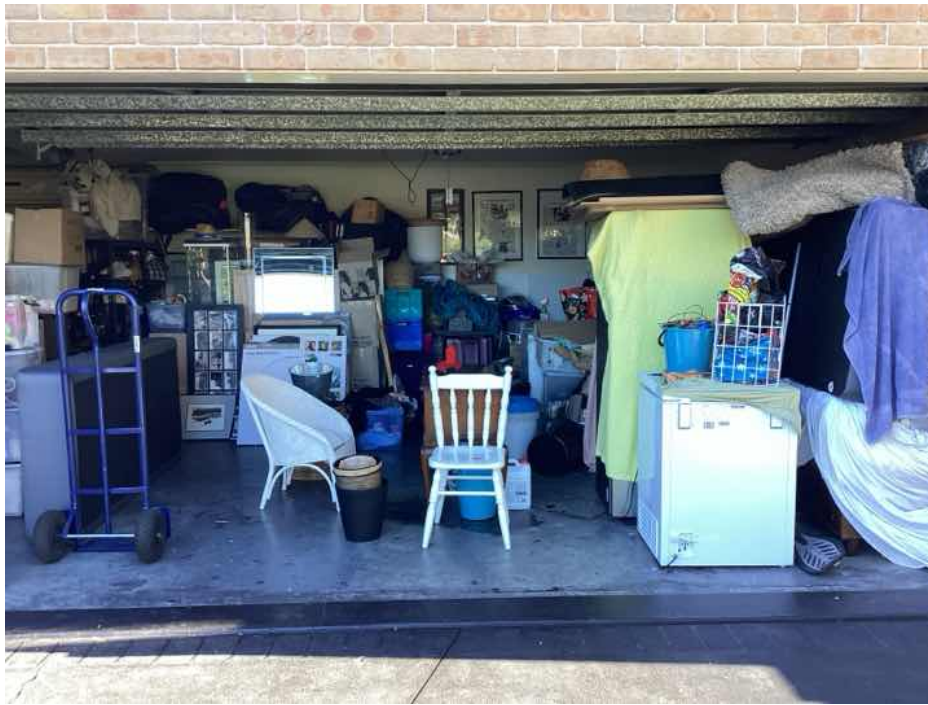
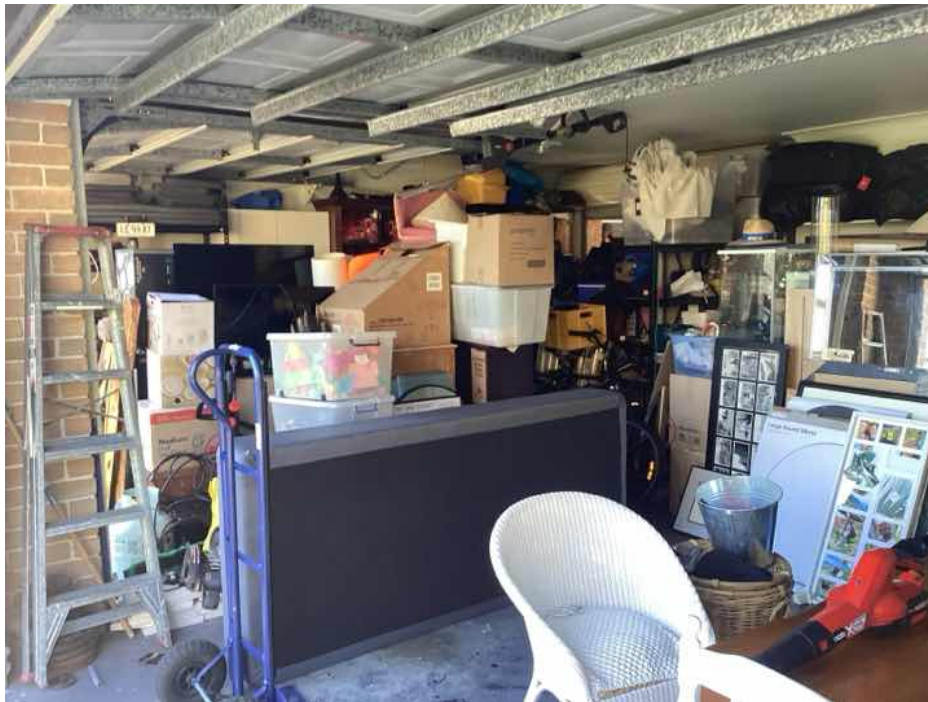
Stored items restricted a full and thorough inspection of this area. Defects may exist in the obstructed and inaccessible areas. It is strongly recommended that full access be granted to enable a thorough inspection as there may be timber pest activity, damage or defects. Note: Where vehicles and storage has restricted a full inspection it is advised that this area be cleared so a full and unobstructed inspection can be carried out.

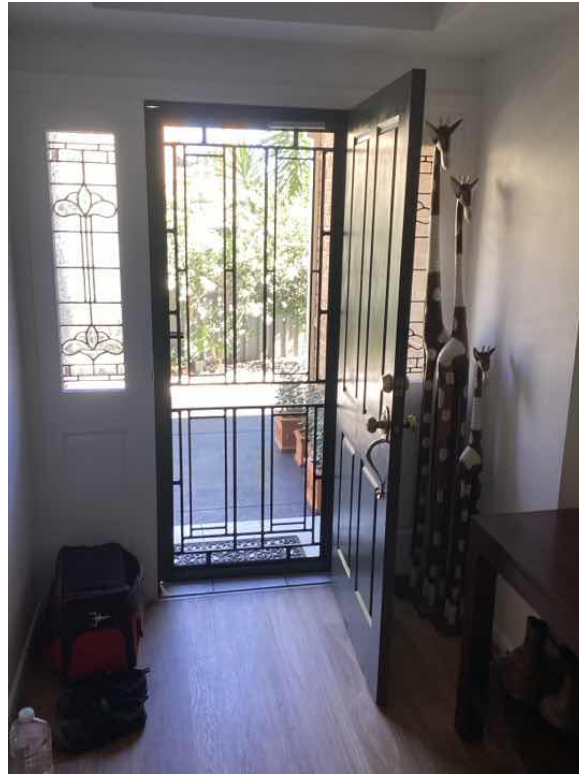
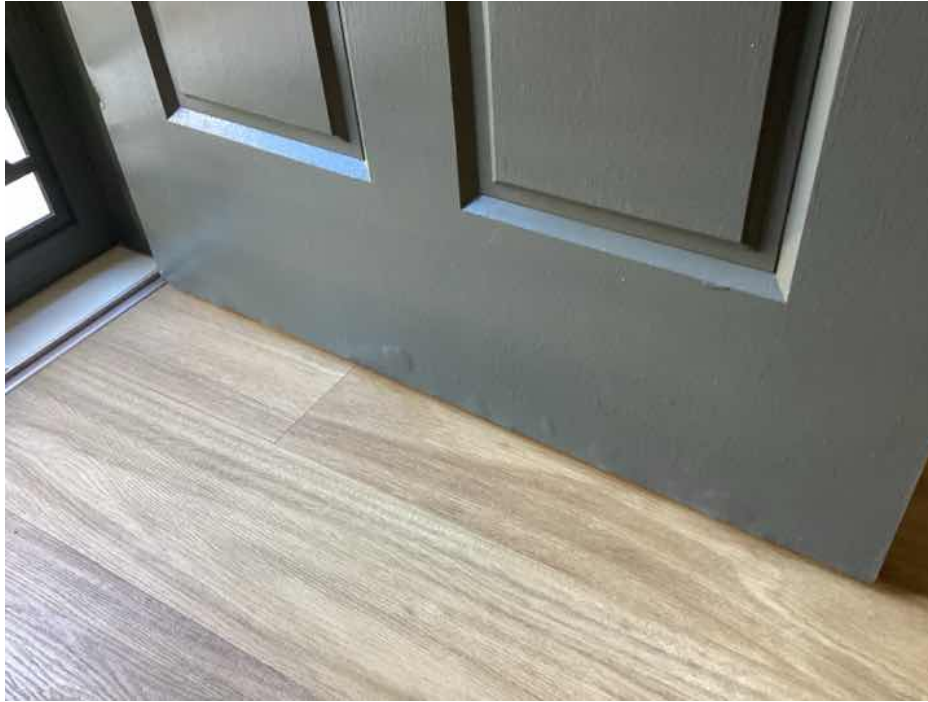
Damp damage to entry door/frame - It appear water has damaged / penetrated areas of the door/frame. I am not able to ascertain if this is still occurring and this can only be ascertained during heavy rainfall periods. If penetration occurs a qualified carpenter should be engaged for advice and recommendations re repair/sealing from weathering.
