SDB Inspecta Homes T/A

Pre Purchase Visual Inspection Report

47 Tall Timbers Rd Wamberal

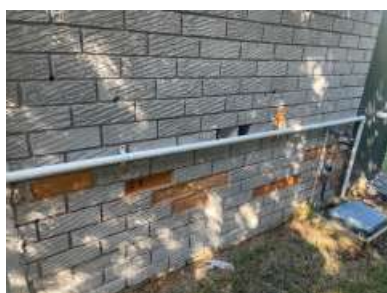
DAMPCOURSE

A damp proof coursing material could not be identified due to applied render coating. Where a damp proof coursing material is not visible or cannot be identified, dampness, rising or otherwise, may become a future problem. Recommend an invasive inspection to determine the status of the dampcourse material.

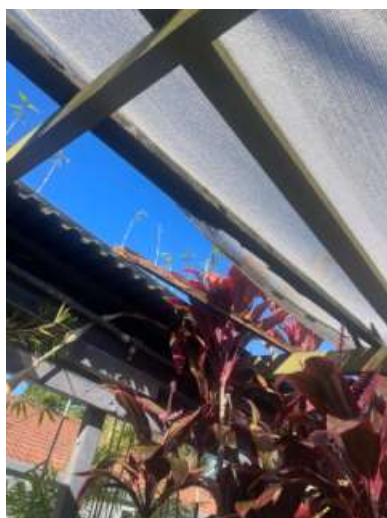
Roof Covering Condition Detail:

The overall condition of the roof coverings is fair. Damage visible and timber rot.

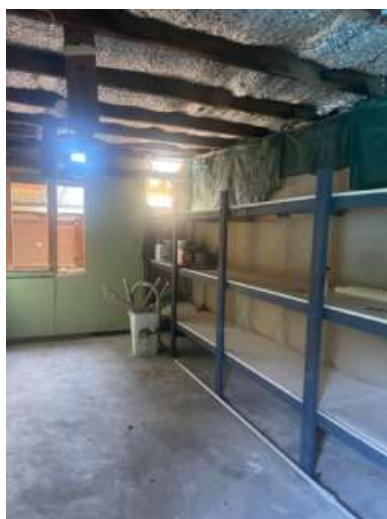
Shed.

Rear elevation.

Recommend that an upgrade of this structure be considered.

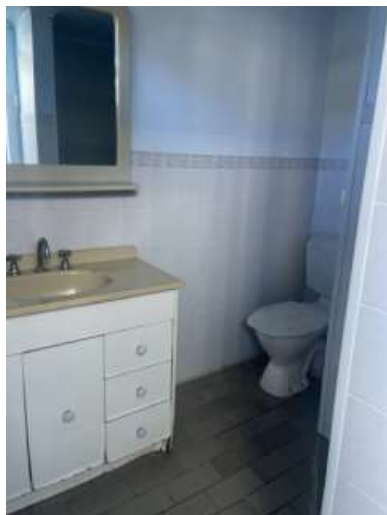
The shower recess was not tested due to stored goods or access limitations. Comments are not provided on this area. Defects may be present and not detected. Silicone sealant has been applied to the interface of the floor and walls in the shower recess in an apparent attempt to prevent water penetration to surrounding areas. This method of repair can only be considered to be temporary. Further waterproofing may be necessary.
