# Inspection Report

## ThoroughCheck Building Inspections

**18 Michaela Road, Terrigal, NSW, 2260**

### Pest And Building Inspection

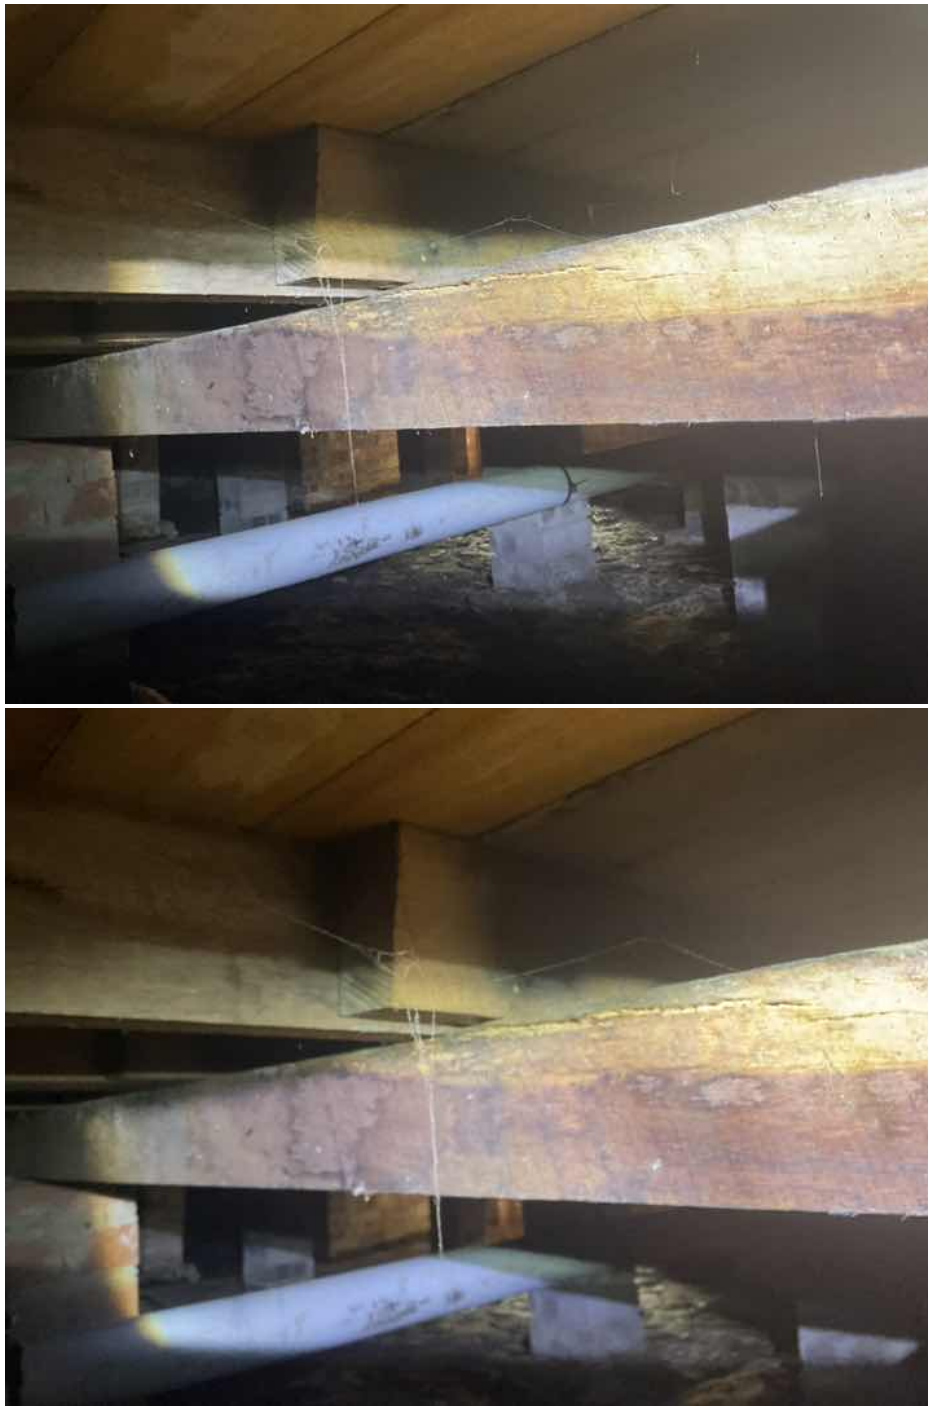
## Bearers

| Section | Location | Name | Comment |
|---|---|---|---|
| SUBFLOOR | Sub-Floor Observation. | Bearers | Borer damage was observed on one bearer. It appeared to be minor in nature. Engage a qualified carpenter to assess and make recommendations |

Borer damage was observed on one bearer. It appeared to be minor in nature. Engage a qualified carpenter to assess and make recommendations

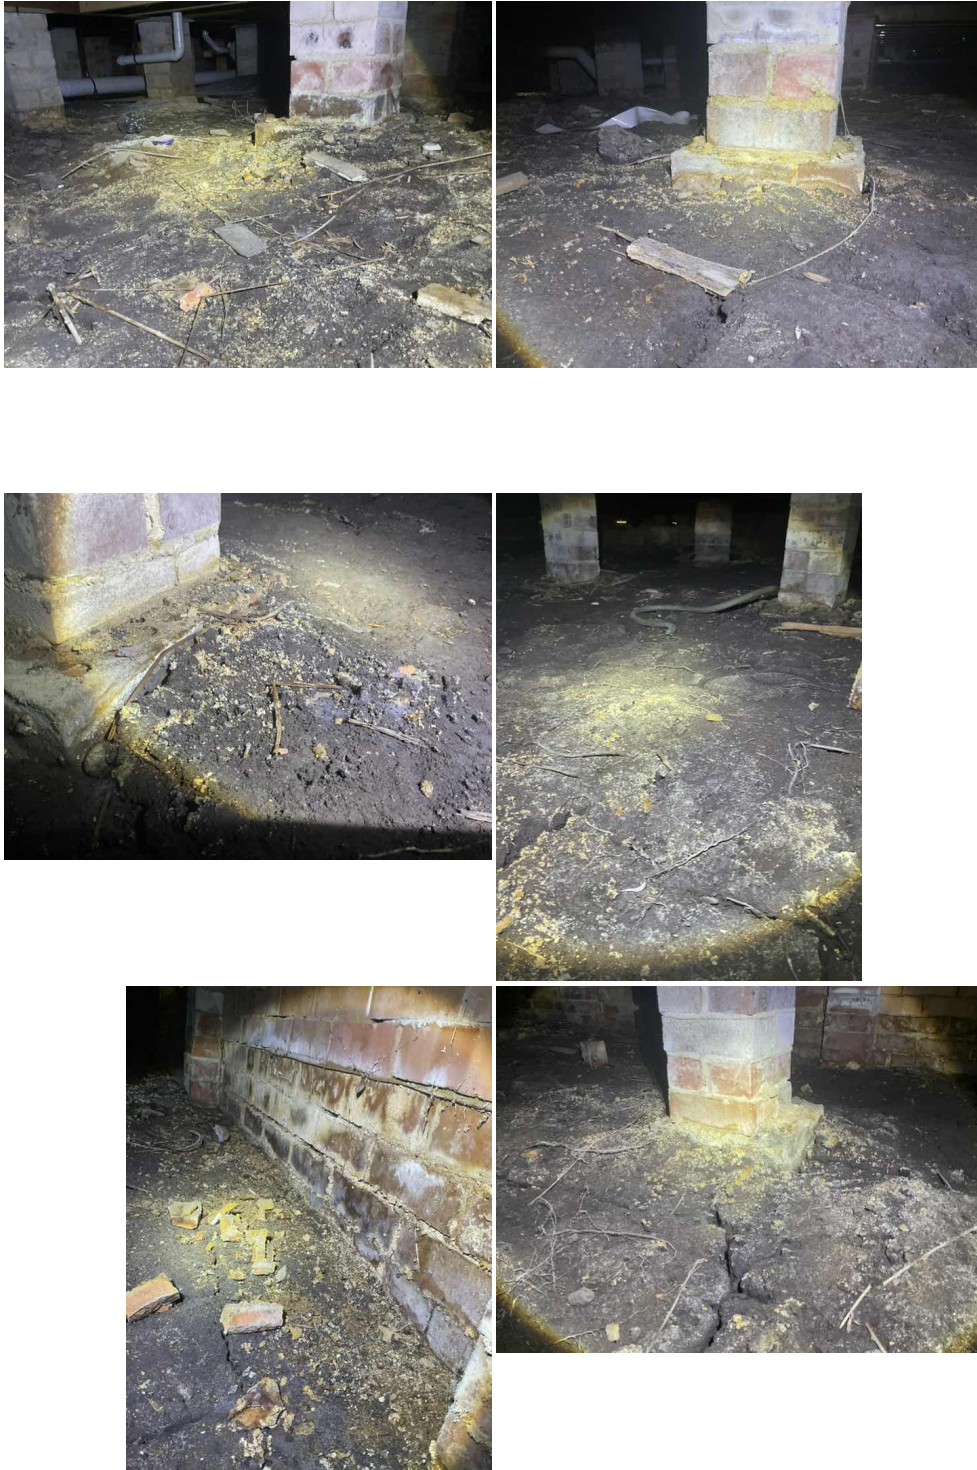
### Dampness

| Section | Location | Name | Comment |
|---|---|---|---|
| SUBFLOOR | Sub-Floor Observation. | Dampness | Yellow mould was observed in sections of the subfloor area at the time of inspection. The presence of mould may present potential health concerns. It is recommended that the affected areas be further assessed by a suitably qualified professional, with any necessary remediation undertaken as required. |

| Section | Location | Name | Comment |
|---|---|---|---|
| SUBFLOOR | Sub-Floor Observation. | Dampness | Dampness in sub floor soil. Damp sub floor soil should be avoided as it can cause fungal decay, mould and possibly footings problems. Recommendations: A qualified drainage plumber should be engaged for advice and recommendations. |

Dampness in sub floor soil. Damp sub floor soil should be avoided as it can cause fungal decay, mould and possibly footings problems. Recommendations: A qualified drainage plumber should be engaged for advice and recommendations.

Yellow mould was observed in sections of the subfloor area at the time of inspection. The presence of mould may present potential health concerns. It is recommended that the affected areas be further assessed by a suitably qualified professional, with any necessary remediation undertaken as required.

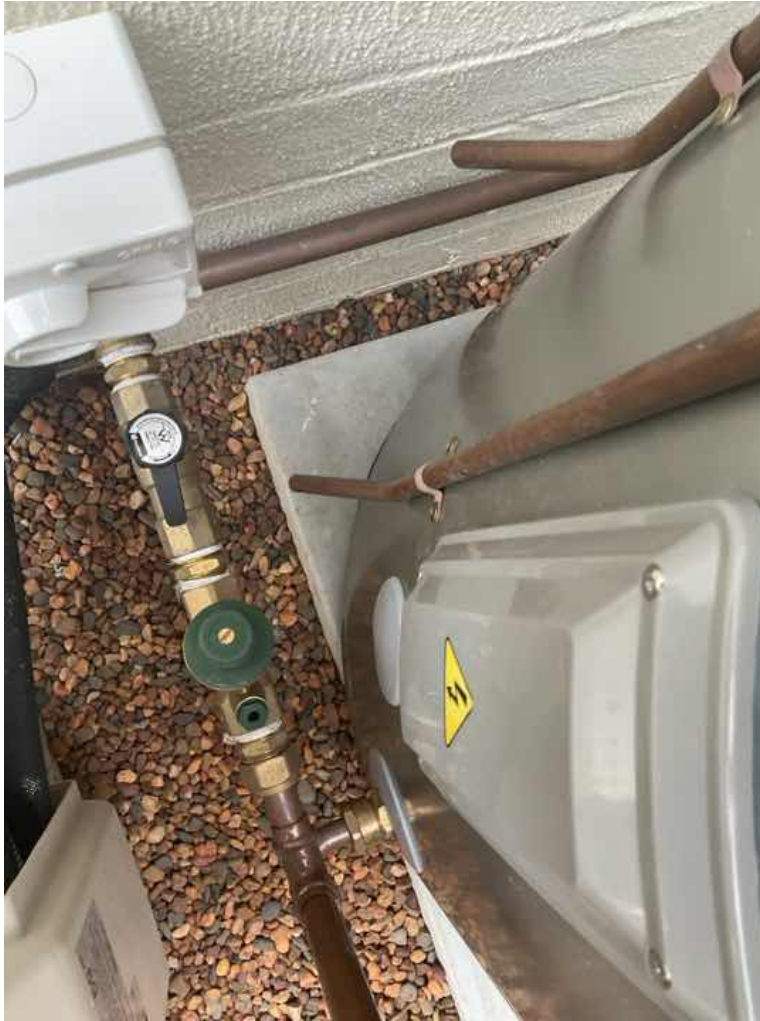
#### **Was the overflow sufficiently drained**

No. Divert hot water overflow away from the building perimeter.
