# BUILDING & PEST INSPECTION

12 Gloster Close, East Gosford NSW 2250

18th November, 2025

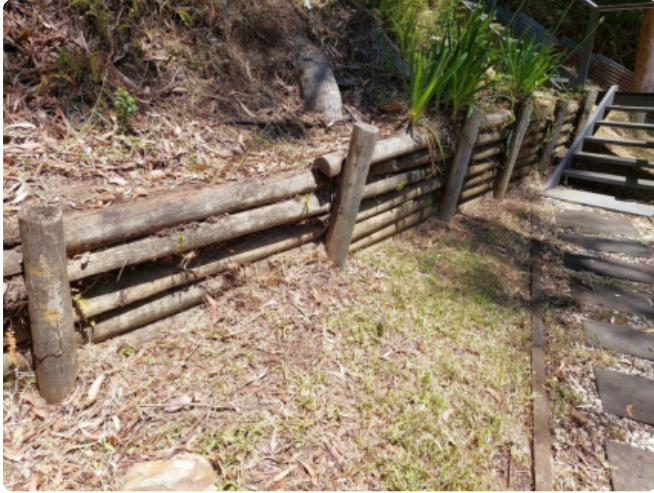
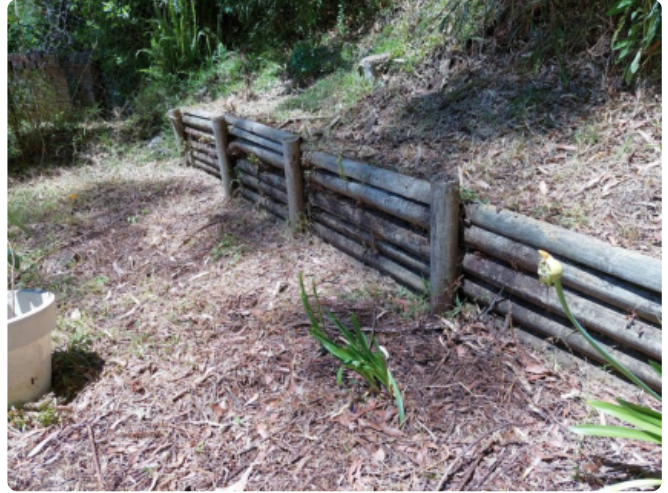
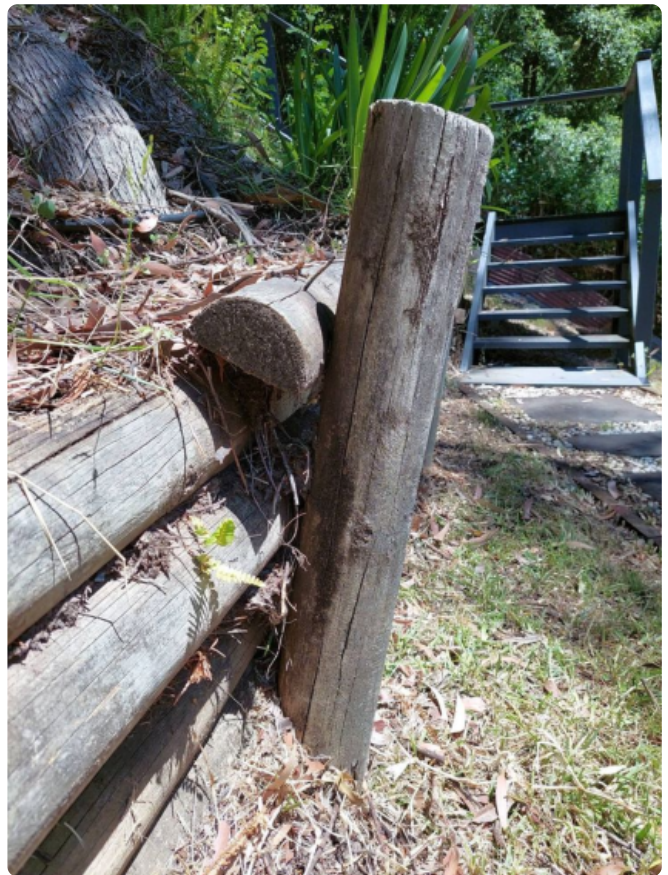
Timber retaining walls exhibit signs of weathering, moisture exposure, and localised deterioration, which may compromise structural integrity and increase susceptibility to movement, decay, or termite activity over time.

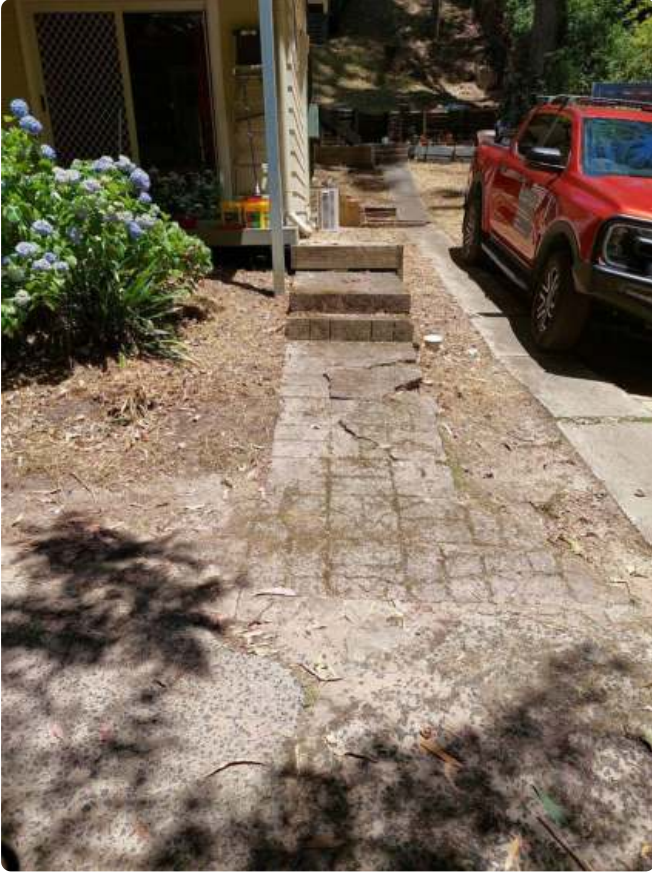
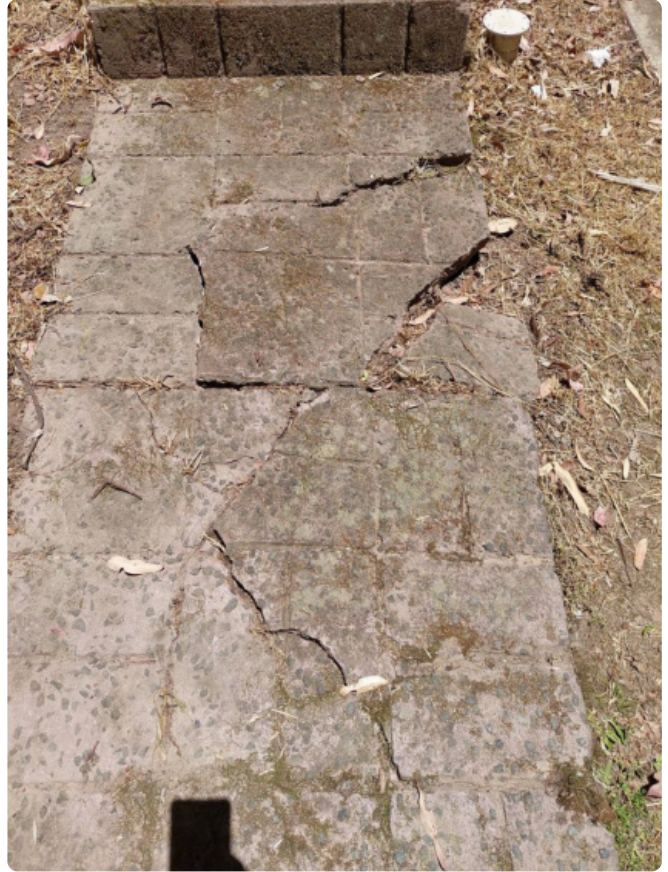
Cracked and uneven path pavers present a potential trip hazard and may allow water ingress, leading to further deterioration and increased risk of injury or structural movement affecting adjacent areas.

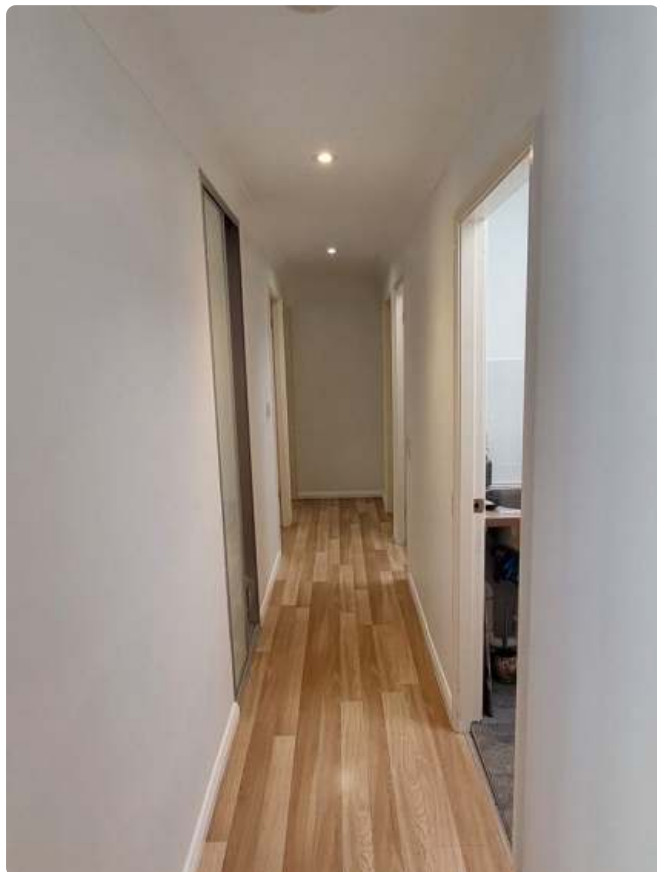
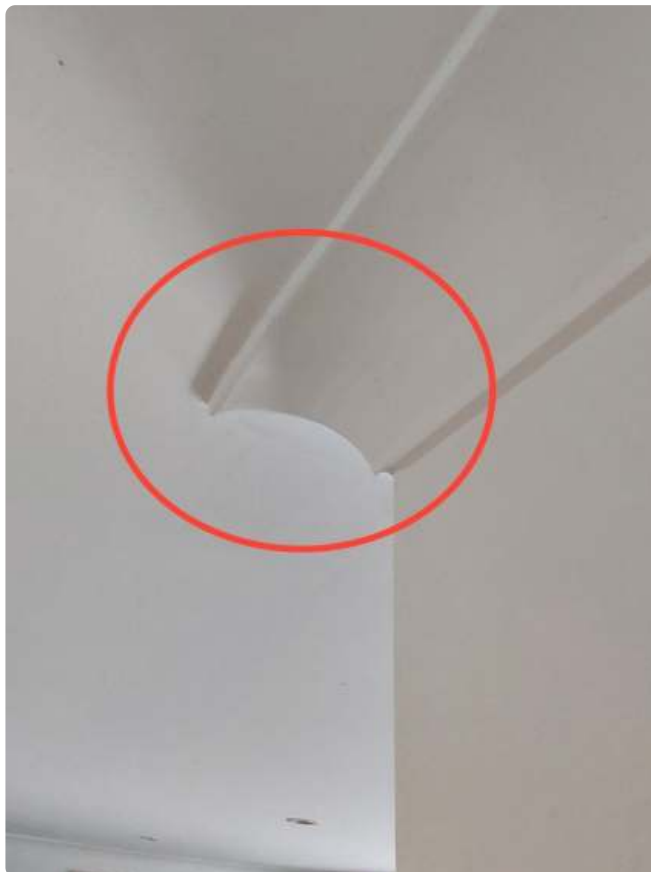
## Hallway

Cracking observed in the hallway cornice and sloping of the hallway floor towards Bedroom 1 indicate possible movement or differential settlement.

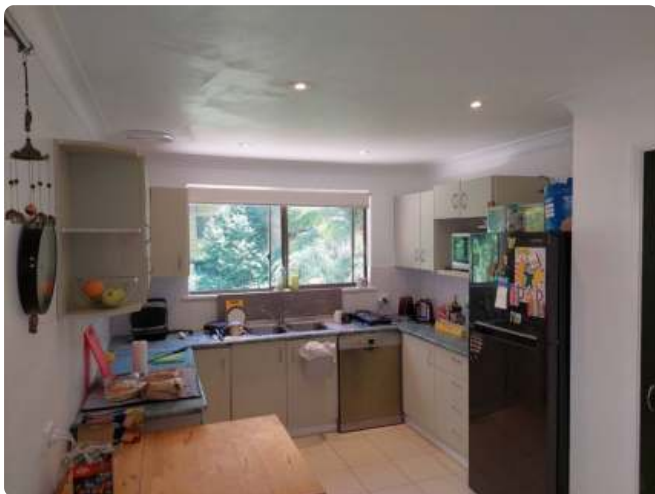
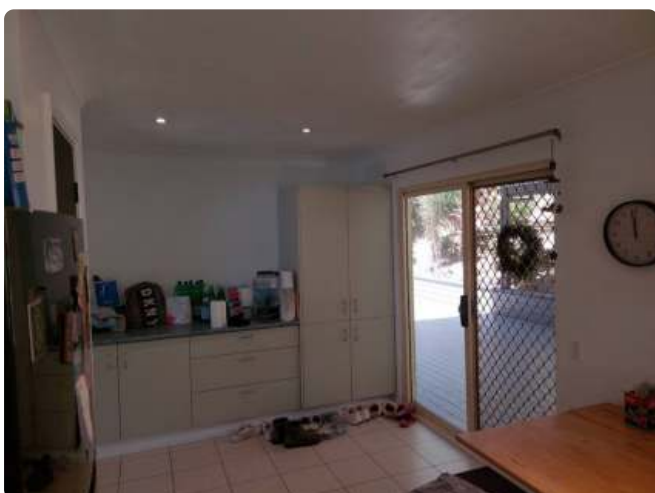
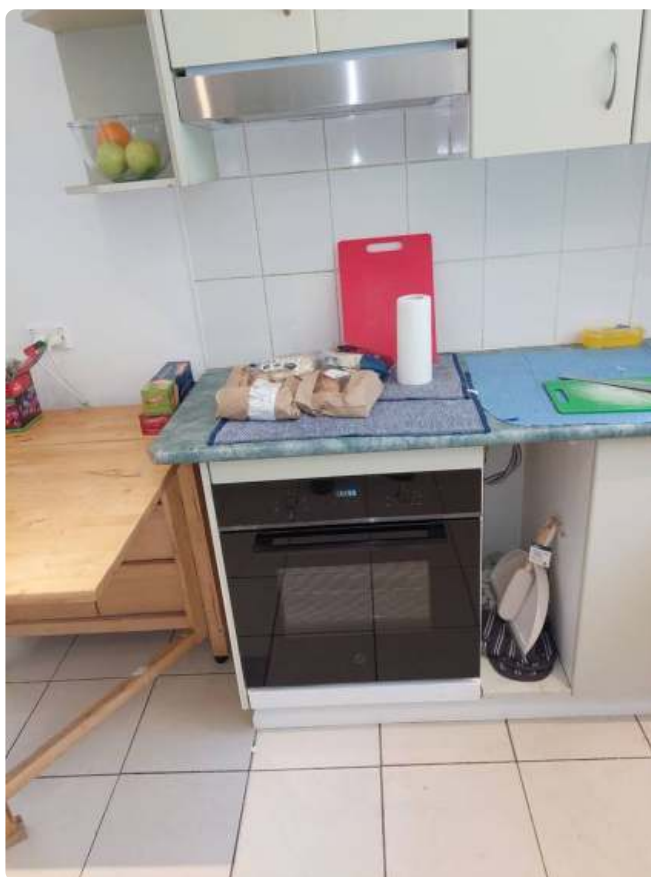
## Kitchen

Multiple kitchen floor tiles are cracked, which may present a trip hazard, allow moisture ingress into the subfloor, and indicate possible movement or inadequate substrate preparation.

Sealant cracking at the bench and wall tiles will likely cause water ingress within benchtop.

Damage evident below the window frame.

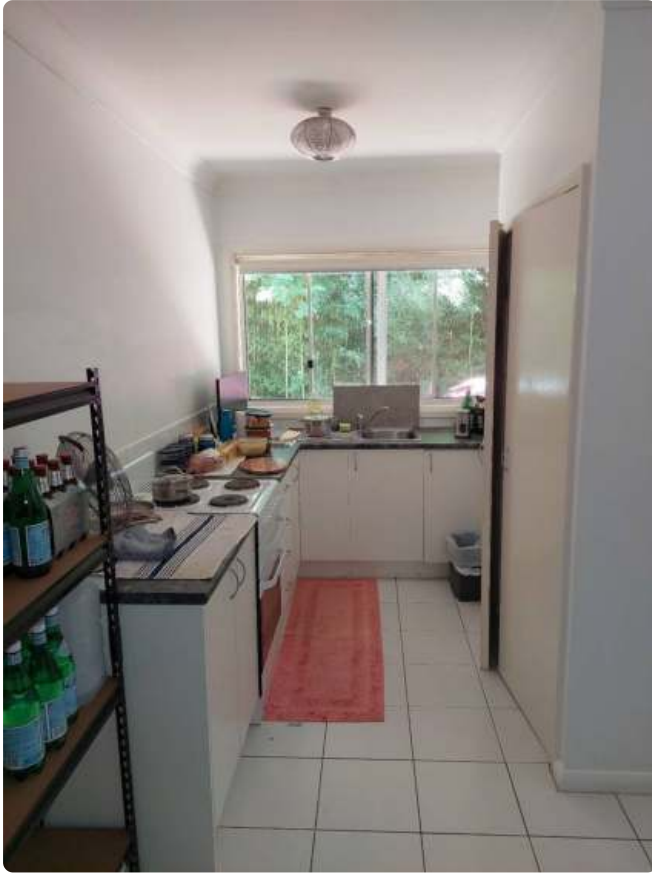
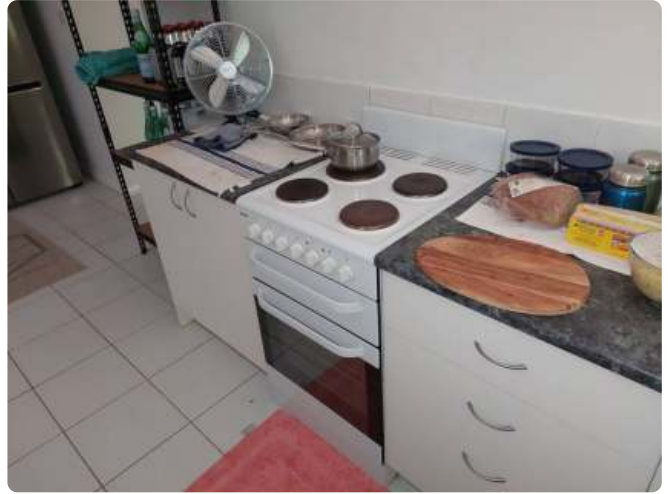
## Kitchen 2

Multiple cracks and areas of minor water staining are present on the walls and ceiling in Kitchen 2, which may indicate movement or previous moisture ingress, raising concerns about possible structural movement and the potential for concealed water damage or conditions conducive to timber pest activity.

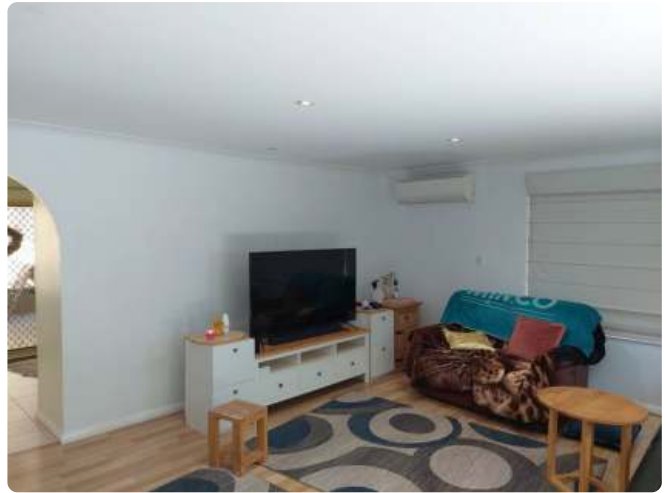
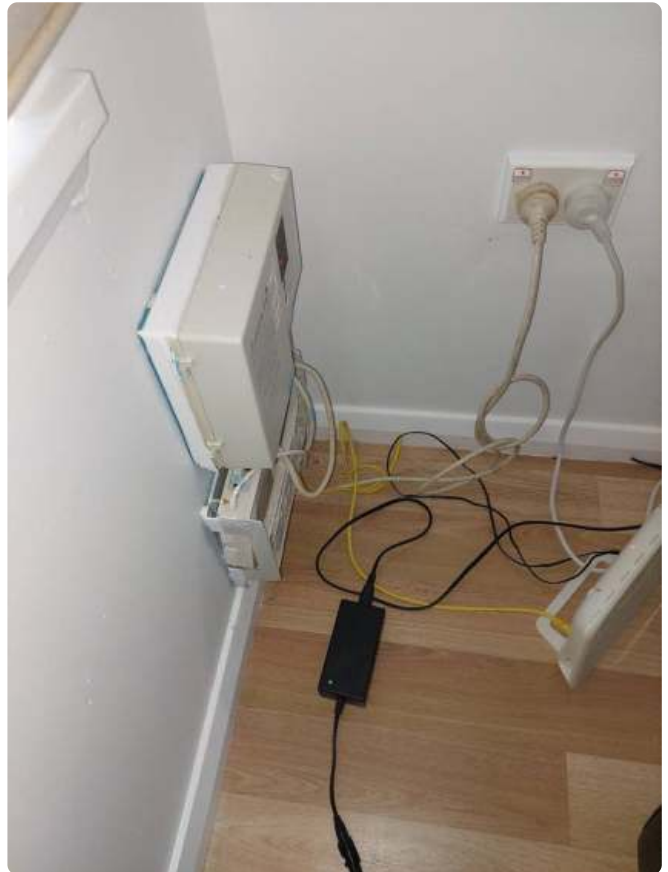
## Lounge

Moisture staining and discolouration are present on the lounge ceiling, and bubbling paint in the corner of the wall are indicating a history of water ingress. Damage noted to fireplace.

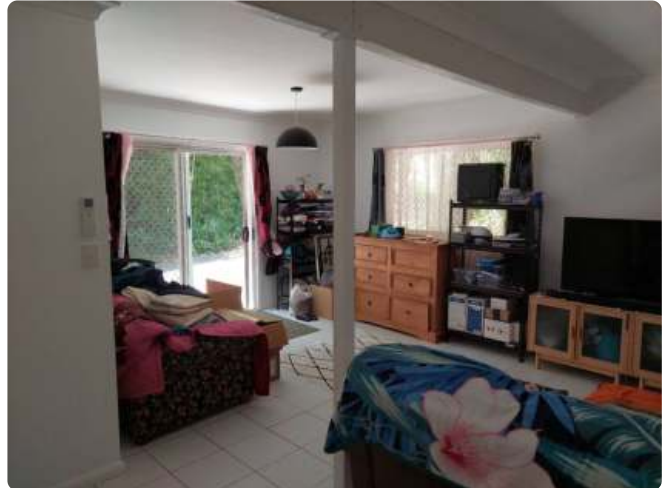
## Family

Multiple structural and movement-related cracks are present in the ceiling, cornices, and wall junctions of the Family area, indicating possible building movement or settling.

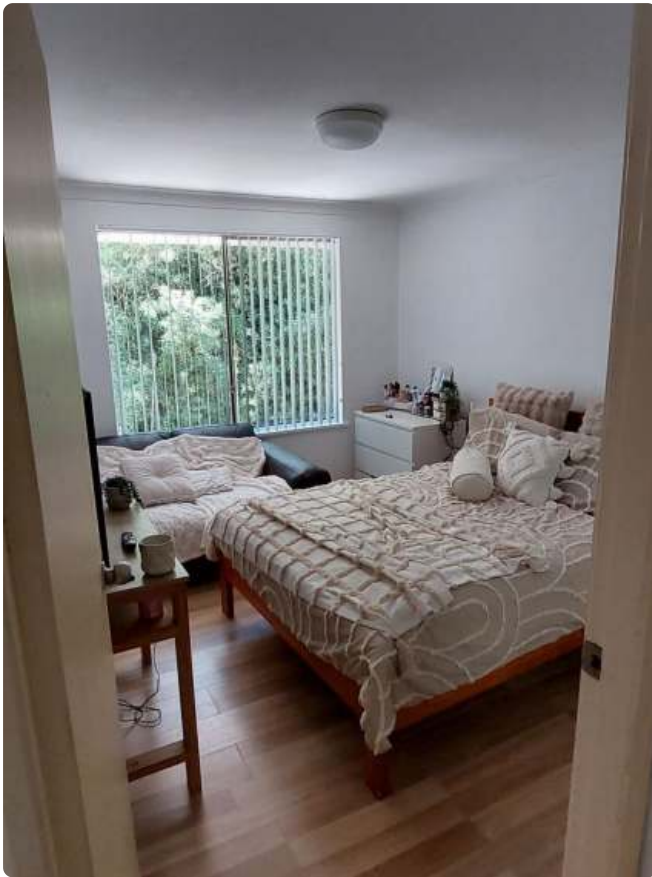
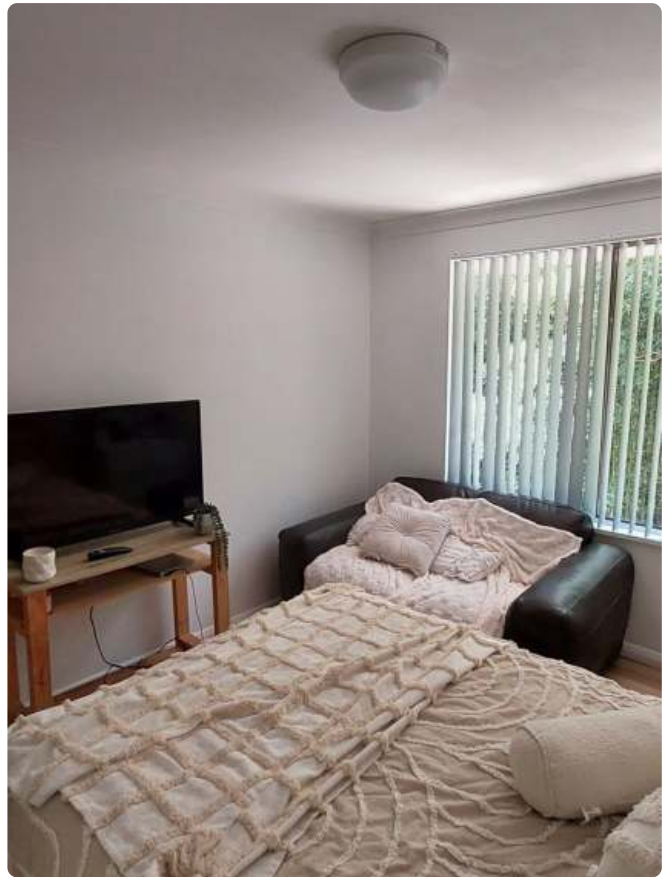
## Bedroom 1

Lifting or delaminating vinyl flooring is present in Bedroom 1, which allows moisture ingress that may lead to subfloor deterioration.

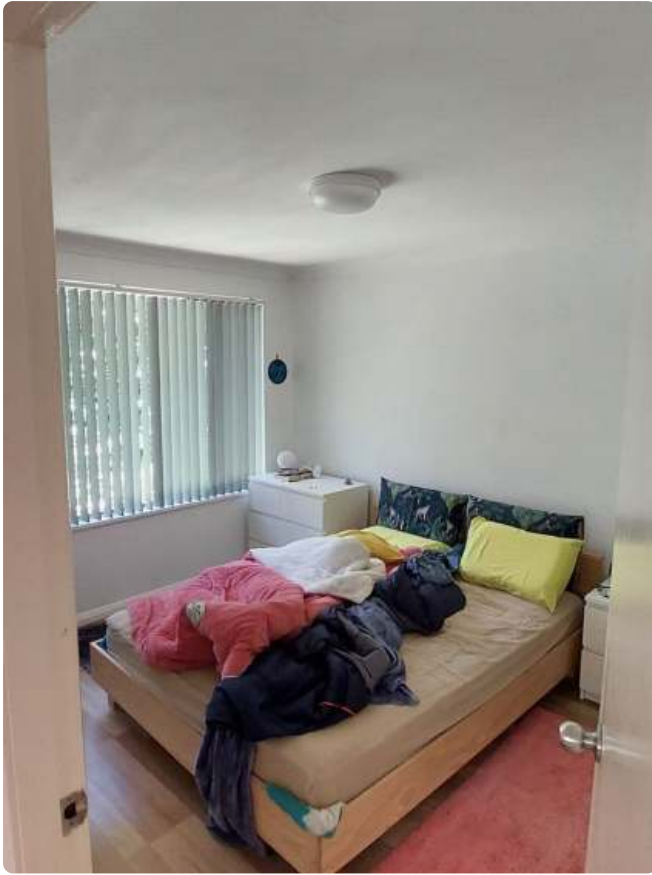
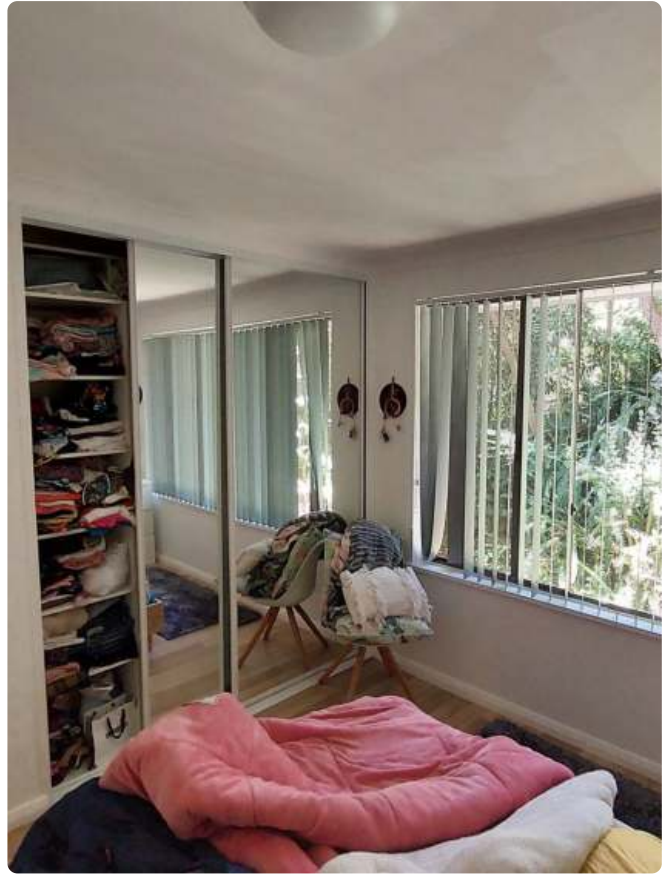
### Bedroom 3

Flooring in Bedroom 3 slopes toward the window and cracking is present above the window, indicating possible differential settlement or structural movement.

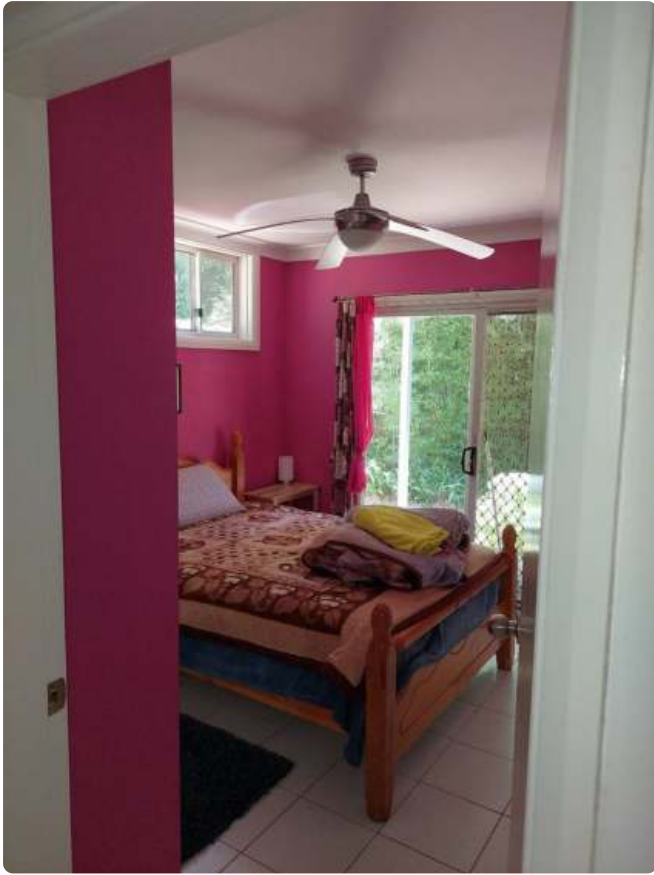
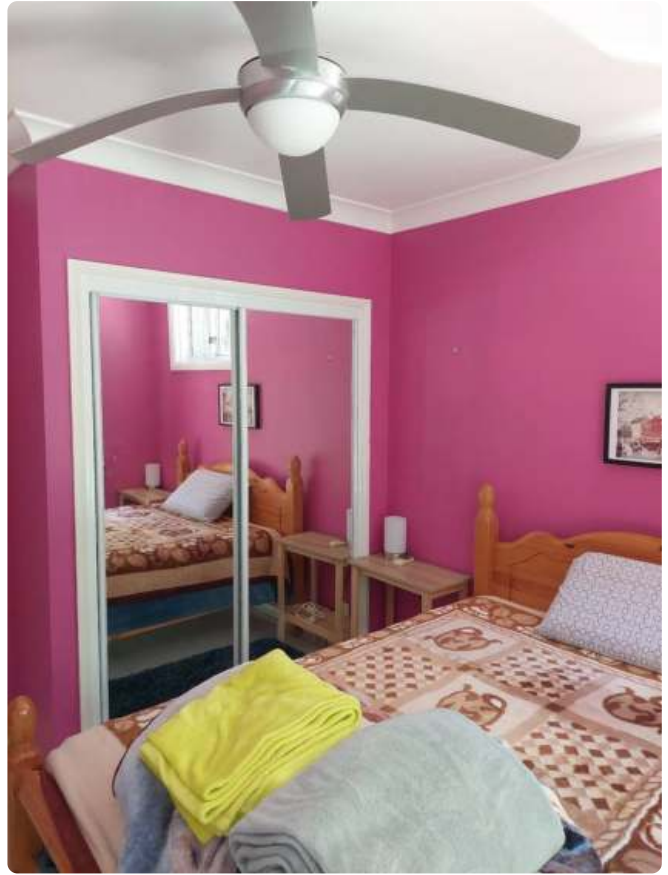
## Bedroom 4

Localised areas of paint bubbling and uneven finish are present on the wall and window reveal in Bedroom 4, which may indicate previous moisture ingress or substandard surface preparation.

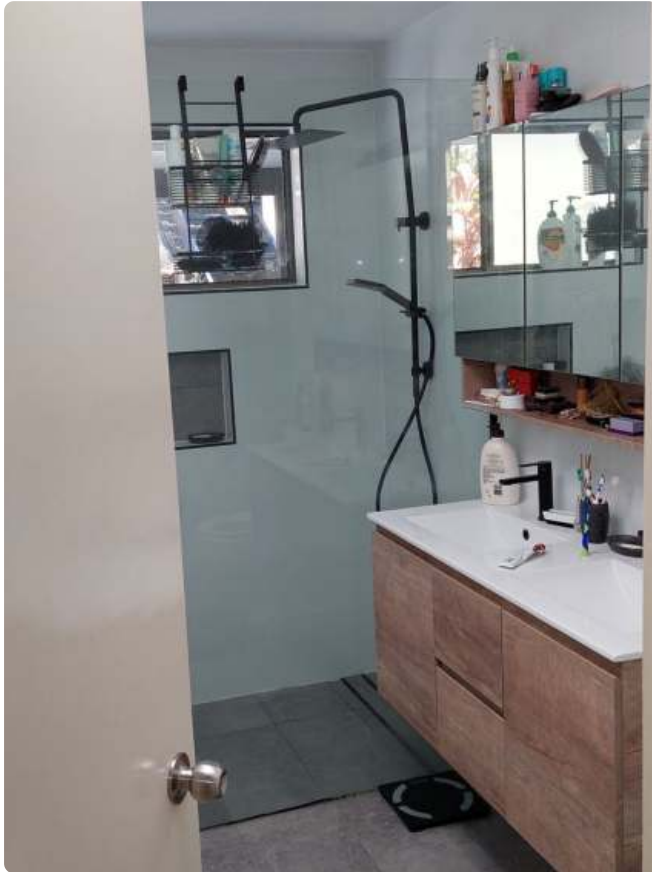
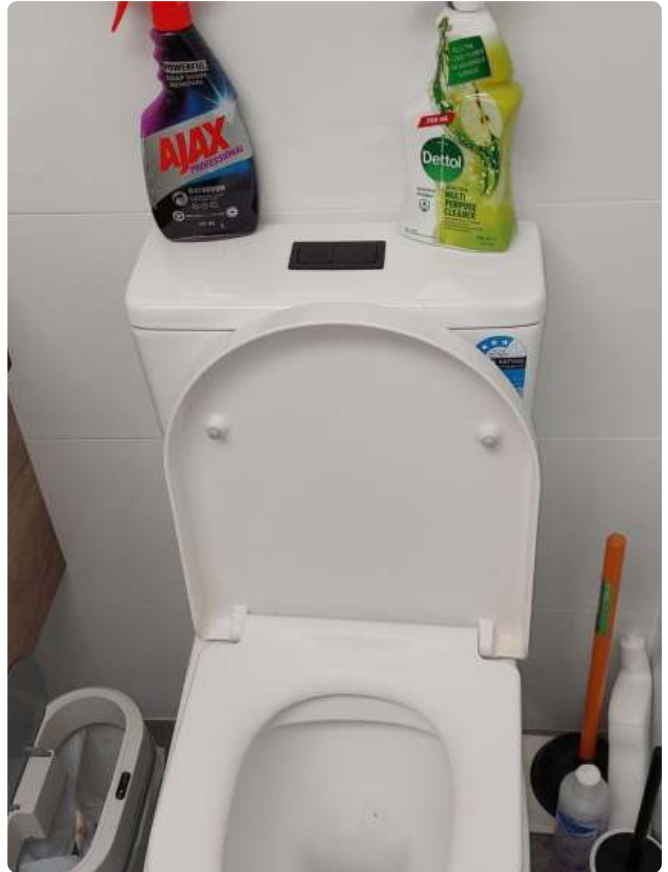
## Bathroom

The bathroom exhibits water damage and swelling to the base of the door and visible deterioration to the shower screen base, indicating ineffective waterproofing and ongoing moisture ingress.

- **Wet Areas (Bathrooms/Laundry):** Both the primary **Bathroom** and **Bathroom 2** show signs of poor waterproofing.
  - The main bathroom door base is swollen and the shower screen base is deteriorating, meaning water is escaping the shower area.

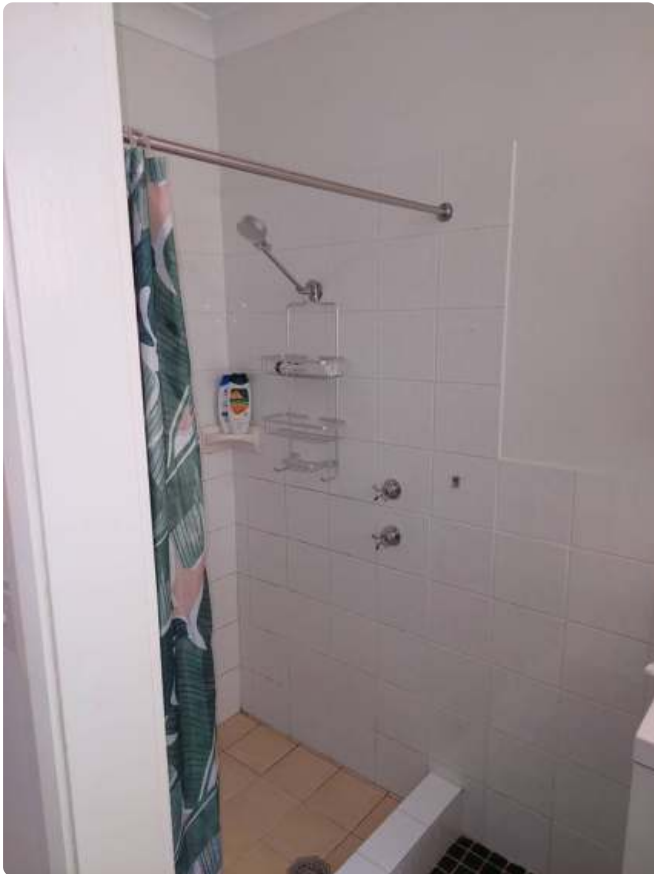
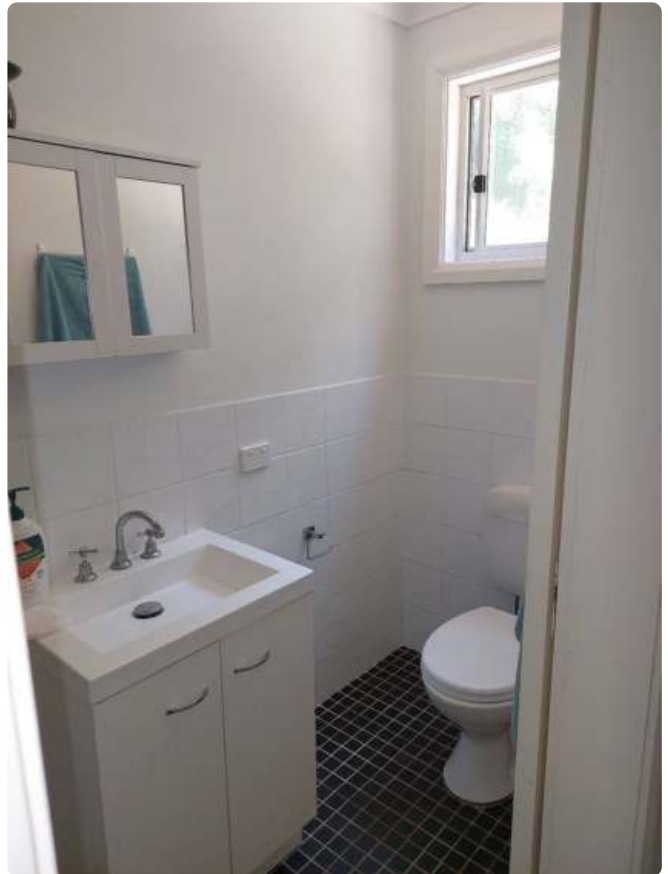
## Bathroom 2

Cracked wall and floor tiles, along with missing grout in the shower area of Bathroom 2, present a risk of water ingress to underlying building elements, which can lead to concealed moisture damage, potential structural deterioration, and conditions conducive to timber pest activity.

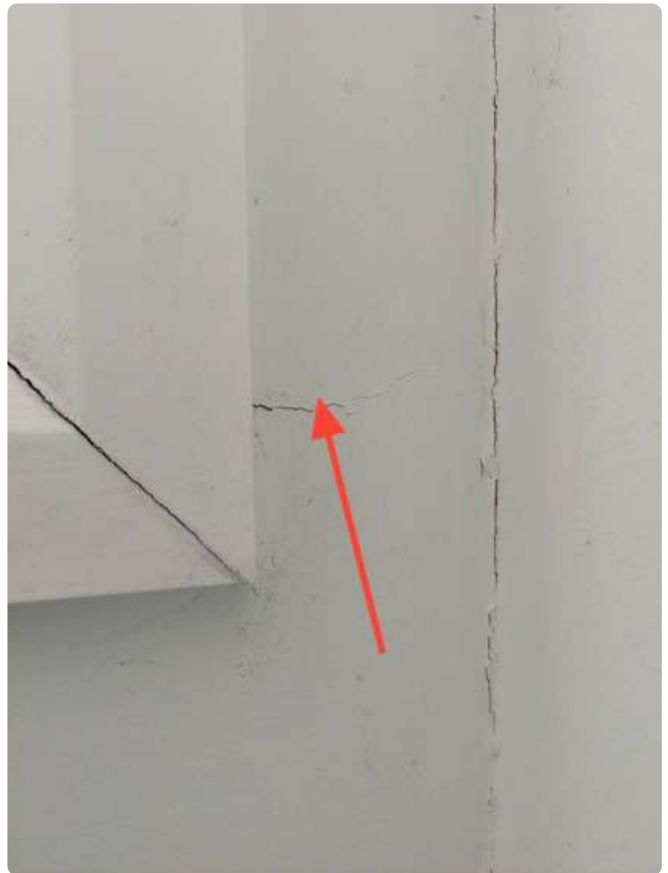
wall crack adjacent window

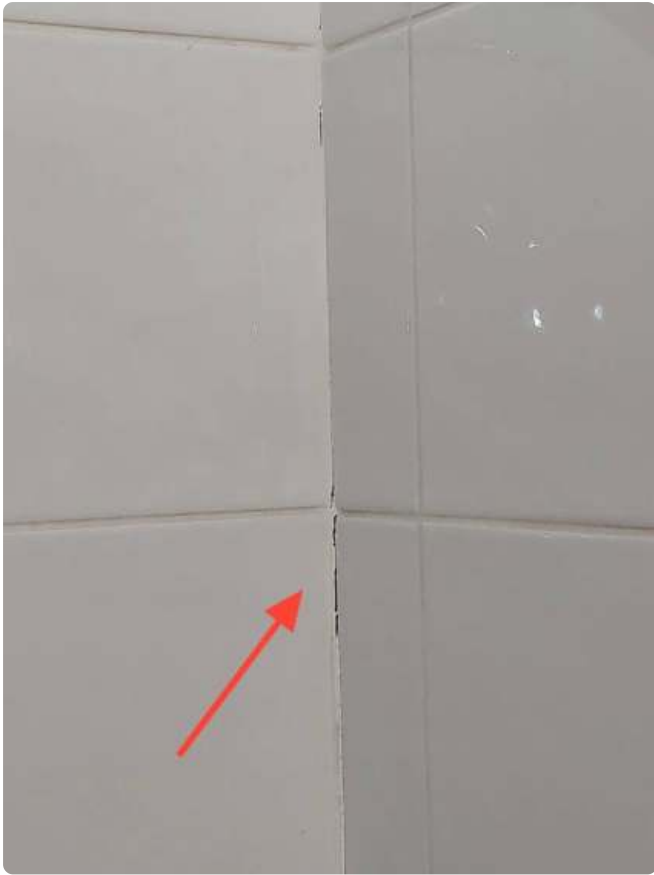
grout missing on shower wall

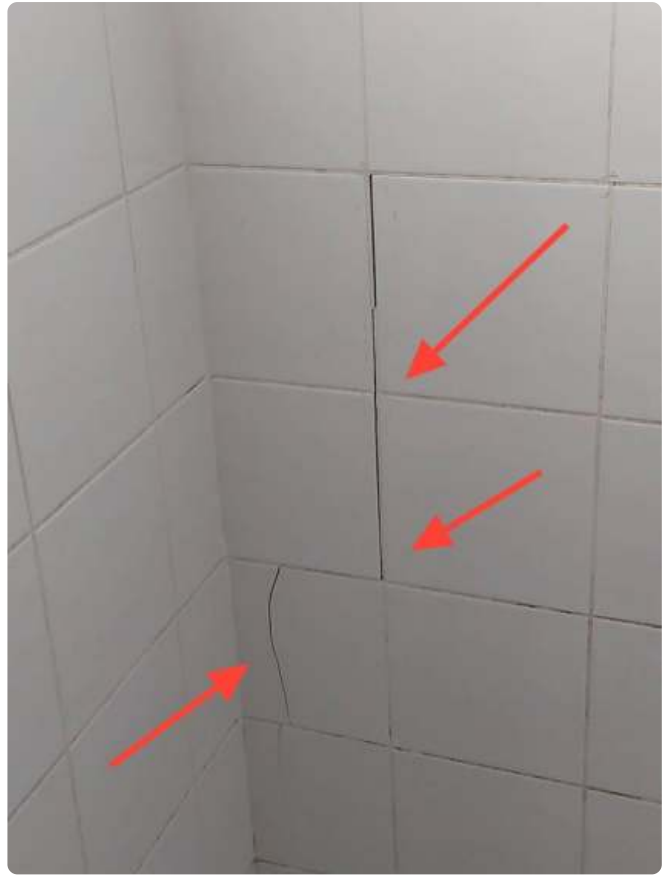
Tiles cracked in shower

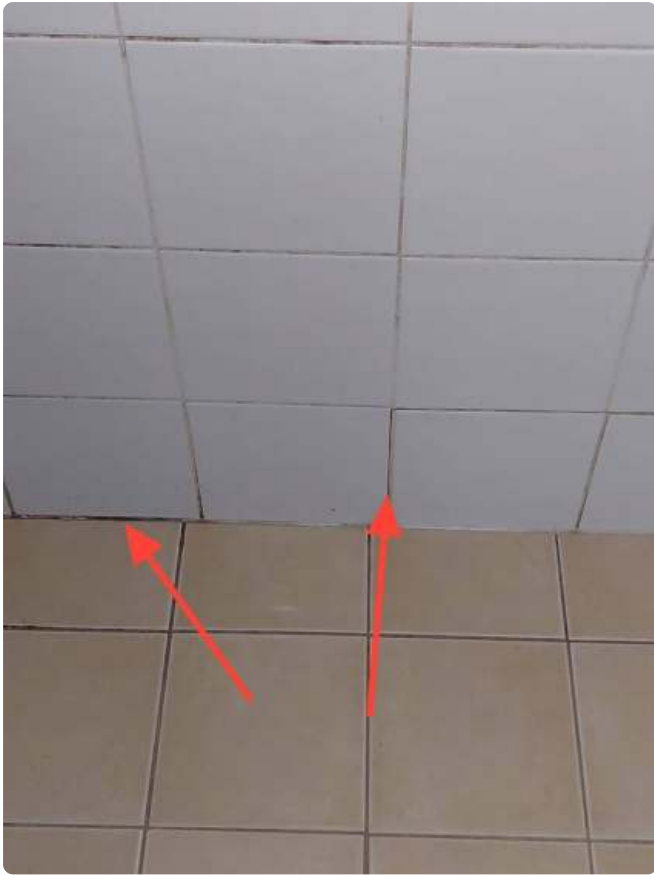
Grout missing in shower

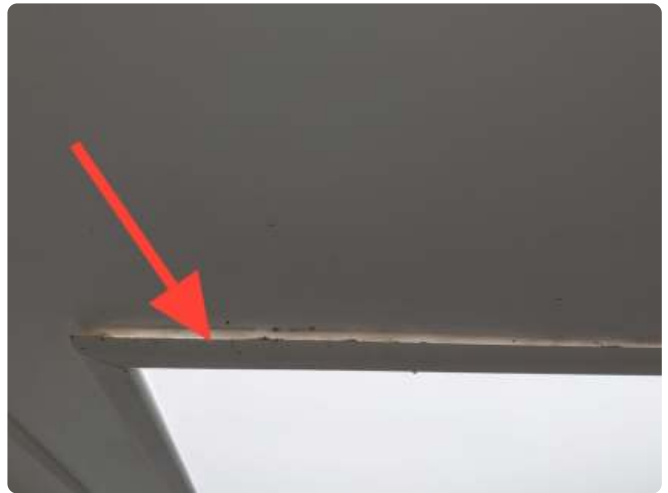
Visible separation at the skylight frame in the Laundry ceiling presents a risk of water ingress, which can lead to moisture damage.

skylight frame separation
