# Visual Timber Pest Inspection and Report in Accordance with AS 4349.3-2010

12 - 14 Lakes Drive, Tweed Heads West

Type of inspection: Timber Pest Inspection AS 4349.3-2010

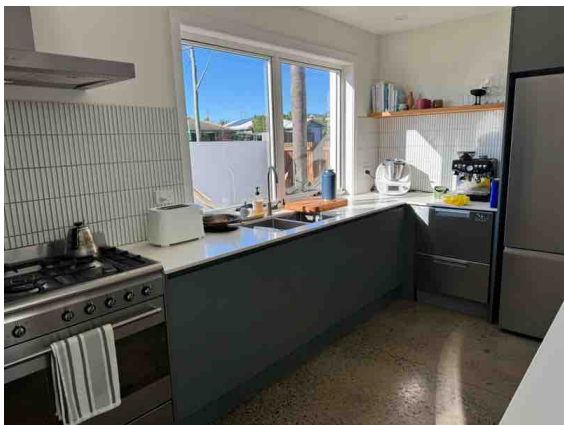
Example of kitchen cupboards and appliances limiting full visual inspection

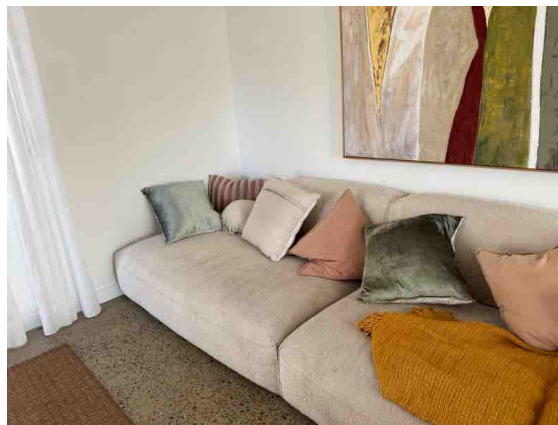
Example of heavy furniture limiting full visual inspection

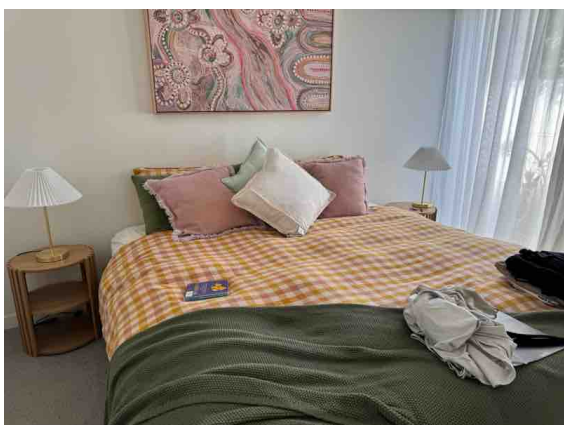
Heavy furniture items restricted full visual inspection of walls.

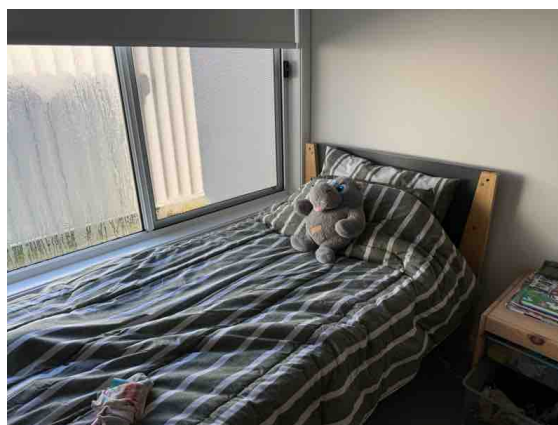
Heavy furniture items restricted full visual inspection of walls.

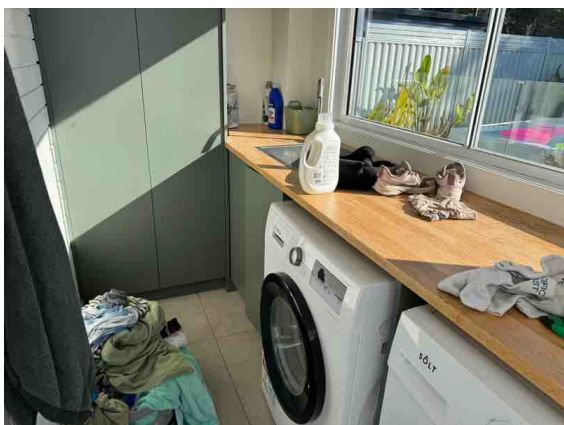
Laundry appliances and cupboards prevented full visual inspection of walls.

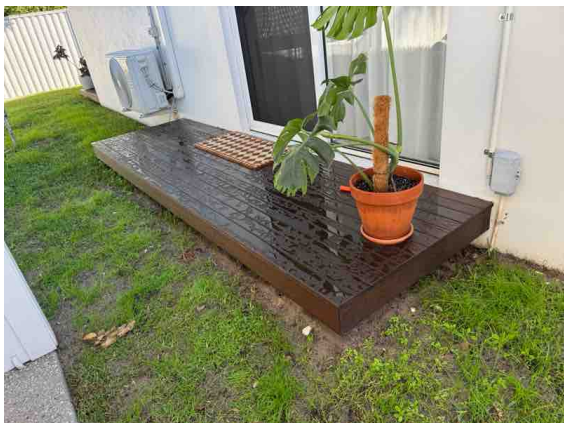
Timber decks conceal base of exterior walls.

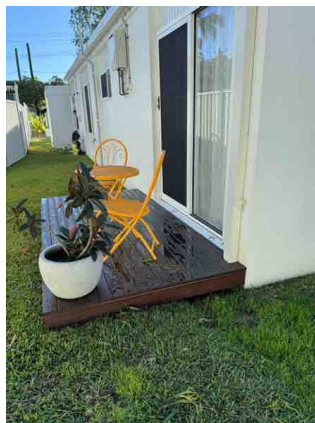
Timber decks conceal base of exterior walls.

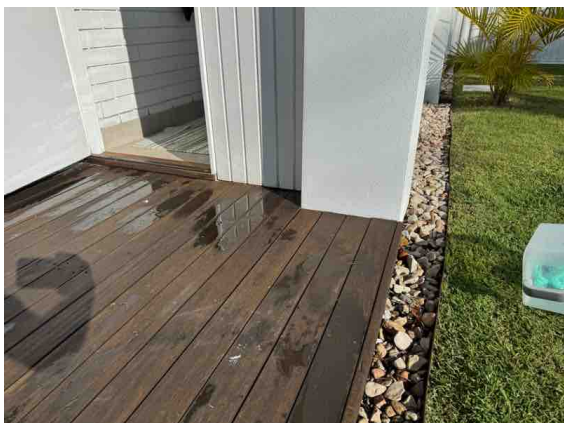
Timber decks conceal base of exterior walls.

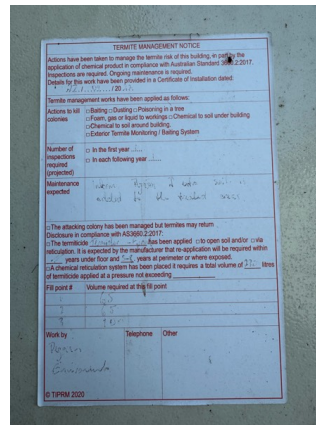
**Image of Termite Management Sticker**

**It is recommended that enquiries are made regarding any Termite Management systems installed at the Site.** Reticulation System TermX Reticulation System installed as a preconstruction termite treatment.

Perimeter Reticulation System on eastern, southern and northern sides of structure now due for recharging.

<b>Termite Management Recommendation:</b>	Strongly Recommended
<b>Frequency of Further Inspections:</b>	12 months
<b>Other Inspections Recommended:</b>	No
<b>Comments regarding a Subterranean Termite Treatment Proposal:</b>	Reticulation System on eastern, southern and northern sides of structure now due for recharging. A Proposal will be provided.
