Inspection Report

Besafe Group Pty Ltd

34 Abingdon Road, Roseville, New South Wales, 2069

Report/Agreement #	12092024
Inspection Date:	12 Sep 2024
Inspection Time:	09:01 AM

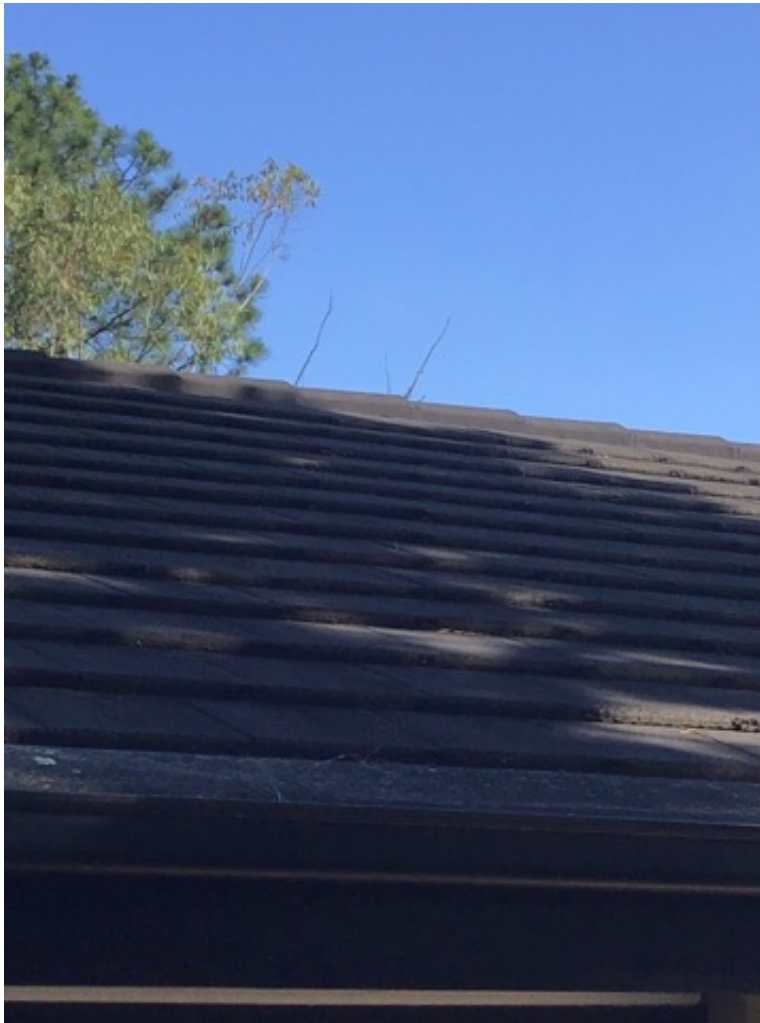
Roof Covering Condition

Visible section of The roof cladding appeared in a serviceable condition for the age of this dwelling. Annual maintenance inspection recommended.

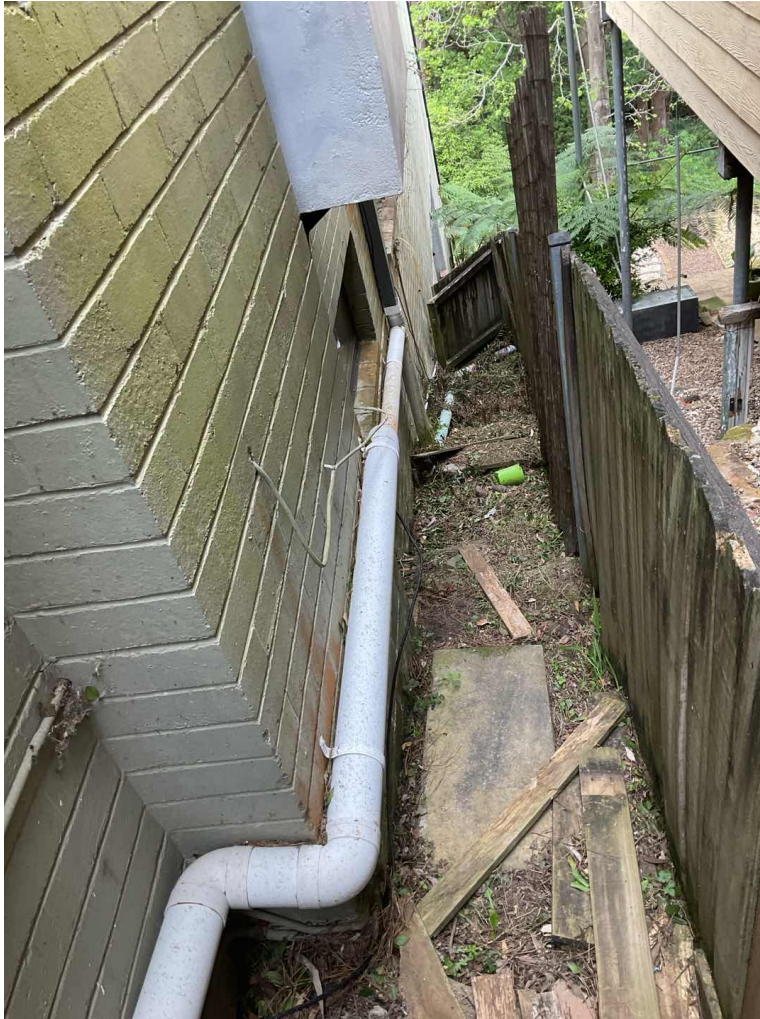
Frame

Timber fungal decay in the side stairs which i believe it has been decommissioned. - Recommendations: A qualified carpenter should be engaged for advice and recommendations.

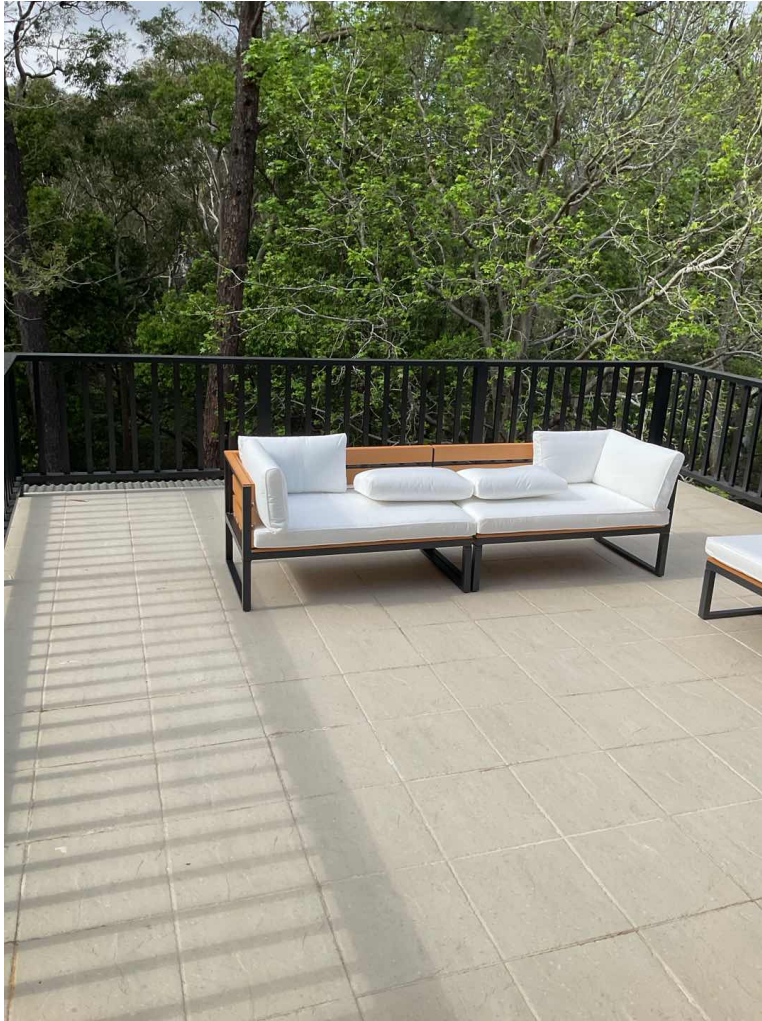
Flooring

Tile grout deterioration - Recommendations: A qualified tiler should be engaged for advice and recommendations. Grout deterioration may cause leaking and water penetration through to lower levels. Regular maintenance is required.

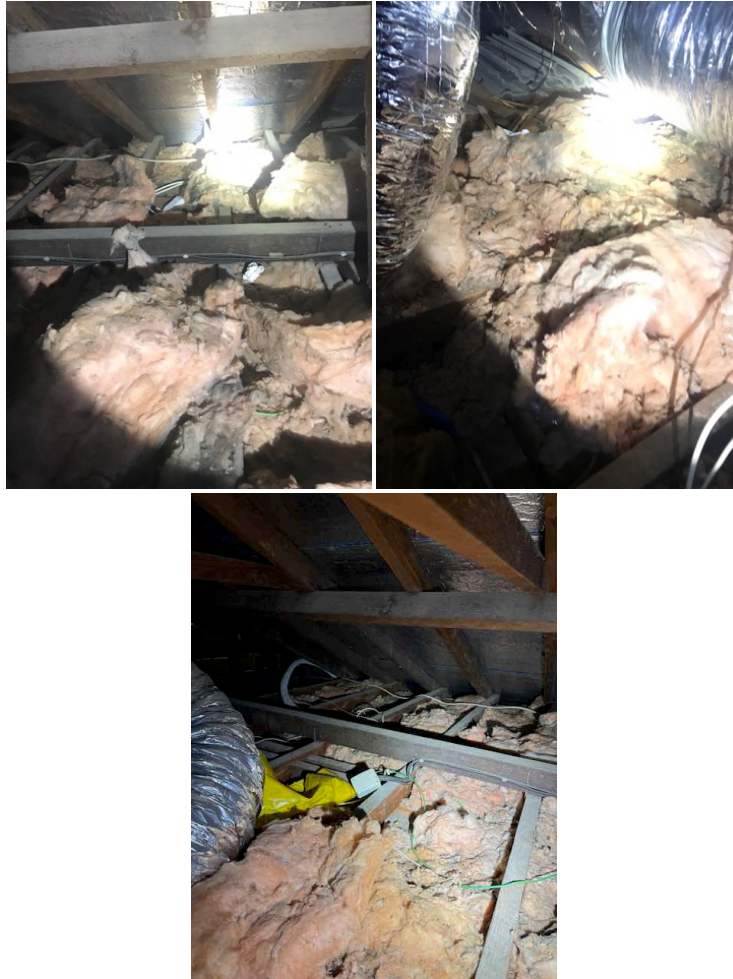
Overall Condition

Visible sections of the roof void is in a serviceable condition for age of this dwelling.

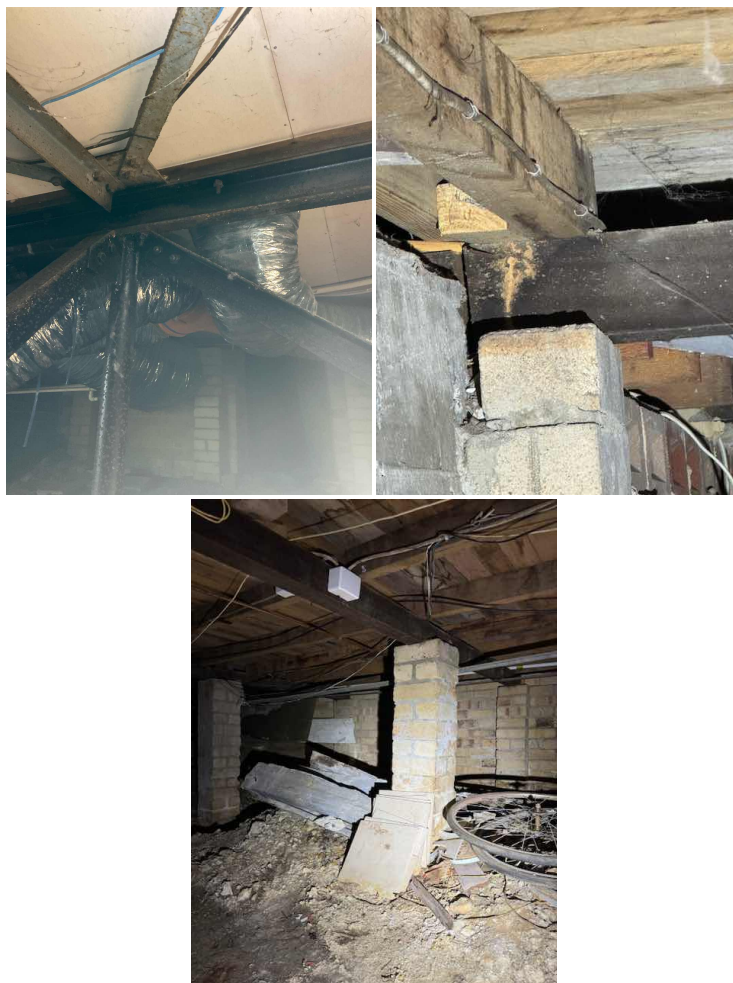
General Condition

Of areas accessible and visible, the subfloor and components appeared to be in a serviceable condition. Rust was also sited to the supporting beam and treatment is required .

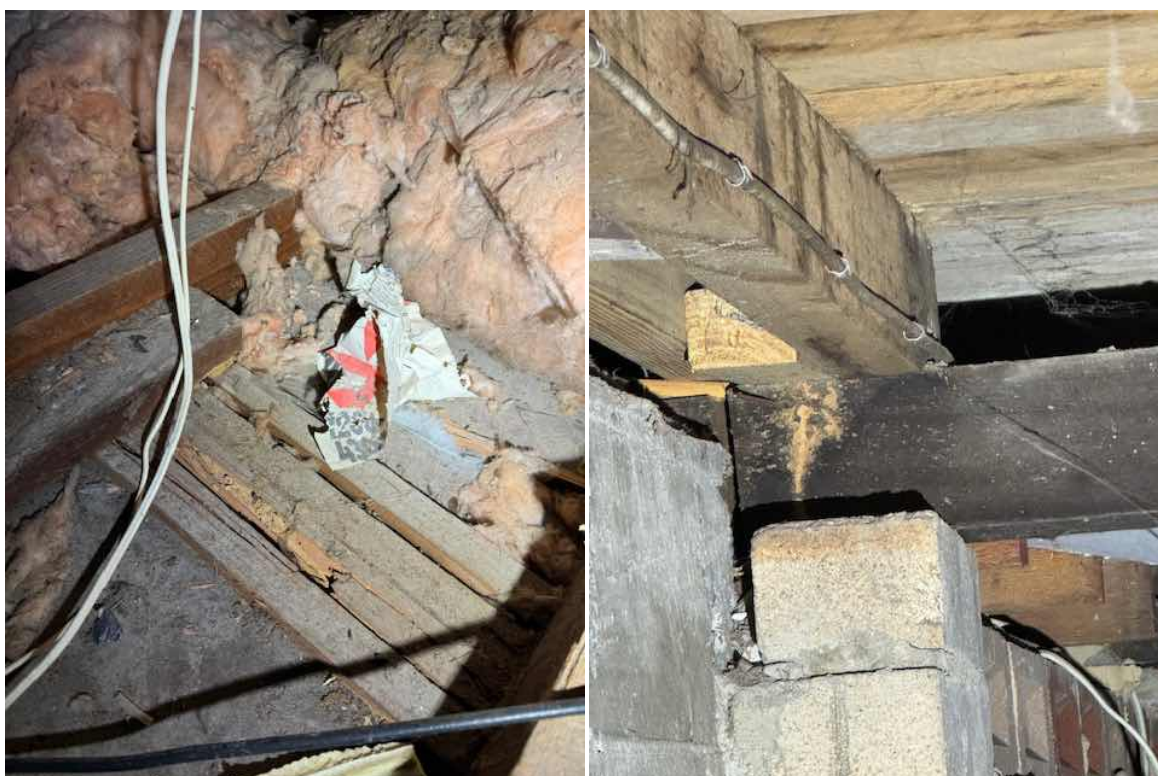
Old termite damage was found in the roof frame timber however no activity was detected at the time of inspection.

Old Mudding was observed in the subfloor timbers.
