## **VISUAL BUILDING & PEST INSPECTION REPORT**

Complies with Australian Standard 4349.1 & 4349.6

### **Vendor Report**

**33 Boundary Road Wahroonga**

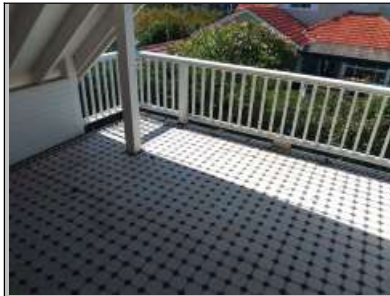
Northern elevation.

Where an external structure is constructed from timber or has significant timber components, and exposed to the elements, a suitably qualified engineer should inspect the structure to determine if it is structurally sound. We cannot determine or advise what weight the structure can hold, The general condition of this structure is fair.

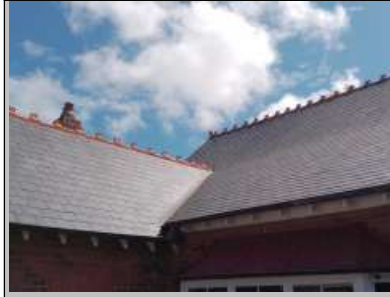
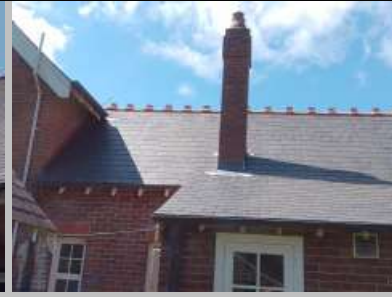
The roof is of pitched construction.

The overall condition of the roof coverings is good.

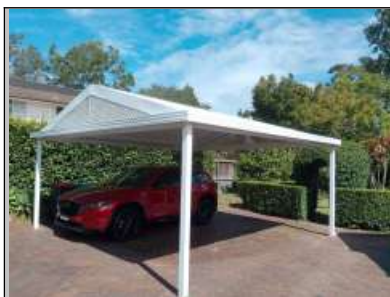
Carport.

The structure is generally in good condition.

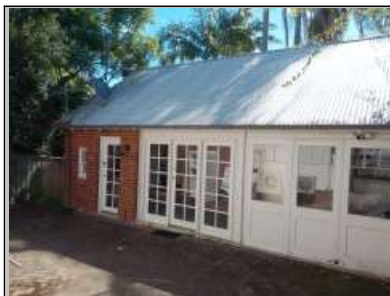
Granny flat.

The structure is generally in fair condition.

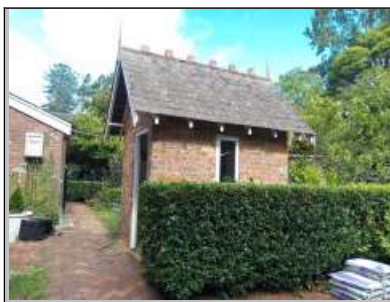
Laundry.

The structure is generally in fair condition.

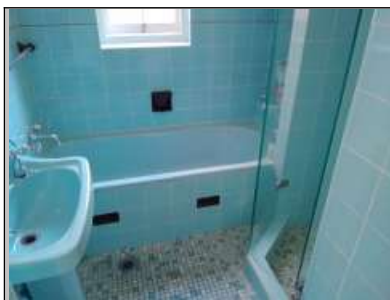
Adjacent to the kitchen.

The shower recess was tested and found to be leaking. Continued leaking may allow damage and decay to surrounding components. Rectification will be required and evaluation of extent of works should be requested from a Licensed Builder.

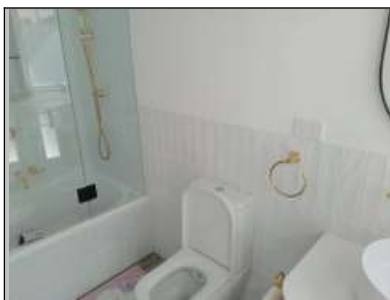
Ground floor.

The shower is located over the bathtub. The area will need to be kept well sealed to prevent water penetration to surrounding areas.

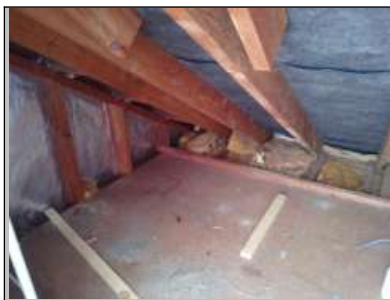
The cut and pitched roof timbers appear to provide adequate support.

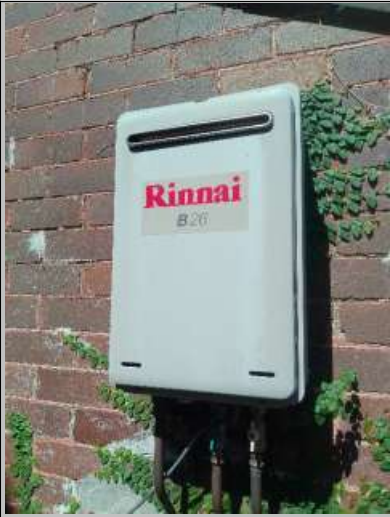
Gas hot water system: Mains pressure: Instantaneous: Located externally: The hot water system appears to be in working condition. No specific tests other than running the hot water tap were carried out. No determination has been made as to the suitability or adequacy of the hot water system in relation to capacity or otherwise.

The hot water service has no date but appears to be new.

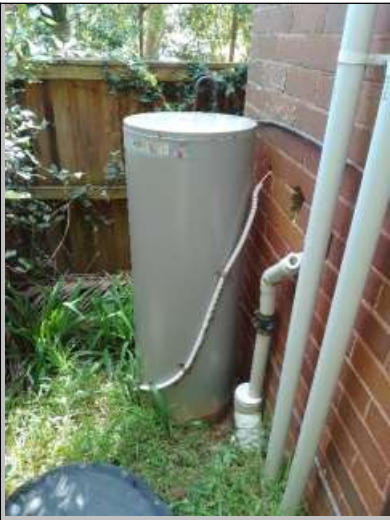
Mains electric hot water system: Mains pressure: Located externally: The hot water system appears to be in working condition. No specific tests other than running the hot water tap were carried out. No determination has been made as to the suitability or adequacy of the hot water system in relation to capacity or otherwise.

The unit was manufactured in 2005.
