## **VISUAL BUILDING & PEST INSPECTION REPORT**

### **Vendor Report**

**35 Archbold Road Roseville**

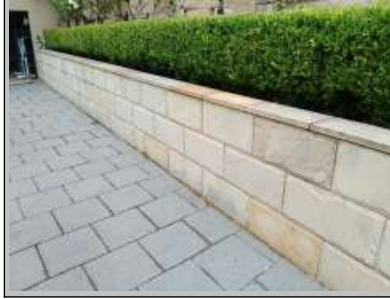
The masonry retaining walls appear in acceptable condition.

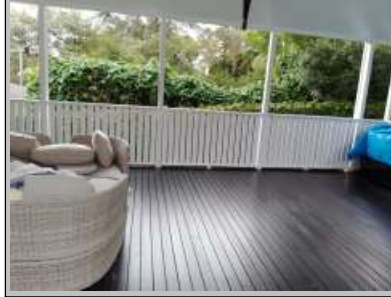
Rear elevation.

The general condition of this structure is fair.

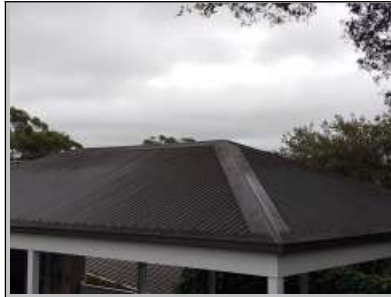
Corrugated steel.

The overall condition of the roof coverings is good.

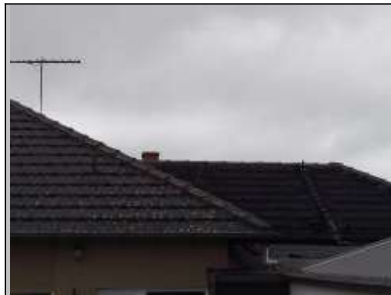
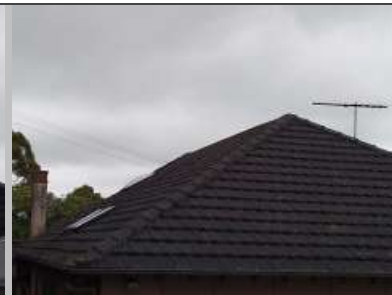
No access was possible to part of the external roof area due to the roof not being accessible from a 3.6 meter ladder.

The overall condition of the roof coverings is fair.

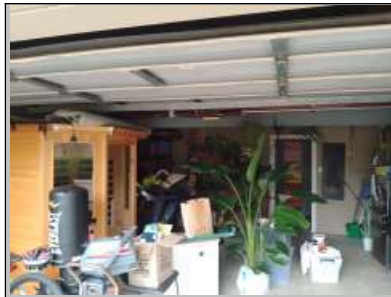
Garage.

The structure is generally in good condition.

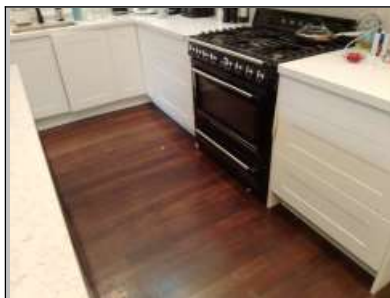
The condition of the fixtures is generally good, A stone splashback is located over the benchtop area.

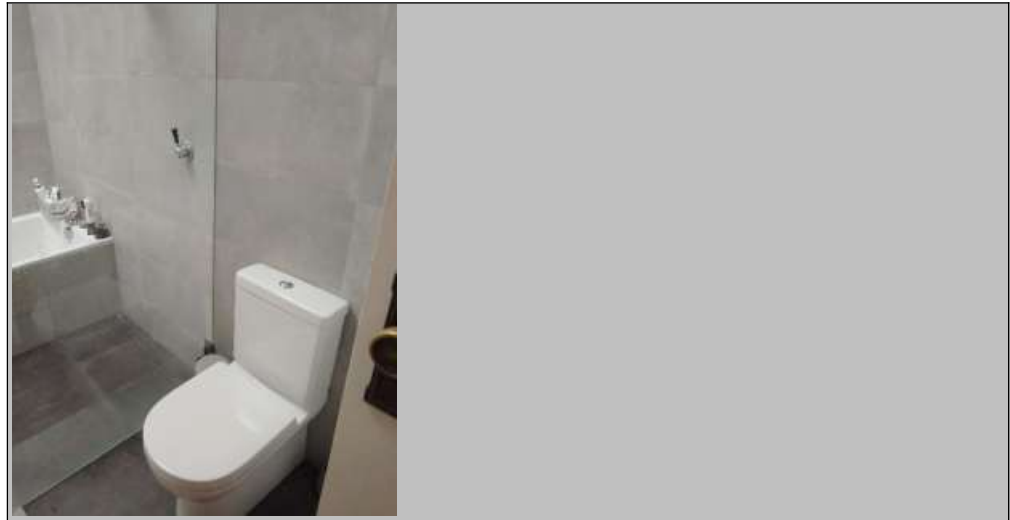
Adjacent to hall.

The shower recess was tested and there was no visible water penetration to surrounding areas. IMPORTANT NOTE: This test may not reveal water leaks until the shower is put into constant use and surrounding areas monitored over a period of time.

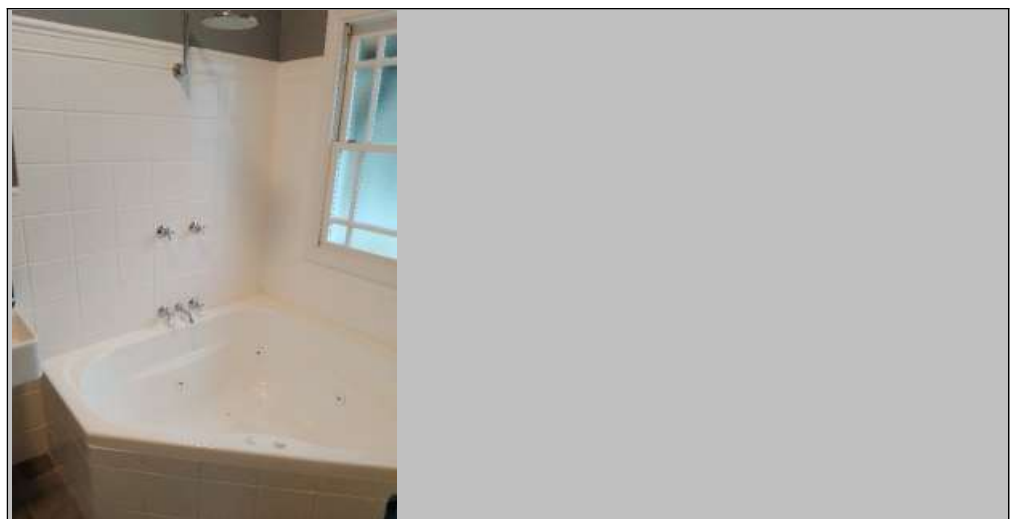
Rear.

The shower is located over the bathtub. The area will need to be kept well sealed to prevent water penetration to surrounding areas. A spa bath is present however, due to the requirement to fill the unit above jet level for testing the spa was not tested for adequacy or reliability. Defects may be present and not detected.

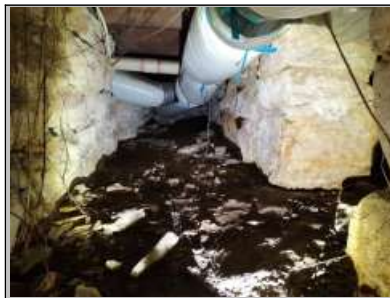
Full inspection was limited by the presence of ducting associated with air-conditioning or heating. We recommend a more complete inspection of this area. Inspection was restricted in or below the following locations and or areas: Bathroom. Hallway.

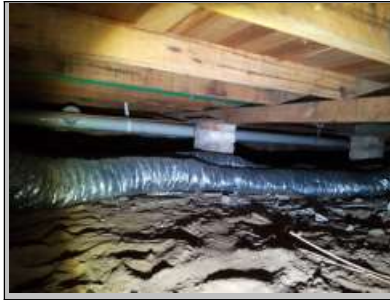
The building is constructed on a combination of strip footings and piers. The footings appear to be generally sound.

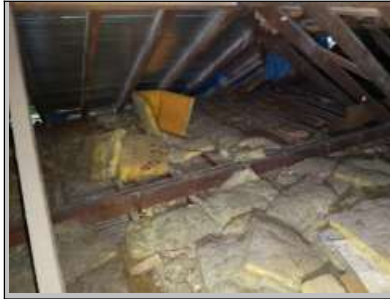
Insulation is present in the roof cavity. This restricted inspection to some roofing timbers. Removal of insulation is not within the scope of a standard visual inspection report, however as in accordance with "industry best standard" the inspector will lift insulation in 3 areas in roof void. Sarking membrane covered tile battens restricting inspection.

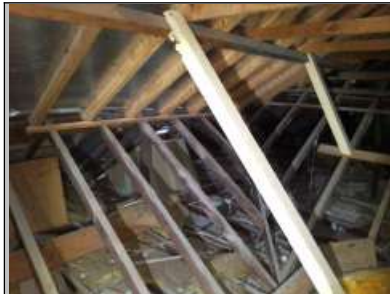
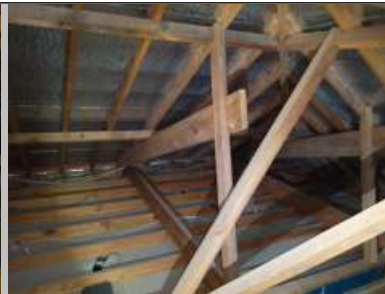
The cut and pitched roof timbers appear to provide adequate support.

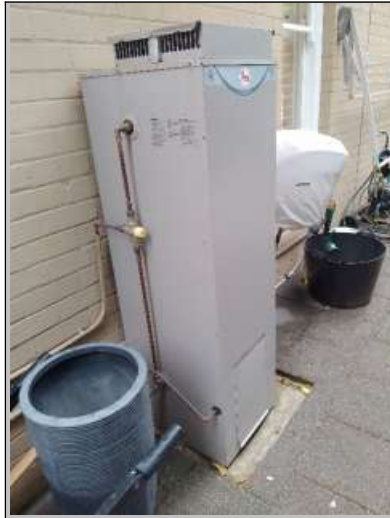
Gas hot water system: Mains pressure: Located externally: The hot water system appears to be in working condition. No specific tests other than running the hot water tap were carried out. No determination has been made as to the suitability or adequacy of the hot water system in relation to capacity or otherwise.

The unit was manufactured in 2017.

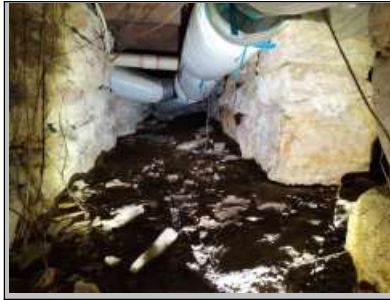
Full inspection was limited by the presence of ducting associated with air-conditioning or heating. We recommend a more complete inspection of this area. Inspection was restricted in or below the following locations and or areas: Bathroom. Hallway.

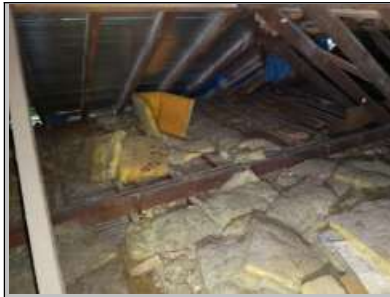
Insulation is present in the roof cavity. This restricted inspection to some roofing timbers. Removal of insulation is not within the scope of a standard visual inspection report, however as in accordance with "industry best standard" the inspector will lift insulation in 3 areas in roof void. Sarking membrane covered tile battens restricting inspection.
