Building and Timber Pest Inspection Report

Inspection Date: Tue, 22 Oct 2024

Property Address: 25 Warrangi St, Turramurra NSW 2074,
Australia

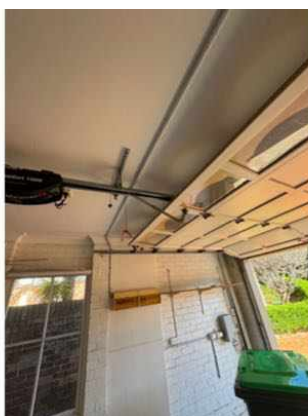
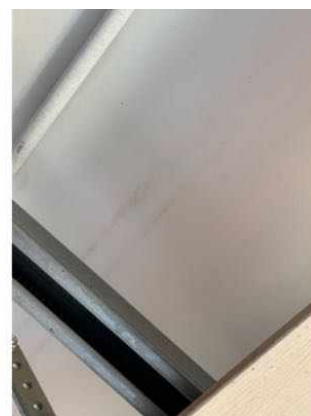
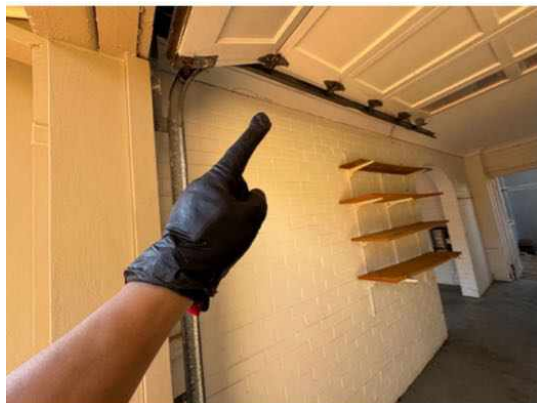
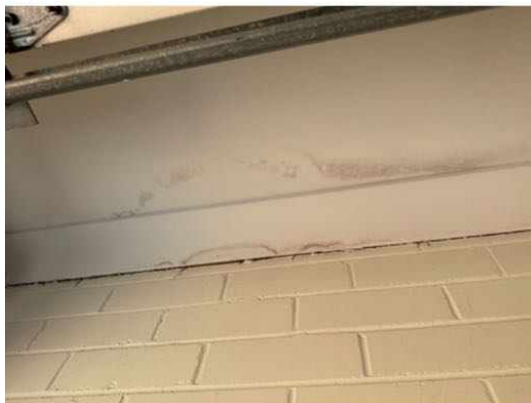
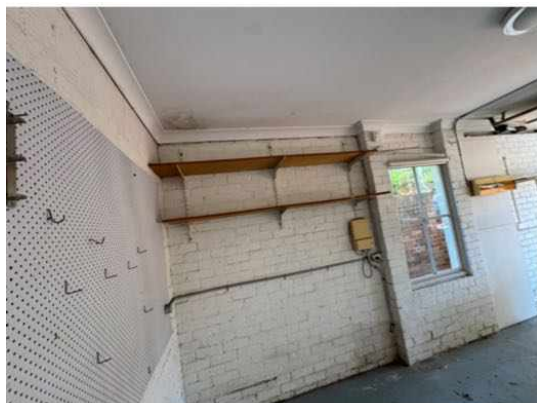
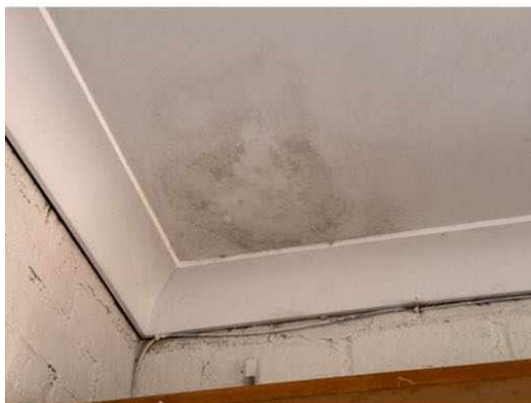
Finding: Ceiling - Water stained

Information: Water staining to ceiling linings in this area was evident at the time of inspection. Water staining indicates that surfaces have been exposed to excessive moisture over time. The minerals and other elements in the water lead to staining, which may graduate to corrosion and deterioration if left unmanaged.

While mostly an appearance defect, water staining can be indicative of more serious defects, which may be currently concealed by interior ceilings.

Where water staining is active, a licensed plumber must be consulted to identify the cause of the staining and to provide advice on any reparation works that may be required. Replacement of any damaged structures is advised.

Conversely, where water staining is old and inactive, affected building materials may be repaired or replaced at client discretion.

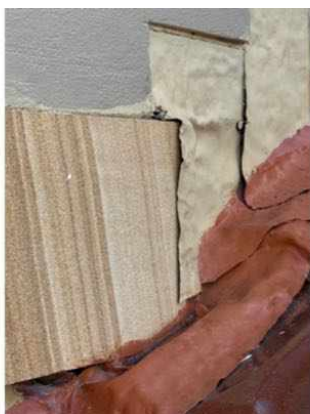
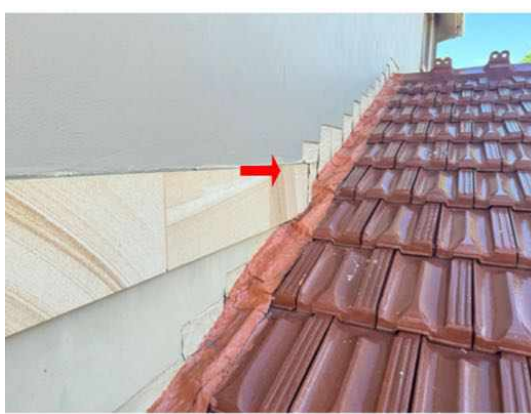
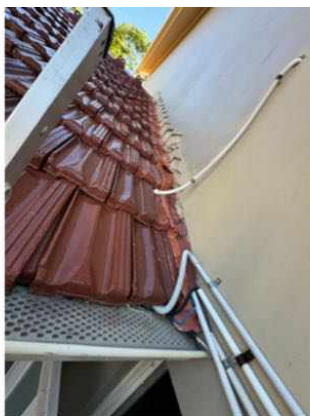
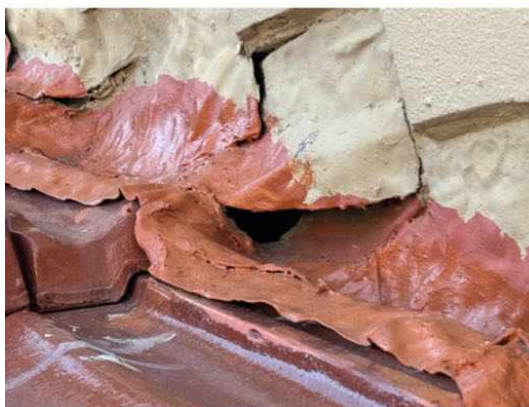
Finding 3.02

Building:	Main Building
Location:	Roof Exterior
Finding:	Roof flashing - non-standard
Information:	The roof flashing that has been installed does not appear to comply with current building practice. However the flashing appears to be in an acceptable condition and is fulfilling its purpose in ensuring the roof covering is weather-tight.

Whilst retrospective fixing is not required if flashing begins to come loose from its fixing or deteriorates as evidenced by roof leaks a roofing plumber should be appointed immediately to replace the building element.

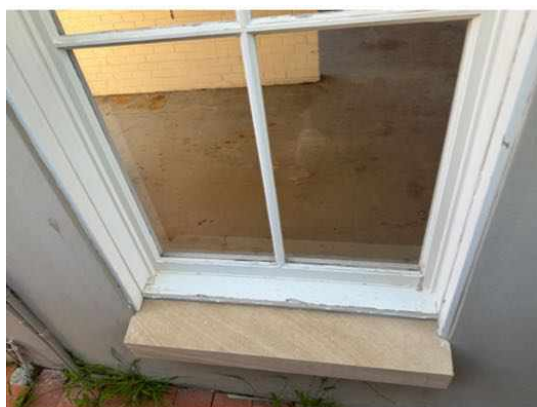
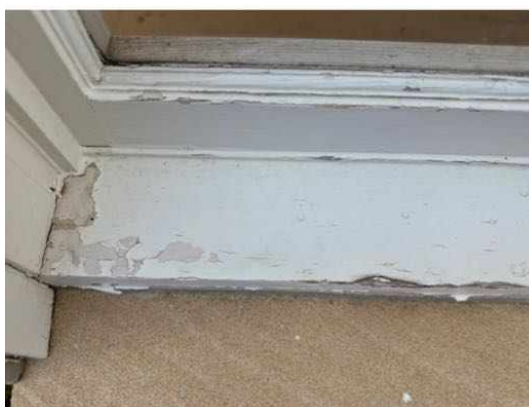
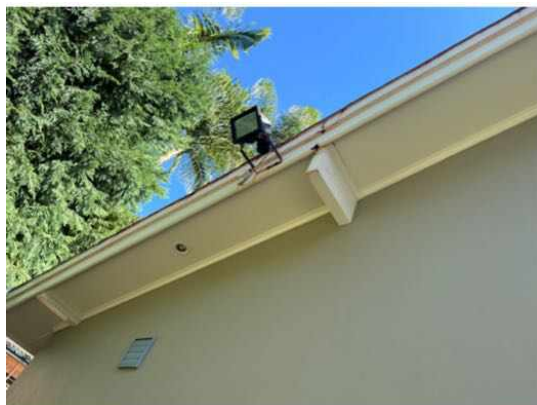
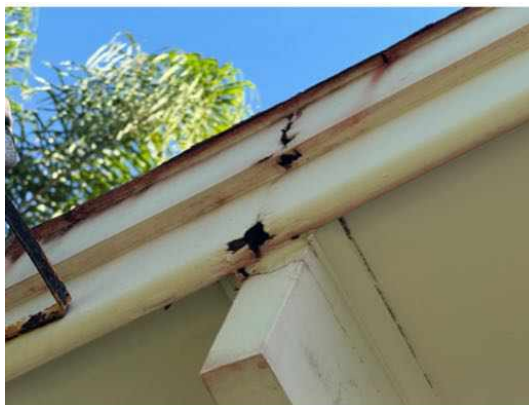
Finding 3.03

Building:	Main Building
Location:	All External Areas
Finding:	External painting deteriorated
Information:	Much of the external paintwork including but not limited to windows, fascias, guttering, veranda and other external fitments have been neglected and require attention to prepare and re-paint.

Whilst incomplete or missing paint finish is generally an appearance defect, it can also lead to the development of secondary building defects over time. Incomplete areas of paint finish expose the area to moisture, potentially accelerating the deterioration of underlying building materials.

Degraded paint finishes should be sanded back, filled, leveled and painted, as applicable. Where inadequate or missing paint protection has led to the deterioration of the associated building element, repair and/or replacement of this building element may be required.

A painting contractor should be appointed as soon as possible to perform necessary works to aid the appearance of the affected area and to ensure the area is protected against further deterioration. Alternatively, the homeowner following manufacturer instructions may perform these works.

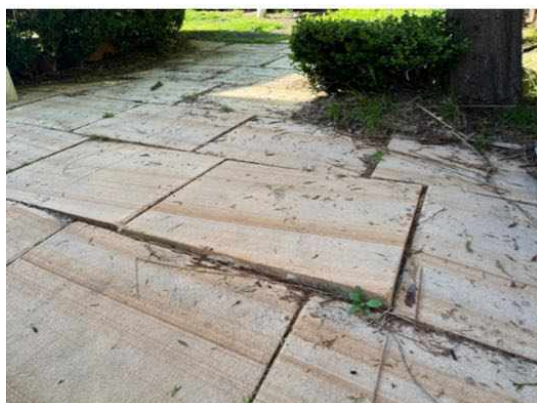
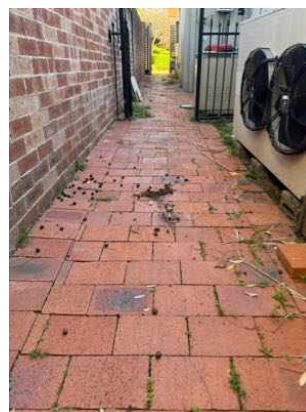
Finding 3.04

Information: Sections of the external paved area are uneven, creating a potential trip hazard. It appears as though the area has been subject to rough installation, or that paving sections have lifted due to movements in the foundation of the property.

Where paving creates a trip hazard, personal injury may ensue if due caution is not taken by all persons within this area.

Re-paving of the area is required as soon as possible to remedy this situation. Further consultation with a specialist concreter is advised.

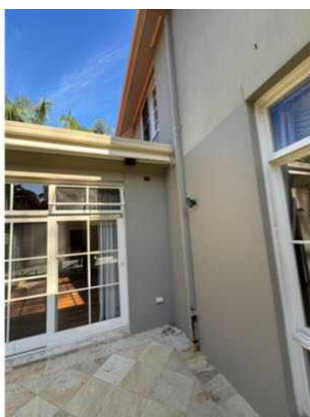
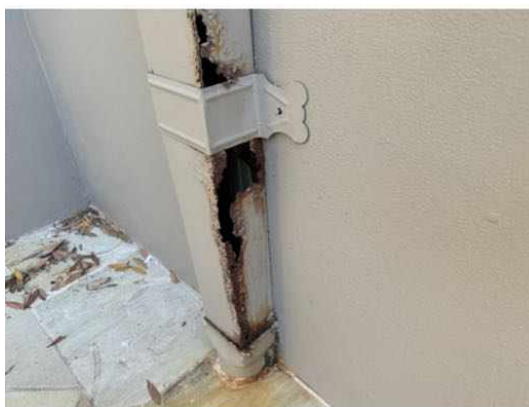
Finding 3.05

Finding: Roof plumbing - Rusted or corroded

Information: The roof plumbing has areas of rust and corrosion. It is suspected that this has been caused by blockages, resulting in pooling or standing water, that have prematurely rusted elements of the roof plumbing.

Rusted roof plumbing will generally develop holes and leaks that can affect other building elements with poor drainage of storm water. Poorly drained roof areas will also lead to damp conditions surrounding the base perimeter of the building which, if left unmanaged, can lead to a range of secondary building defects.

Repair and/or replacement of rusted roof plumbing is highly required in order to reinstate the roof drainage system to a fully operational level. To further maintain these areas, gutters should be cleaned frequently, allowing the avoidance of any partial blockages.

A licensed plumber or specialist roof restoration company should be appointed to undertake these works. It is advised that such works be completed as soon as possible to prevent any further damage and deterioration.

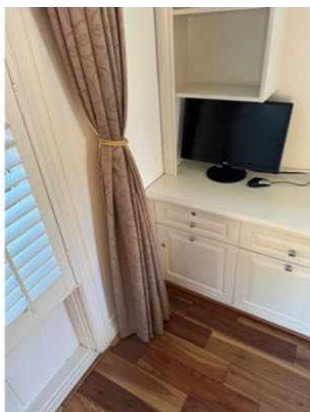
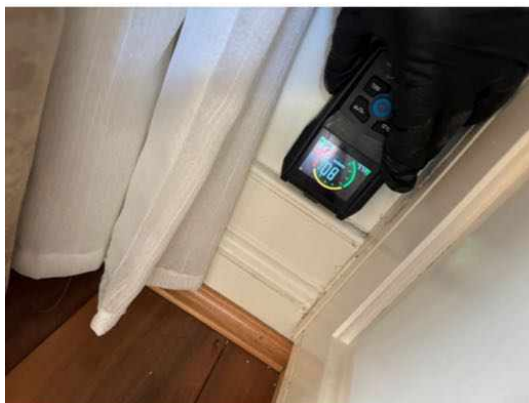
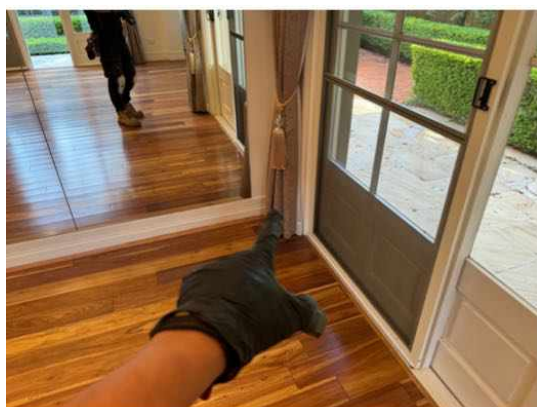
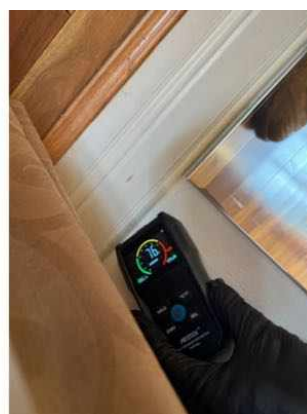
Finding 3.06

Building:	Main Building
Location:	Ground floor
Finding:	Damp - Rising
Information:	Rising damp describes the upward movement of water in low sections of building elements (e.g. walls) by capillary action - the movement of water through porous materials such as bricks, sandstone or mortar.

Rising damp is generally managed by the installation of a damp proof course during construction. A Damp Proof Course (DPC) is an impermeable barrier at the base of the wall above ground level. However, many 19th Century buildings have no damp course installed, or the materials have failed. The DPC may have been omitted as a consequence of poor workmanship, or it may have been bridged where materials built up against the side of the house allow moisture ingress above the DPC level.

The first step in addressing rising damp is to diagnose the cause. The identified cause should be addressed first before addressing the appearance and other defects which have resulted from the rising damp. If the original cause is not resolved, further cases of damp are likely to ensue, resulting in secondary defects.

Consultation with a qualified plumber is advised immediately to identify the cause of the damp and perform remedial works as required.

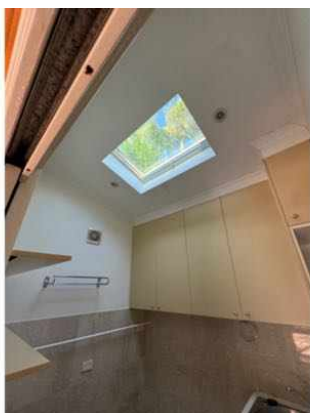
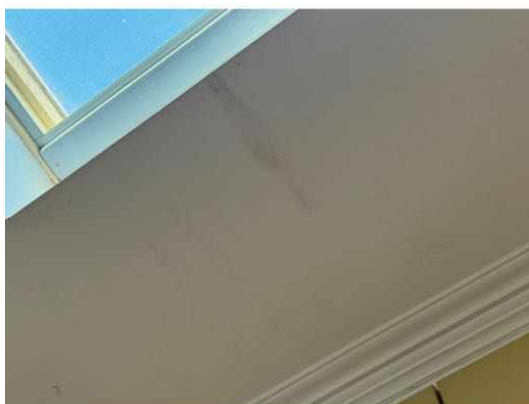
Finding 3.07

Building:	Main Building
Location:	Laundry
Finding:	Ceiling - Water stained
Information:	Water staining to ceiling linings in this area was evident at the time of inspection. Water staining indicates that surfaces have been exposed to excessive moisture over time. The minerals and other elements in the water lead to staining, which may graduate to corrosion and deterioration if left unmanaged.

While mostly an appearance defect, water staining can be indicative of more serious defects, which may be currently concealed by interior ceilings.

Where water staining is active, a licensed plumber must be consulted to identify the cause of the staining and to provide advice on any reparation works that may be

required. Replacement of any damaged structures is advised.

Conversely, where water staining is old and inactive, affected building materials may be repaired or replaced at client discretion.

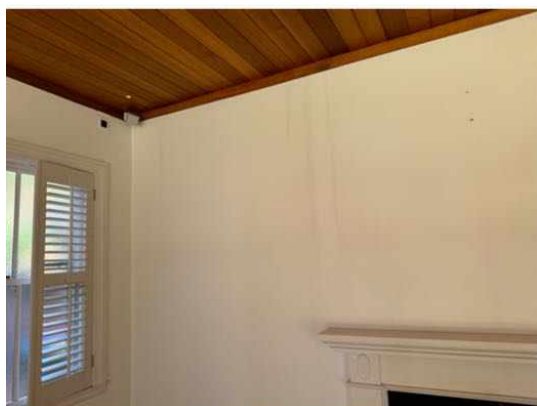
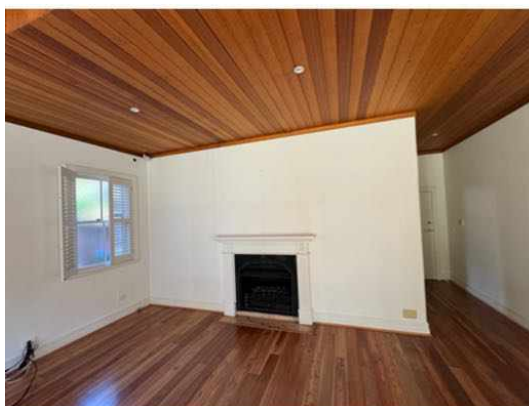
Finding 3.08

Finding: Walls - Water stained

Information: Water staining to sections of the walls in this area was evident at the time of inspection. Water staining indicates that surfaces have been exposed to excessive moisture over time. The minerals and other elements in the water lead to staining, which may graduate to corrosion and deterioration if left unmanaged.

While mostly an appearance defect, water staining can be indicative of more serious defects, which may be currently concealed by wall linings.

Where water staining is active, a licensed plumber must be consulted to identify the cause of the staining and to provide advice on any reparation works that may be required. Replacement of any broken or damaged structures is advised.

Conversely, where water staining is old and inactive, affected building materials may be repaired or replaced at client discretion.

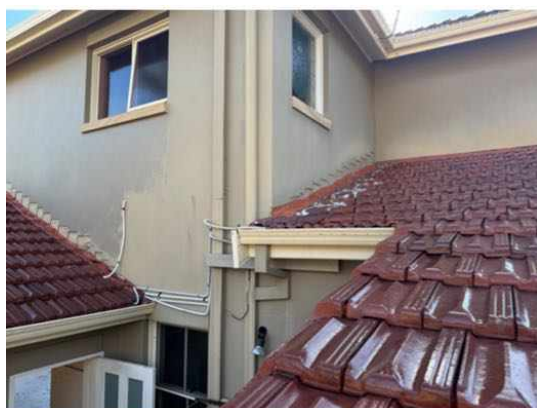
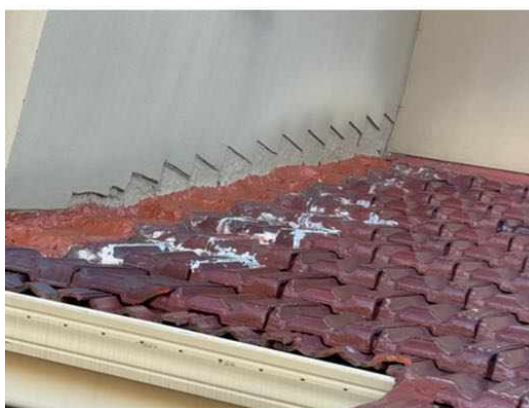
Finding 3.09

Building:	Main Building
Location:	Roof Exterior
Finding:	Roof tiles - Excessive silicone work
Information:	The silicone repair work performed to the roofing tiles appears to have been completed to an unsatisfactory standard. Excess silicone was evident in many sections of the tiled area providing a blemish on the appearance as well as detracting from the drainage of the area.

While weather-tight the excess silicone should be removed in order to increase roof drainage and to prevent accelerated deterioration of the roof tiles. A roofing contractor or general handyman may be appointed to perform these works at client discretion.

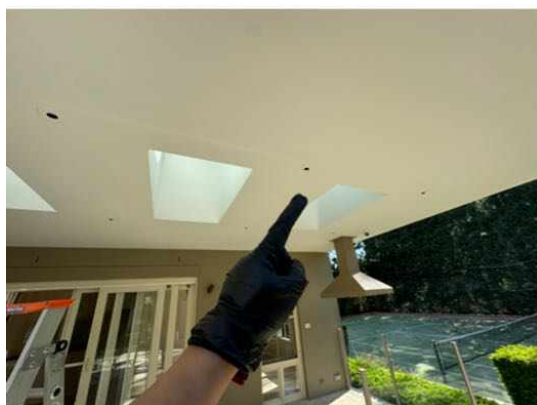
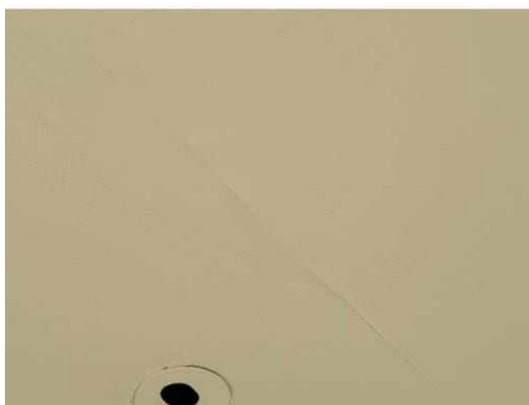
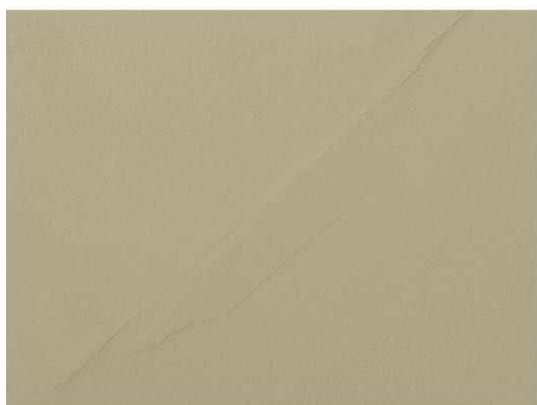
Finding 3.10

Building:	Main Building
Location:	Alfresco
Finding:	Cracking - Damage Category 1 - Fine (up to 1mm)
Information:	Although fine cracks are quite noticeable, they are often only considered to be an appearance defect, and usually do not indicate any structural damage. Generally, the cause of a fine crack is indicative of a separation between building materials and finishes (e.g. paint, plaster, etc.) along joins.

Cracking of this nature can generally be repaired with minor sanding, filling and/or repainting. Such works should be performed by a qualified painter or a general handyman.

Monitoring of all cracking should be conducted frequently. Always contact a building inspector should cracks widen, lengthen, or become more numerous.

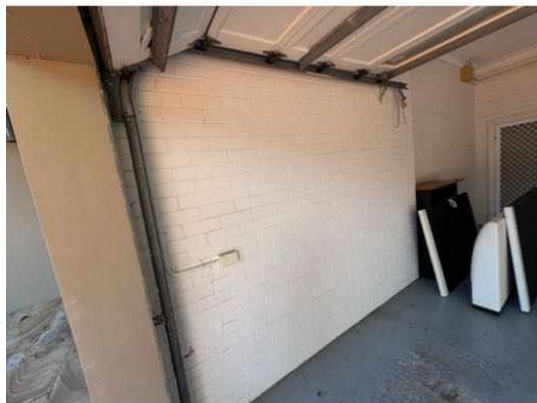
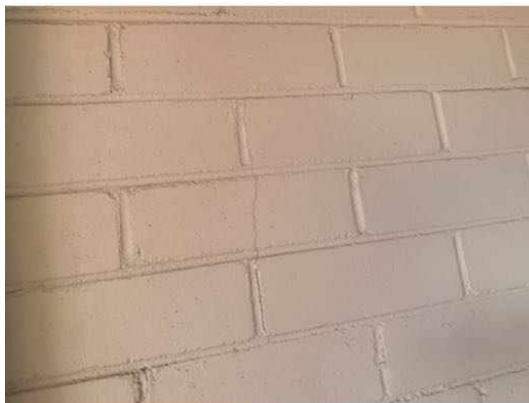
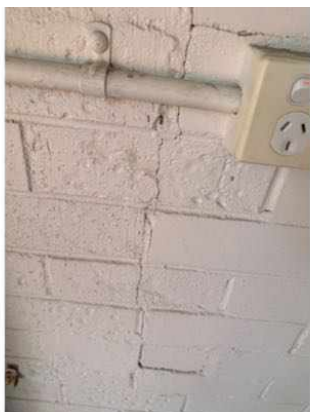
Finding 3.11

Finding: Brickwork - Cracking [Fine]

Information: Although fine cracks are quite noticeable, they are often only considered to be an appearance defect and usually do not indicate any structural damage. Generally, the cause of a fine crack is indicative of a separation between brickwork and mortar throughout the structure, but single bricks may also show cracks of this nature.

Cracking of this nature can generally be repaired with minor filling and should be conducted by a qualified bricklayer.

Always contact a building inspector should cracks widen lengthen or become more numerous.

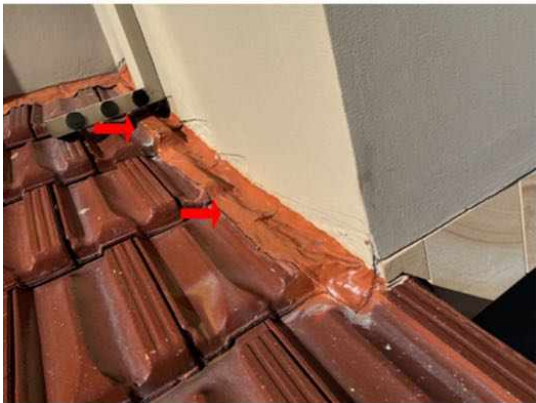
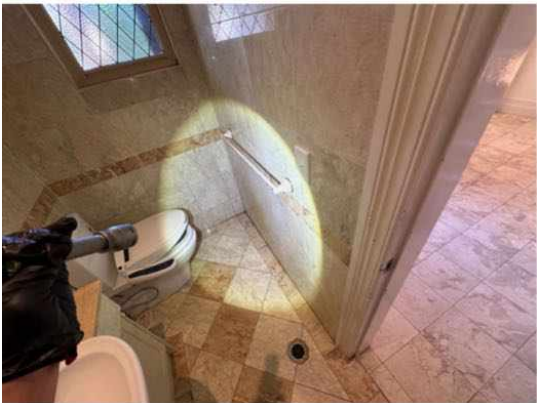
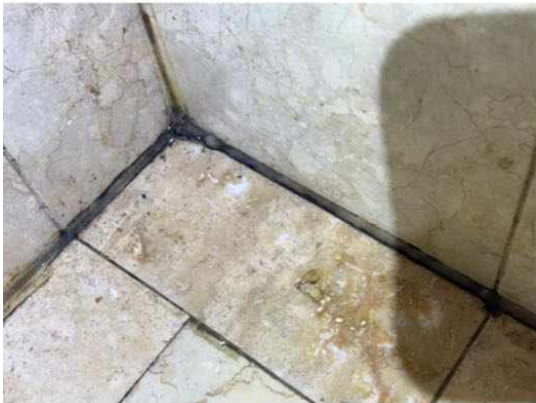
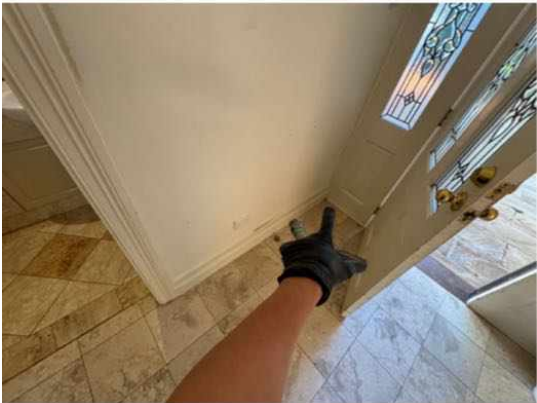
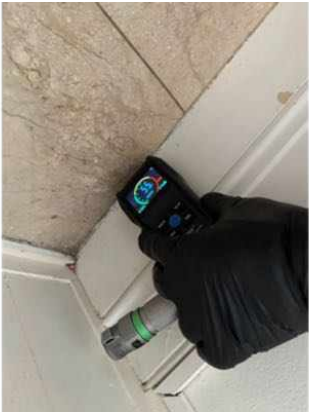
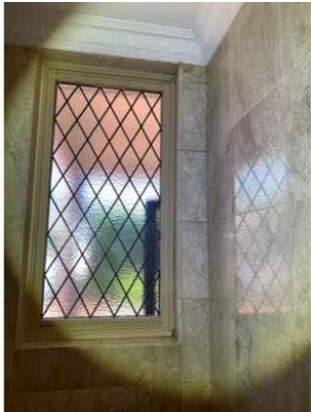
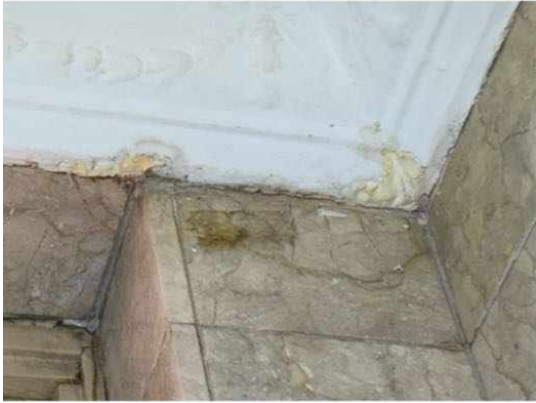
Finding 3.12

Building:	Main Building
Location:	Roof Exterior
Finding:	Roof plumbing - Flashing inadequate
Information:	Some sections of the roof are missing or have inadequate roof flashings. Flashings are metal and other materials which are applied to seals and intersections between roof coverings and building elements. They are designed to aid in weatherproofing of roof joins.

Flashings that are not installed adequately or are missing are likely to result in water penetration to the interior of the property, as well as creating excessively damp conditions against the exterior surfaces and around the base perimeter of the building.

Premature ageing and secondary building defects are imminent where roof plumbing is missing or inadequately installed. Additionally, water pooling also creates an environment that is susceptible to termite and pest infestation.

A roofing plumber should be appointed as soon as possible to install relevant roof plumbing materials, ensuring that no further damage is sustained.

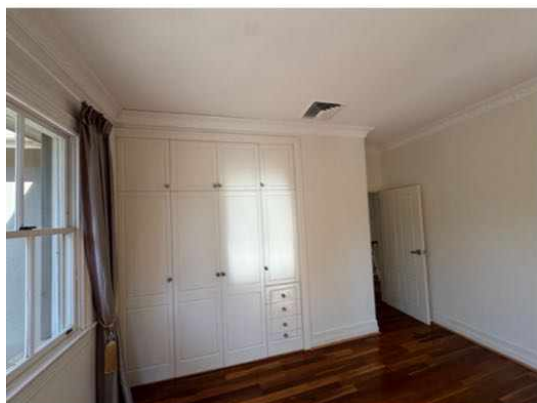
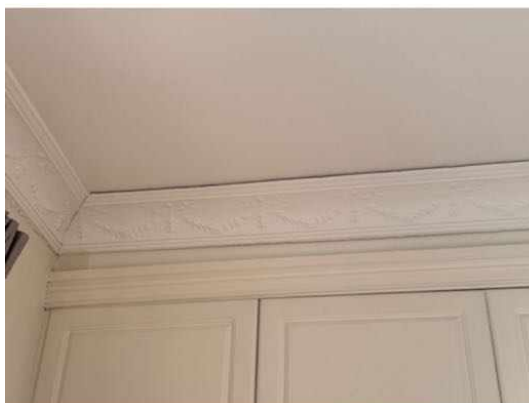
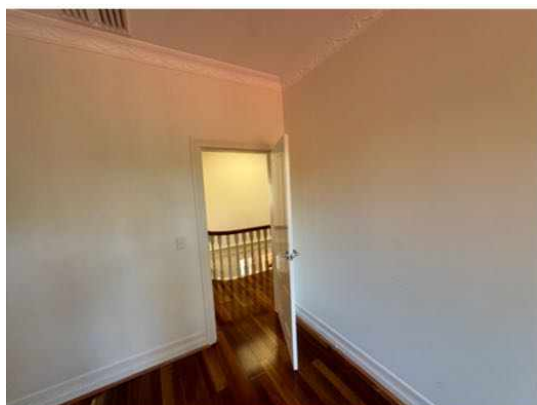
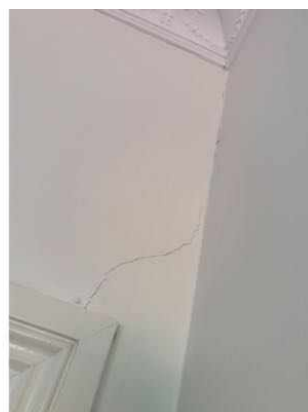
Finding 3.13

Building: Main Building
 Location: Bedroom
 Finding: Cracking - Damage Category 1 - Fine (up to 1mm)
 Information: Although fine cracks are quite noticeable, they are often only considered to be an appearance defect, and usually do not indicate any structural damage. Generally, the cause of a fine crack is indicative of a separation between building materials and finishes (e.g. paint, plaster, etc.) along joins.

Cracking of this nature can generally be repaired with minor sanding, filling and/or repainting. Such works should be performed by a qualified painter or a general handyman.

Monitoring of all cracking should be conducted frequently. Always contact a building inspector should cracks widen, lengthen, or become more numerous.

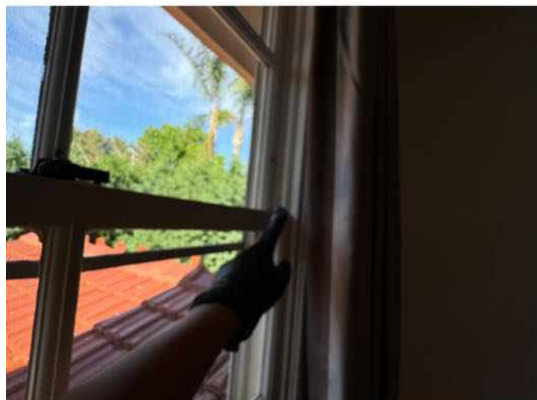
Finding 3.14

Building: Main Building
 Location: First floor
 Finding: Windows - Sash balances broken
 Information: Sashes are the moveable panes of windows that primarily slide vertically over each other to expose one half of the window area. Each sash is provided with springs balances and/or compression weather-stripping, which act to hold the window in

place in one position.

The sash balance mechanism will need replacement to allow the window to function as intended. Such works may be completed by a qualified carpenter or registered builder.

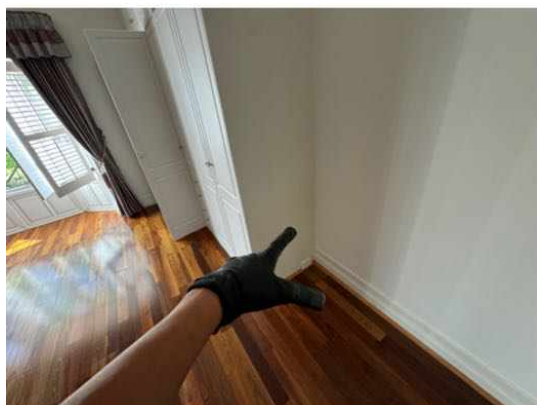
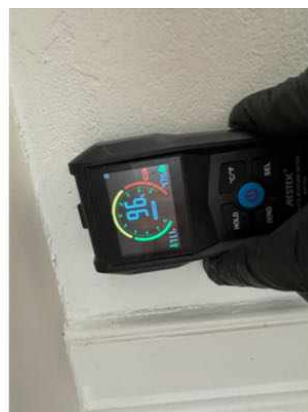
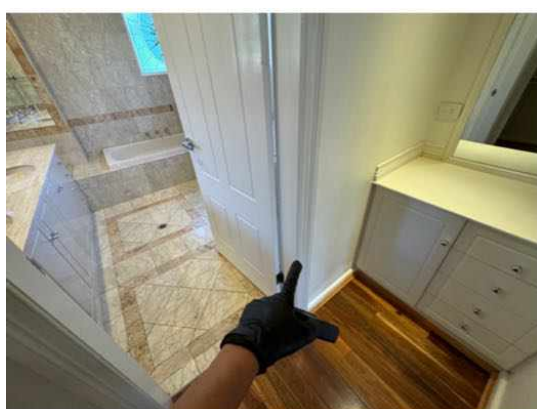
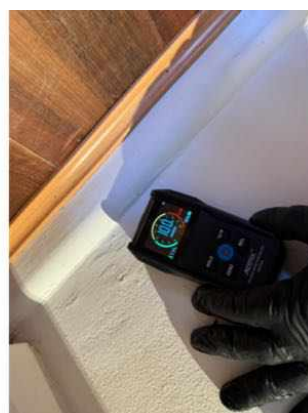
Finding 3.15

Building:	Main Building
Location:	Bathroom and en-suite
Finding:	Shower - Damp
Information:	Damp is evident to the lower 300mm of wall to the shower alcove. This defect is quite common, and is suspected to have been caused by moisture permeating through the grouting in this area, which shows evidence of deterioration. Leaking pipes within the adjoining wall is also a possible cause.

Damp (or structural damp) refers to the presence of unwanted moisture in the structure of a building, either as the result of intrusion from outside, or condensation from within the structure. In the shower area, internal water leaks or other sources of excessive moisture are generally the cause of damp.

Unmanaged damp in the shower recess is likely to facilitate the formation and development of mould and fungi growth, decaying associated building materials and compromising their structural integrity. It is important to address damp conditions, as the World Health Organisation notes that excess moisture leads - on almost all indoor materials - to growth of microbes such as moulds, fungi and bacteria, which subsequently emit spores and other matter into the indoor air. Exposure to these contaminants is associated with a wide range of respiratory and other health-related problems.

Consultation with a qualified plumber or bathroom specialist is advised immediately to identify the cause of damp and to perform remedial works as required. Where excessive mould growth is present, further inspection by a specialist environmental health inspector should also be considered.

Always ensure that sealant and grout is in good condition to prevent any moisture issues occurring in the future.

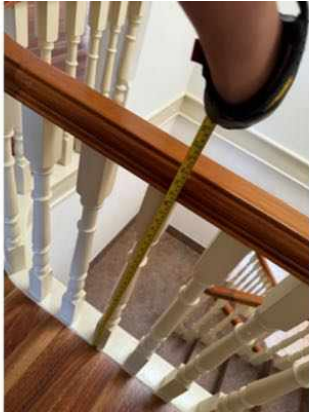
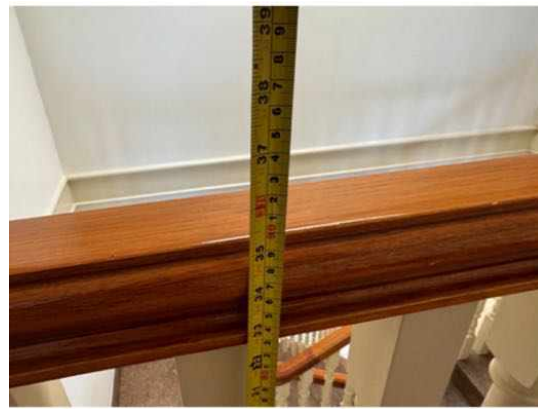
Finding 3.16

Building:	Main Building
Location:	Stairs - Internal
Finding:	Balustrade - Suspected Non-Compliance
Information:	The balustrade was measured and found to less than the present building regulation requirement of 1000mm high.

This defect creates a potential safety hazard and should be rectified as soon as possible to ensure the safety of the area and to meet present building standards and regulations.

A registered builder should be contacted to discuss possible rectification solutions.

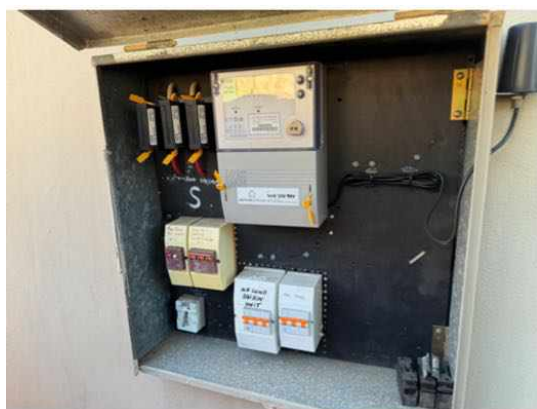
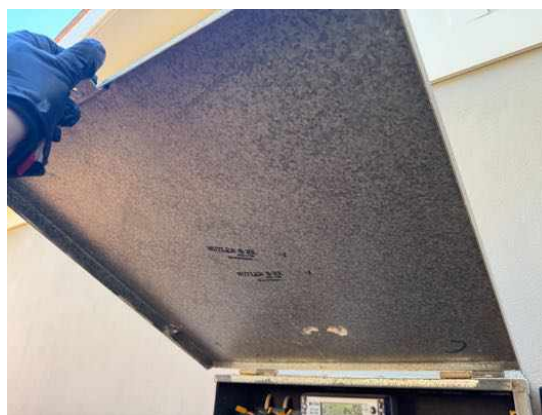
Building: Main Building
 Location: All External Areas
 Finding: Termite Management System - no evidence of a chemical installation
 Information: The application of a post-construction chemical termite barrier is highly recommended for all properties, particularly if live termite activity has been found on the site previously. Such barriers are highly effective in preventing termite attack on any timber building elements throughout the property.

A durable notice should be placed in the switchboard unit to indicate current termite barriers. At the time of inspection, it appeared as though no termite management system has been installed, with no evidence to suggest preventative works taking place.

The client may consider gaining further advice from a pest controller as to the costs and procedures involved with this application. It is recommended that obtaining such advice be a short-term priority.
