## VISUAL BUILDING & PEST INSPECTION REPORT

Complies with Australian Standard 4349.1 & 4349.6

**43 Abingdon Road, Roseville**

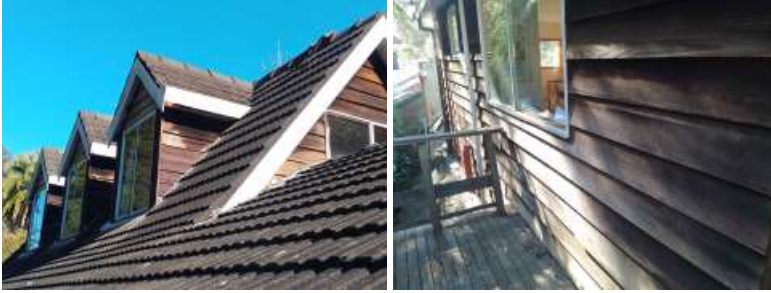
The condition of the walls is generally fair. The external wall timbers show signs of age and weathering. Maintenance and or repairs will be required.

The condition of the exterior of the windows is generally fair. Paint is peeling off the window frames and maintenance is required.

The condition of the exterior of the doors is generally fair. The sliding door/s have poor operation and require adjustment and or repair.

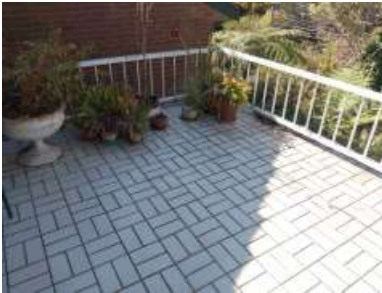
Front elevation.

Constructed from concrete or masonry. The general condition of this structure is fair.

Balustrade requires replacement

There is no step down between external and internal floors. This situation will allow wind driven rain to penetrate from the exterior of the building. Lack of suitable stepdown may be considered a latent defect.

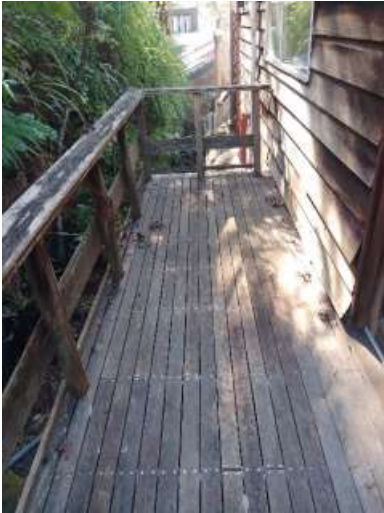
Rear elevation.

Where an external structure is constructed from timber or has significant timber components, and exposed to the elements, a suitably qualified engineer should inspect the structure to determine if it is structurally sound. We cannot determine or advise what weight the structure can hold, Recommend that an upgrade of this structure be considered.

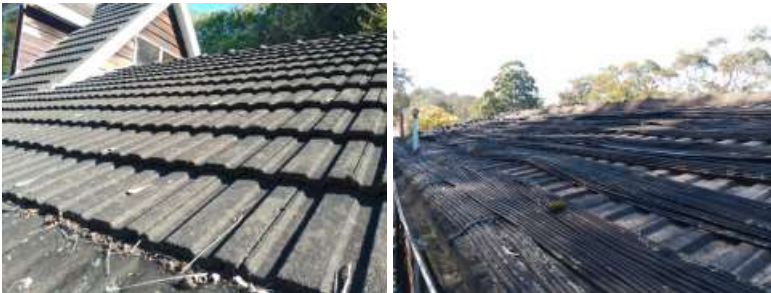
The overall condition of the roof coverings is fair. Mortar beds to the hip and ridge capping are cracked and require maintenance or re bedding and pointing in areas.

Flashing material is of lead. Flashings appear to be in serviceable condition. Flashing is split, and will require rectification / sealing to the following areas; dormer.

Appear to be in serviceable condition. Gutters are damaged or rusting and should be repaired or replaced as necessary.

The overall condition of the fascias/bargeboards is fair. Moderate wet rot decay is present to some sections of the timber fascias/bargeboards. Maintenance and or replacement of damaged timber will be required.

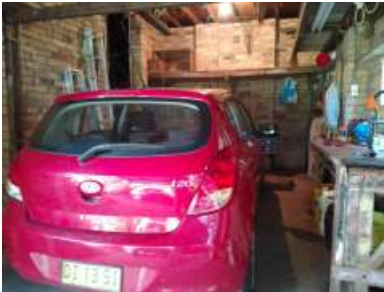
The structure is generally in fair condition.

The condition of the walls is generally fair. Base of some walls are below the external soil levels and are subject to lateral dampness or water entry. Additional waterproofing will be required or modifications will need to be made to lower moisture levels.

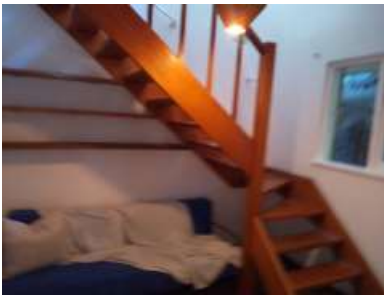
The stairs are constructed primarily from timber. The overall condition of the stairs is fair. The handrails and balustrades do not comply with current Standards for height and or spacing.

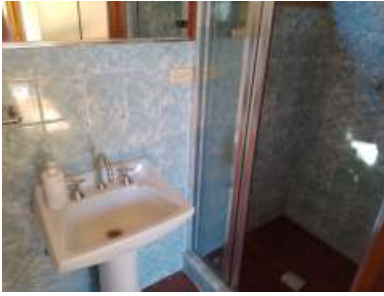
Level one.

The shower recess was tested and found to be leaking. Continued leaking may allow damage and decay to surrounding components. Rectification will be required and evaluation of extent of works should be requested from a Licensed Builder.

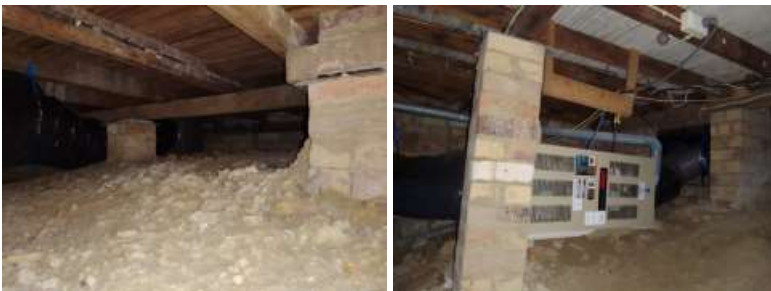
Full inspection was limited by the presence of ducting associated with air-conditioning or heating. We recommend a more complete inspection of this area. Crawl space was limited due to the method of construction resulting in a limited visual inspection from a distance being carried out. Inspection was restricted in or below the following locations and or areas: Laundry. Kitchen. Bedroom two.

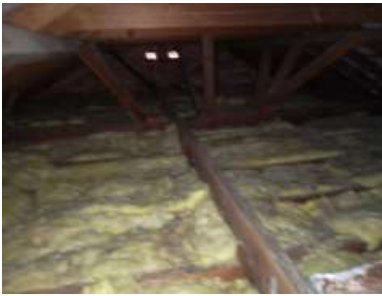
Insulation is present in the roof cavity. This restricted inspection to some roofing timbers. Removal of insulation is not within the scope of a standard visual inspection report, however as in accordance with "industry best standard" the inspector will lift insulation in 3 areas in roof void.

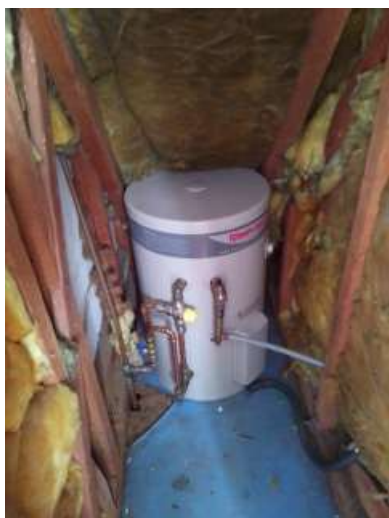
Mains electric hot water system: Mains pressure: Located in level 1l cupboard: A safety tray was not installed. Where water tanks are installed internally, a safety tray should be installed to prevent damage to surrounding areas in case of a water leak to the tank.

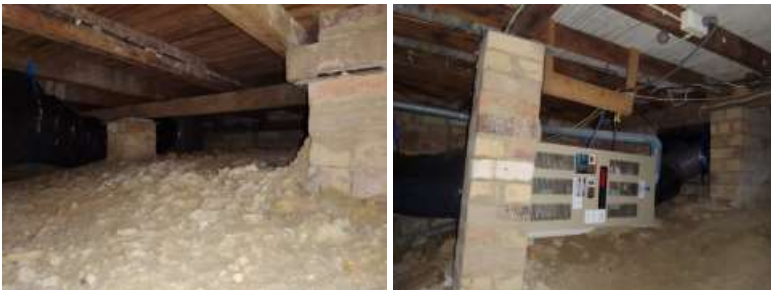
Full inspection was limited by the presence of ducting associated with air-conditioning or heating. We recommend a more complete inspection of this area Crawl space was limited due to the method of construction resulting in a limited visual inspection from a distance being carried out. Inspection was restricted in or below the following locations and or areas: Laundry. Kitchen. Bedroom two.

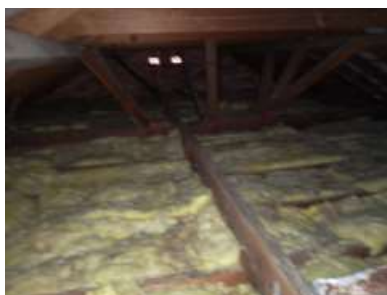
Insulation is present in the roof cavity. This restricted inspection to some roofing timbers. Removal of insulation is not within the scope of a standard visual inspection report, however as in accordance with "industry best standard" the inspector will lift insulation in 3 areas in roof void.
