VISUAL BUILDING AND PEST INSPECTION REPORT

Complies with Australian Standard 4349.1 & 4349.3

19 Nicholson Street, Chatswood

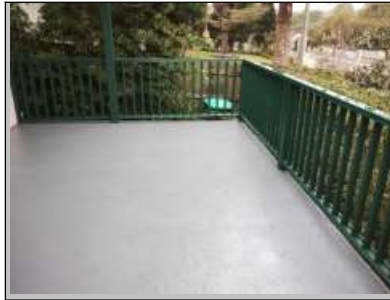
Front elevation.

Constructed from concrete or masonry. The condition of the structure is generally acceptable.

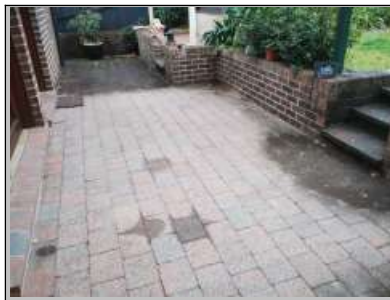
Rear elevation.

Constructed from concrete or masonry. The condition of the structure is generally acceptable.

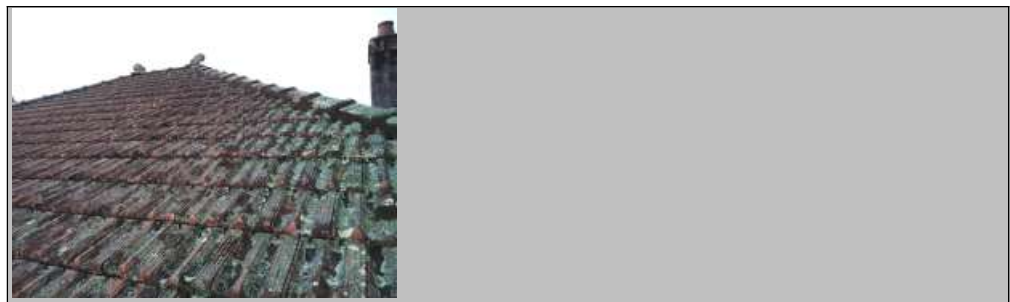
The roof is of pitched and skillion construction.

No access was possible to part of the external roof area due to the roof not being accessible from a 3.6 meter ladder.

The overall condition of the roof coverings is fair. Mortar beds to the hip and ridge capping are cracked and require maintenance or re bedding and pointing in areas.

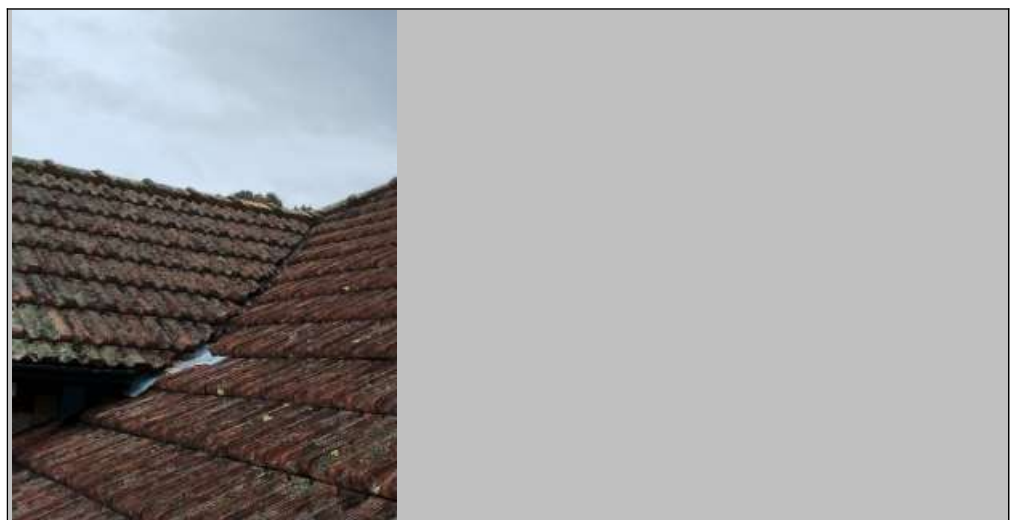
The overall condition of the valley metal is fair. Valley metals are rusting and should be treated or replaced as required.

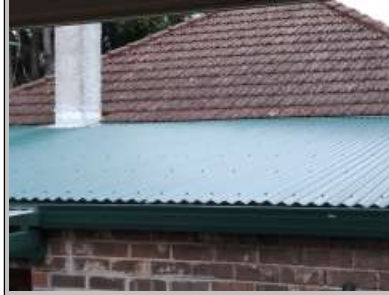
Rear elevation.

The overall condition of the roof coverings is good.

Flashing material is of sheet metal. Flashings appear to be in serviceable condition.

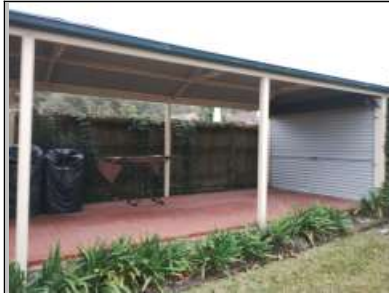
Carport.

To the rear of the main building.

The structure is generally in fair condition.

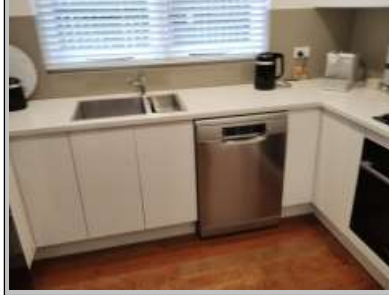
The condition of the fixtures is generally good. A glass splashback is located over the benchtop area. Glass appears to be in serviceable condition.

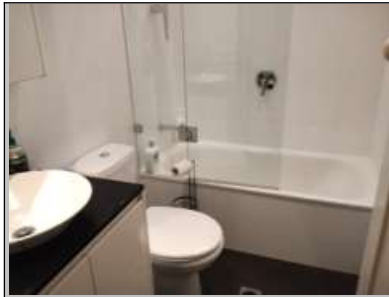
Adjacent to hall.

The shower is located over the bathtub. The area will need to be kept well sealed to prevent water penetration to surrounding areas.

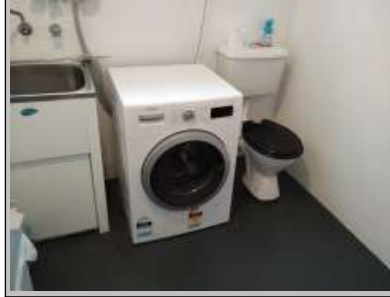
Rear.

The tub and taps appear serviceable. Drain appears serviceable.

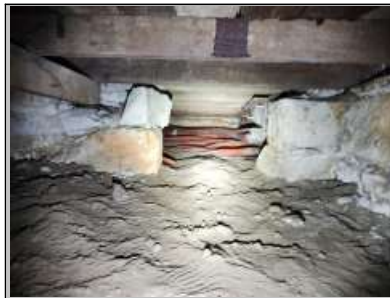
Some areas of the building are a concrete slab on ground construction and to these areas there is no accessible void for inspection. Crawl space was limited due to the method of construction resulting in a limited visual inspection from a distance being carried out. Inspection was restricted in or below the following locations and or areas: Bedroom three. Rumpus room.

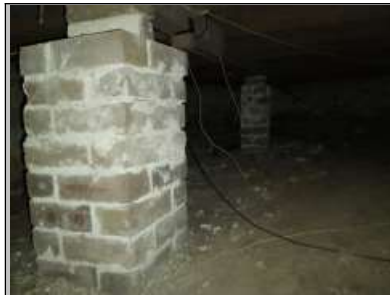
The building is constructed on a combination of strip footings and piers. The footings appear to be generally sound.

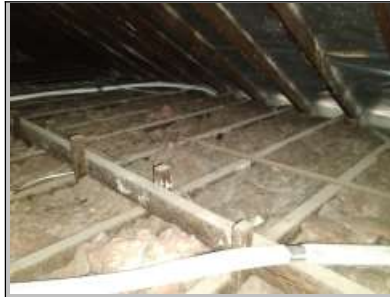
Insulation is present in the roof cavity. This restricted inspection to some roofing timbers. Removal of insulation is not within the scope of a standard visual inspection report, however as in accordance with "industry best standard" the inspector will lift insulation in 3 areas in roof void.

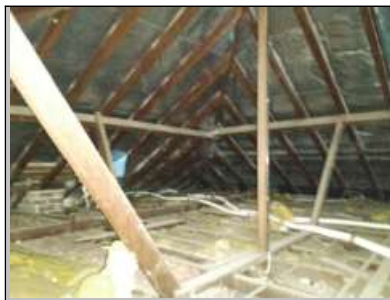
The cut and pitched roof timbers appear to provide adequate support.

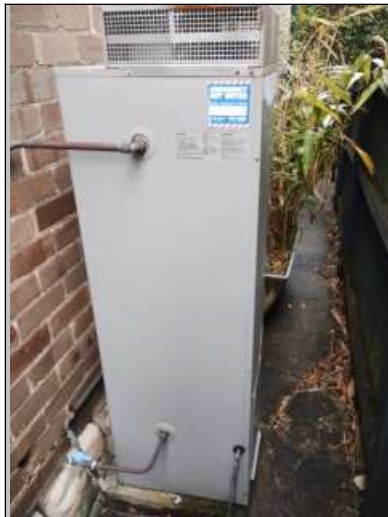
Gas hot water system: Mains pressure: Located externally: The hot water system appears to be in working condition. No specific tests other than running the hot water tap were carried out. No determination has been made as to the suitability or adequacy of the hot water system in relation to capacity or otherwise.

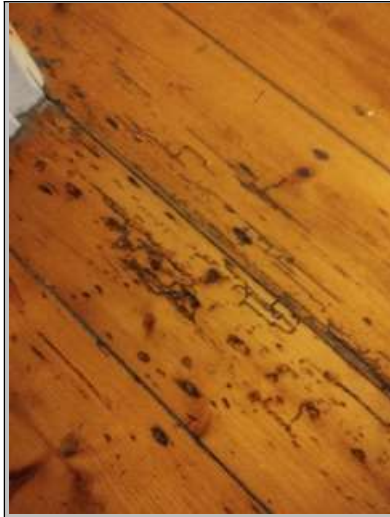
Flooring timbers.

Yes - Anobium borer damage was noted to the following timber(s)/area(s). Without destruction of the timbers it is not possible to determine whether activity exists or the extent of timber damage within.

Visible timber damage appears minor. Please refer to the building report for details or if a building inspection was not commissioned we recommend a builder inspection and report on the property. Refer to the definitions section of this report - Section 1.6 - Timber Damage.

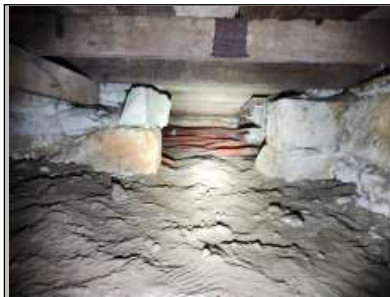
Some areas of the building are a concrete slab on ground construction and to these areas there is no accessible void for inspection. Crawl space was limited due to the method of construction resulting in a limited visual inspection from a distance being carried out. Inspection was restricted in or below the following locations and or areas: Bedroom three. Rumpus room.

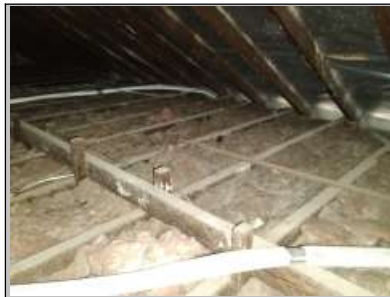
Insulation is present in the roof cavity. This restricted inspection to some roofing timbers. Removal of insulation is not within the scope of a standard visual inspection report, however as in accordance with "industry best standard" the inspector will lift insulation in 3 areas in roof void.
