VISUAL BUILDING AND PEST INSPECTION REPORT

Complies with Australian Standard 4349.1 & 4349.3

Inspected Property:
39 Archbold Road, Roseville

30.5.24.

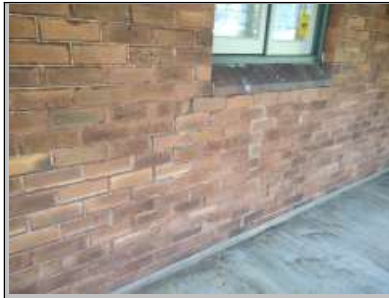
Front elevation.

The condition of the walls is generally fair. Cracks are evident to masonry. Visible cracking appears minor. Periodic maintenance may be required. Please refer to section of this report - CRACKING OF BUILDING ELEMENTS for additional details.

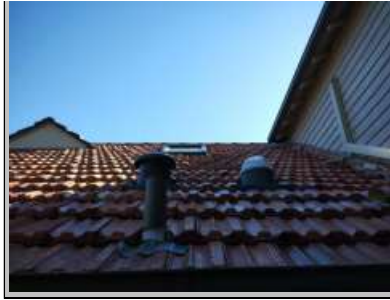
Flashing material is of lead. Flashings appear to be in serviceable condition. Minor repairs required to apron flashing. Junction of the pitched roof and wall.

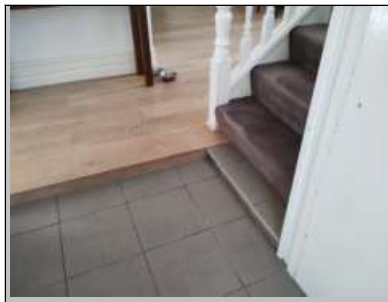
The stairs are constructed primarily from timber. The overall condition of the stairs is fair. Rise and going (height & depth) of bottom tread is considered hazardous and does not comply with current Standards. Recommend this area is modified.

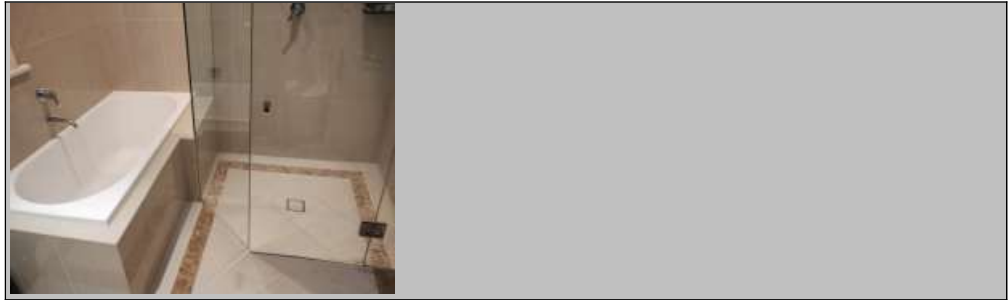
Ground floor.

There is no visible floor waste and no way for any overflow of water to escape. In the case of an overflow water may enter areas adjacent and cause a safety hazard or damage. Recommend a floor waste be installed.

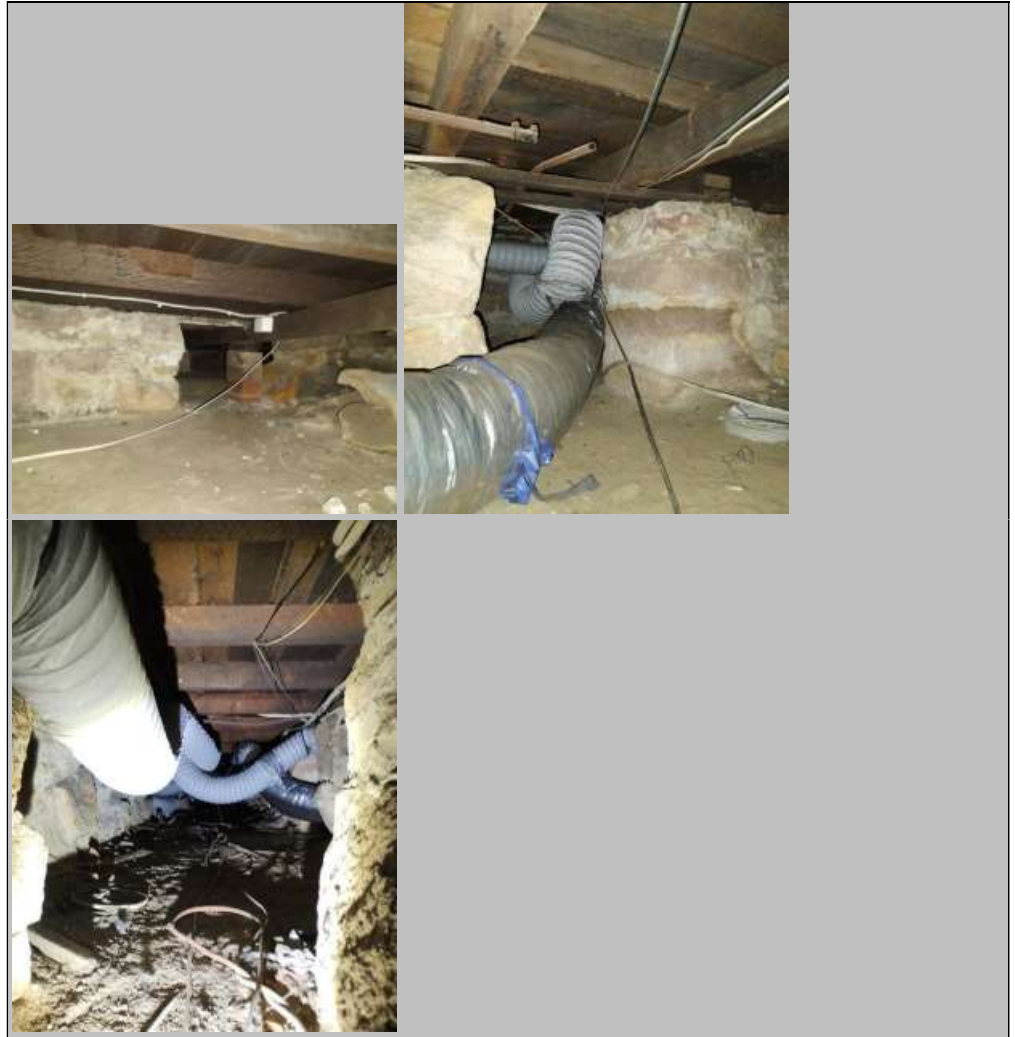
Full inspection was limited by the presence of ducting associated with air-conditioning or heating. We recommend a more complete inspection of this area. Crawl space was limited due to the method of construction resulting in a limited visual inspection from a distance being carried out. Inspection was restricted in or below the following locations and or areas: Kitchen. Bedroom two. Bedroom three.

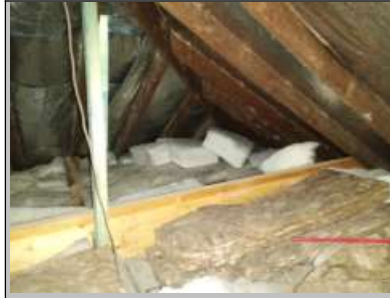
Insulation is present in the roof cavity. This restricted inspection to some roofing timbers. Removal of insulation is not within the scope of a standard visual inspection report, however as in accordance with "industry best standard" the inspector will lift insulation in 3 areas in roof void. Sarking membrane covered tile battens restricting inspection.

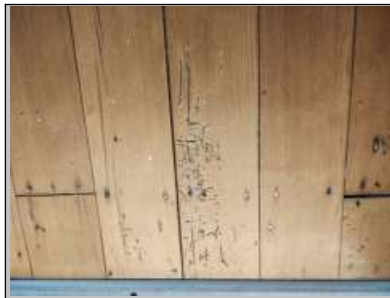
Flooring timbers.

Visible timber damage appears minor. Please refer to the building report for details or if a building inspection was not commissioned we recommend a builder inspection and report on the property. Refer to the definitions section of this report - Section 1.6 - Timber Damage.

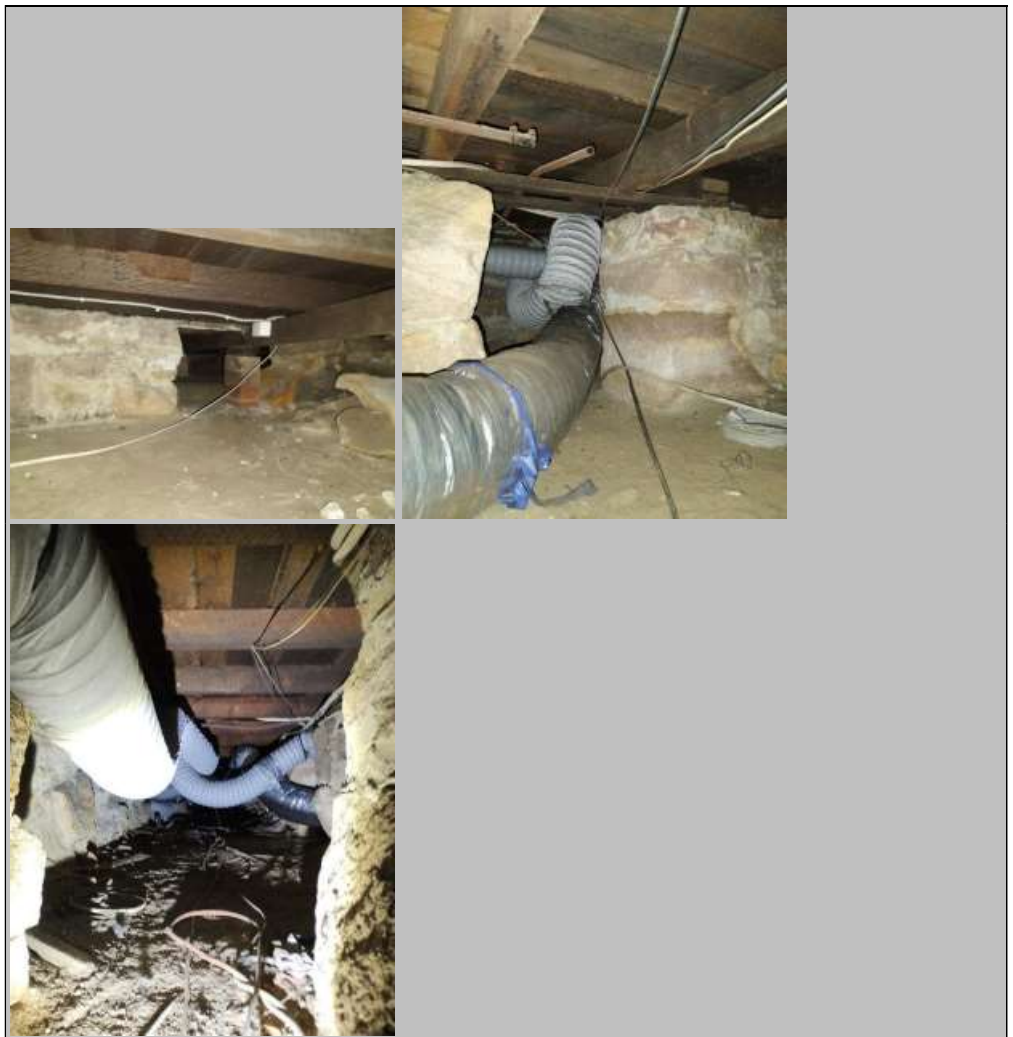
Full inspection was limited by the presence of ducting associated with air-conditioning or heating. We recommend a more complete inspection of this area. Crawl space was limited due to the method of construction resulting in a limited visual inspection from a distance being carried out. Inspection was restricted in or below the following locations and or areas: Kitchen. Bedroom two. Bedroom three.

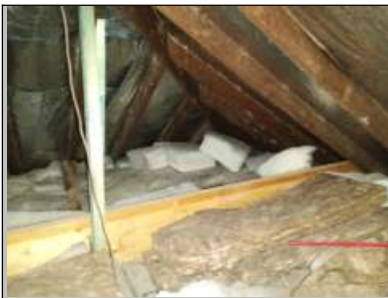
Insulation is present in the roof cavity. This restricted inspection to some roofing timbers. Removal of insulation is not within the scope of a standard visual inspection report, however as in accordance with "industry best standard" the inspector will lift insulation in 3 areas in roof void. Sarking membrane covered tile battens restricting inspection.
