# Building Defect Inspection Report

To AS4349.0-2007 Inspection of Buildings General Requirements

237 McManus Street , Whitfield

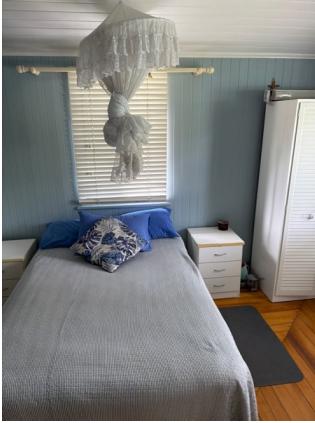
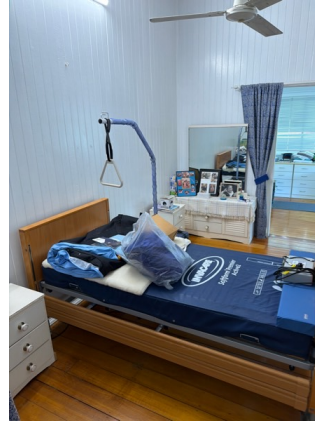
Bed, Heavy Furniture, Personal Items

Image of stored goods.

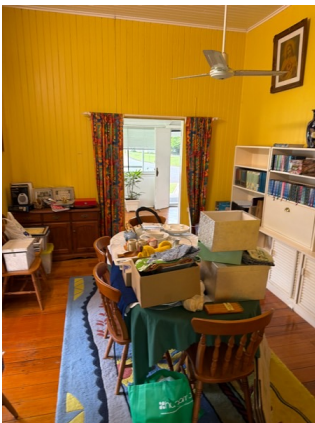
Chairs, Couch, Desk, Heavy Furniture

Image of stored goods.

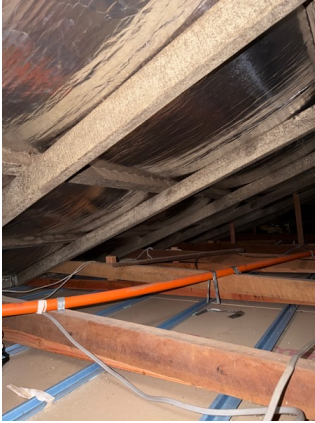
Pitch, Roof Frame, Sarking

Image of roof void, pitch and vapour barrier restrictions.

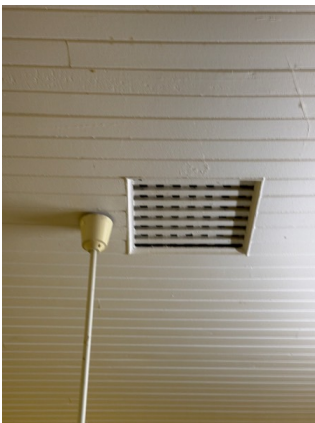
Access Point Not Usable

Image of sealed access point.

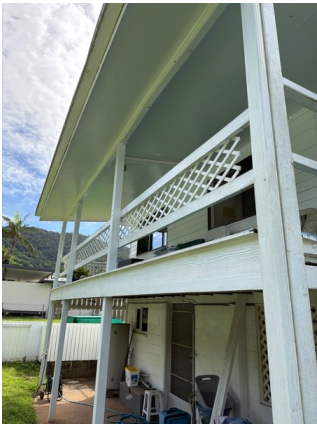
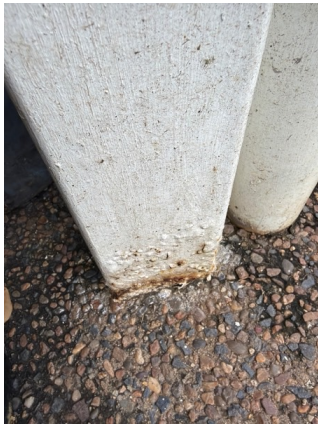
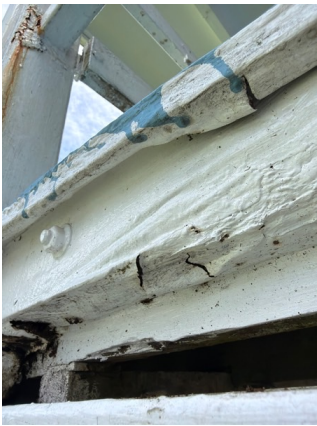
| Description: | Decay to joists, Decay to decking Corrosion observed to steel posts. |
| Ongoing Consequence: | Water ingress to building, Damage to support elements |

Image of balcony.

Image of corrosion effecting steel posts.

Image of damage to joists.

| Building Professional: | <b>Note: This defect should be referred to a qualified building professional for the repairs/scope of work required.</b><br><br>Building Professional Required: Carpenter, Painter |

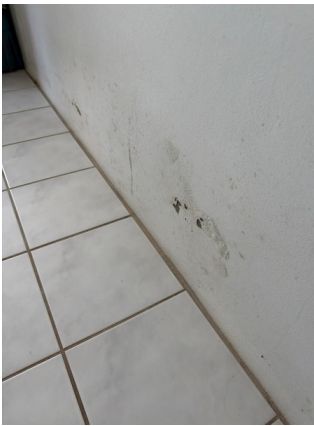
| Description: | Lateral damp observed in exterior sub floor walls. |
| Ongoing Consequence: | Further deterioration |

Image of moisture effected sub floor wall.

| Building Professional: | <b>Note: This defect should be referred to a qualified building professional for the repairs/scope of work required.</b><br><br>Building Professional Required: Builder |

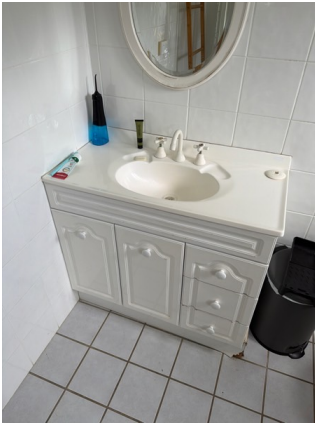
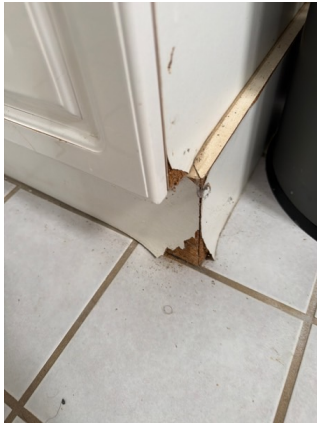
| Description: | The vanity is swollen due to water damage |
| Ongoing Consequence: | Water ingress will affect the serviceability of the vanity |

Image of bathroom vanity.

Image of moisture damaged vanity Timbers.

| Building Professional: | <b>Note: This defect should be referred to a qualified building professional for the repairs/scope of work required.</b><br><br>Building Professional Required: Carpenter |

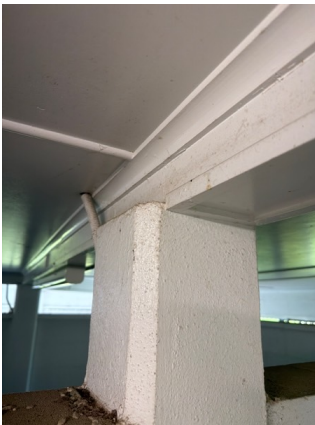
| Description: | Ant shields incomplete in areas of sub floor. |
| Ongoing Consequence: | Further deterioration |

Image of missing ant shields.

| Building Professional: | <b>Note: This defect should be referred to a qualified building professional for the repairs/scope of work required.</b> |
| | Building Professional Required: Carpenter. |

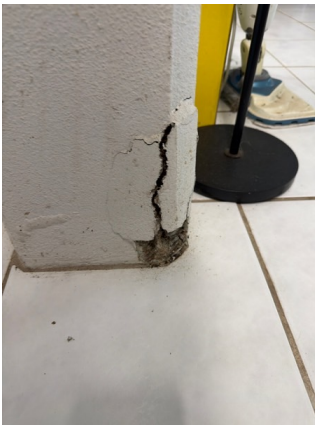
| Description: | Cracking observed to masonry piers. |
| Opinion of Cracking: | Serviceability cracking |

Image of damaged pier.

| Building Professional: | <b>Note: This defect should be referred to a qualified building professional for the repairs/scope of work required.</b> |
| | Building Professional Required: Builder |

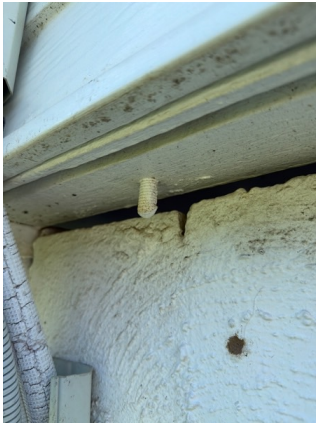
| Description: | A small number of tie down points are not secured. |
| Ongoing Consequence: | Floor may begin excessive bounce |

Image of incomplete wall tie down point.

| Building Professional: | <b>Note: This defect should be referred to a qualified building professional for the repairs/scope of work required.</b> |
| | Building Professional Required: Carpenter |

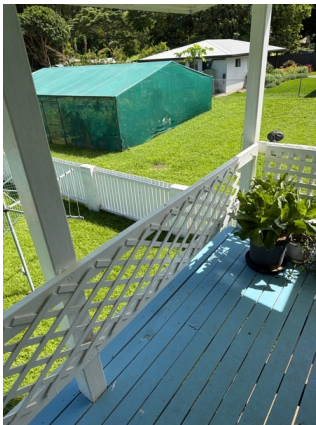
| Description: | Handrails appear to be low |
| Ongoing Consequence: | Personal injury, Personal injury |

Image of non compliant handrails.

| Building Professional: | <b>Note: This defect should be referred to a qualified building professional for the repairs/scope of work required.</b> |
| | Building Professional Required: Carpenter |

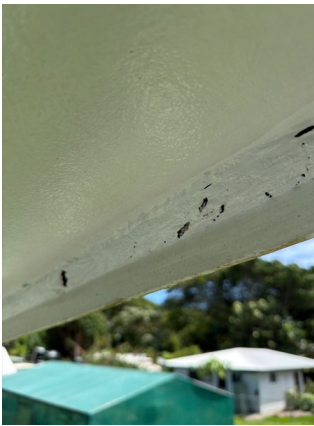
| Description: | Evidence of water ingress |
| Ongoing Consequence: | Damage to surrounding elements |

Image of moisture effected eave section.

| Building Professional: | <b>Note: This defect should be referred to a qualified building professional for the repairs/scope of work required.</b> |
| | Building Professional Required: Carpenter |

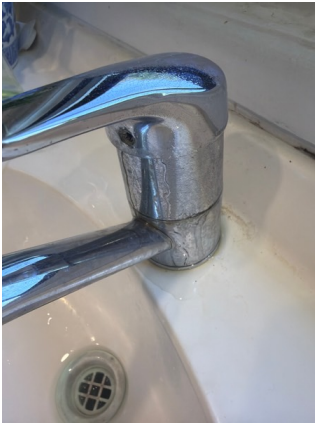
| Description: | The taps are leaking |
| Ongoing Consequence: | Damage to surrounding elements |

Image of leaking basin tap.

| Building Professional: | <b>Note: This defect should be referred to a qualified building professional for the repairs/scope of work required.</b> |
| | Building Professional Required: Plumber |

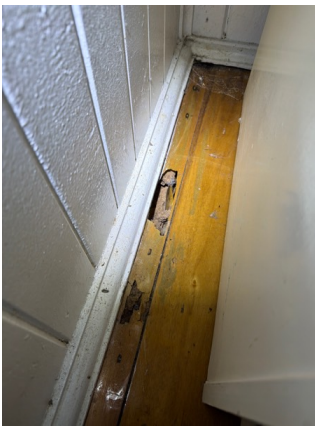
| Description: | Termite damage observed in flooring. |
| Ongoing Consequence: | Ongoing deterioration of the floor boards |

Image of damaged floor.

| Building Professional: | <b>Note: This defect should be referred to a qualified building professional for the repairs/scope of work required.</b> |
| | Building Professional Required: Carpenter |

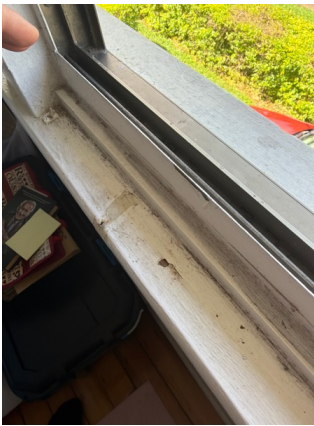
| Description: | Termite damage observed to wall and window sill timbers. |
| Ongoing Consequence: | Deterioration of wall and adjoining finishes |

Image damaged window sill timbers.

| Building Professional: | <b>Note: This defect should be referred to a qualified building professional for the repairs/scope of work required.</b><br><br>Building Professional Required: Carpenter |

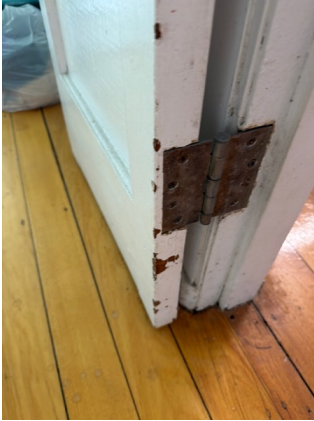
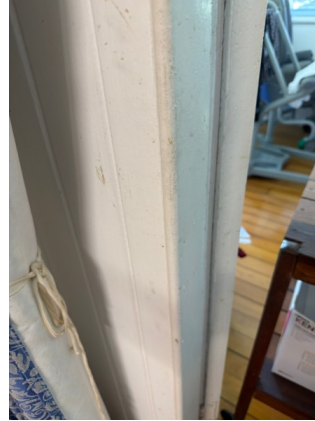
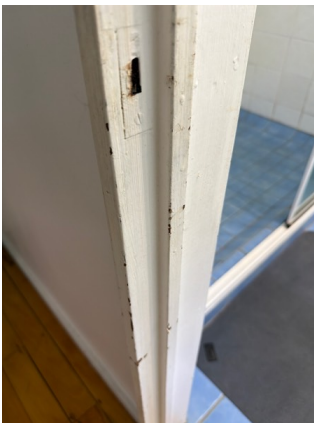
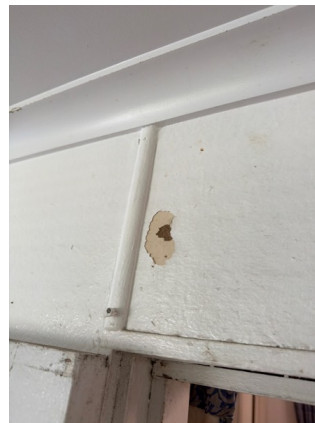
Internal walls and woodwork have wear and tear observed and consultation with painting professional advised to make required touch ups and adjustments.

Image of wear and tear to internal doors, consultation with painting professional advised.

Image of wall wear and tear. Consultation with painting professional advised

Image of internal door jamb requiring additional protective paint coverings.

Image of wall wear and tear. Consultation with painting professional advised.

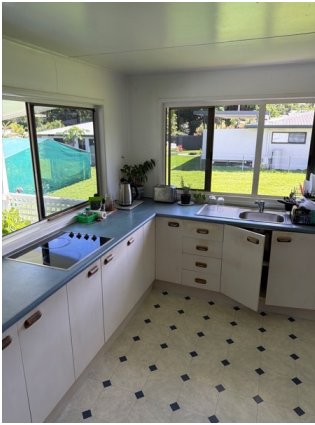
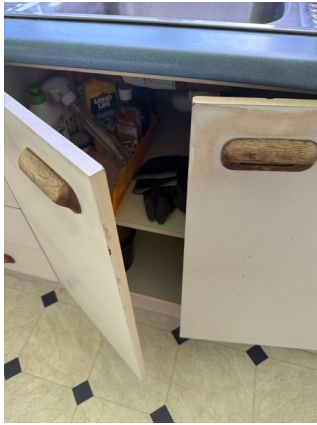
Kitchen serviceable at time of inspection. Wear and tear typical of a kitchen of this age was observed including laminate deterioration and basic adjustments required.

Image of kitchen.

Image of laminate wear and tear.

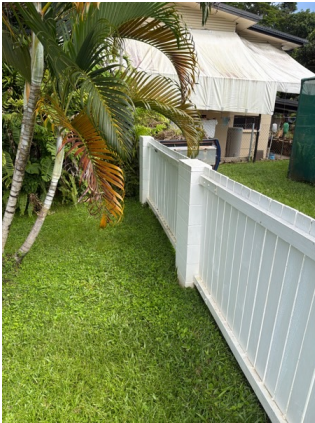
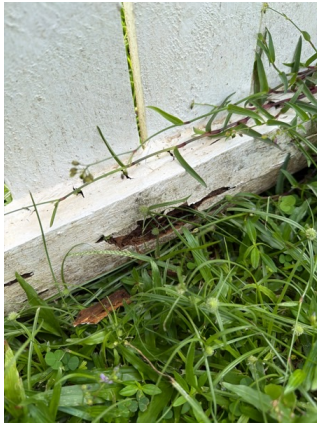
| Description: | Moderate timber decay present in fencing timbers. |
| Ongoing Consequence: | Further deterioration |

Image of site fencing.

Image of decay effecting fencing Timbers.

| Building Professional: | <b>Note: This defect should be referred to a qualified building professional for the repairs/scope of work required.</b> |
| | Building Professional Required: Carpenter |

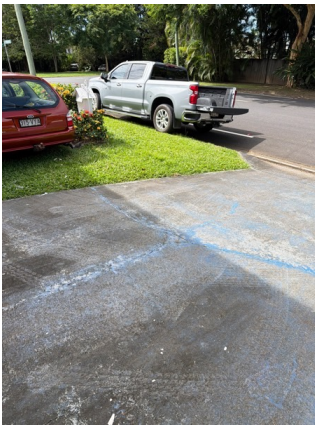
| Type of Defect: | The driveway has subsided |
| Opinion of Cracking: | Serviceability cracking |

Image of driveway cracking.

| Building Professional: | <b>Note: This defect should be referred to a qualified building professional for the repairs/scope of work required.</b> |
| | Building Professional Required: Concreter |

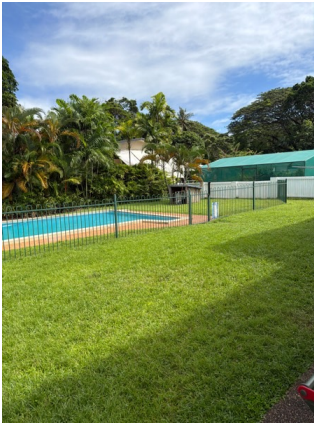
| Description: | Due to dry weather conditions at the time of the inspection an opinion on site drainage could not be formed , it is recommended that allowance be made for site drainage improvements and maintenance moving forward |

Image of current site condition.
