# Visual Timber Pest Inspection and Report in Accordance with AS 4349.3-2010

237 McManus St. Whitfield

| Work Order/Reference Number: | 3131 |

| Type of inspection: | Timber Pest Inspection AS 4349.3-2010 |

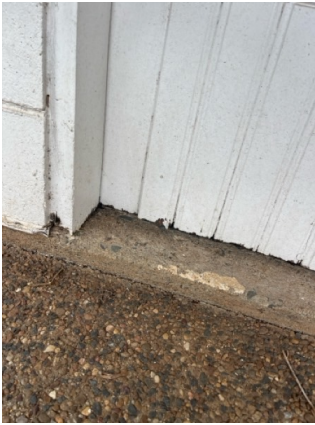
| | Fungal Decay Damage Extent: Moderate |
| <b>Other Comments:</b> | Moderate fungal decay present in door frame, door, veranda timbers and eave trim. Old termite leads present on slab edge and door frame. |

Image of fungal decay present in timber door frame and door.

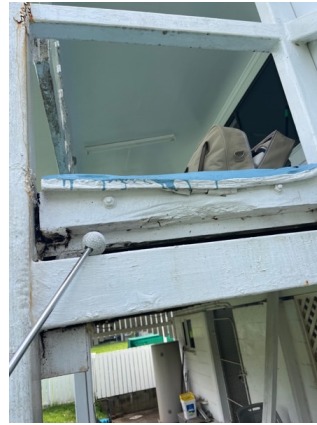
Image of fungal decay present in veranda timber

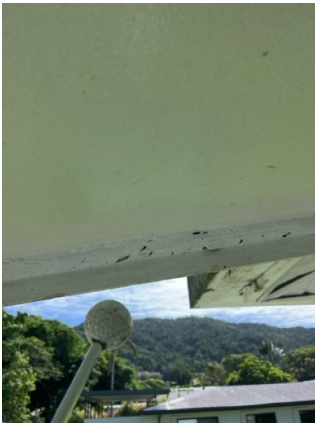
Image of fungal decay present in timber eave trim

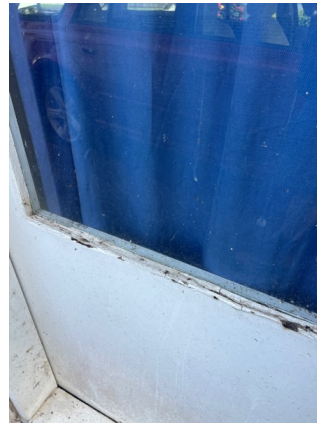
Image of fungal decay present in timber exterior door

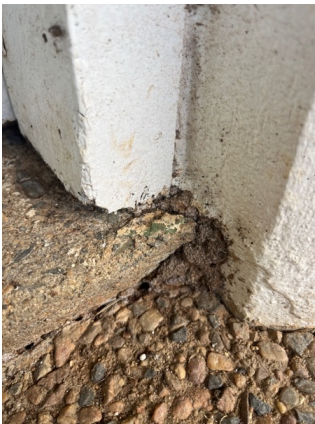
Image of old termite lead on the exterior concrete slab edge timber door frame.

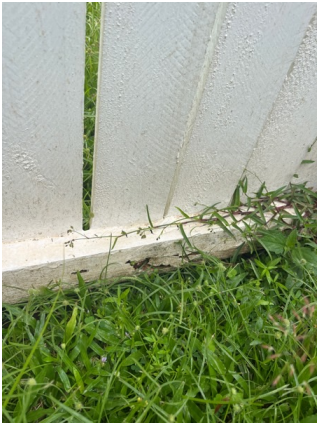
| Other Comments: | Moderate fungal decay present timber fence |

Image of fungal decay present in timber fencing

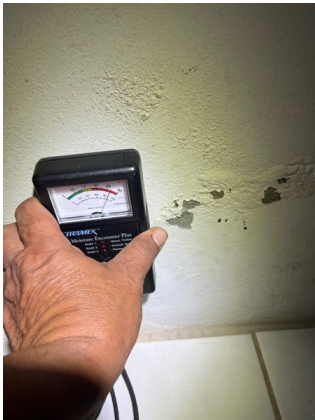
High moisture reading observed in the enclosed subfloor walls

Image of high moisture reading observed in the enclosed subfloor wall

Yes Invasive wall inspection where high moisture reading's were observed

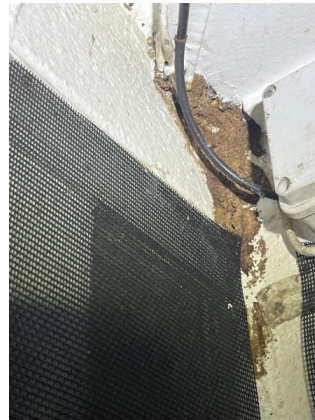
High moisture reading observed in the enclosed subfloor wall. Moderate old termite damage present in timber bearer and old termite lead marks present on the concrete block subfloor wall.

Image of old termite leads present on subfloor block wall and subfloor bearer

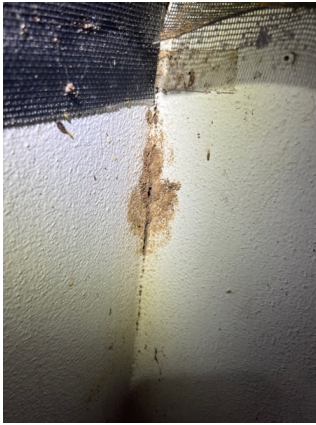
Image of old termite lead mark present on concrete block subfloor wall

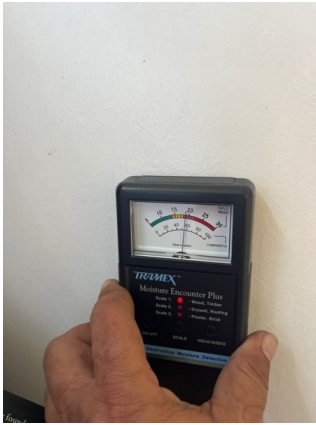
| | High moisture reading observed in the wall of bedroom 3 |

Image of high moisture reading observed in the wall of bedroom 3

| Is an invasive inspection recommended? | Yes Invasive wall inspection where high moisture reading's were observed in the wall of bedroom 3. |

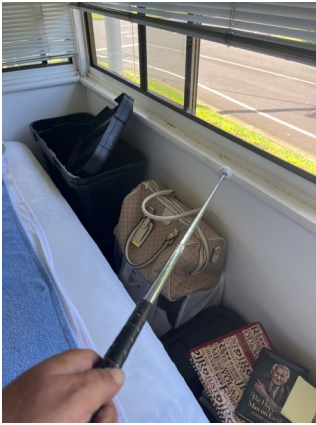
| Other Comments: | Moderate old termite damage present in timber window frame in bedroom 3 |

Image of timber window frame with old termite damage

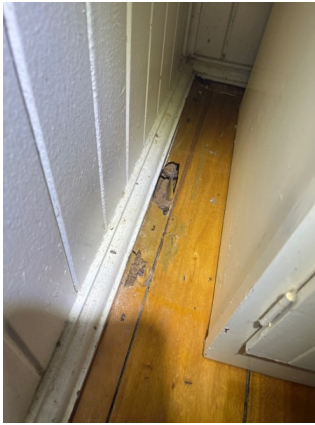
| Other Comments: | Moderate termite damage observed in timber flooring in bedroom 1 |

Image of old termite damage in timber flooring in bedroom 1

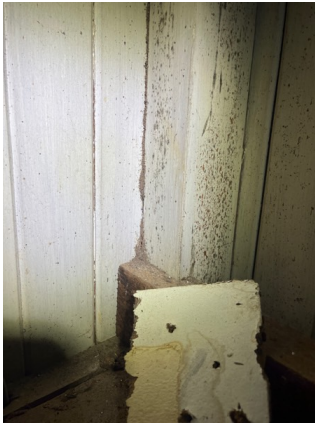
| Other Comments: | Moderate old termite leads present in the timber wall frame and moderate termite damage present in timber wall. |

Image of old termite leads present on timber wall frame

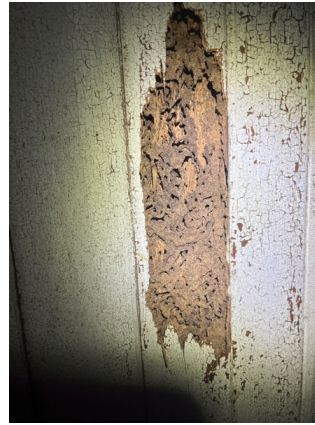
Image of Old termite damage present in timber wall

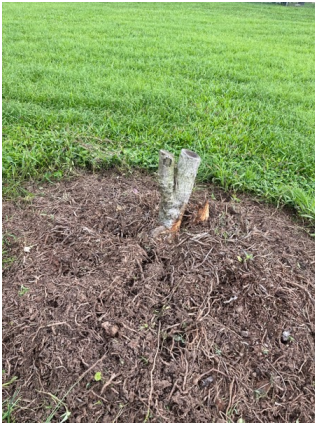
Image of tree stump present

Slab Edge Not Exposed or Not Fully Exposed, Timber on Ground Present, Tree Present, Tree Stump Present  
Where possible conducive conditions should be rectified to reduce environmental risk of destructive timber pest activity

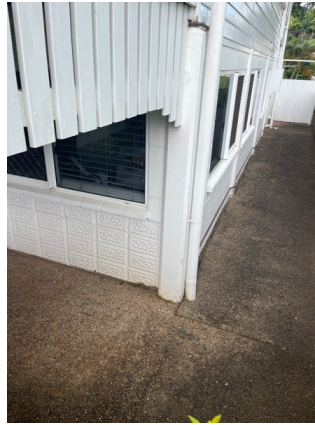
Image of no slab edge exposure

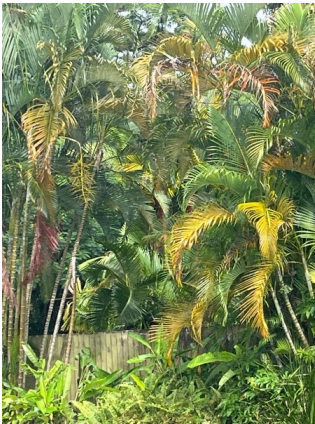
Image of vegetation too close to the fence structure and trees present

Fence, Main Structure  
Remove vegetation away from the main structure and fence structure

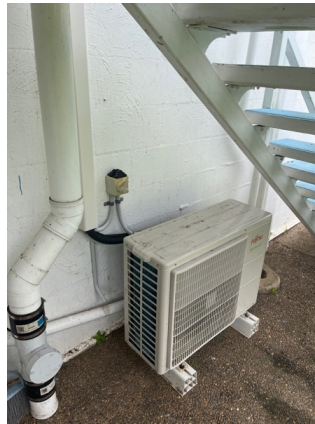
Image of aircon discharge next to the structure

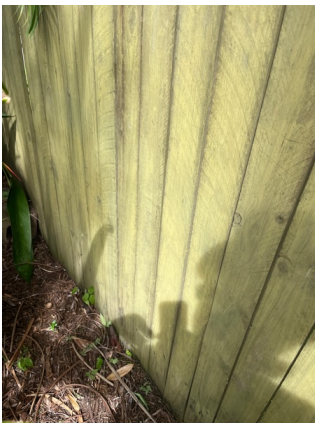
Image of timber fence in contact with the ground

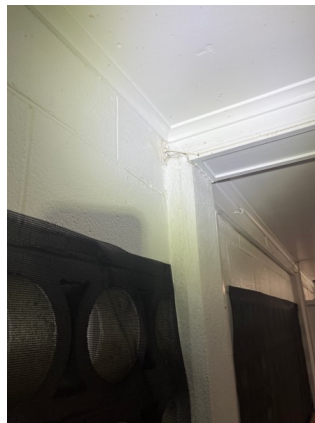
Termite Shields Damaged and/or Missing Old termite damage  
High moisture reading observed in the wall of the enclosed subfloor area and moderate old termite evidence on subfloor concrete block wall and moderate old termite damage present in timber bearer in the enclosed subfloor area.

Image of no full termite shielding

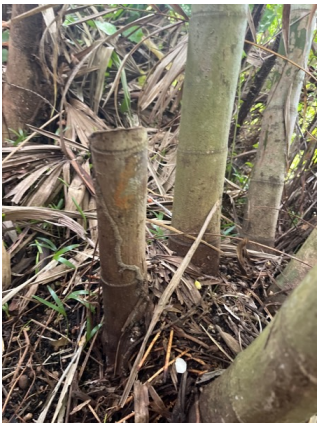
| Termite: | Yes<br>Live Termites Present<br><br>Coptotermes Spp Termite Nest Identified - In tree stump in garden bed |

Image of tree stump with live termite activity

| Other Comments: | Recommend to spot treat live termite activity and nest in tree stumps in the backyard |

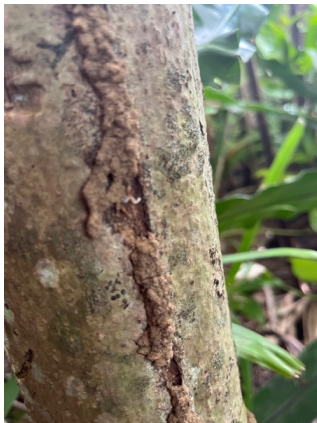
Image of live termite present

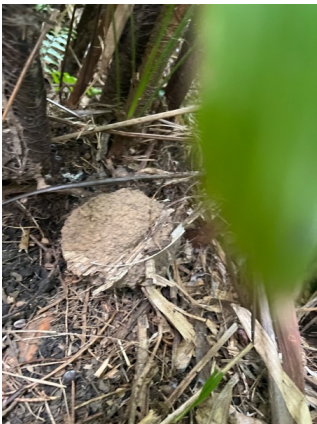
Image of termite nest present in tree stump in the yard

Annual inspection's recommended and spot treat live termite activity and nest in tree stumps in the garden bed in the backyard.

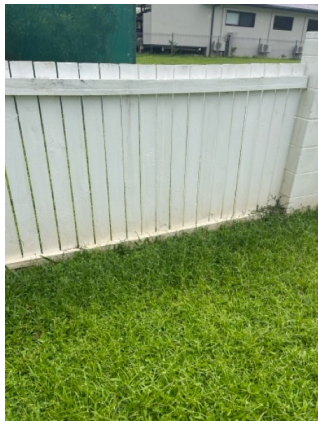
Image of timber fence in contact with the ground

Exterior conductive conditions should be rectified to ease environmental risk of destructive timber pest activity

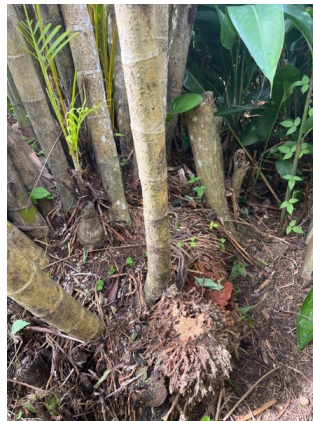
Image of tree stump present
