Building and Pest Report

26 Mosman Chase Lennox Head

Pest And Building Inspection

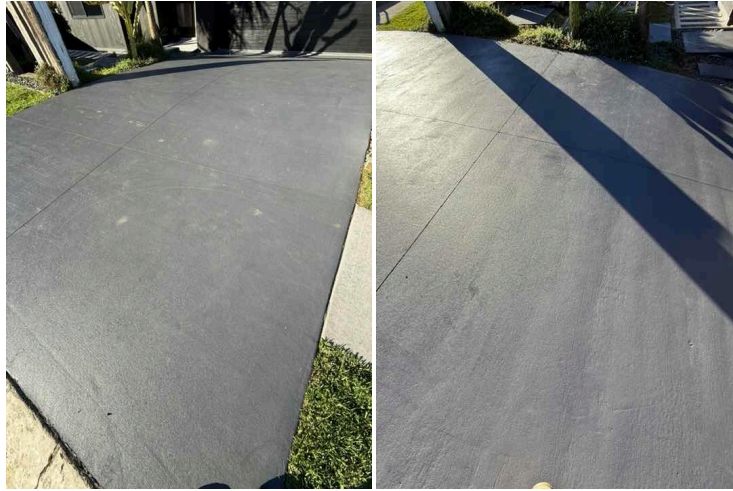
Driveway Condition

Common cracks were observed on the driveway. Whilst these cracks appeared to be typical at the time of inspection, we strongly recommend you monitor these cracks and if worsening occurs contact a concreter for further advice.

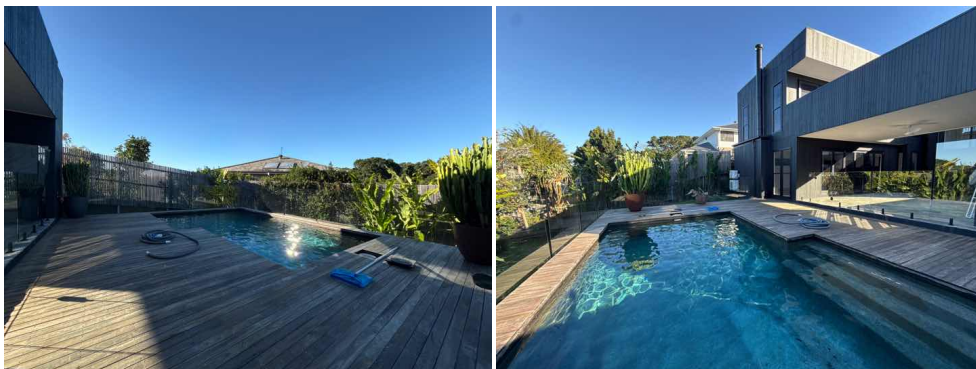
Pool fence and signage were sighted.

The appropriate warning signs do not appear to be present. You should check with your local council regarding the required signs.

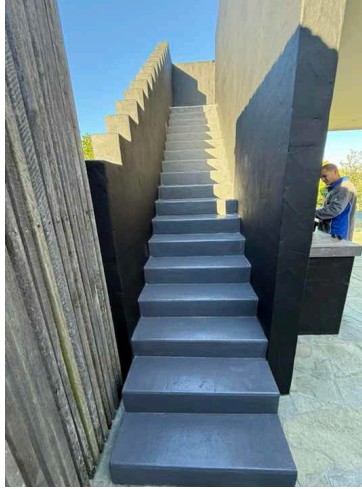
There are no rails on the stairs. This presents a fall risk. Have repaired immediately.

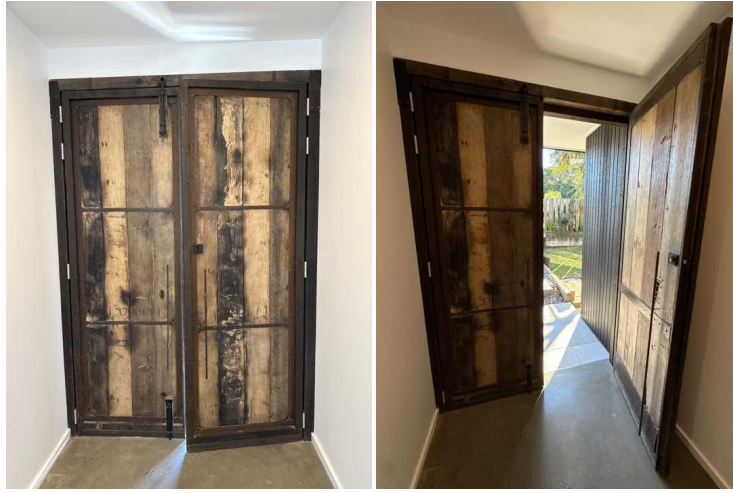
Binding entry door - Doors that bind on the frame can relate to some differential settlement, frame movement, age, expansion, shrinkage or poor hanging. A qualified carpenter should be engaged for repairs.

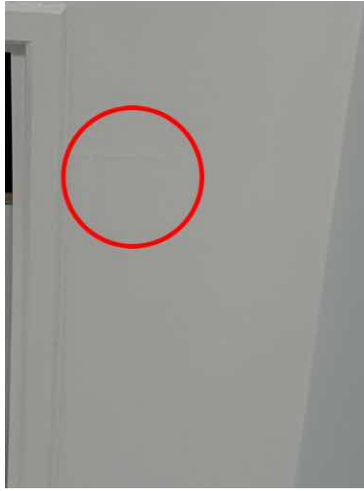
Settlement Cracks Noted. These are typical and generally patch and paint will suffice, however monitoring these cracks is advised for 12 months and if they become worse, further investigation by a suitably qualified professional is advised.

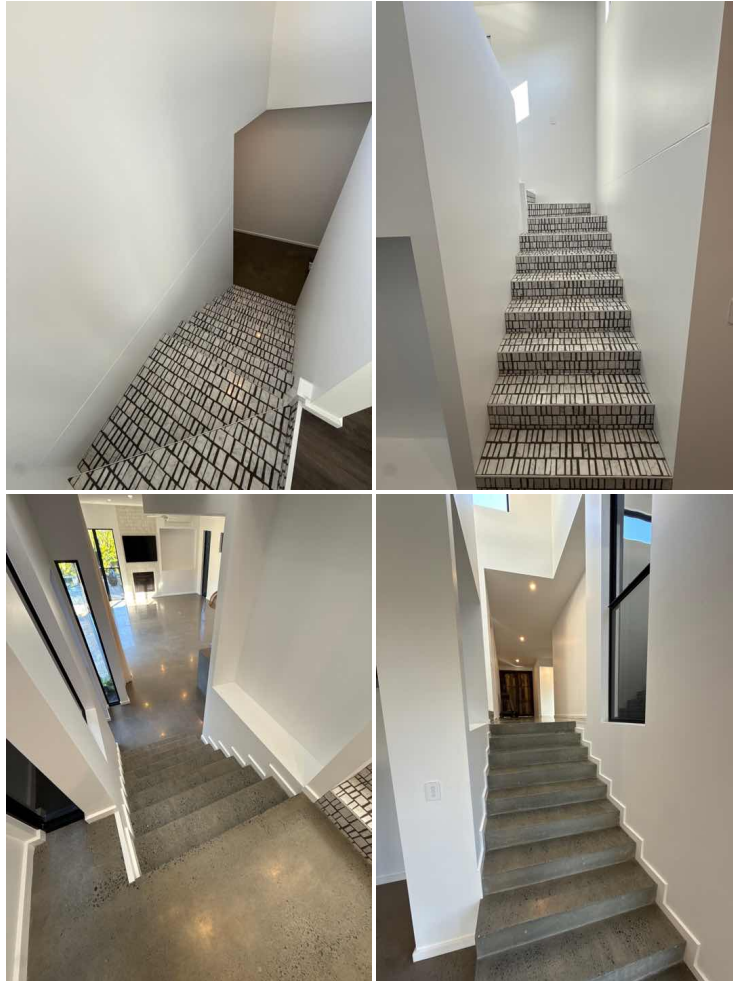
No hand rail installed to the staircase. This is a building requirement and presents a safety hazard. Contact a qualified carpenter or builder for repairs prior to purchase.
