# Building and Pest Report

## 1/14 The Terrace, East Ballina

### Pest And Building Inspection

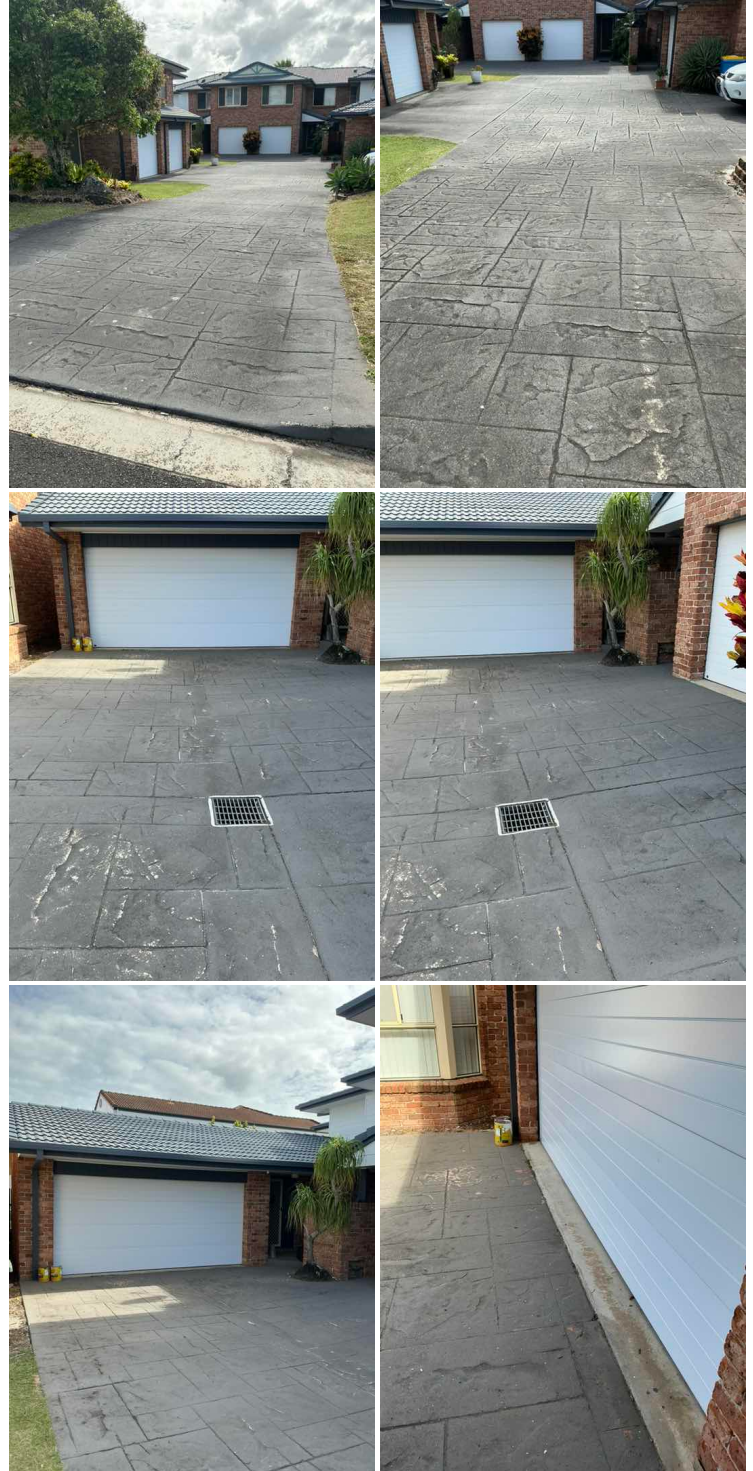
#### Driveway Condition

On visual inspection, the general condition of the driveway is serviceable.

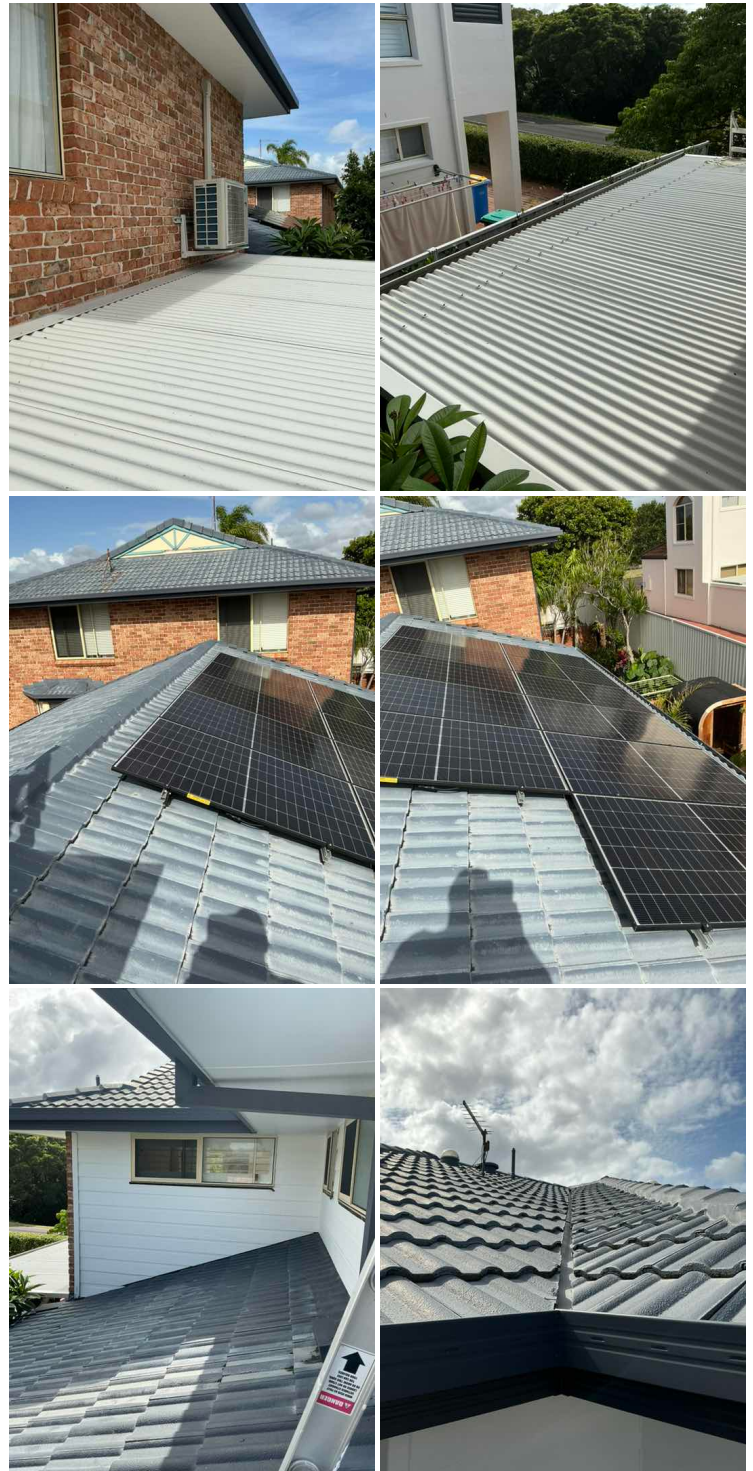
Of the visible areas, the general condition of the roof is in serviceable condition for the age.

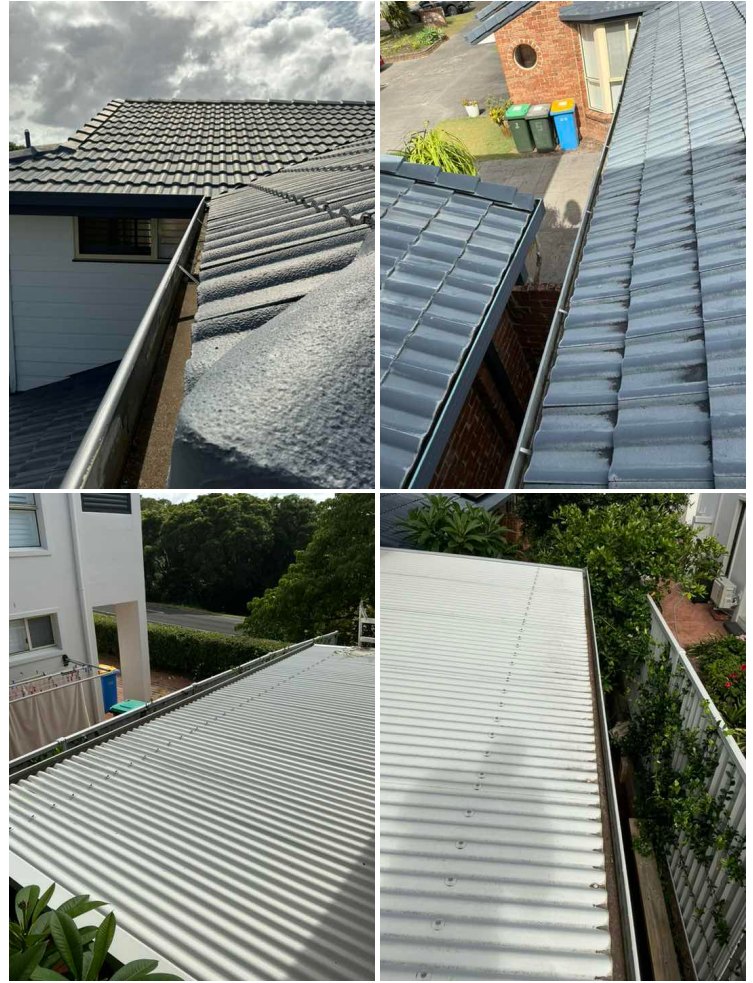
### Gutter Findings

All visible and accessible of the physical nature of the guttering system appears to be in a serviceable condition with no apparent defects at the time of inspection. In the absence of prolonged rain fall efficiency of the guttering can not be assessed and you may find that further investigation or repairs maybe required. Note: Periodic maintenance checks should be carried out for rust penetrations and leaks.

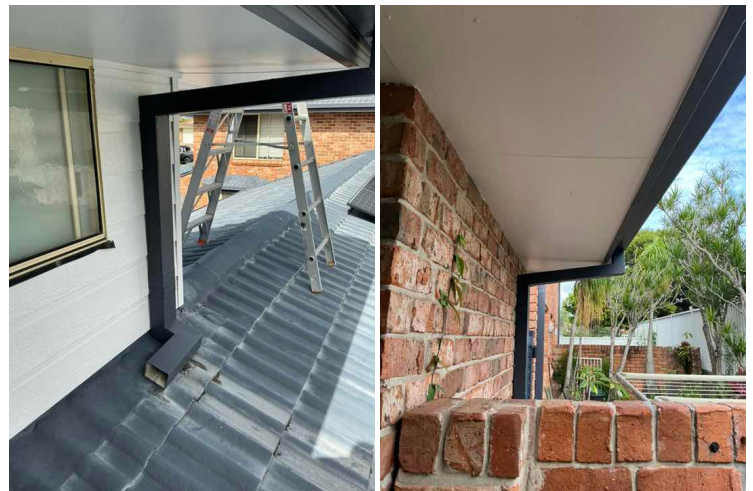
### Downpipe Findings

On visual inspection no apparent defects were noted to the down pipes and are considered serviceable, however no comment can be made with regard to blockages or connections to stormwater or functionality in the absence of rain. Note: Periodic maintenance checks should be carried out for rust penetrations and leaks.

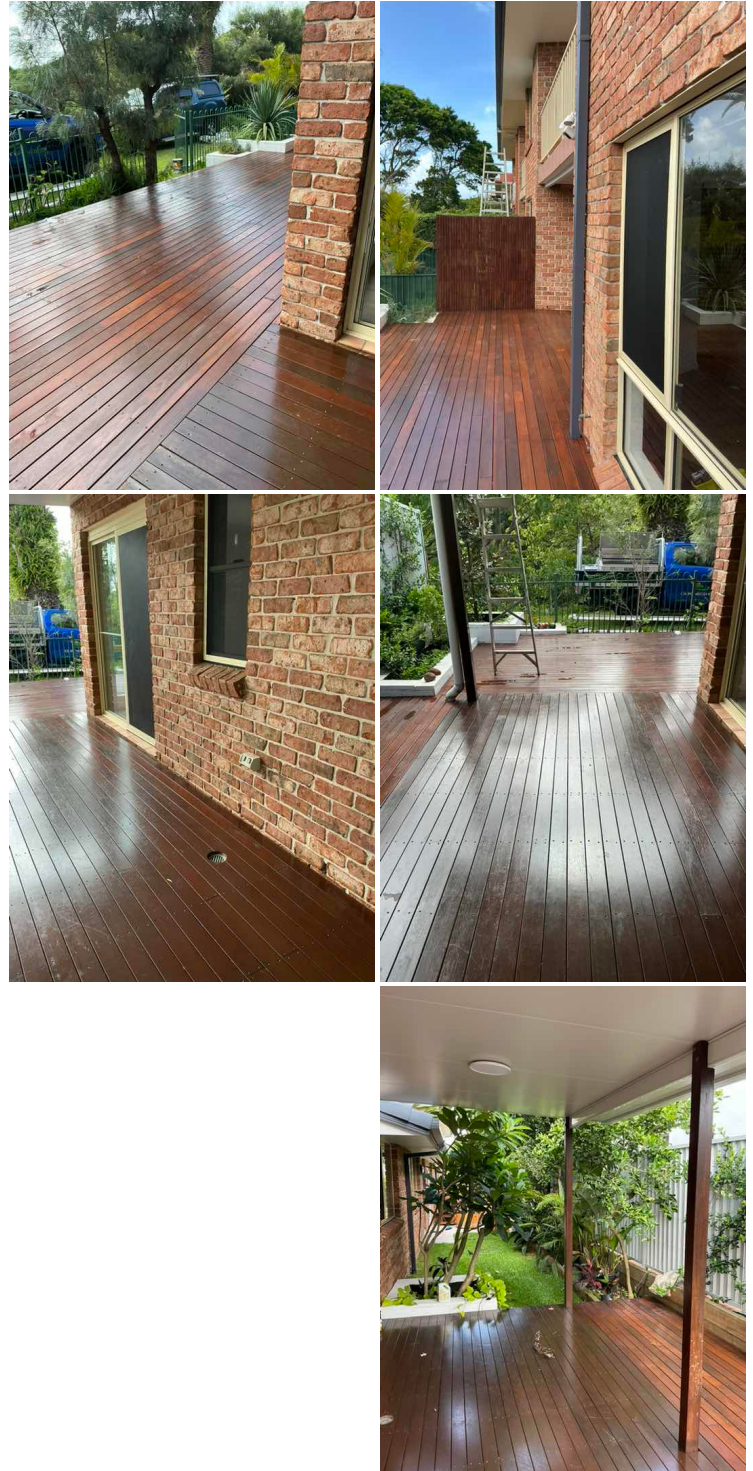
Of areas visible, the decking appears to be in a serviceable condition.

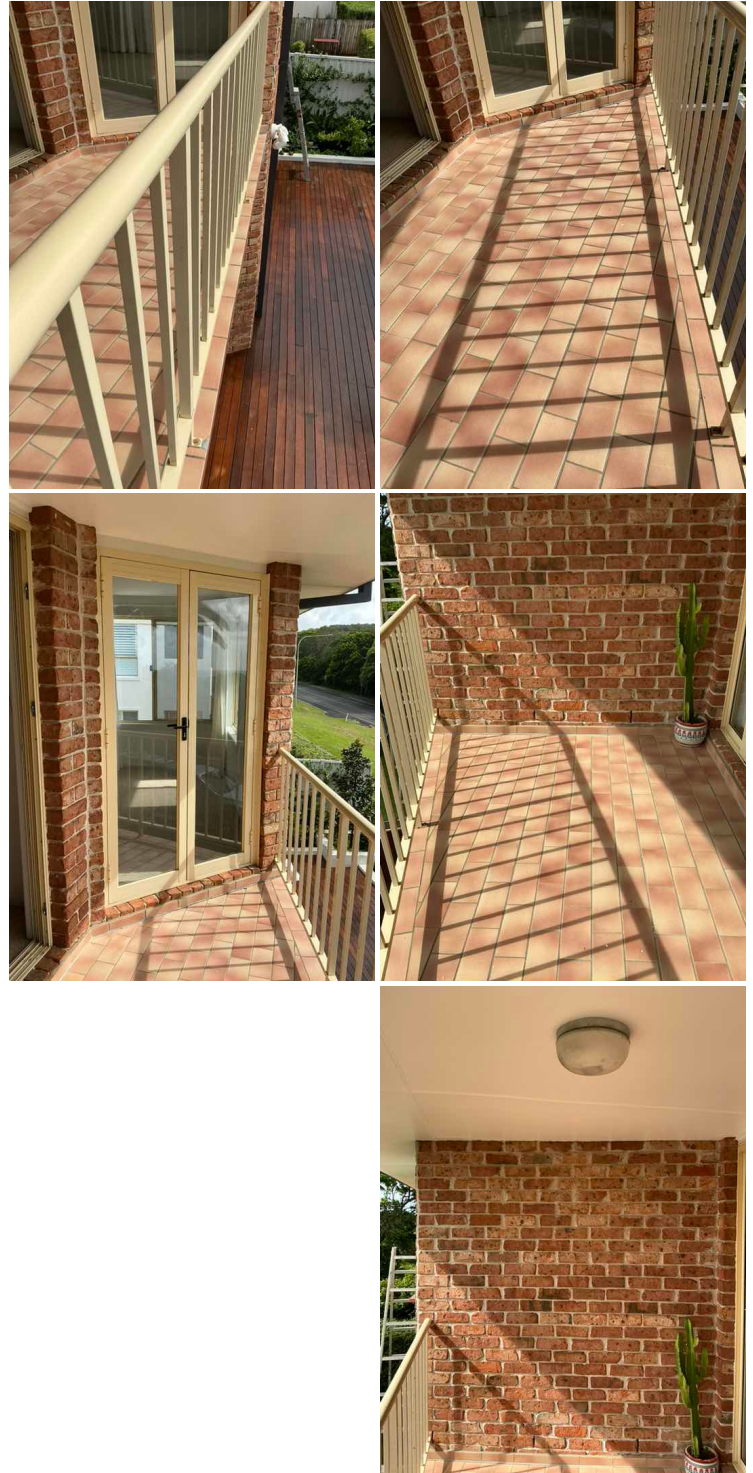
## **Balcony Findings**

Though we are not structural engineers the balcony/s appear to be in a serviceable condition.

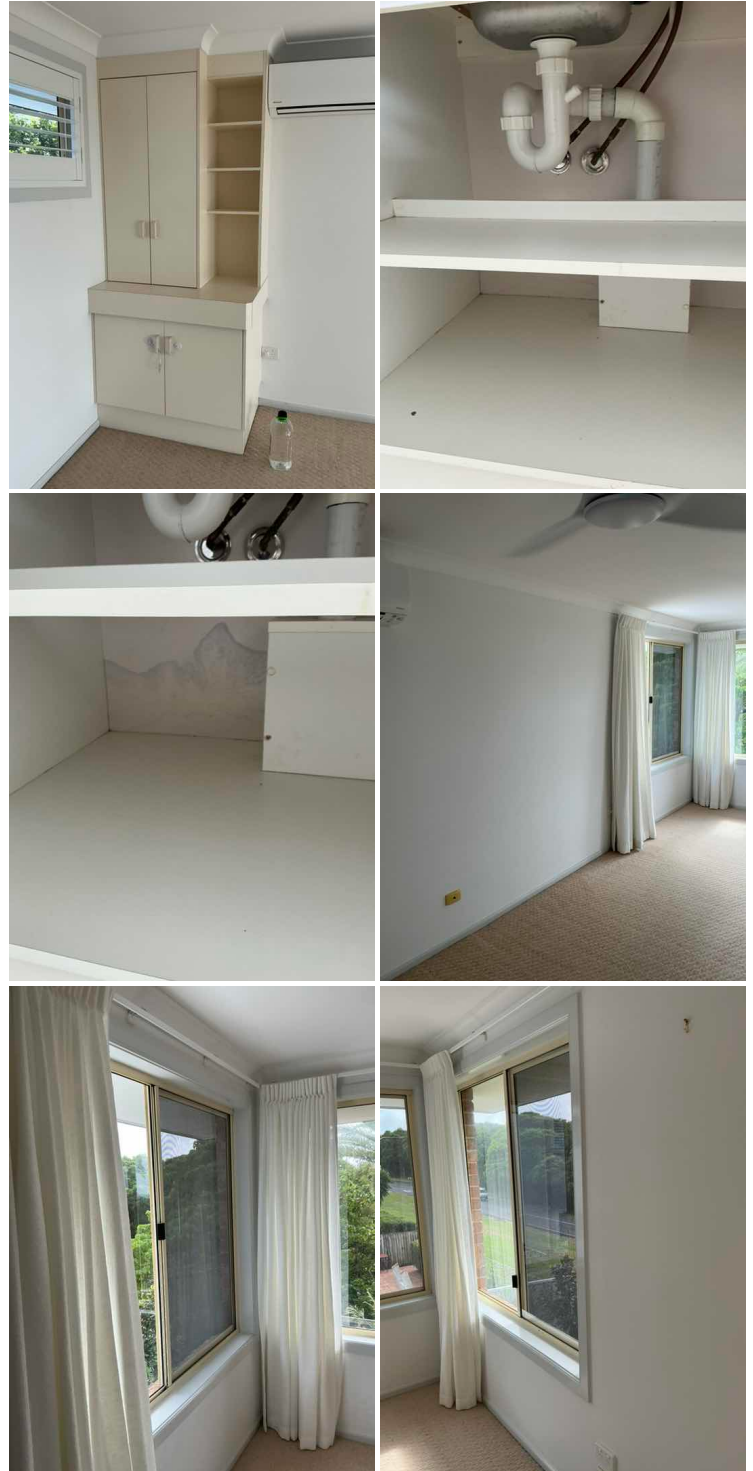
## Upstairs Leisure Room

Upon visual inspection, water damage is evident on the cabinet's back panel. Recommend engaging a licensed plumber to inspect and repair any leaks. A qualified carpenter should replace damaged sections and ensure proper sealing to prevent future issues.

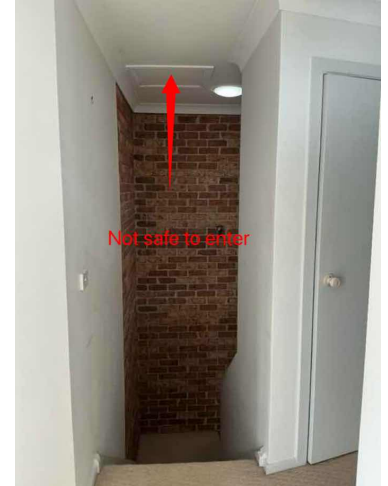
## ROOF VOID

Viewed from out side due to restricted entry. No comment can be made regarding condition
