Building and Pest Report

1/22 Barrett Drive, Lennox Head

Pest And Building Inspection

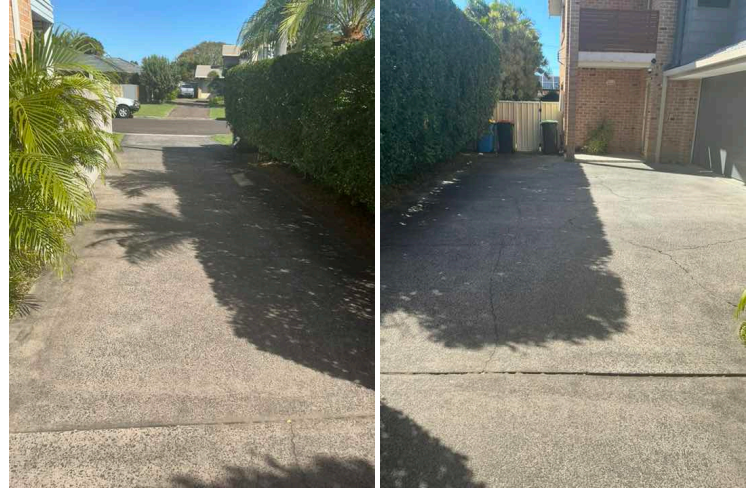
Driveway Condition

Common cracks were observed on the driveway. Whilst these cracks appeared to be typical at the time of inspection, we strongly recommend you monitor these cracks and if worsening occurs contact a concreter for further advice.

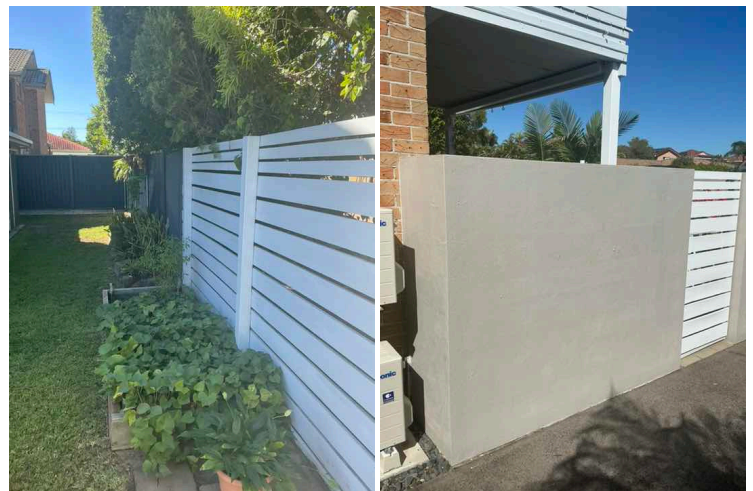
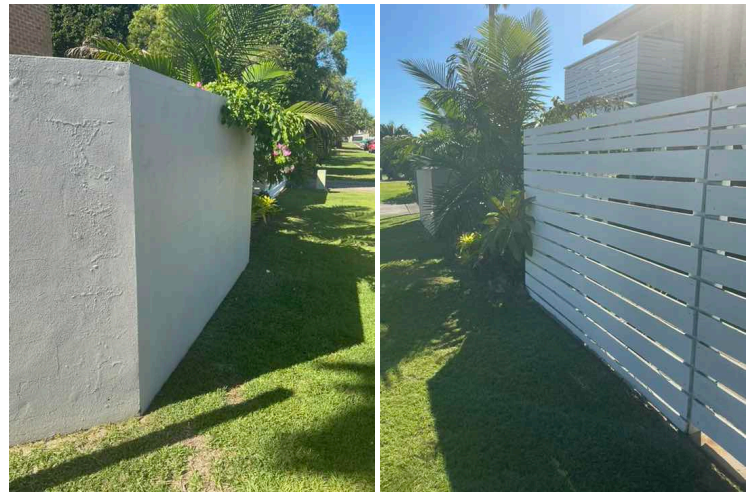
Overall Condition

Of the visible areas, the general condition of the fences and gates is serviceable for the age of dwelling.

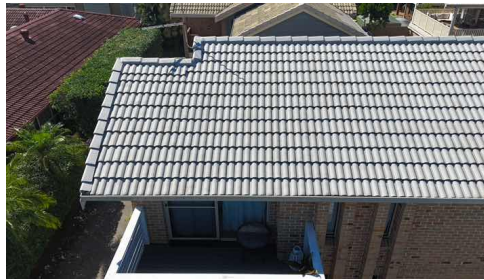
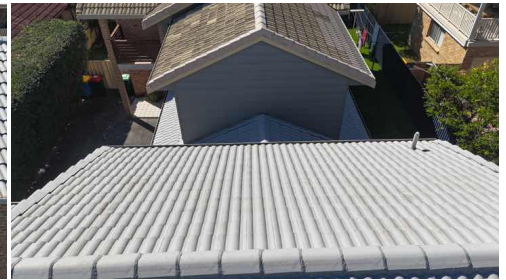
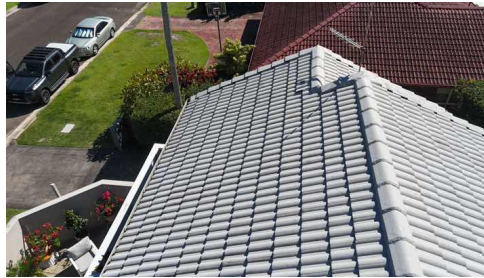
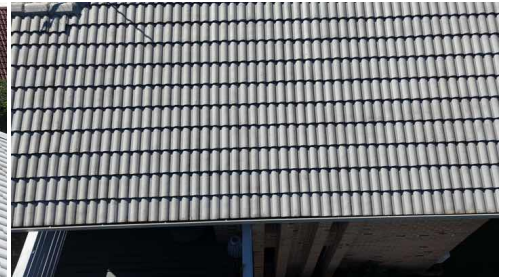
Overall Condition

Of the visible areas, the general condition of the roof is in serviceable condition for the age.

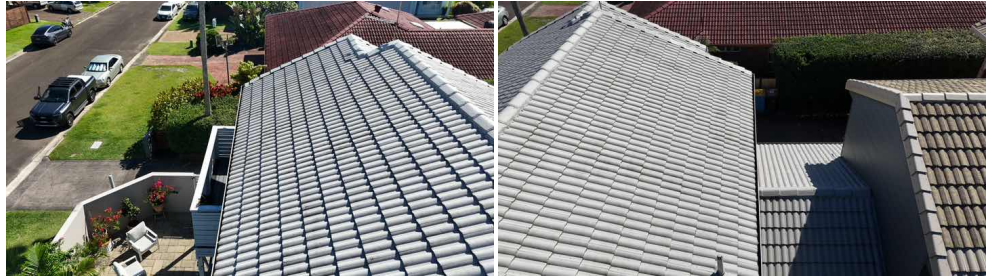
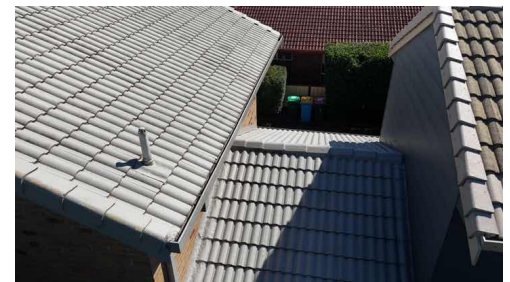
Gutter Findings

All visible and accessible of the physical nature of the guttering system appears to be in a serviceable condition with no apparent defects at the time of inspection. In the absence of prolonged rain fall efficiency of the guttering can not be assessed and you may find that further investigation or repairs maybe required. Note: Periodic maintenance checks should be carried out for rust penetrations and leaks.

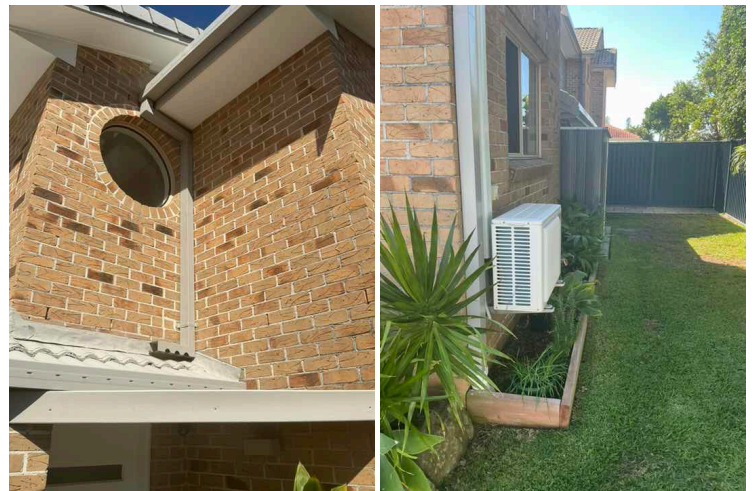
Downpipe Findings

On visual inspection no apparent defects were noted to the down pipes and are considered serviceable, however no comment can be made with regard to blockages or connections to stormwater or functionality in the absence of rain. Note: Periodic maintenance checks should be carried out for rust penetrations and leaks.

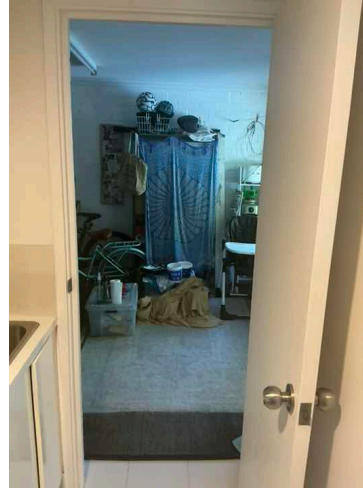
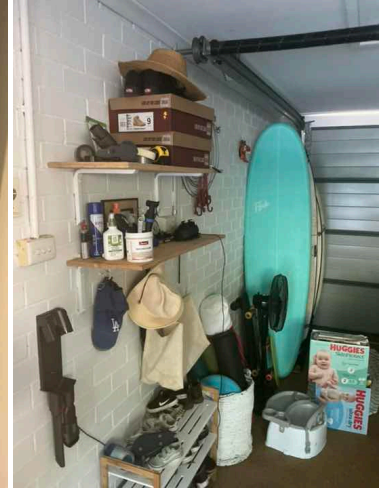
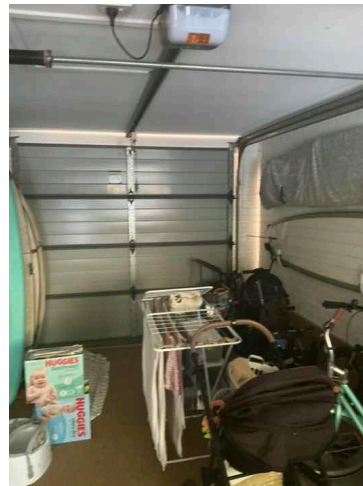
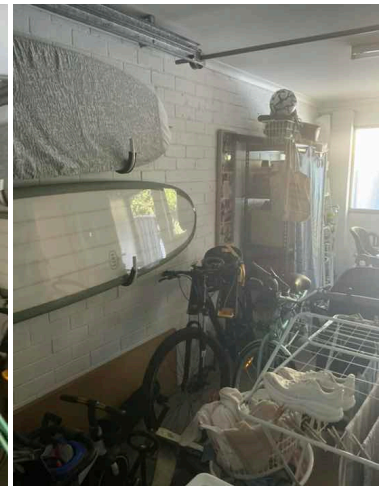
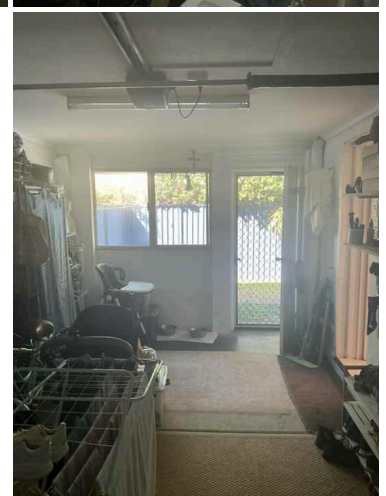
Areas Restricted

Stored items restricted a full and thorough inspection of this area. Defects may exist in the obstructed and inaccessible areas. It is strongly recommended that full access be granted to enable a thorough inspection as there may be timber pest activity, damage or defects. Note: Where vehicles and storage has restricted a full inspection it is advised that this area be cleared so a full and unobstructed inspection can be carried out.
