Building and Pest Report

2/17 Sandbreak Crescent Lennox Head

Pest And Building Inspection

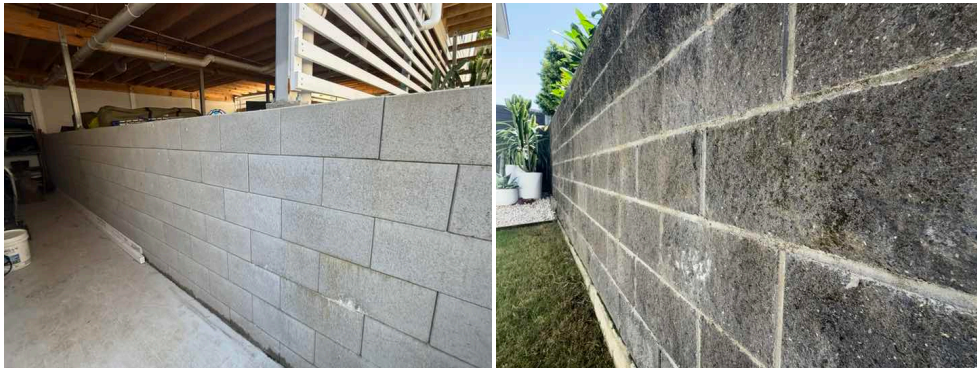
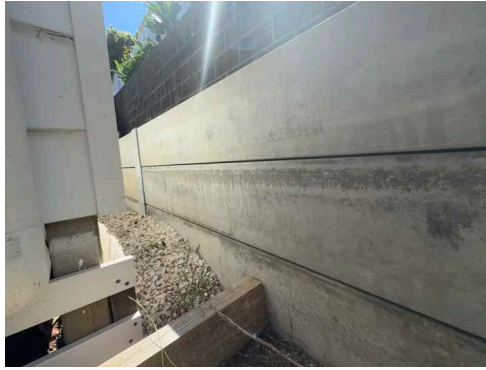
Recommend installing a drainage point under the tap to assist with drainage.

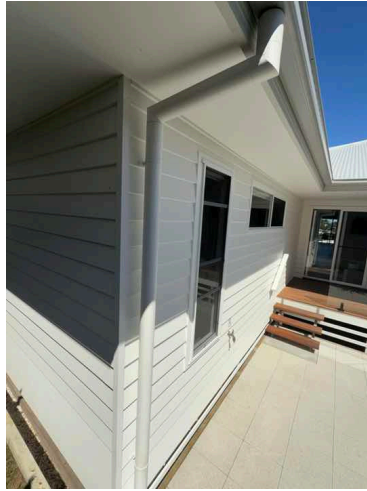
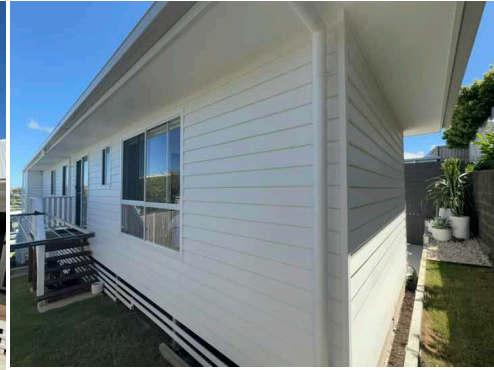
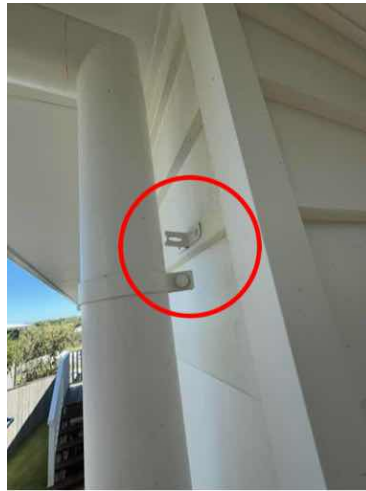
The downpipe/s wall clips is detached or missing. Although minor and easily rectifiable, we recommend a licensed roof plumber be engaged for repairs.

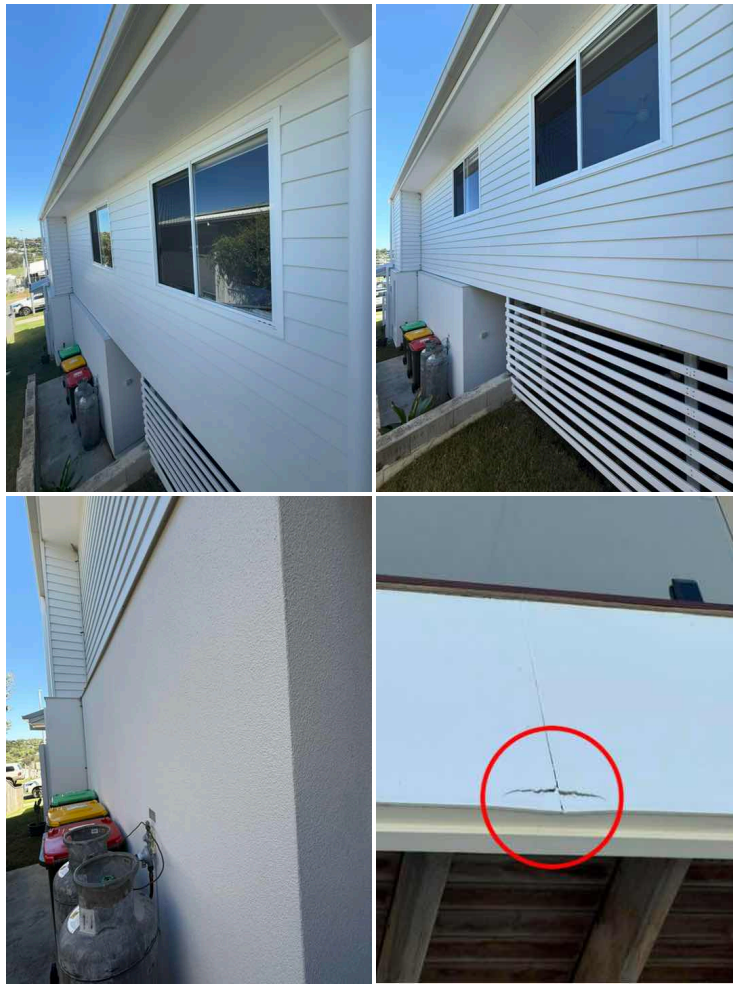
Paneling/cladding damaged. Have a suitably qualified tradesman assess and repair.

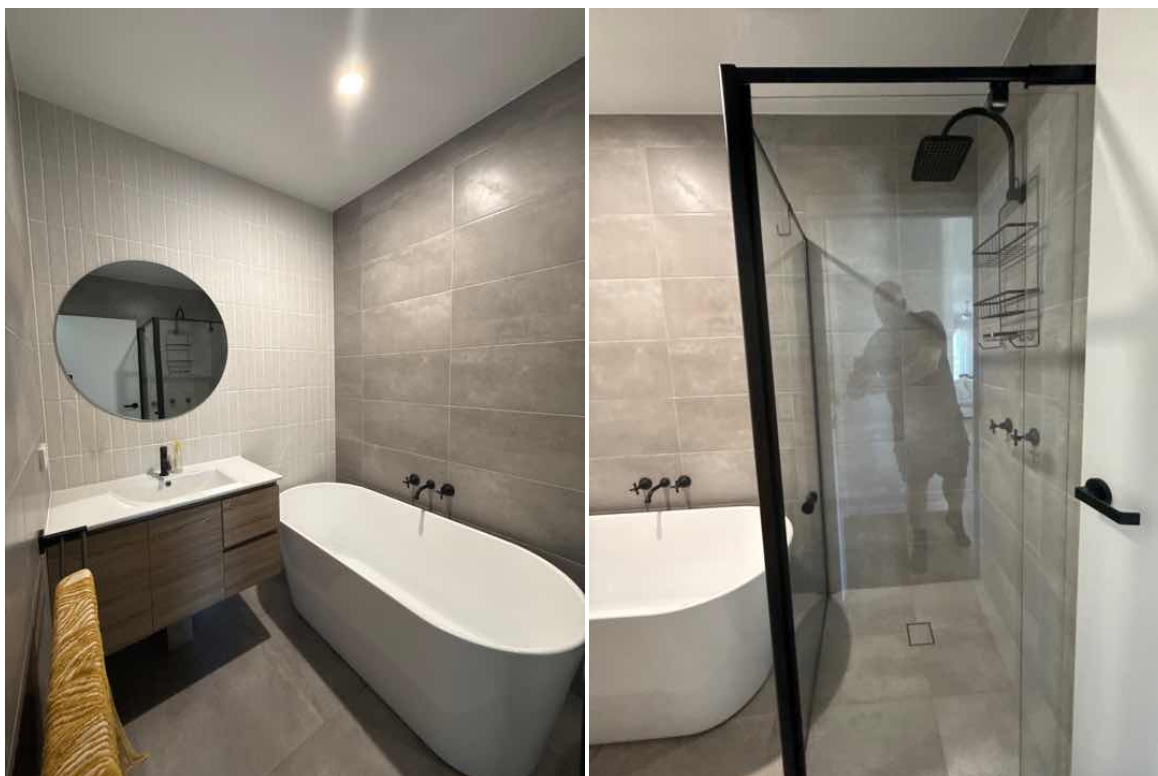
Shower head is leaking. Replacement recommended.

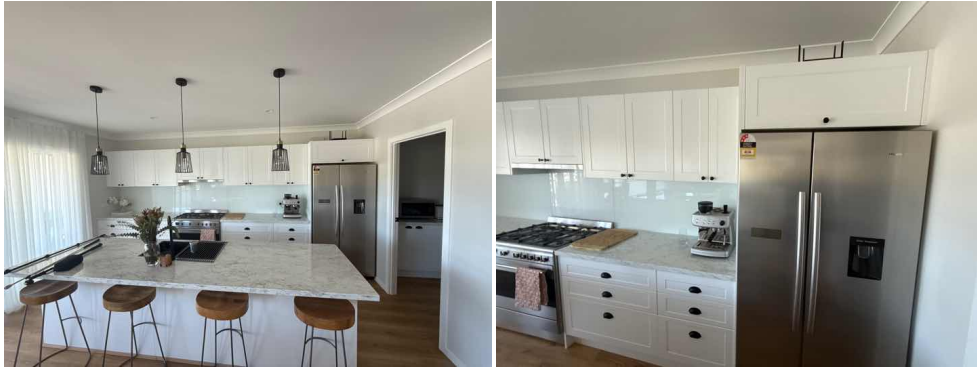
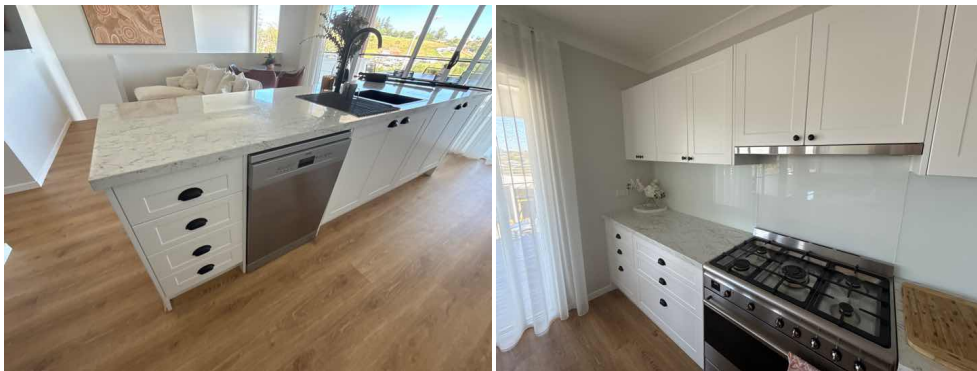
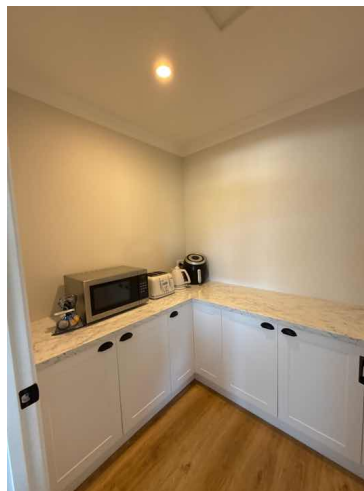
Adjustment to cabinet doors required, in some instance hinges may need to be replaced.
