PEST AND BUILDING PRE-PURCHASE REPORTS

BUILDING & PEST INSPECTIONS

7 Sand Street
Skennars Head

BPI - INSPECTION REPORT

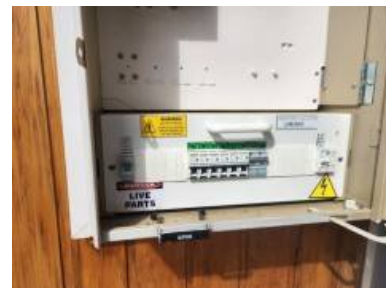
Whilst not an electrician, it appears that an electrical safety switch is present.

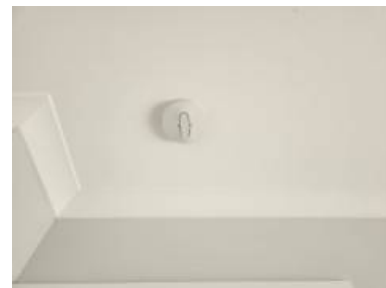
Present - Hall.

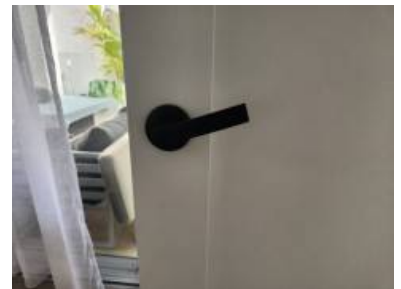
Some handles need minor adjustment.

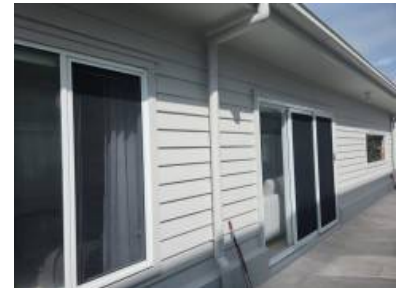
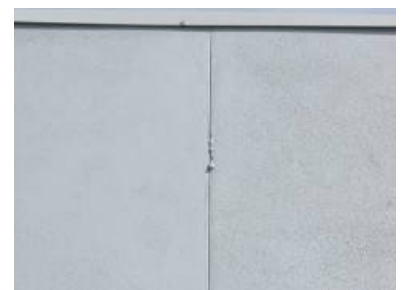
Minor chipping to render join above garage.

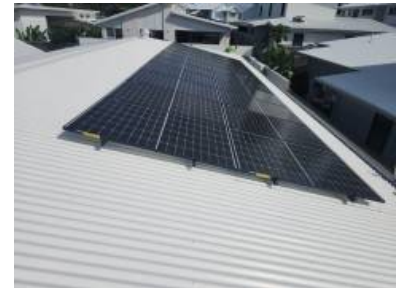
Solar Panels are present to the Roof Exterior and restricted the inspection of the roofing material beneath. Concealed damage may be present but not identified in the report.

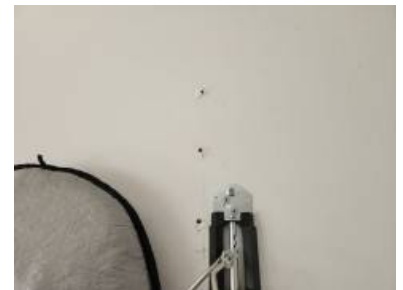
Some walls need patching and painting.

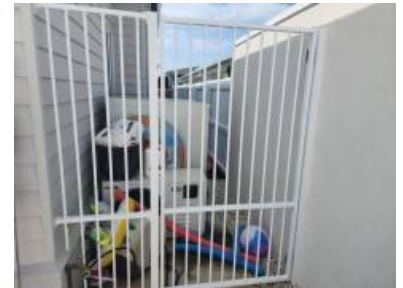
The Pool Gate does not self-close and requires repair / adjustment. This is a safety Hazard and requires Immediate Rectification.

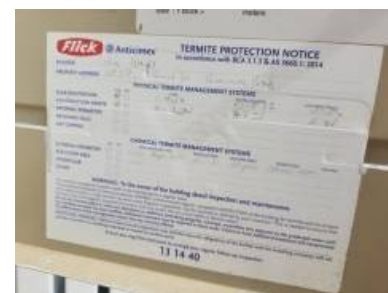
A termite barrier / treatment notice in the Meter Box / Kitchen Cupboard indicates that the slab penetrations, cold joints and perimeters are protected from termite activity by Anticimex barriers. We strongly recommend you obtain all barrier paperwork & warranty information. These barriers were installed in 2022.
