# Building and Pest Report

## 5 Blackwood Cres Bangalow

| Inspection Date: | 25 Sep 2025 |

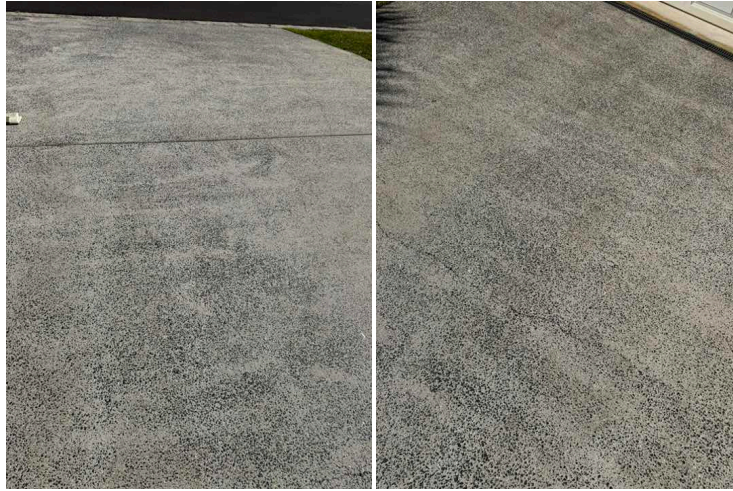
Common cracks were observed on the driveway. Whilst these cracks appeared to be typical at the time of inspection, we strongly recommend you monitor these cracks and if worsening occurs contact a concreter for further advice.

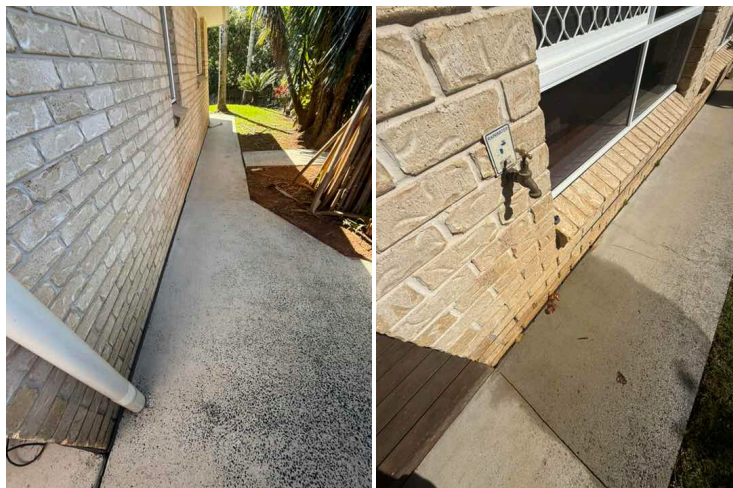
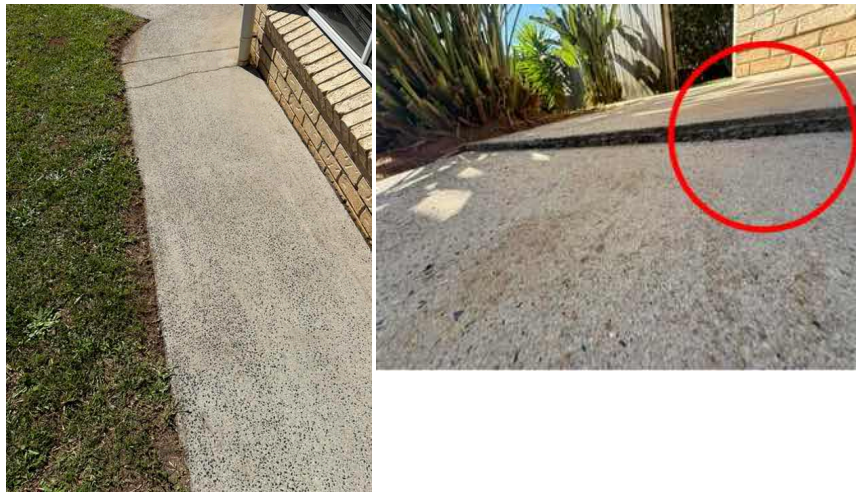
Common cracks and settlement were observed on paths. Whilst these cracks appeared to be typical at the time of inspection, we strongly recommend you monitor these cracks and if worsening occurs contact a concreter for further advice.

Surface raised and settled in some areas. This can cause water ponding. Relaying recommended.

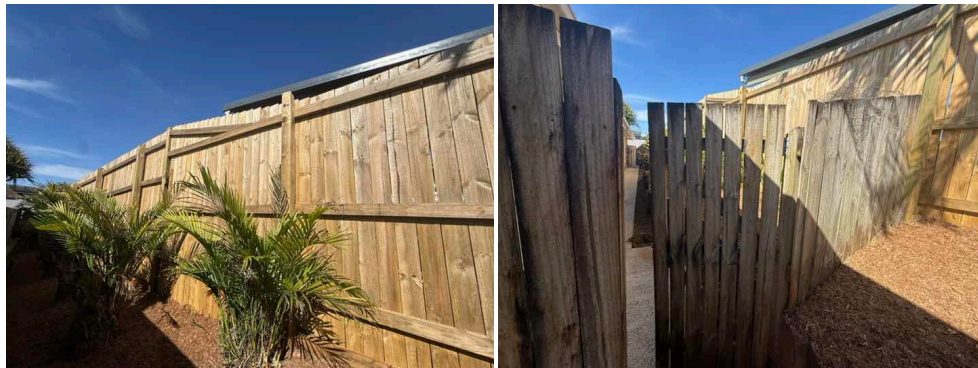
General age to fence components. General upkeep and maintenance required. A qualified fencing contractor should be engaged for repairs.

General age/damage/binding of gate/s components - Recommendations: A qualified fencing contractor should be engaged for advice and recommendations.

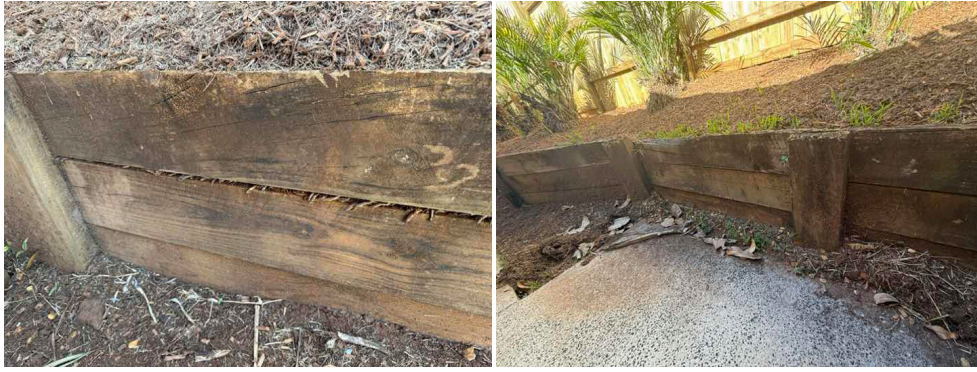
Timber fungal decay evident. Recommendations: A qualified landscaping contractor should be engaged for repairs and recommendations.

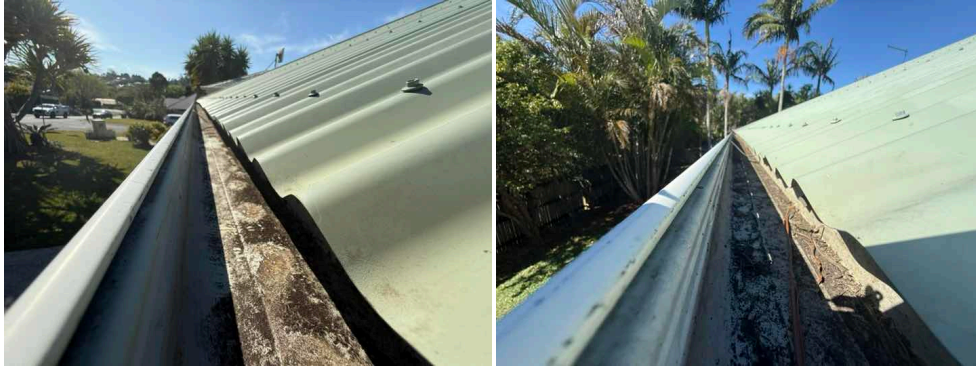
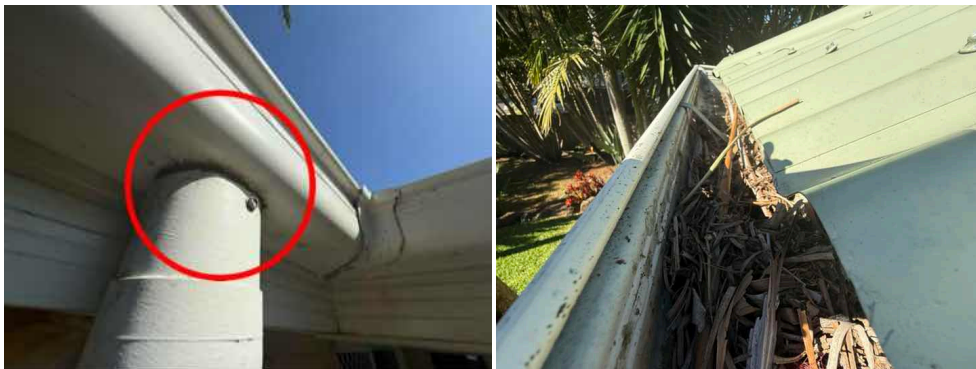
Debris in guttering areas- this requires cleaning out to prevent blocking of downpipes and leaking into eaves and fascia. Have gutters cleaned and assessed by a plumber for adequate fall. Regularly clean to prevent ponding. Ponding water will contribute to rust.

Gutter surface rust in sections- the rust is yet to penetrate and repairs/sealing may be an option. A qualified roof plumber should be engaged for advice and recommendations.

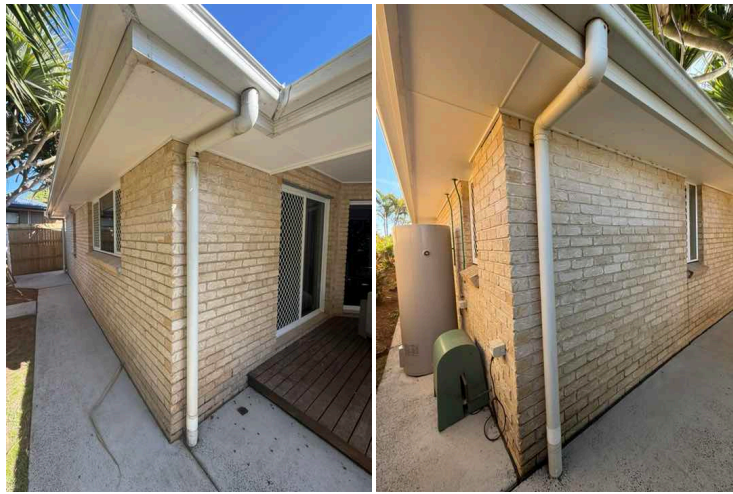
Leaking downpipe joints visible. This can be conducive to termite infestation and cause water damage to cladding over time. A qualified roof plumber should be engaged to repair.

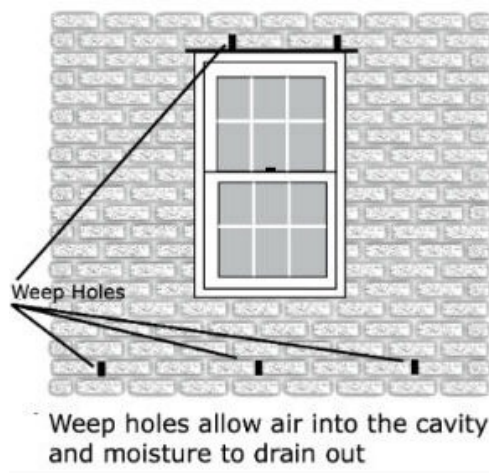
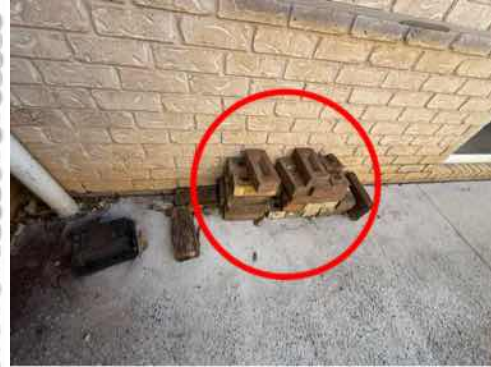
Vents are covered by decks. Sub floor vents should be exposed and allowing free flowing air.

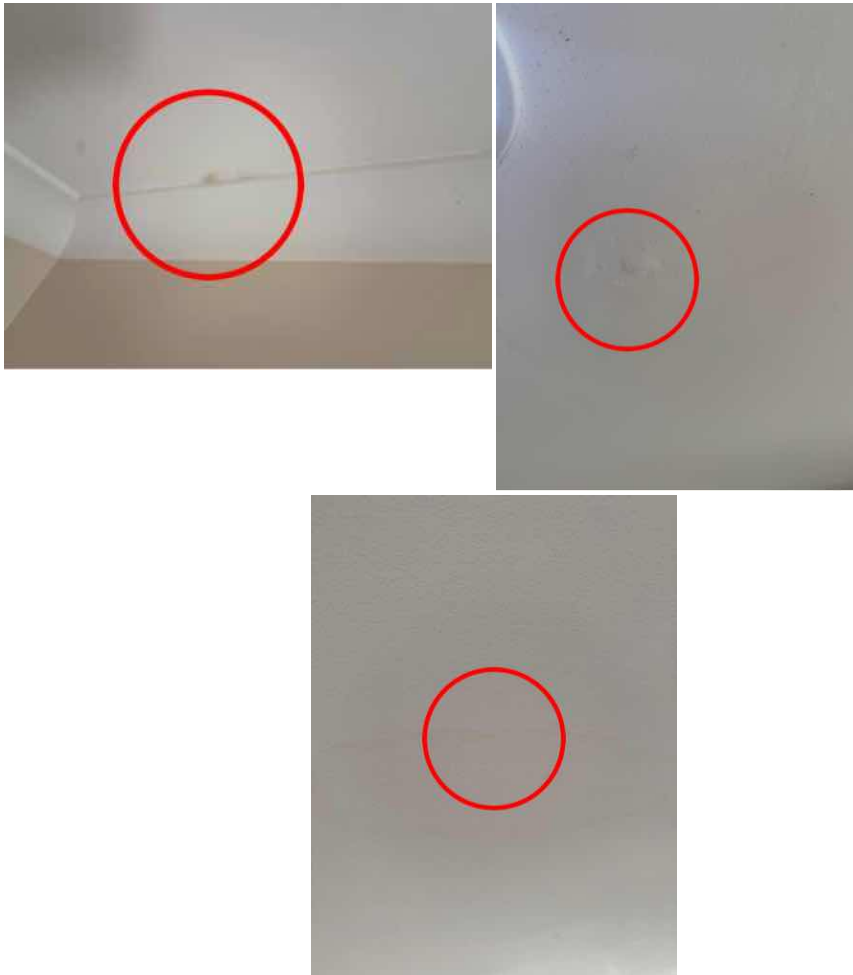
Incomplete patch/paint repairs noted. I recommend you contact a qualified painter for repairs.

Ceiling stains - No moisture readings obtained. These may have been repaired however you will need to monitor after a prolonged period of rainfall. If leaking persists, a qualified plumber should be engaged for advice and recommendations. All water damaged plaster should be replaced.

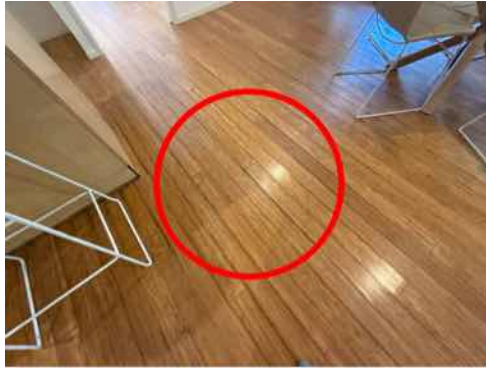
Stained timber flooring - This is normally due some water penetration. This will not be able to be removed and options include replacement, staining all the boards dark or lining same to cover. A qualified carpenter should be engaged for advice and recommendations.

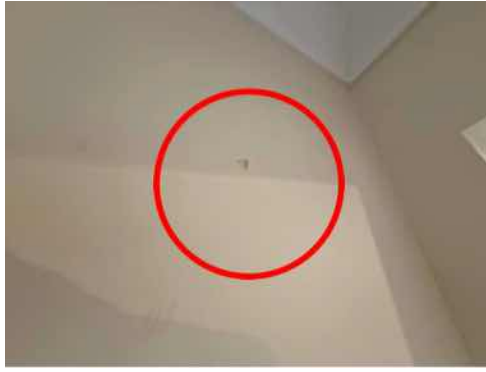
Impact damage noted. Contact a qualified painter for repairs.

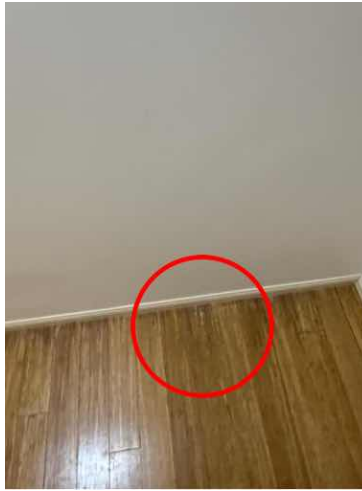
Stained timber flooring - This is normally due some water penetration. This will not be able to be removed and options include replacement, staining all the boards dark or lining same to cover. A qualified carpenter should be engaged for advice and recommendations.

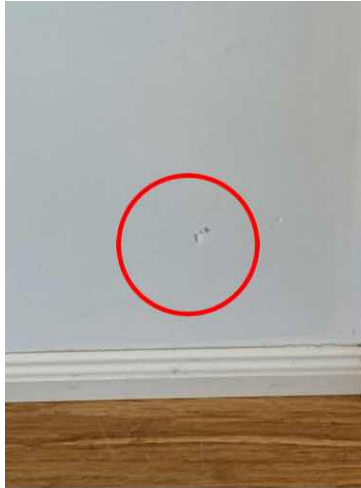
Impact damage noted. Contact a qualified painter for repairs.

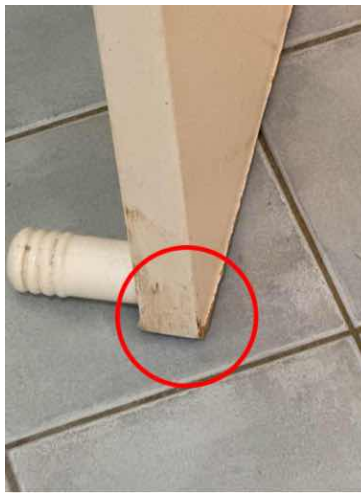
Water damaged door. Possible due to leak in bathroom. Replacement recommended.

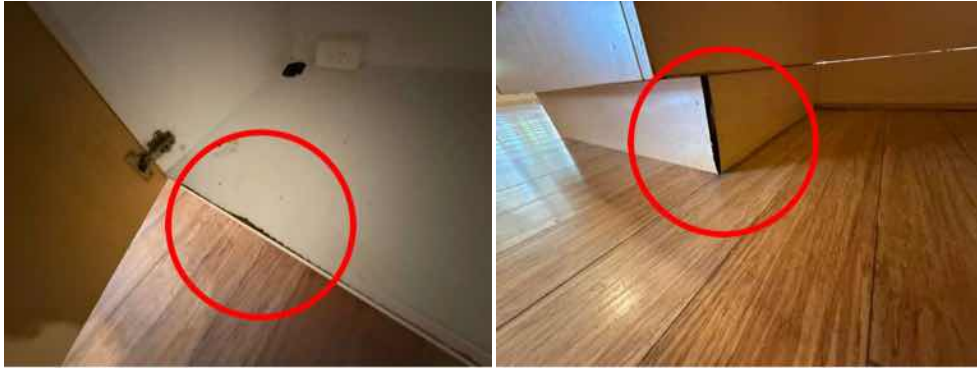
Adjustment to cabinet doors required, in some instance hinges may need to be replaced.

Damage was noted to the cabinets, contact a joinery company for repairs

Water damage to cabinet observed. Replacement required. Contact a cabinet maker for repairs.

Apply flexible sealant to cabinet/wall junction for a clean finish.

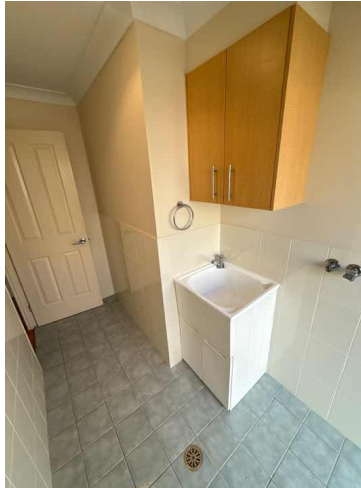
Drummy tiles noted. This needs to be repaired at the earliest as this has the potential to lead to many related issues such as damp, water ingress to other areas and cracked tiles. Contact a qualified tiler for repairs and recommendation.
